Ref No.: 100440EN121145

**Contract No. EP/SP/58/08**  
**Sludge Treatment Facilities**  
**Environmental Monitoring and Audit Report**  
**For**  
**September 2012**

Date : 04 October 2012

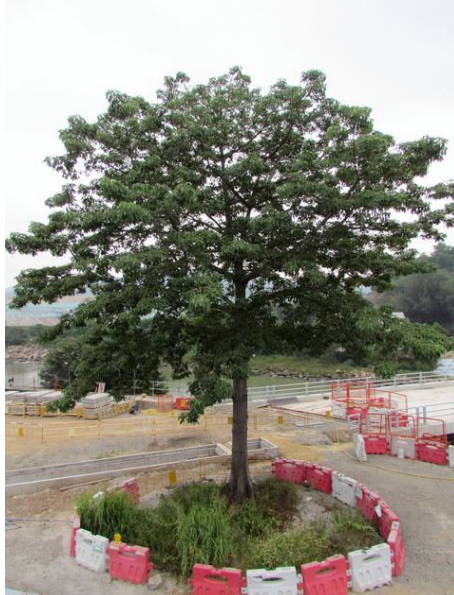
**2. Photographic Record of Protection to the Fell / Retained Trees**

T758 is confirmed to be retained on site. Proper tree protection should be applied to protect T758. Amendment to the tree felling application will be submitted.

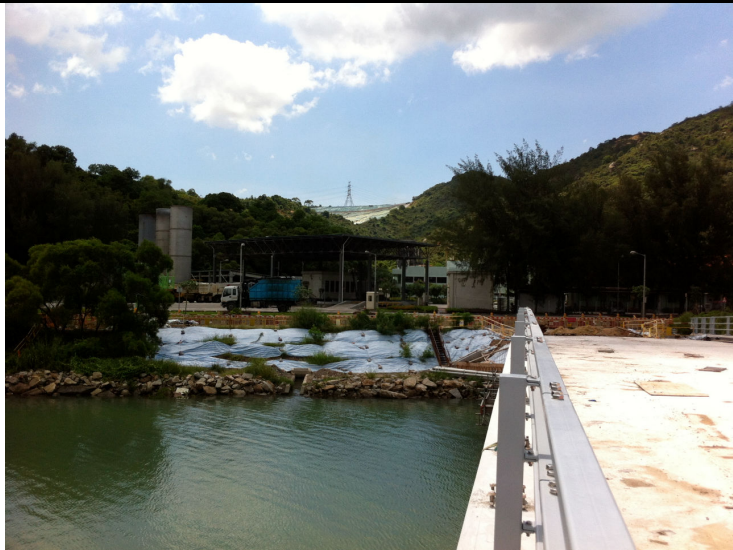
**3. Photographic Record of the Original Transplant Trees Location**

The new tree plantings will be proposed on the either side of the bridge at portion 6 to fulfil the EIA requirement.

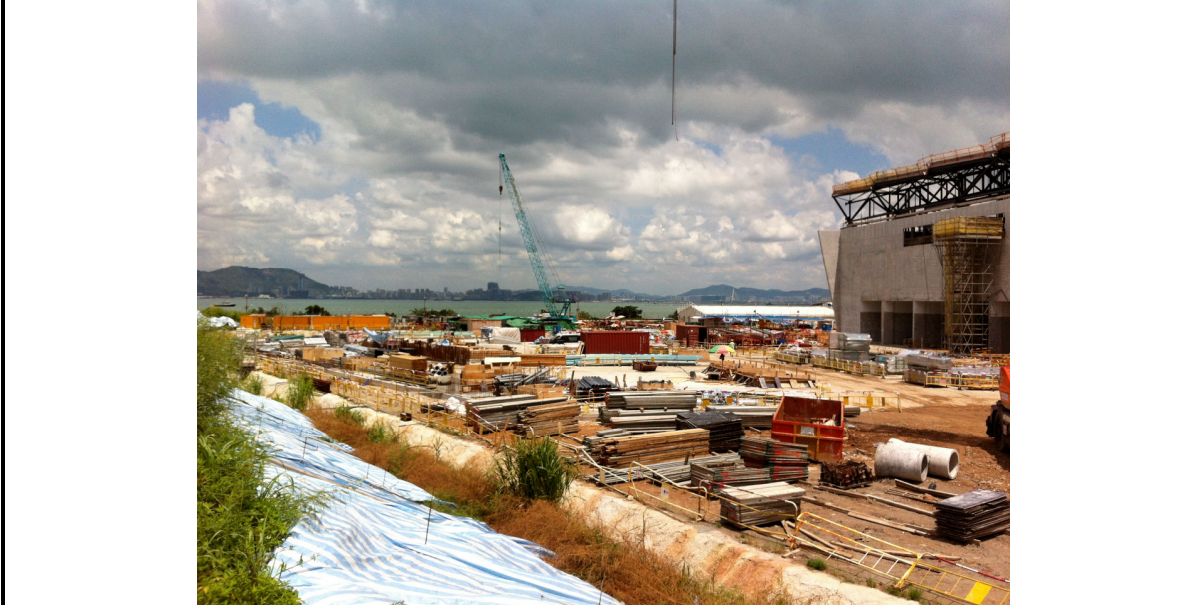
**4. Photographic Record of the Compensatory Tree Locations**

More compensatory trees will be added for the dead transplant trees, which should be reflected in the tree felling resubmission. Final locations of the compensatory planting to be verified on site by the contractor. These shall be reflected in the revised compensatory proposal as well.

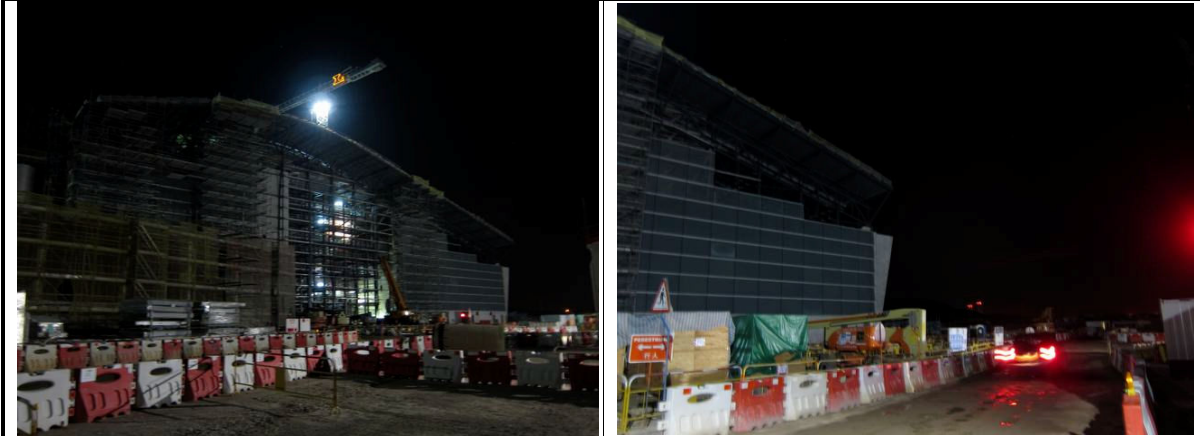
**5. Photographic Record of the Night-Time Working**

The lighting during night-time working is confined within the working area within the site boundary. Periphery area and the sensitive receivers are not affected by the lighting during night-time working.
