Contract No. DC/2007/24
Harbour Area Treatment Scheme Stage 2A
Construction of Sewage Conveyance System from Aberdeen to Sai Ying Pun

Environmental Certification Sheet – 47

Contract No. DC/2007/24
Construction of Sewage Conveyance System from Aberdeen to Sai Ying Pun
Condition 4.4 – Submission of Monthly EM&A Report for October 2012 (no. 34)

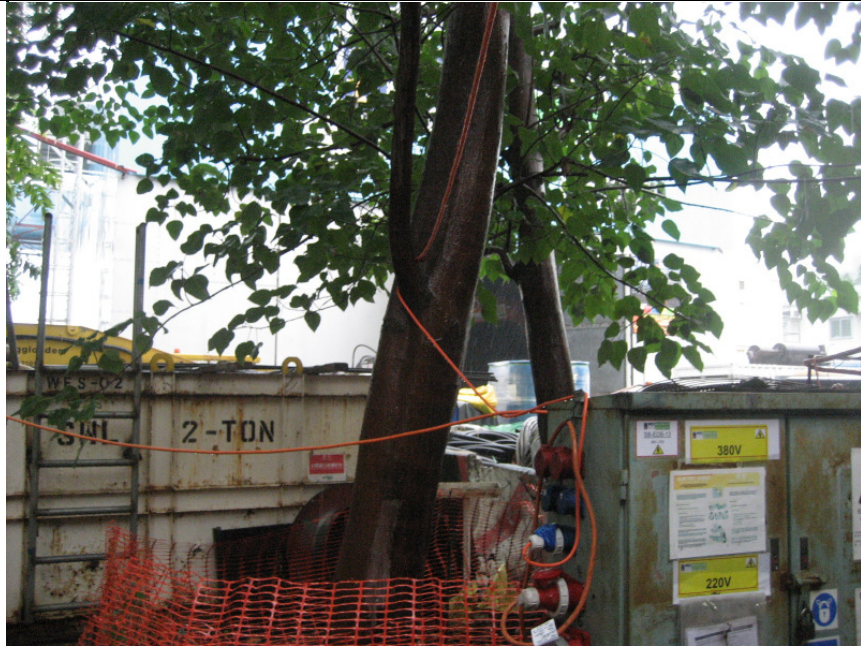
Sandy Bay site --- Photo 1

Cable was still hanging from the tree branches of the retained trees T021(R) and T027(R)

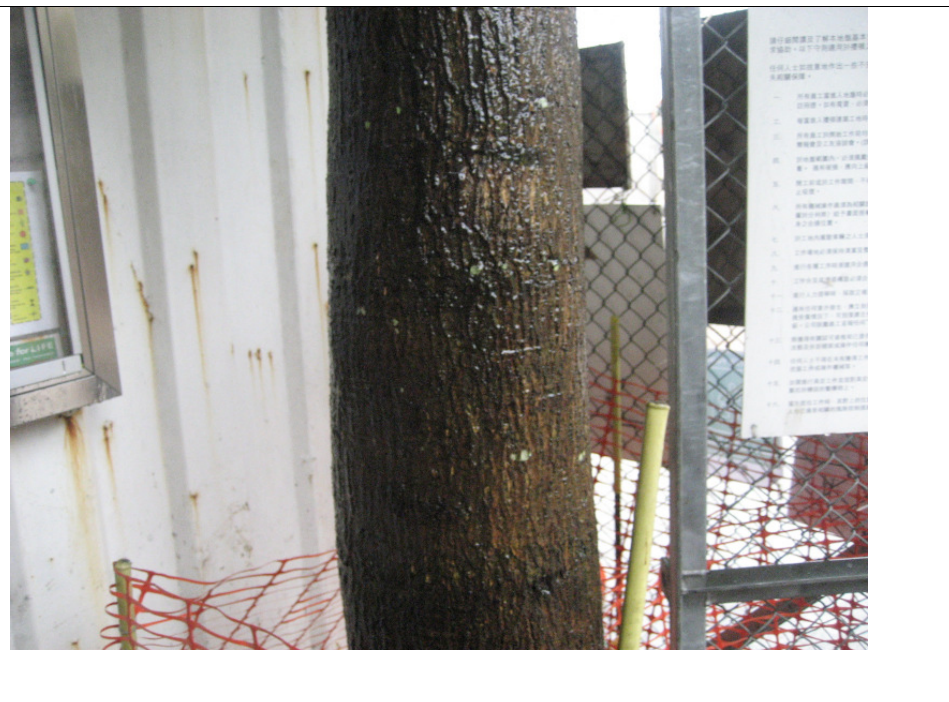
Aberdeen site --- Photo 2

Construction materials were still stored very close to the root area of the retained tree T081(R).

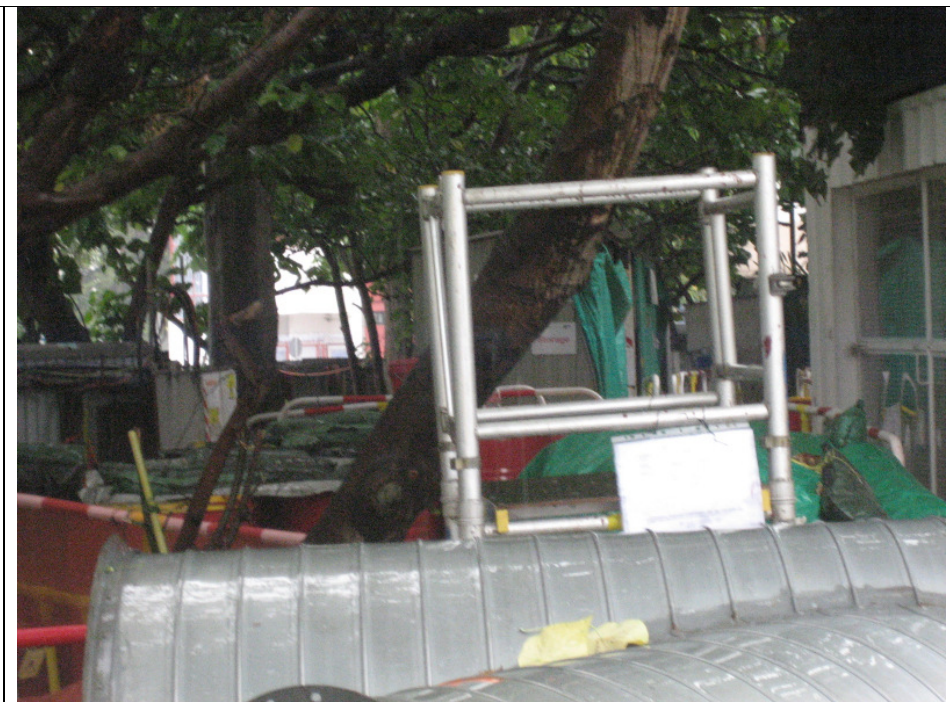
Cyperport site --- Photo 3
 The identification tag for the retained tree T48(R) was missing.

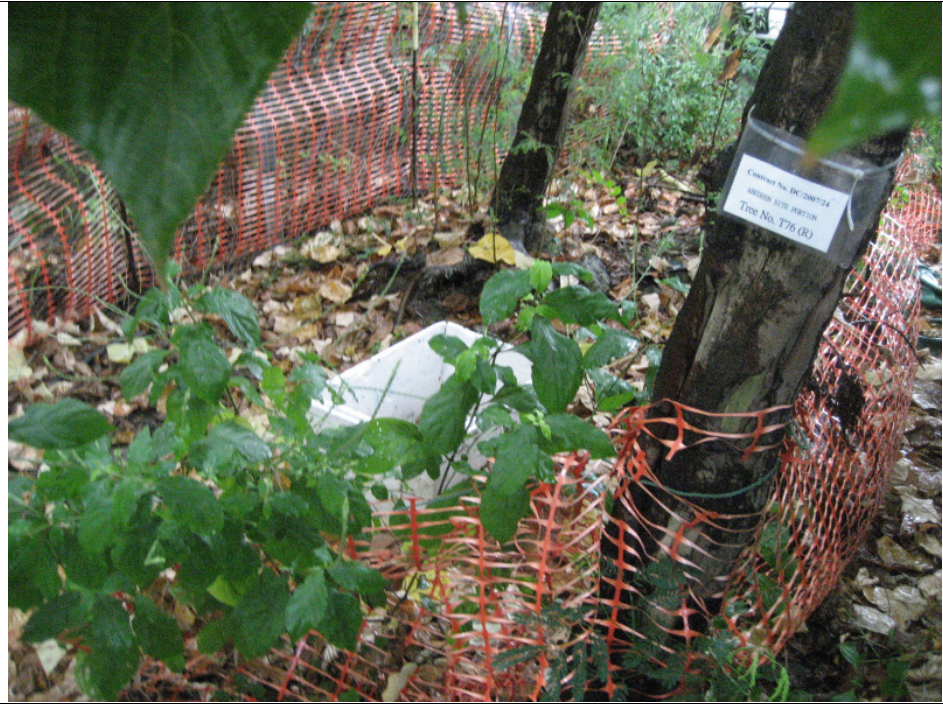
Aberdeen site --- Photo 5

General refuse was dumped within the tree protection zone of the retained tree T76(R).

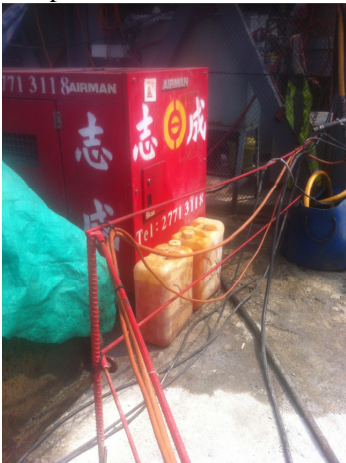
Photo 1 Chemical containers were found to be without drip trays near the compressor area.

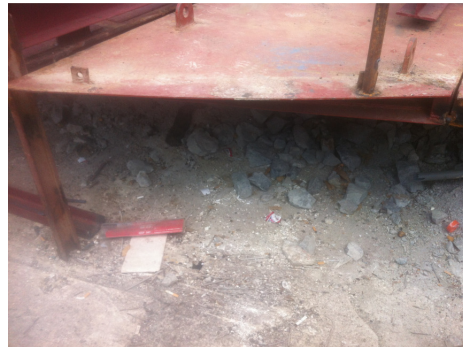
Photo 2 Rubbish and cigarettes butts were found inside the site area.

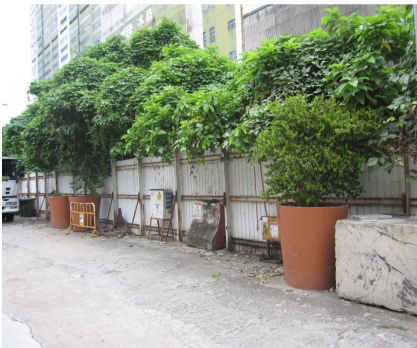
Photo 3 The contractor has removed the chemical container

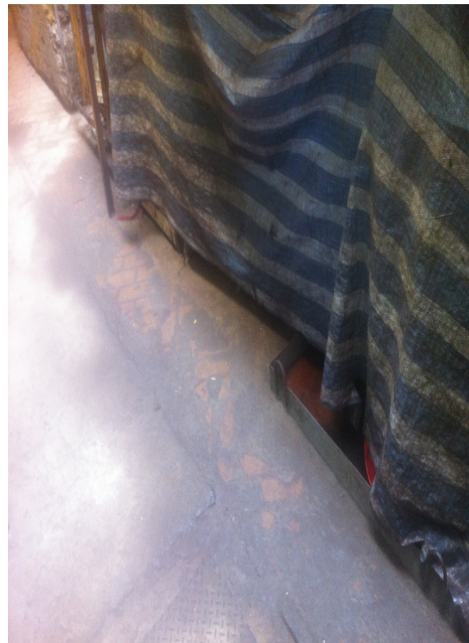
Photo 2 Waste oil was found near the noise enclosure of the inner entrance

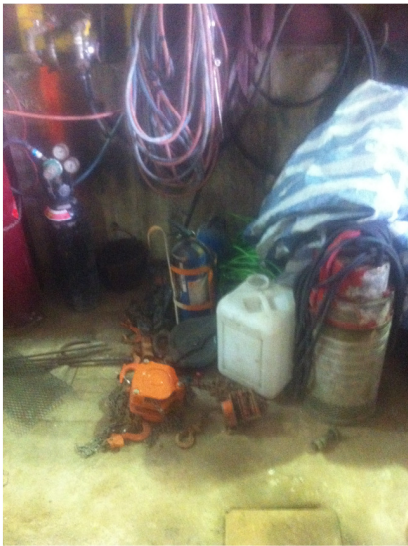
Photo 1 Oil wastes were found within the equipment area inside the noise enclosure.

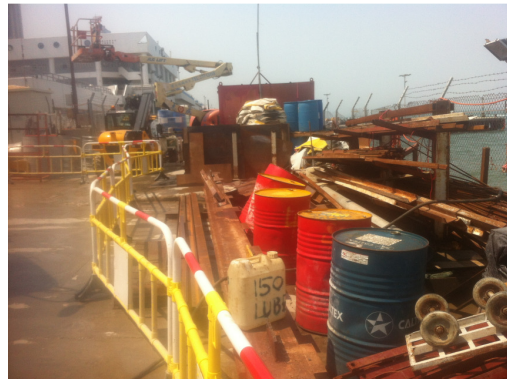
Photo 2 Chemical barrels were found to be without drip trays outside the noise enclosure area

2. The contractor is recommended to provide drip trays for chemical containers.

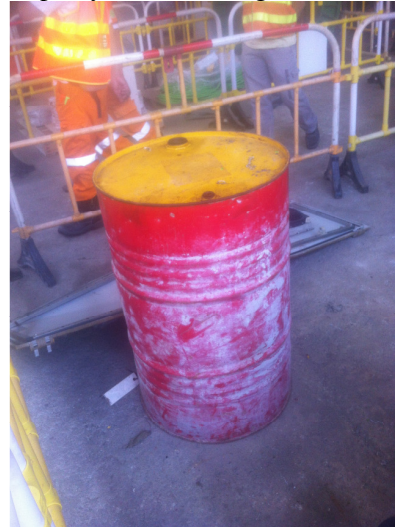
Photo 2 Chemical container was found without a drip tray in the welding area.

1. The contractor is reminded to provide a drip tray to the chemical barrel.
2. The contractor is reminded to provide a drip tray to the chemical container in the welding area.

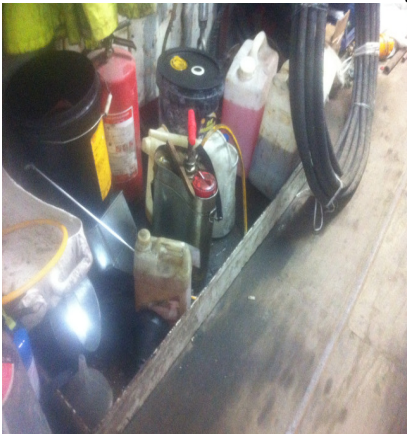
Photo 3 Waste oil was found near the welding area.

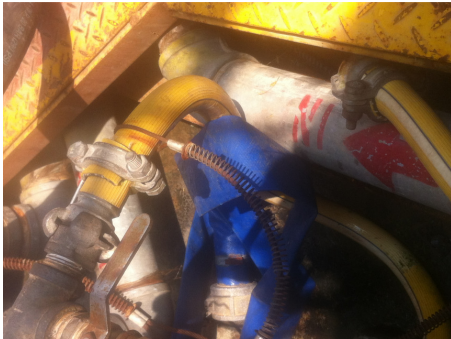
Photos 1 Pipe leakage was found by the equipment area.

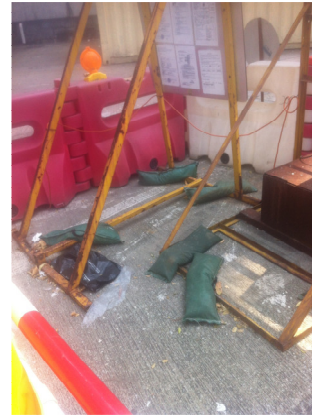
Photos 2 Rubbish and leaves was found near the front entrance of the site.

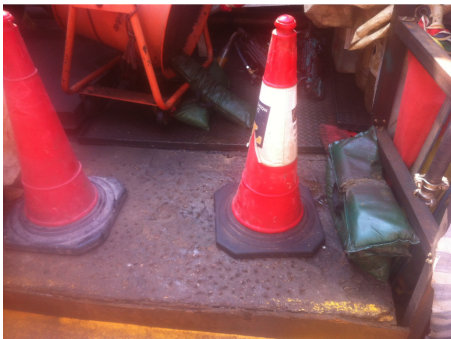
Photo 3 Oil waste was found near the chemical container area.

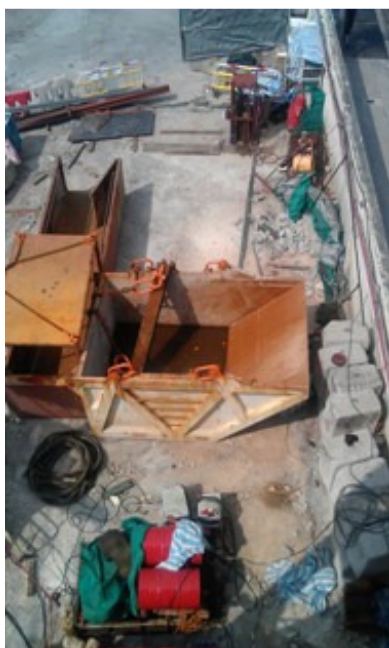
Photo 1 Water-oil mix accumulation was found in skip next to man cage.

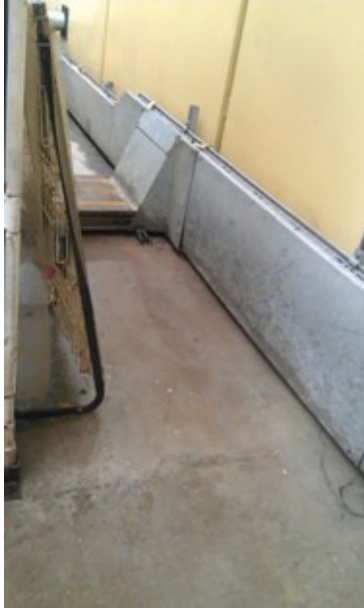
Photo 3 Water accumulation was found on path next to noise enclosure.

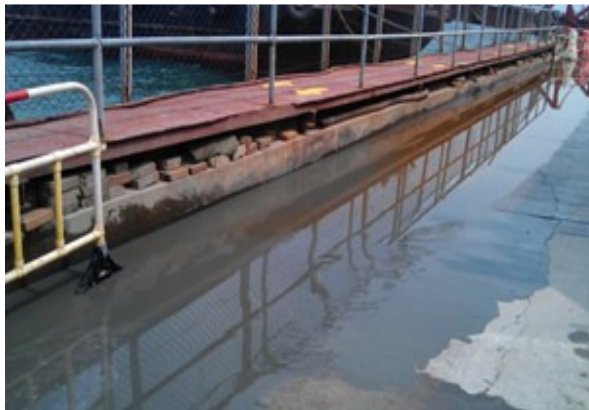
Photo 1 Water with sand was accumulated along the path near the entrance.

1. The contractor is reminded to ensure drainage system is adequate and well maintain.

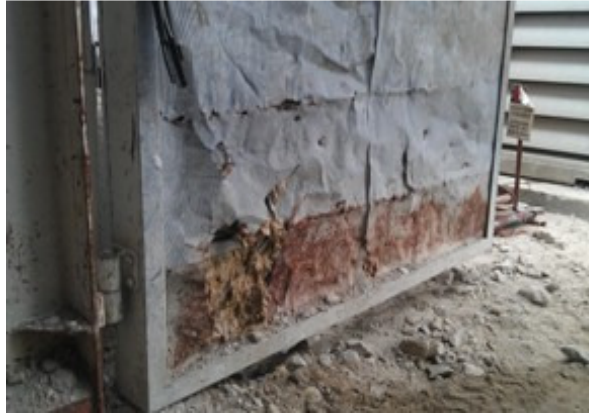
Photos 3 and 4 Door of noise enclosure were broken since last inspection.

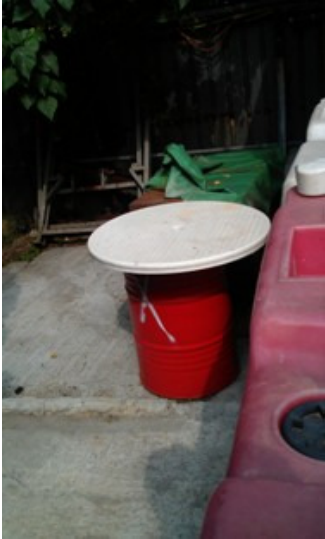
Photo 1 Chemical container was found without a drip tray next to Dangerous Goods container.

1. The contractor is reminded to provide a drip tray next to Dangerous Goods container.
2. The contractor is reminded to clear waste oil in tray near the welding area inside the container.

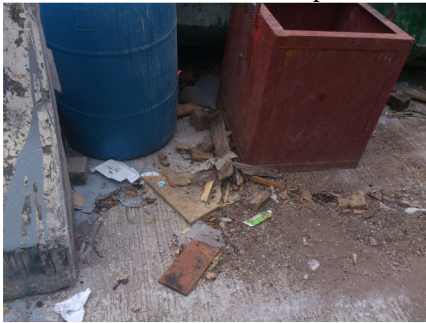
Photo 1 The general waste was found accumulated in the workshop area.

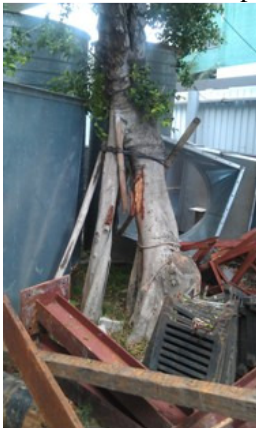
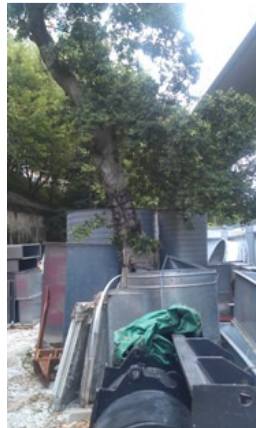
Photos 2 and 3 The items of “Construction materials were stored too close to the tree (T003 (T)) in Storage area” will be follow up in next inspection due to assess road was blocked.

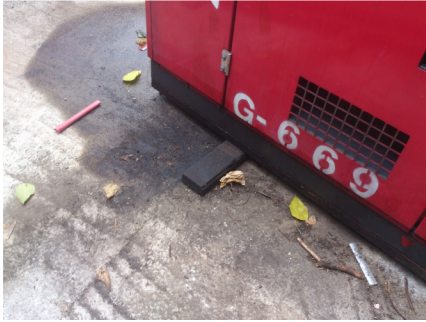
Photo 4 The oil stains were found on the ground near the generator.

1. The contractor is reminded to remov the oil stains properly.

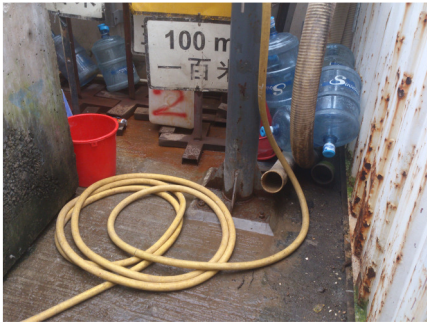
Photo 1 Non-use containers were removed.

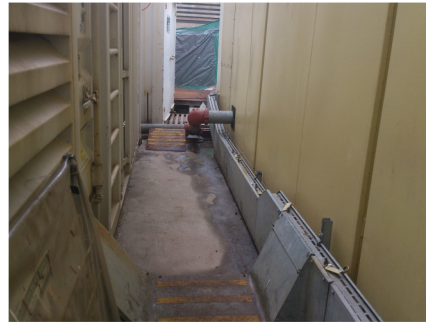
Photo 2 Water accumulation was found on path next to noise enclosure.

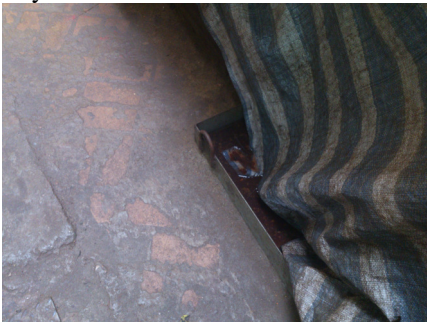
Photo 3 Water accumulation was found in the drip tray next to noise enclosure.

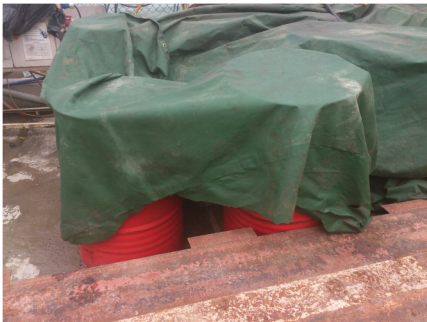
Photo 1 Chemical barrels were found to be without drip trays outside the noise enclosure area

1. The contractor is recommended to provide drip trays for chemical containers.

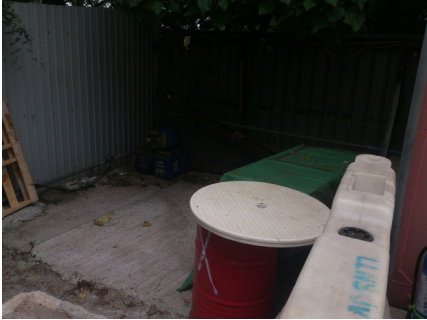
Photo 1 The chemical barrel next to Dangerous Goods container was removed.

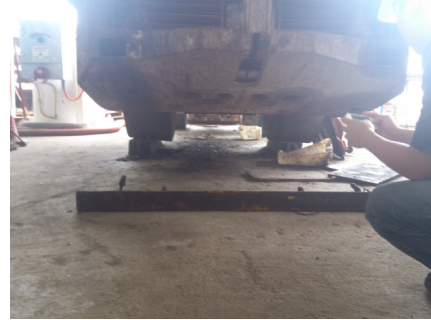
Photo 2 The oil leakage was found from equipment during the maintenances process.

1. The contractor is reminded to clear the oil stains and avoid oil leakage in the maintenance process..

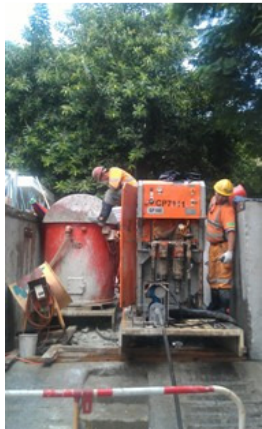
Photo 1 The preparation work for cement mixing was found during the site inspection.

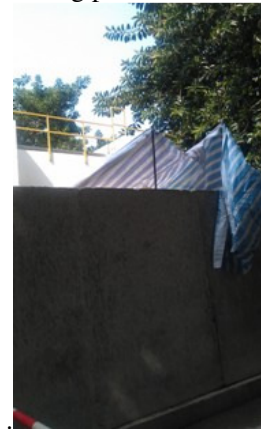
Photo 2 The cover for cement mixing plant was found not properly cover the top and 3 sides of cement mixing plant.

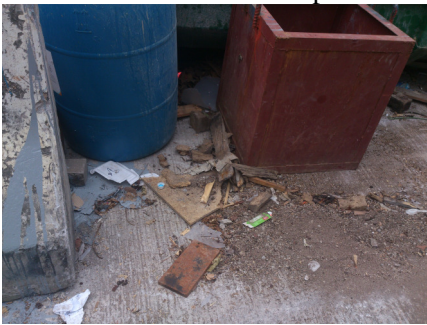
Photo 1 The general waste was found accumulated in the workshop area.

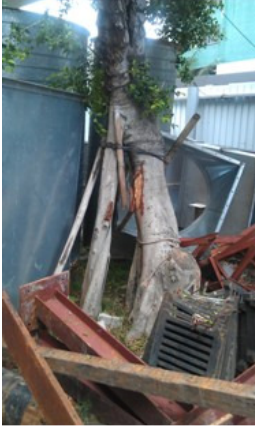
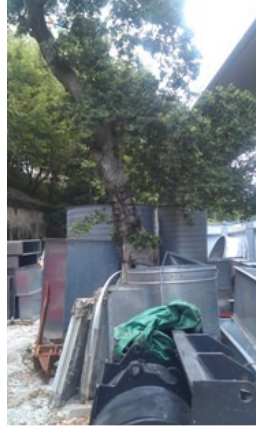
Photos 2 and 3 The items of “Construction materials were stored too close to the tree (T003 (T)) in Storage area” will be follow up in next inspection due to no inspection was under taken.

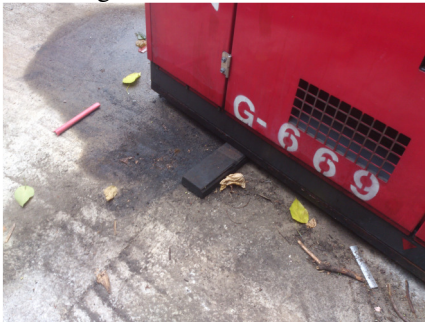
Photo 4 The oil stains were found on the ground near the generator.

1. The contractor is reminded to remove the oil stains properly.

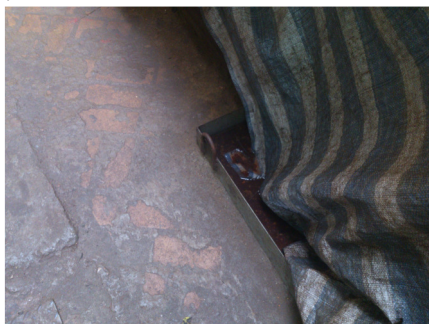
Photo 1 Water accumulation was found in the drip tray next to noise enclosure.

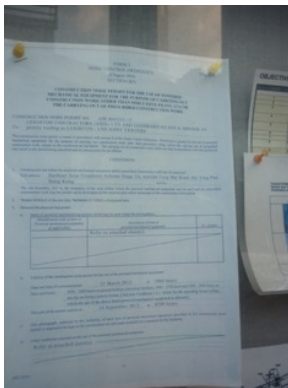
Photo 1 An invalid CNP was found in Notice Broad

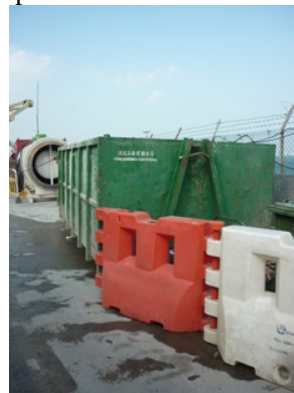
Photo 2 A damage skip was found next to the stockpiles

1. The contractor is recommended to ensure the rubbish skip in good condition.

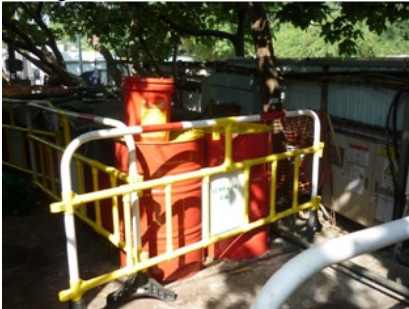
Photo 1 Some chemical barrels were found without drip tray next to chemical storage.

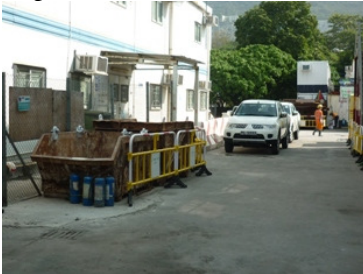
Photo 3 No oil stains was found during inspection.

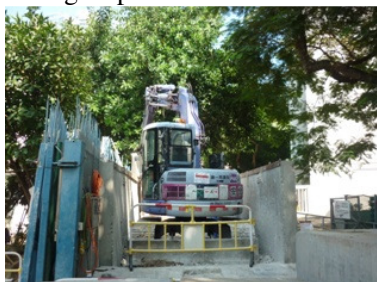
Photo 1 No cement mixing process was found during inspection.

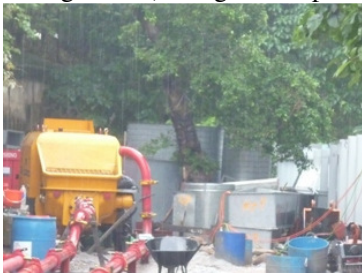
Photo 1 Construction materials were stored too close to the tree (T003 (T)) in Storage area (during last inspection)

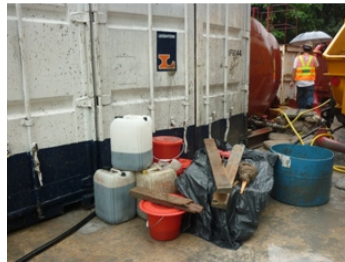
Photo 2 Some unknown chemical drums were found without labels and drip trays

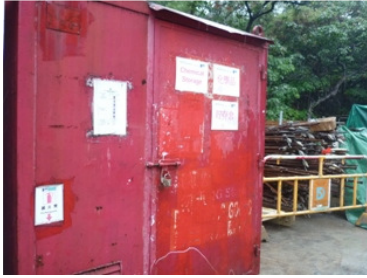
Photos 3 The chemical storage was found without chemical contain list

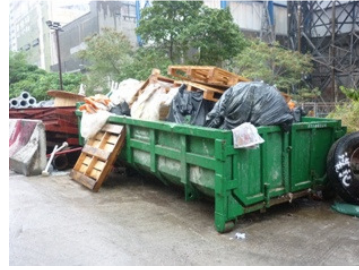
Photo 4 General waste had been placed in skip properly

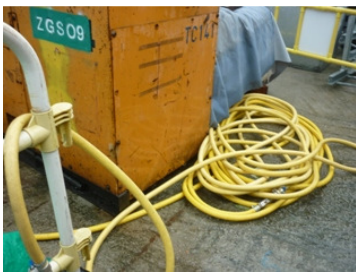
Photo 5 The oil stains were cleared

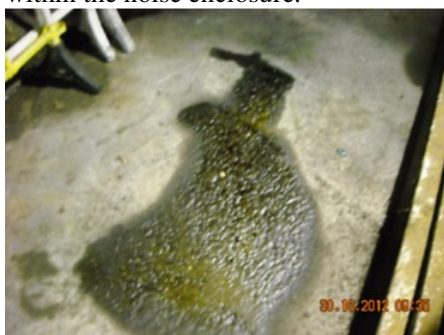
Photo 1 Oil spot was observed on the ground within the noise enclosure.

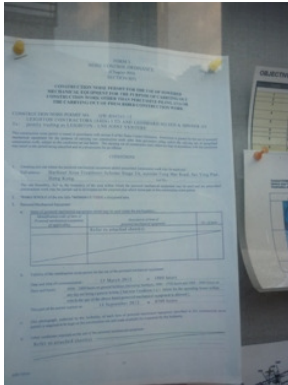
Photo 1 An invalid CNP was found in Notice Board

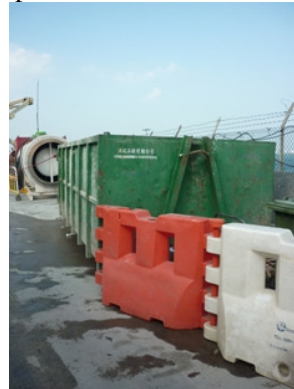
Photo 2 A broken skip was found next to the stockpiles

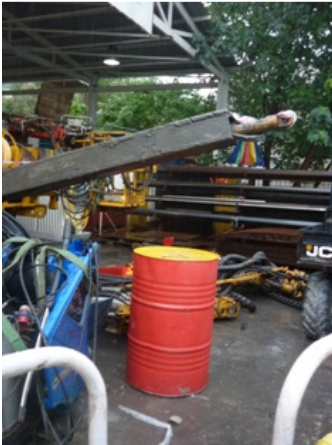
Photos 1 and 2 Some chemical barrels were found without drip tray next to chemical storage.
