Contract No. DC/2007/24  
Harbour Area Treatment Scheme Stage 2A  
Construction of Sewage Conveyance System from Aberdeen to Sai Ying Pun

## Environmental Certification Sheet – 67

**Contract No. DC/2007/24  
Construction of Sewage Conveyance System from Aberdeen to Sai Ying Pun  
Condition 4.4 – Submission of Monthly EM&A Report for January 2014 (no. 49)**

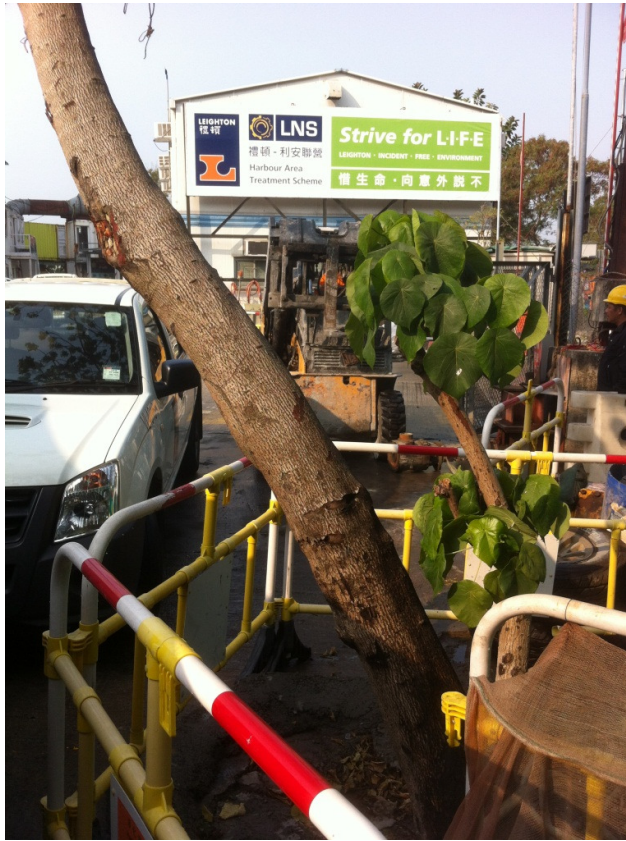
Sandy Bay Site – Photo 1

In Sandy Bay site, the T017 (T) was still in very poor health. The condition of the retained tree T053(R) was still deteriorating with damages to its stems and foliage since the audit of September 2011. Tree identification tag was still observed missing for retained tree T49(R). The tree without label at the entrance of Sandy Bay site was observed with decay fungi. The retained tree T039(R) was observed without tree tag.

Protection fencing had been provided for retained tree T039(R). However tree tag was still missing.

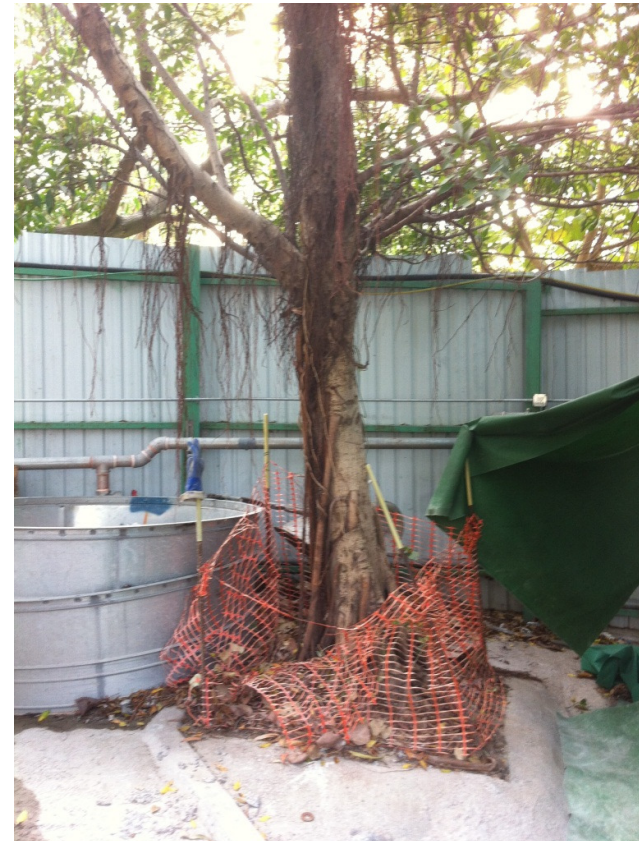
Cyberport Site – Photo 2

In Cyberport site, the identification tag for the retained tree T48(R) was still missing. The condition of the retained tree T068(R) was still observed deteriorating with shrunken leaves. And general refuse was observed on the retained trees T068(R). The tree protection zone was observed damaged of the retained trees T075(R).

Construction material within the tree protection zone of the retained trees T075(R) had been removed. However the tree protection zone was still observed damaged.
