Contract No. DC/2007/24
Harbour Area Treatment Scheme Stage 2A
Construction of Sewage Conveyance System from Aberdeen to Sai Ying Pun

Document/ Plan/Changes/Information to be Certified/ Verified:	Quarterly Environmental Monitoring and Audit Report No.11 (EMA/042, Rev B)
Date of Report:	31 October 2012
Date of correspondence to IEC:	31 October 2012
Date received:	31 October 2012

Contract no. DC/2007/24
Construction of Sewage Conveyance System from Aberdeen to Sai Ying Pun
Submission of 11th Quarterly EM&A Report for July to September 2012 (Rev. B)

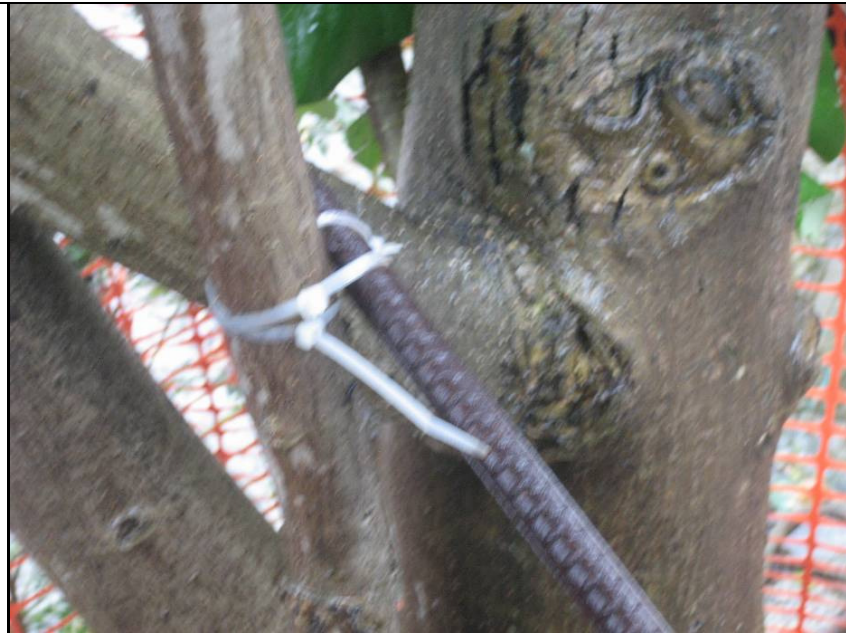
Cyberport site --- Photo 1

A metal bar was still tied to the branch of the retained tree T038(R)

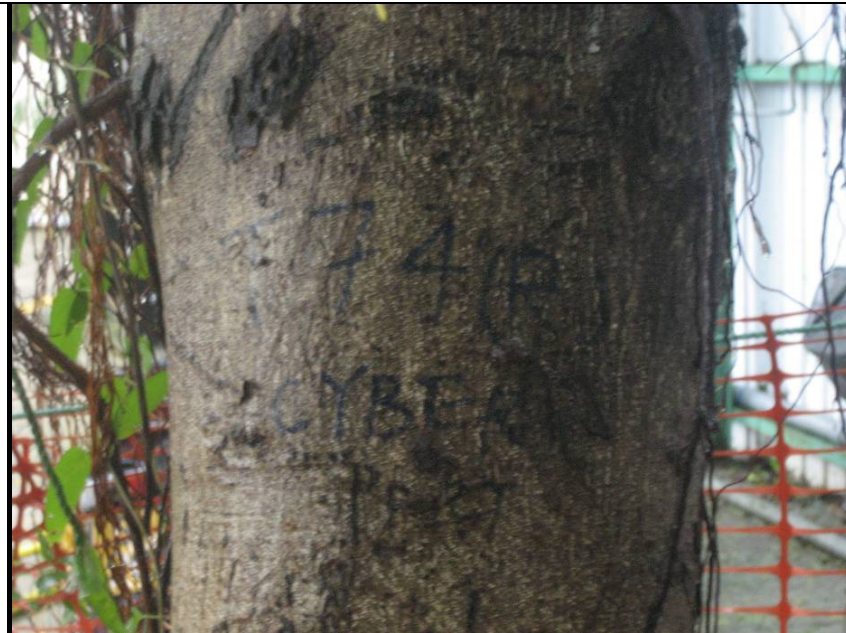
Cyberport site --- Photo 2

The retained tree T074(R) was still not properly tagged and marking was also observed on the tree trunk. The Contractor was asked again to provide a proper identification tag for the retained tree and not to make any marking on the tree surfaces.

The retained tree T074(R) was still not properly tagged. Marking was also observed on the trunk.

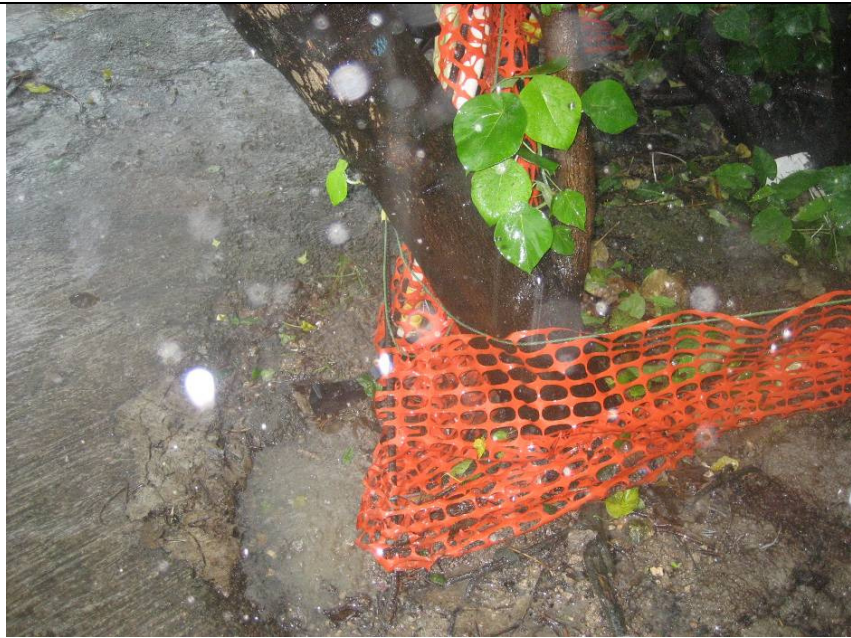
Sandy Bay site --- Photo 3

The tree protection zone for the retained tree T038(R) was inadequate. The fencing was touching the tree trunk and part of the tree root was outside the tree protection zone. The tree identification tag was still missing.

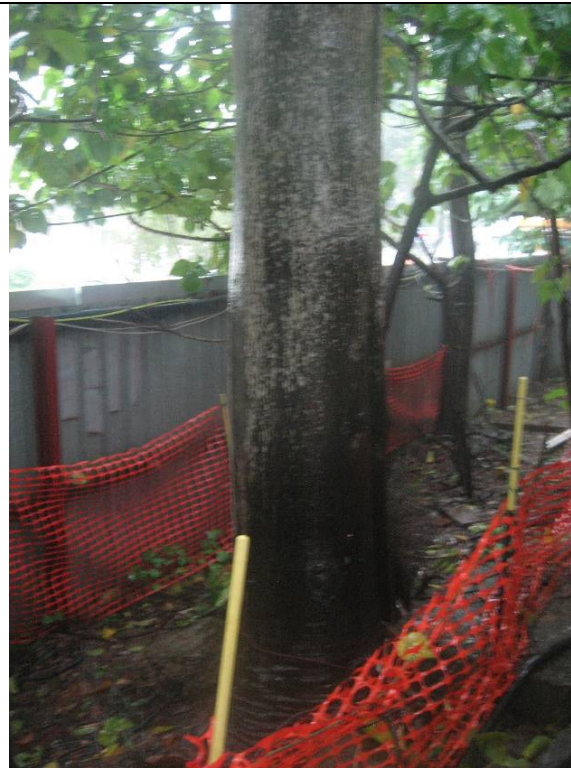
Sandy Bay site --- Photo 4

The tree identification tags were still missing from the retained trees T058(R) and T045(R).

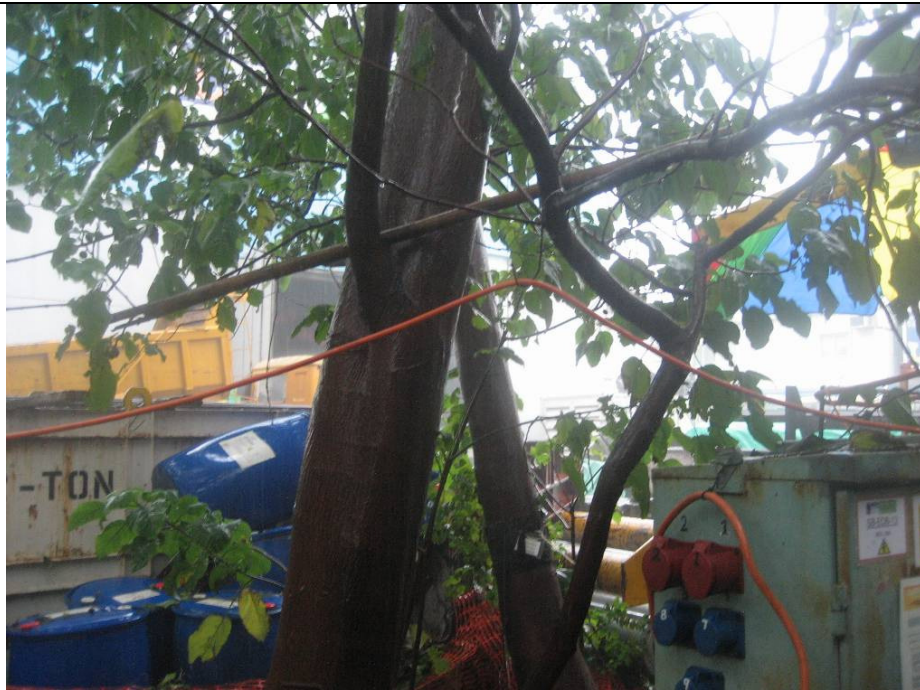
Sandy Bay site --- Photo 5

The retained tree T027(R) was not tagged. Construction materials and a cable were hanging from the branches.

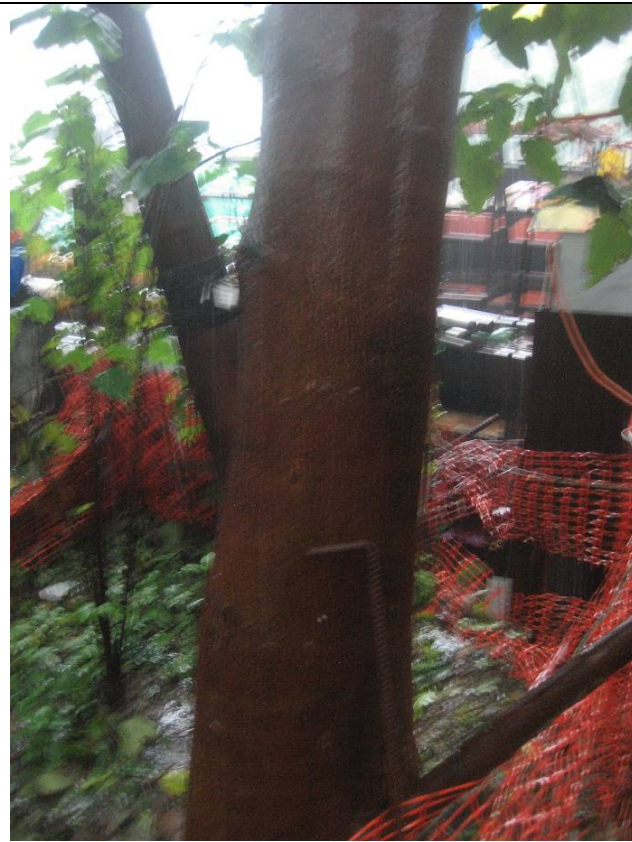
Sandy Bay site --- Photo 6

The tree identification tag was still missing from the retained tree T021(R).

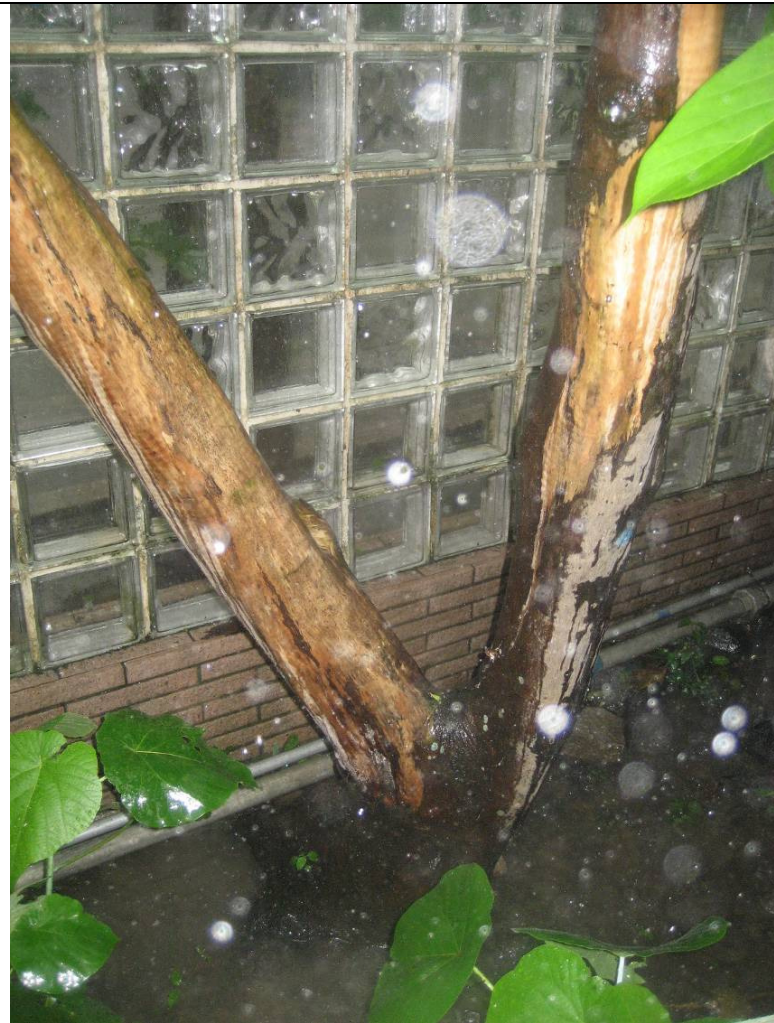
Sandy Bay site --- Photo 7
The tree identification tag was still missing from the retained tree T036(R).

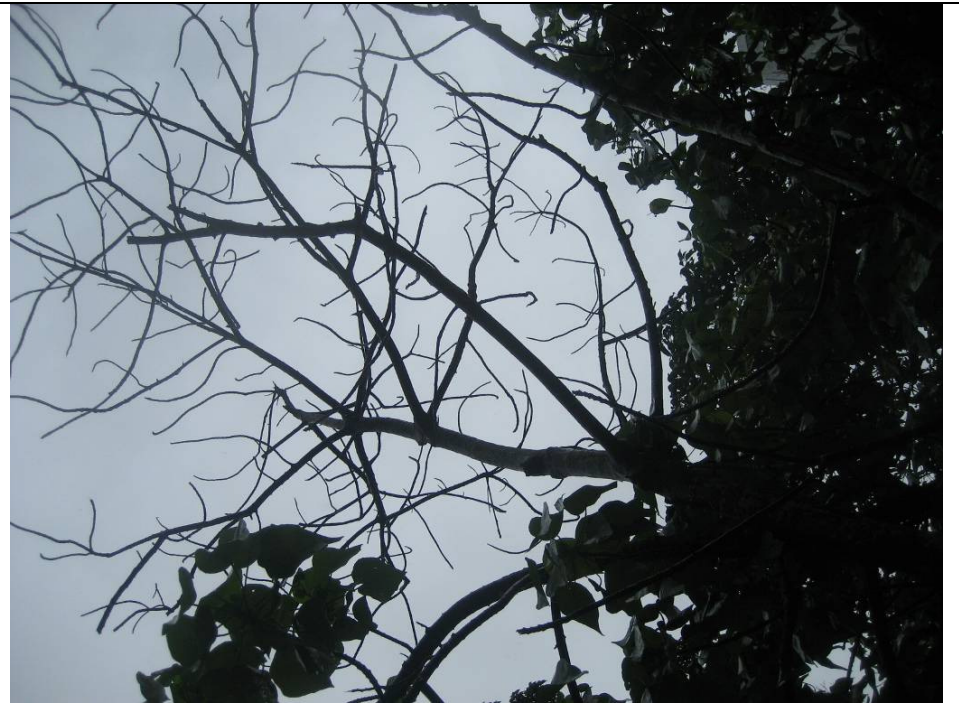
Aberdeen site --- Photo 8
The retained Tree T076(R) was in very poor health.

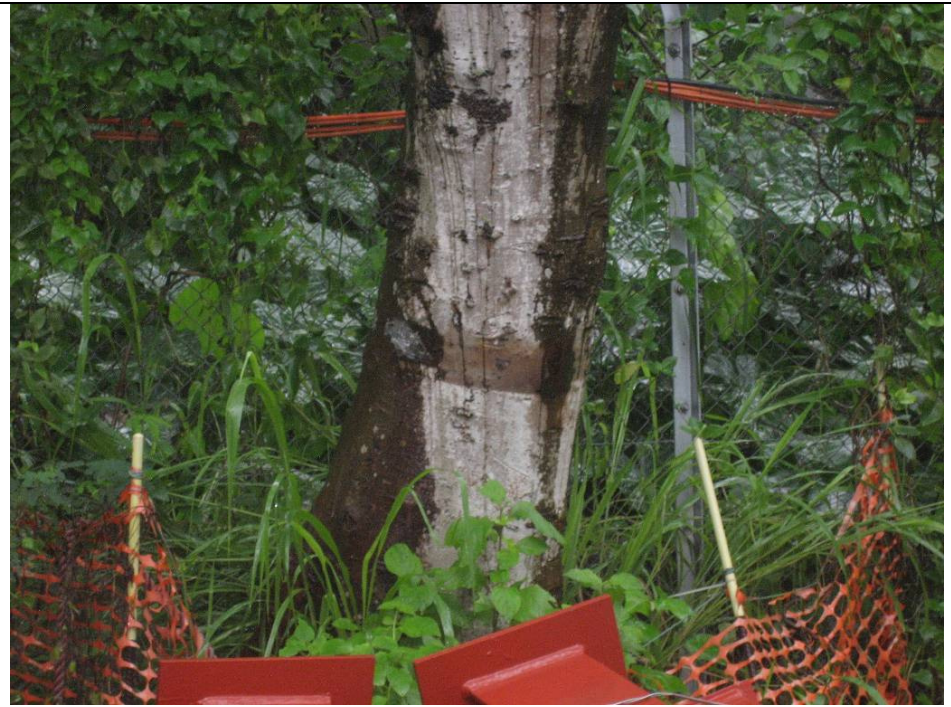
Aberdeen site --- Photo 9

The tree identification tag was still missing from the retained tree T081(R).

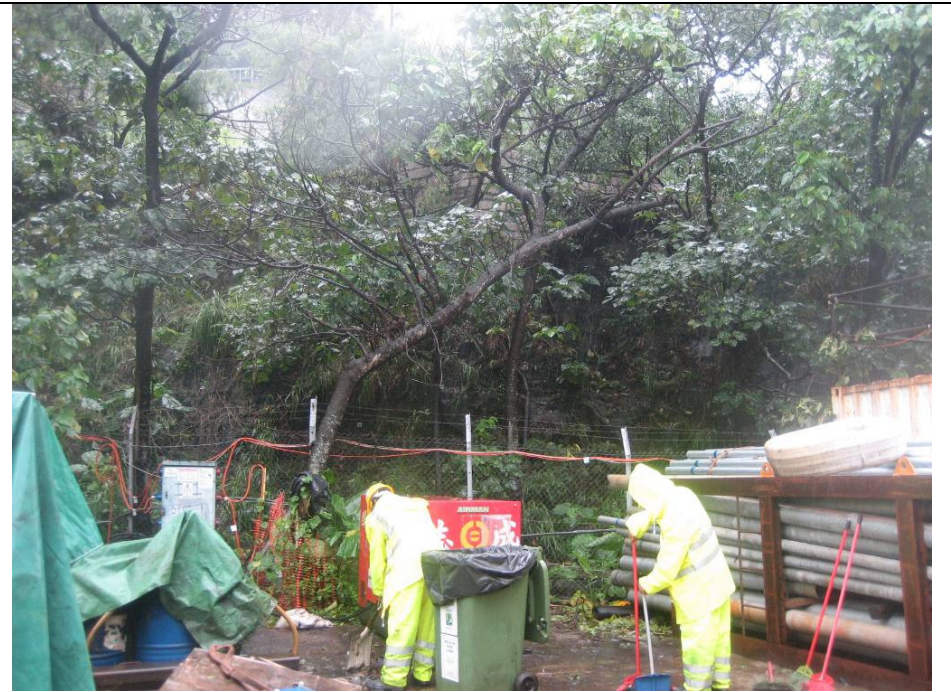
Aberdeen site --- Photo 10

The retained tree T083 was in very poor health.

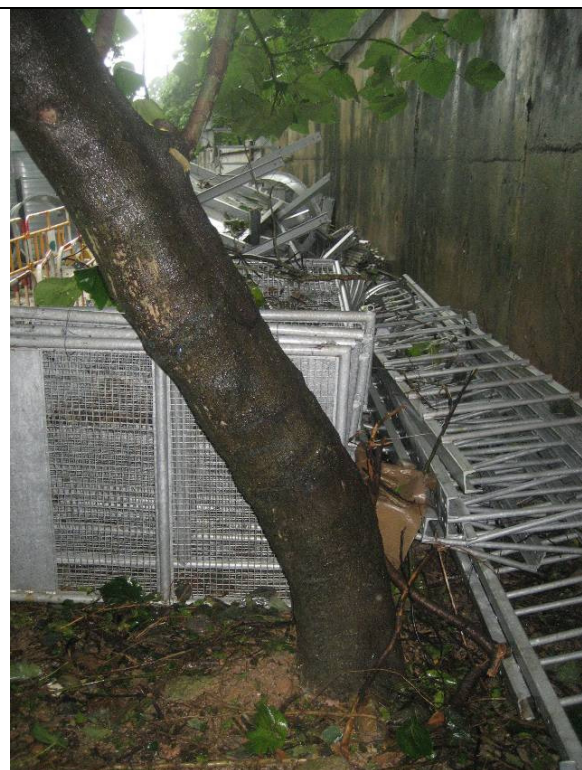
Aberdeen site --- Photo 11

The tree identification tag was still missing from the retained tree T084(R) and the tree next to it. Construction materials were stored close to the retained tree and touching the tree trunk.

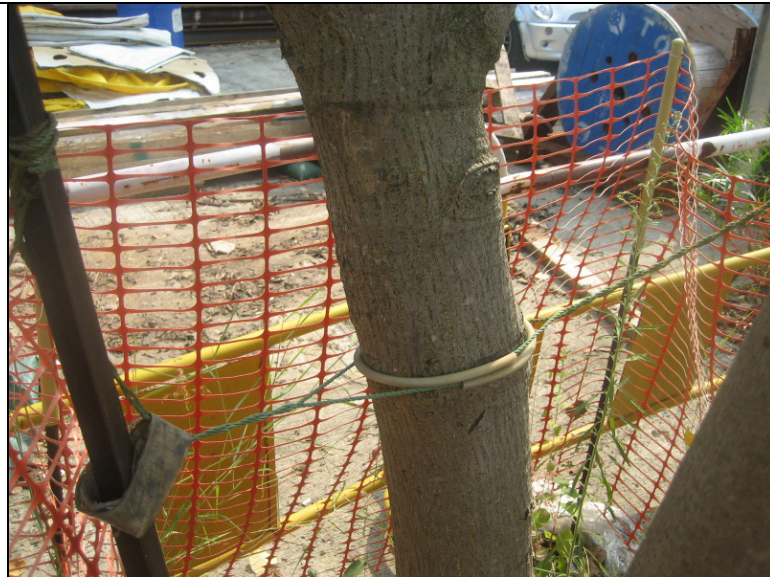
Cyberport site --- Photo 12

On 28 August 2012, the identification tag for the retained tree T066(R) at Cyberport site was missing.

The identification tag for the retained tree T066(R) was missing.

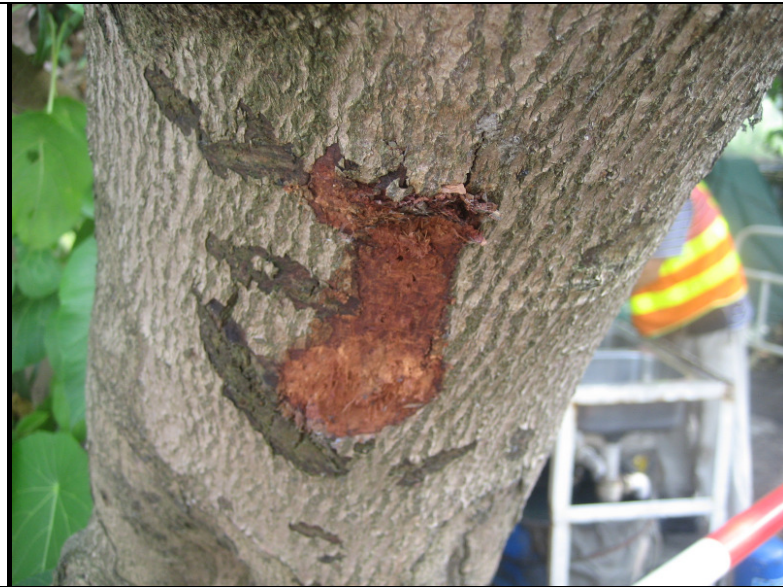
Sandy Bay site --- Photo 13

A new wound was observed on the trunk of the transplanted tree T038(T)

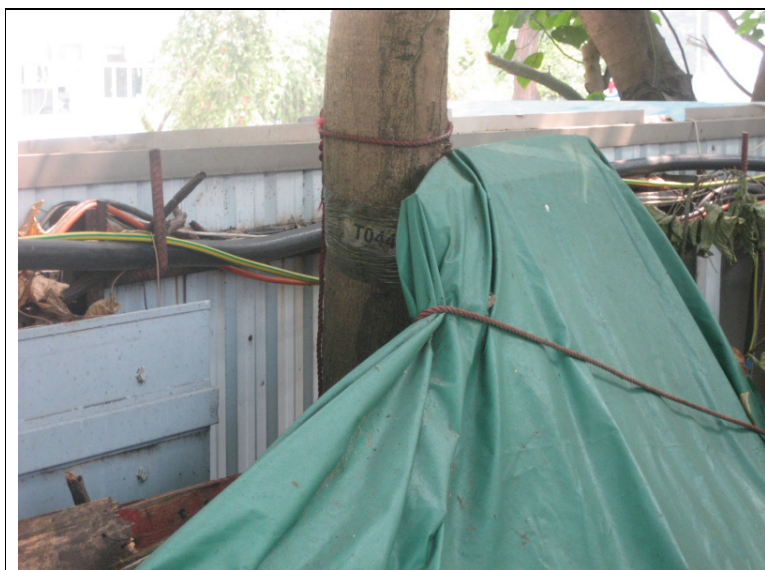
Sandy Bay site --- Photo 14

Construction materials were stored close to the trunk of the retained tree T044(R).

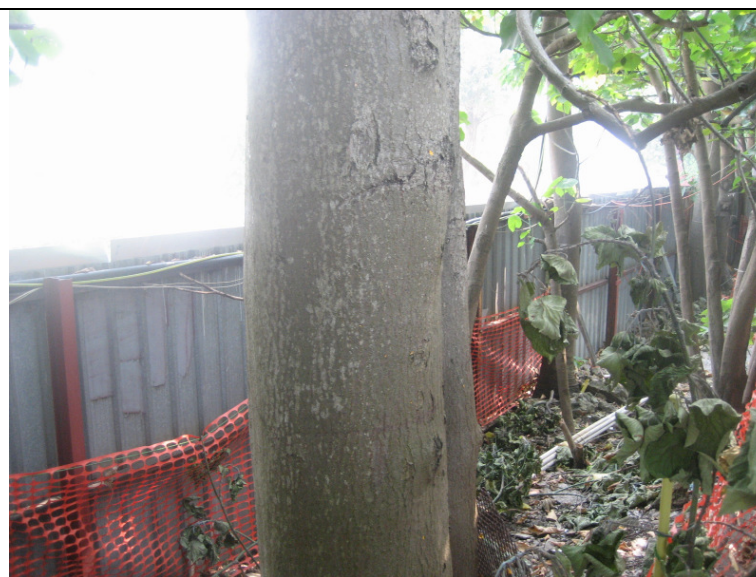
Sandy Bay site --- Photo 15

The identification tag for the retained tree T046(R) was still missing.

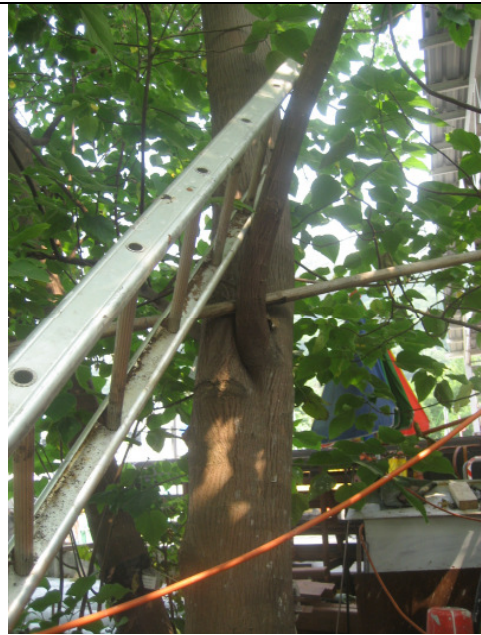
Sandy Bay site --- Photo 16

Construction materials and cables were hanging from the branches of the retained trees T021(R) and T028(R).

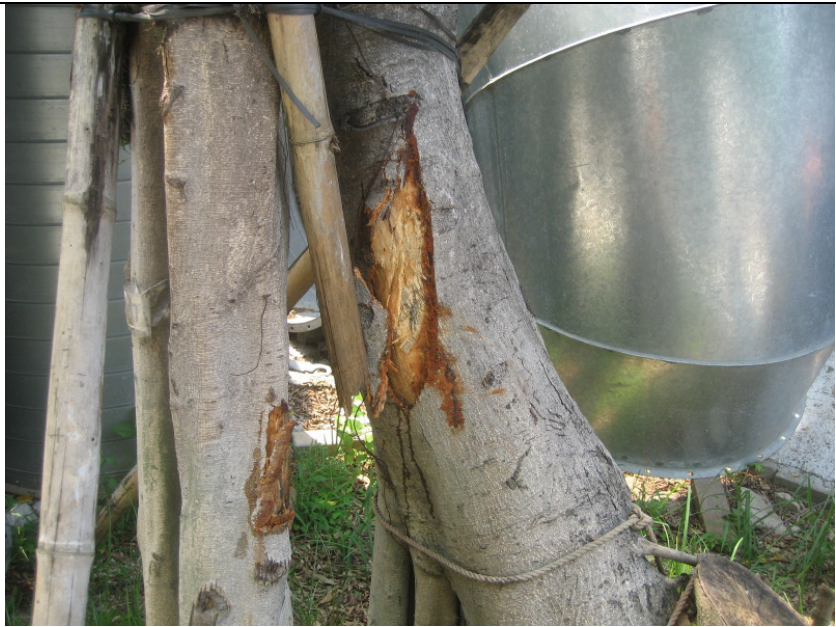
Sandy Bay site --- Photo 17

Construction materials were stored close to the trunk of the transplanted tree T003(T)(R) and a new wound was observed on the tree trunk

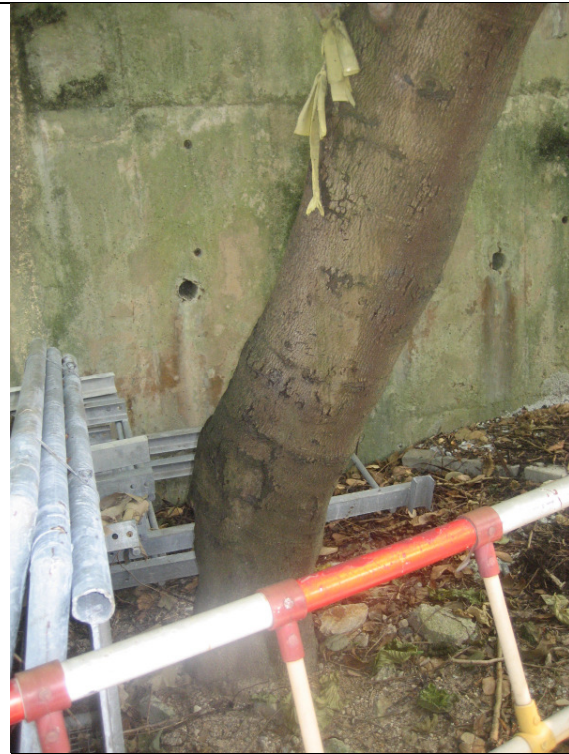
Sandy Bay site --- Photo 18

Construction materials were stored very close to the root area of the retained tree T084(R)

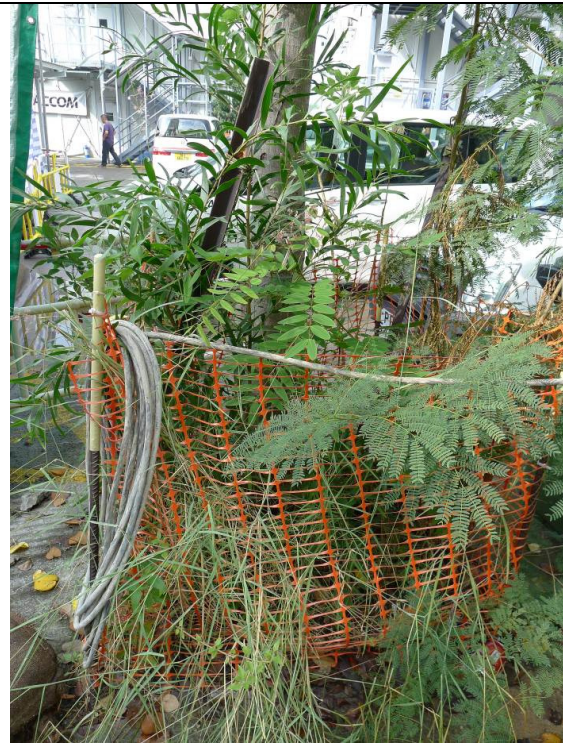
Cyperport site --- Photo 19

Excessive weeds were observed within the root zone of the retained tree T66(R).

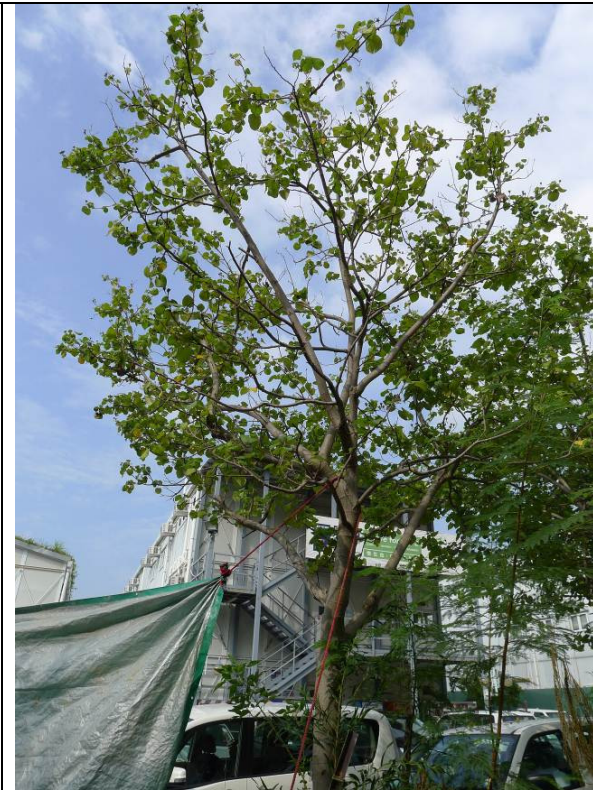
Cyperport site --- Photo 20

A tarpaulin sheet was hung from the branch of the retained tree T72(R) using a rope.

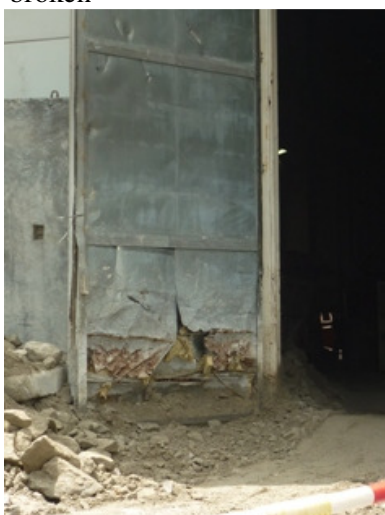
Photo 1 The door of noise enclosure was found broken

2. The contractor was recommended to repair the door of the noise enclosure as soon as possible.

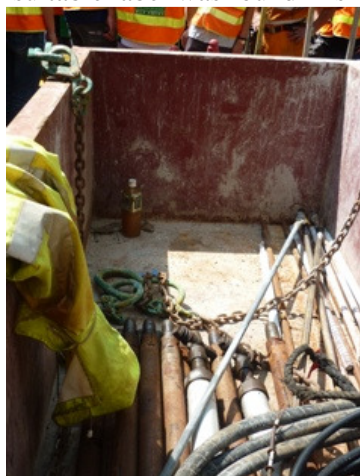
Photo 1 A bottle of chemical without suitable label was found in skip

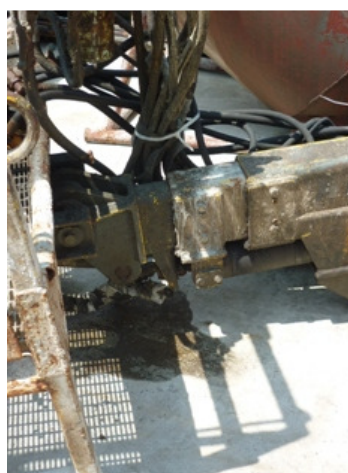
Photo 5 Soil spill out from drip tray was observed in workshop

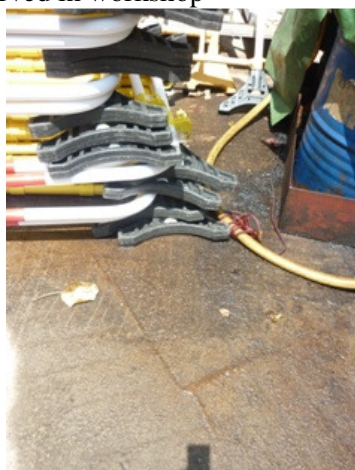
Photo 6 Oil stains was found under the air compressor near stockpiles in workshop

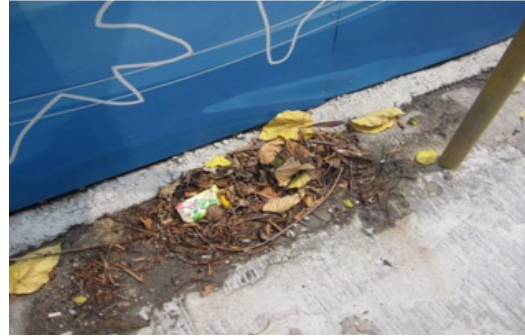
Photo 9 Stagnant pool and leaves were found around the workshop

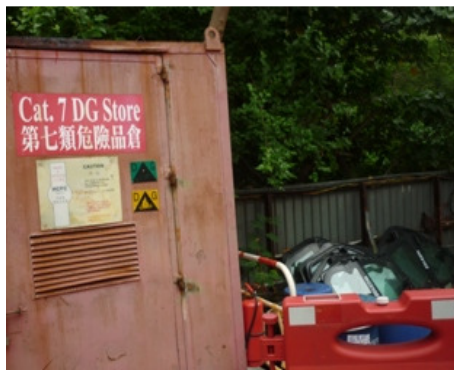
Photo 4 Potential stagnant pools were found on the cover of the barrels near the DG storage area

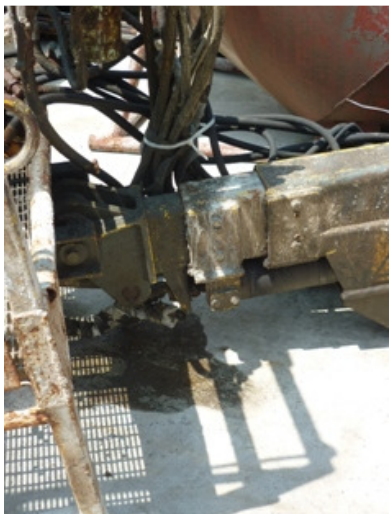
Photo 1 Oil droplets were found near the plants stockpile since last inspection

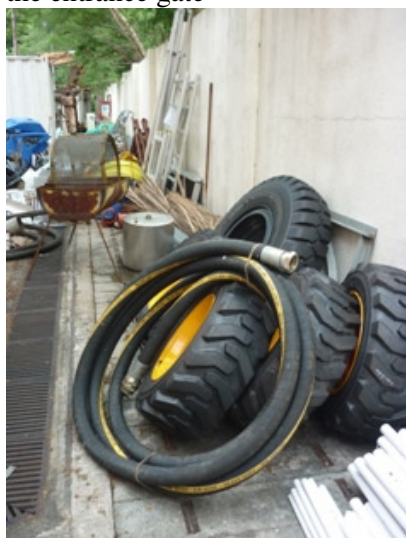
Photo 5 Stagnant pool was found in tyre near the entrance gate

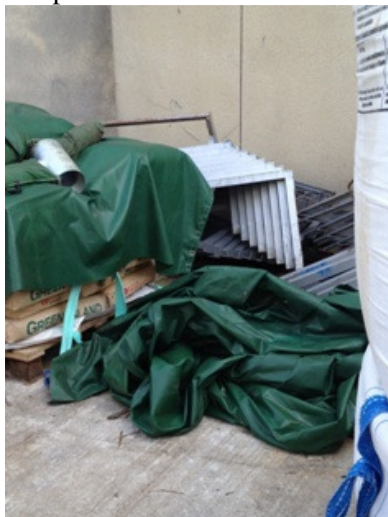
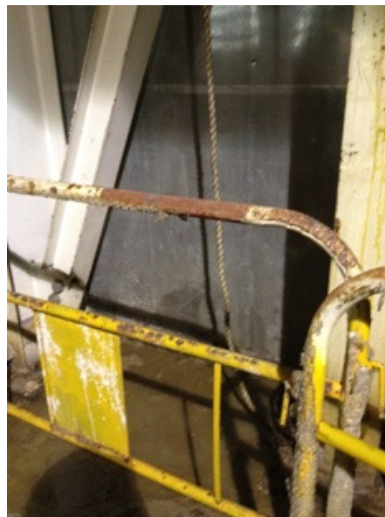
Photos 1 and 2 Water accumulation was found inside the enclosure and on the tarpaulin near the stockpiles

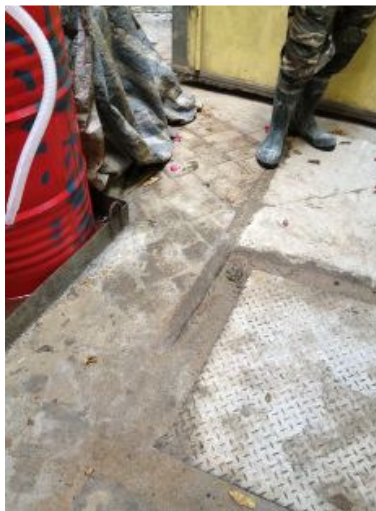
Photo 4 Oil droplets were found near the noise enclosure

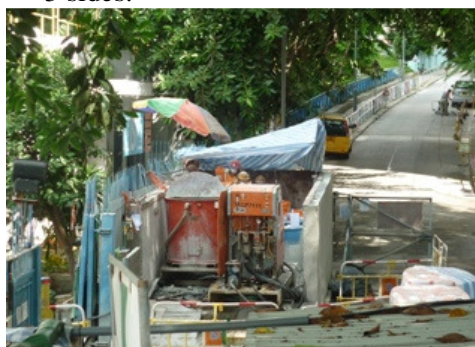
Photo 1 Cement mixing was in process on the platform without proper cover with top and 3 sides.

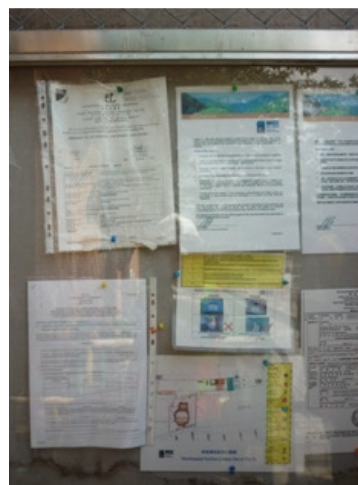
Photo 2 The EP-322/2008/E was missing in the Notice Board near the entrance gate.

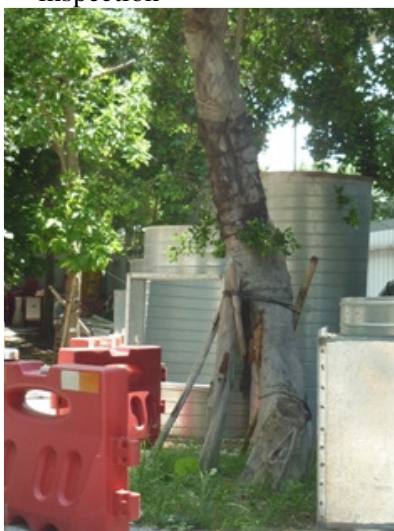
Photo 1 The transplant tree (T003) was found without protective fence since last inspection

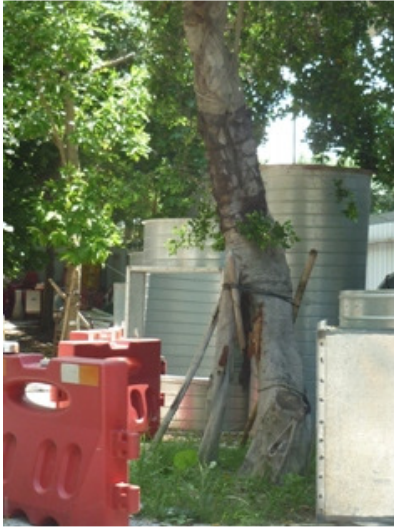
Photo 1 The transplant tree (T003) was found without protective fence on last inspection

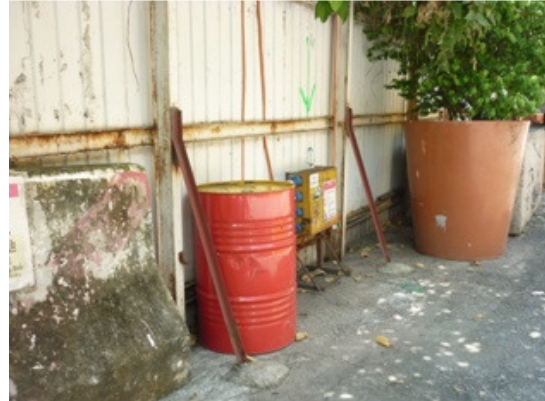
Photo 2 Chemical barrel without drip tray in workshop near electric box on last inspection.

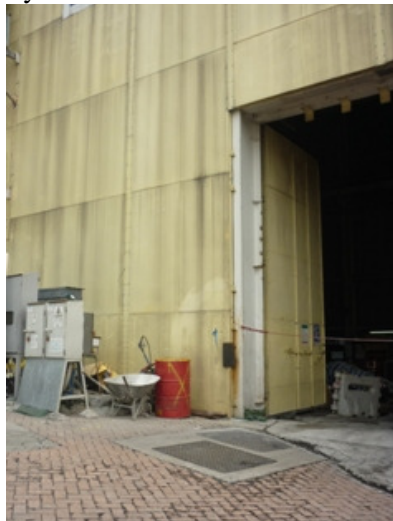
Photo 1 Chemical barrel was found without drip tray near the door of noise enclosure

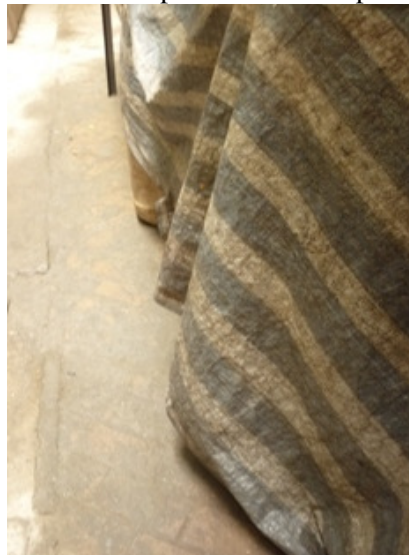
Photo 2 Another chemical drum was found on access near the DSD plant without drip tray

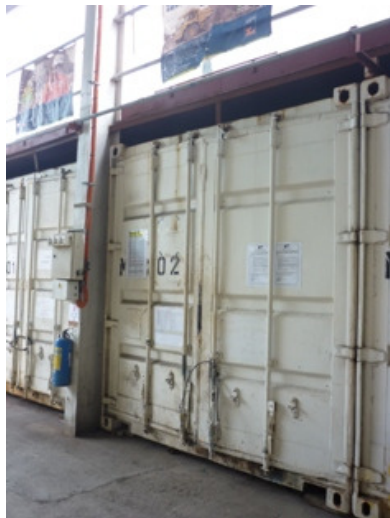
Photo 3 The chemicals without labels were found in Plant container

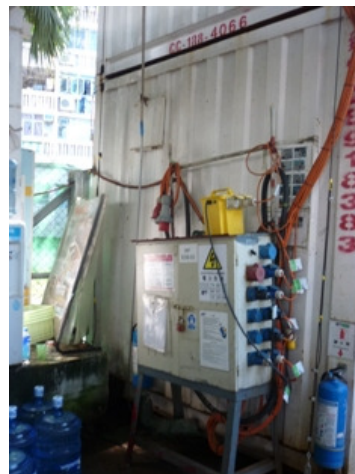
Photos 1 and 2 Dripping from air conditioner was found near material container

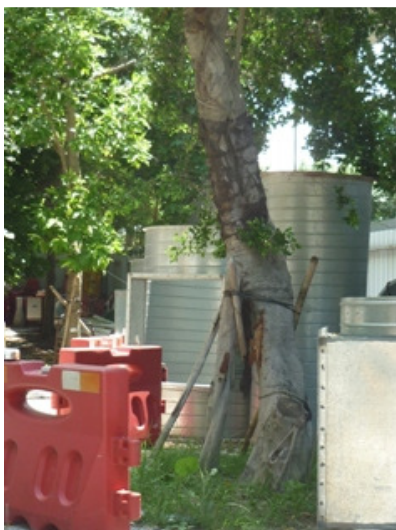
Photo 1 The transplant tree (T003) was found without protective fence on last inspection

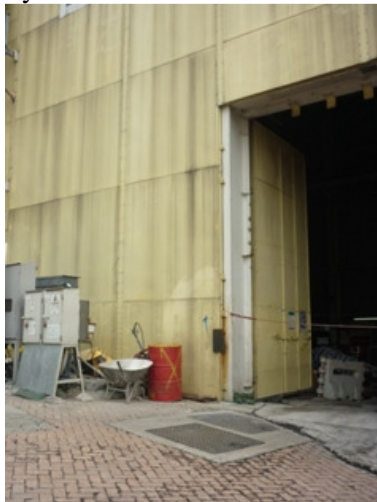
Photo 1 Chemical barrel was found without drip tray near the door of noise enclosure

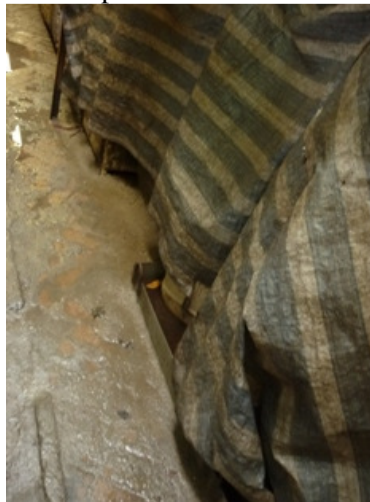
Photo 2 Oil droplets were found next to drip tray near the DSD plant

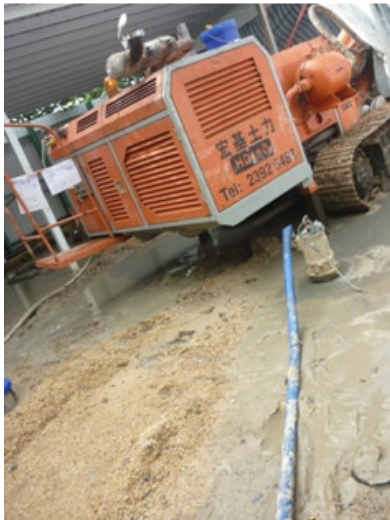
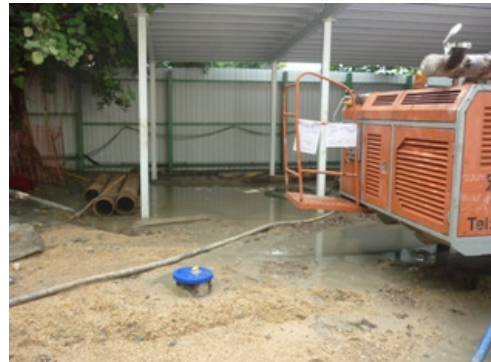
Photos 3 and 4 Waste water was found during drilling

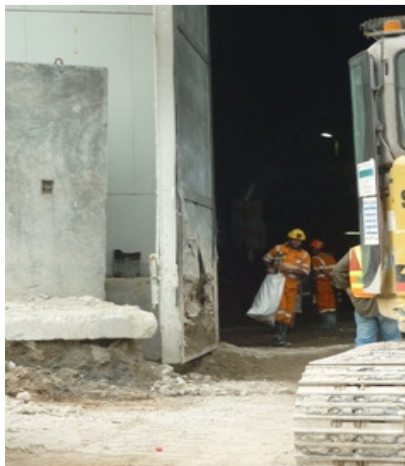
Photo 1 The door of noise enclosure was found broken.

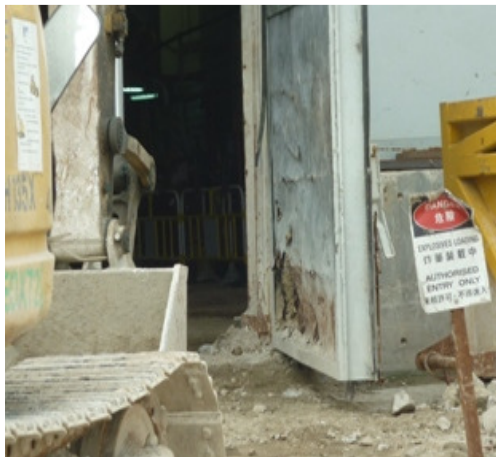
Photo 2 The door of noise enclosure was found broken.

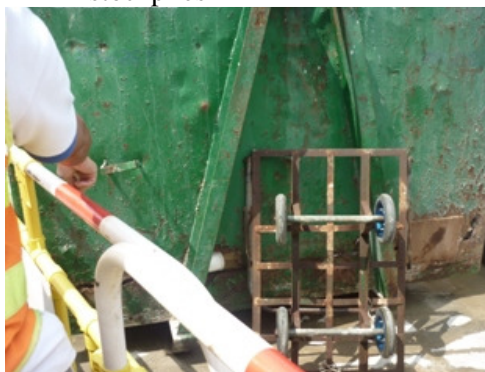
Photo 4 A broken skip was found near stockpiles

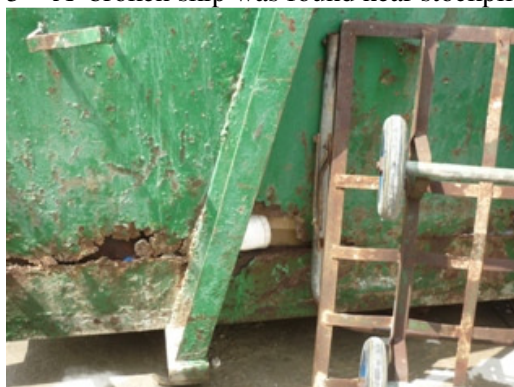
Photo 5 A broken skip was found near stockpiles

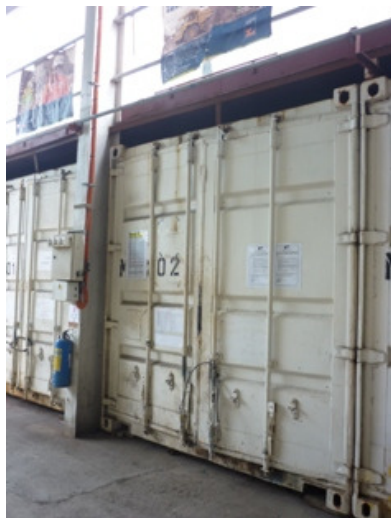
Photo 3 The chemicals without labels were found in Plant container

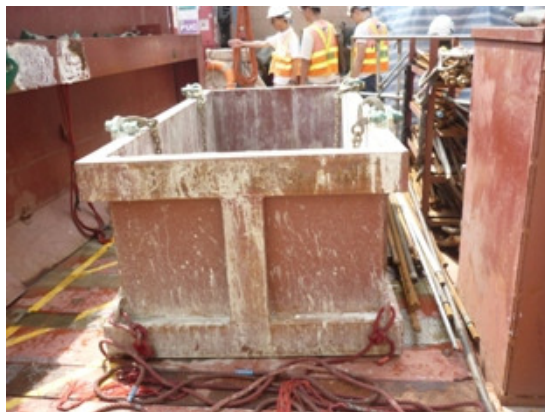
Photos 1 and 2 Water accumulation was found in the skip and near the boundary
