Document Details					
Client Drainage Services Department					
Project Contract No. DC/2007/24 Harbour Area Treatment Scheme Stage 2A Construction of Sewage Conveyance System from Aberdeen to Sai Ying Pun					
Document Title Quarterly Environmental Monitoring and Audit Report No. 12 Covering the Period from 1 October 2012 to 31 December 2012					
Document No. EMA/046					
Distribution					
Copy No.	Issued To		Copy No.	Issued To	
01-02	Leighton-LNS JV		10	Metcalf & Eddy-AECOM JV	
03	Mott MacDonald Hong Kong Ltd		11	ACL (Project Office)	
04-08	EPD		12	ACL (Head Office)	
09	DSD				
Submission Ref				Controlled Copy No.	
SUBM Ref.					
Atkins Ref.(s)	DC/2007/24/31.20/OG4004/EC/SH/SO				
Revision History					
A	28 January 2013	Submission to IEC and ER for Review	Various

Contract No. DC/2007/24
Harbour Area Treatment Scheme Stage 2A
Construction of Sewage Conveyance System from Aberdeen to Sai Ying Pun

Document/Plan/Changes/Information to be Certified/ Verified:	Quarterly Environmental Monitoring and Audit Report No.12 (EMA/046, Rev A)
Date of Report:	1 February 2013
Date of correspondence to IEC:	1 February 2013
Date received:	1 February 2013

**Contract no. DC/2007/24
Construction of

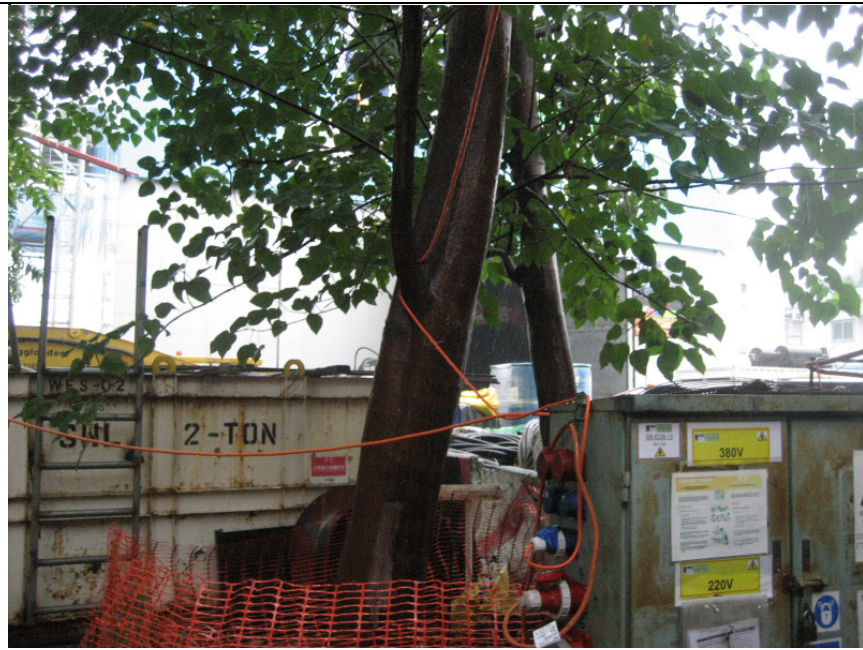
Sandy Bay site --- Photo 1

Cable was still hanging from the tree branches of the retained trees T021(R) and T027(R)

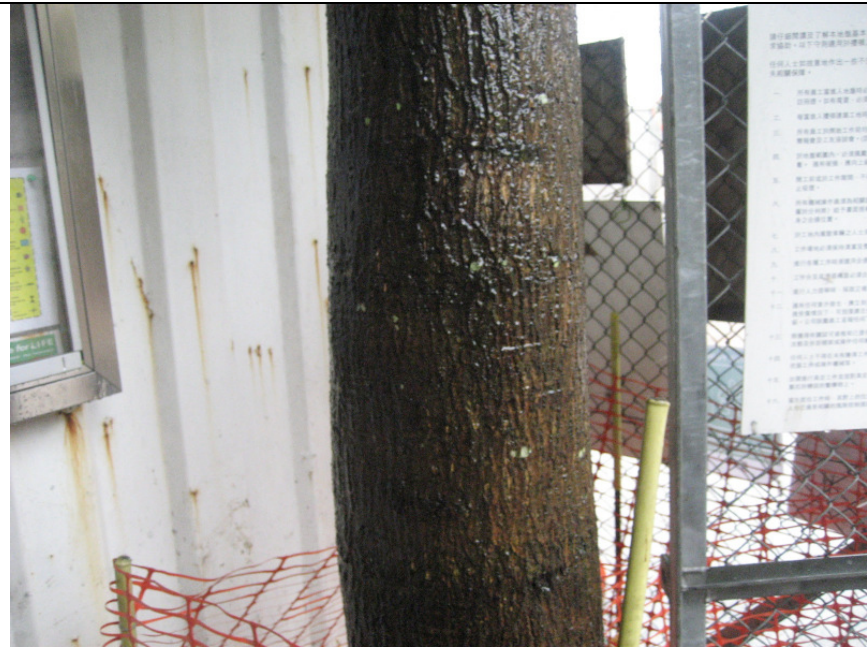
Cyperport site --- Photo 3

The identification tag for the retained tree T48(R) was missing.

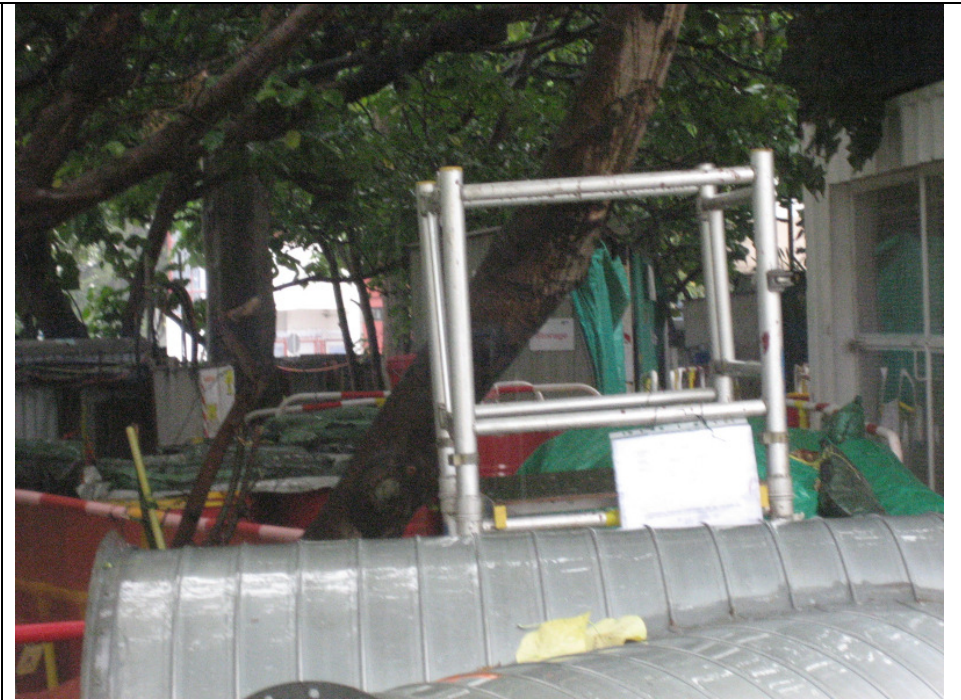
Sandy Bay site --- Photo 4

Construction materials were stored very close to the root area of the retained tree T038(T).

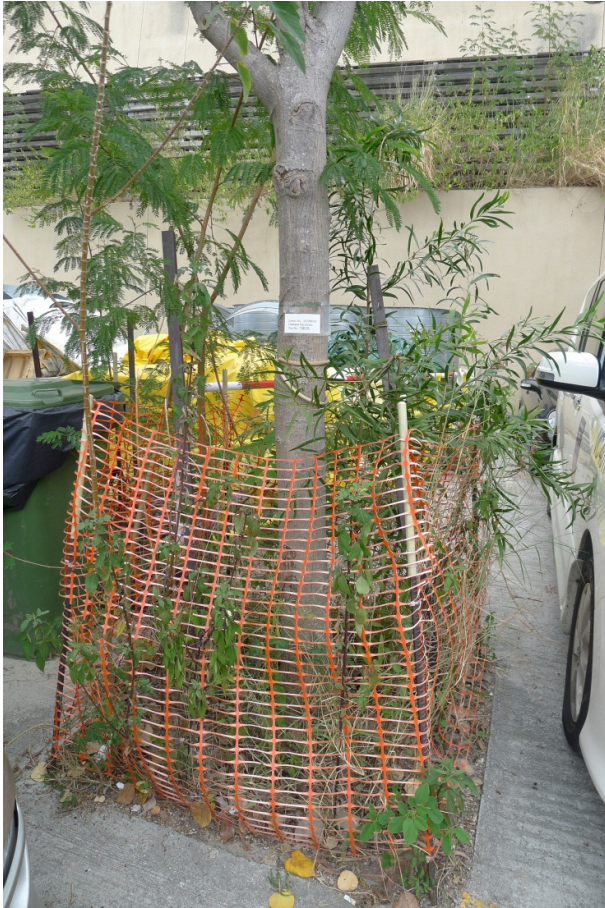
Cyberport Site – Photo 6

The condition of the retained tree T068(R) was deteriorating with invading tree seedlings within its protection zone.

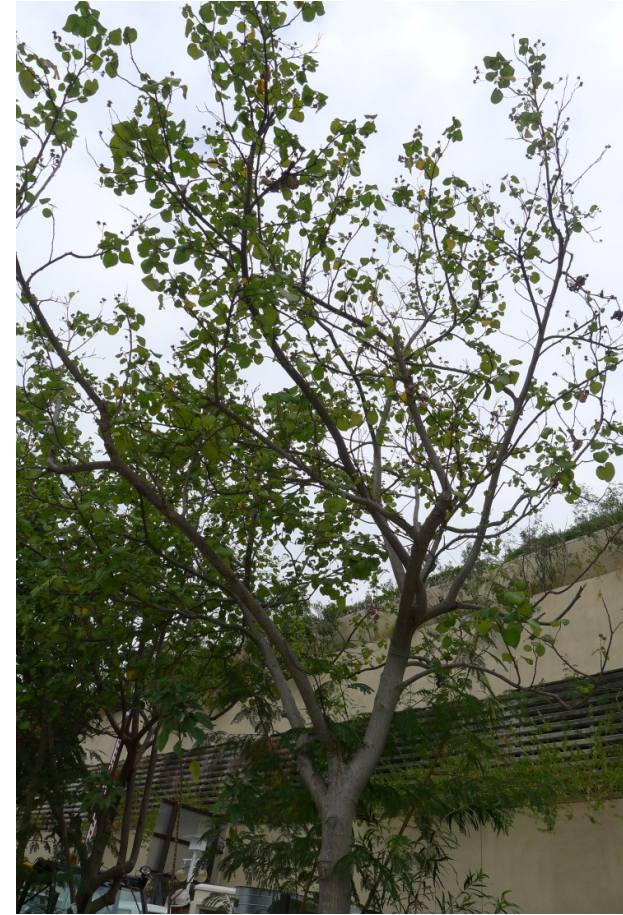
Cyberport Site – Photo 7

The condition of the retained tree T068(R) was deteriorating with shrunken leaves.

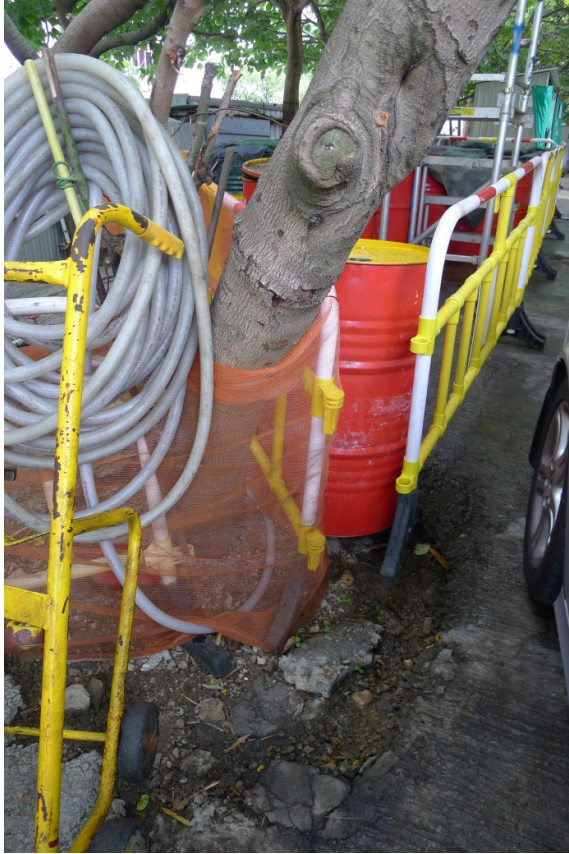
Sandy Bay Site – Photo 8

Construction materials were stored very close to the root area of the retained tree T038 (T).

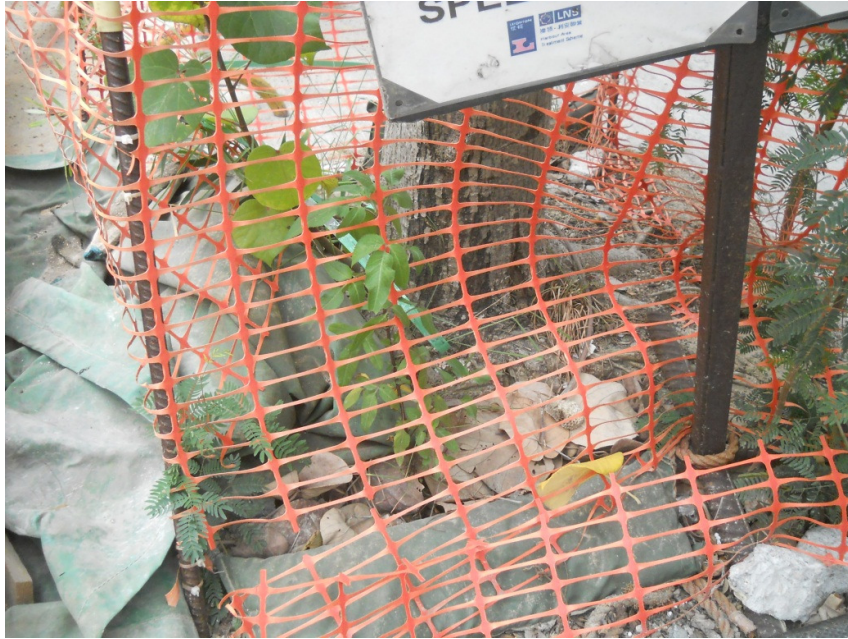
Cyberport Site – Photo 12

Construction material was placed within the tree protection zone of the retained tree T65 (R) and close to the root flare.

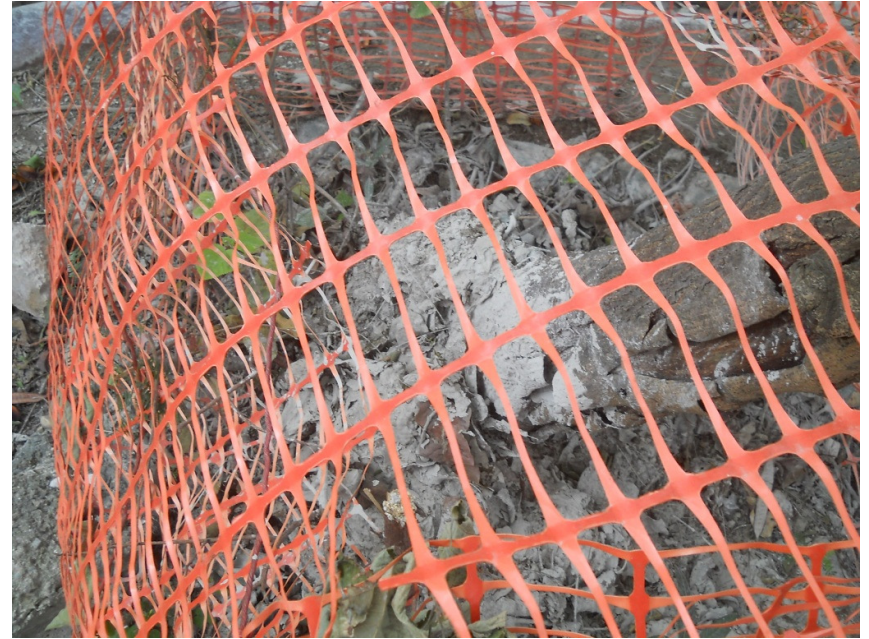
Sandy Bay Site – Photo 13

Cement stain was observed on the top soil and tree trunk of the retained tree T20 (R).

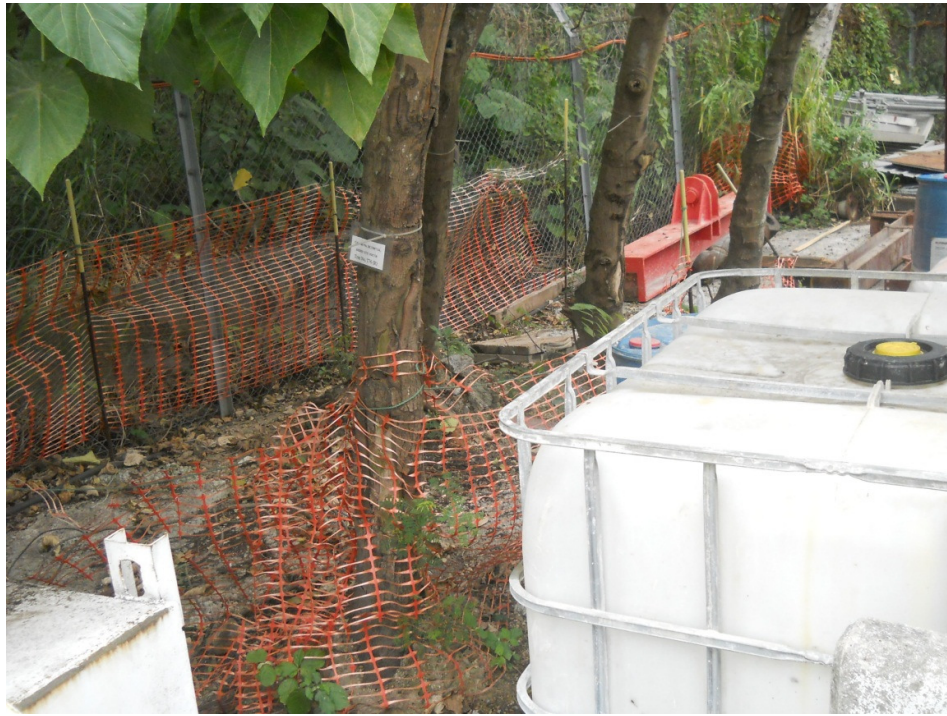
Aberdeen Site – Photo 14

The tree protection zone provided for the retained tree T76 (R) was insufficient. The protective fencing was in contact with the tree trunk.

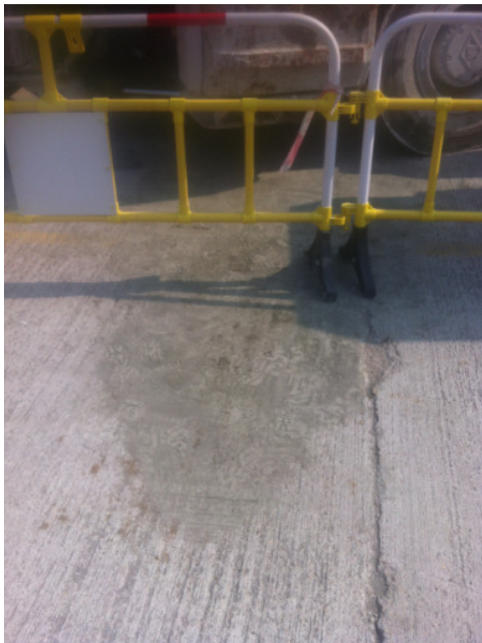
Photo 2 Waste oil was found near the noise enclosure of the inner entrance

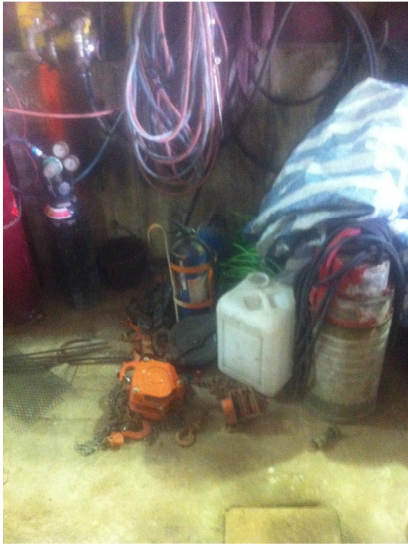
Photo 2 Chemical barrels were found to be without drip trays outside the noise enclosure area

2. The contractor is recommended to provide drip trays for chemical containers.

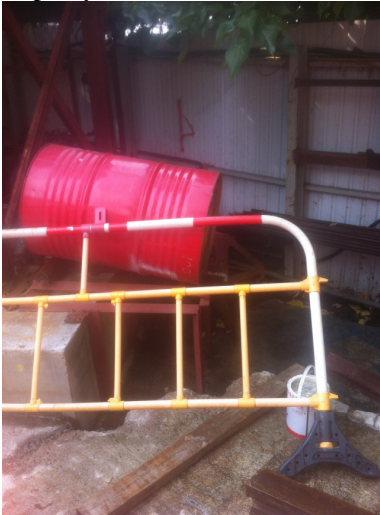
Photo 2 Chemical container was found without a drip tray in the welding area.

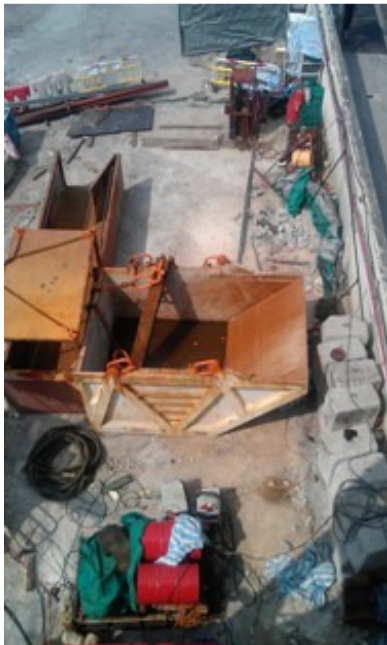
Photo 1 Water-oil mix accumulation was found in skip next to man cage.

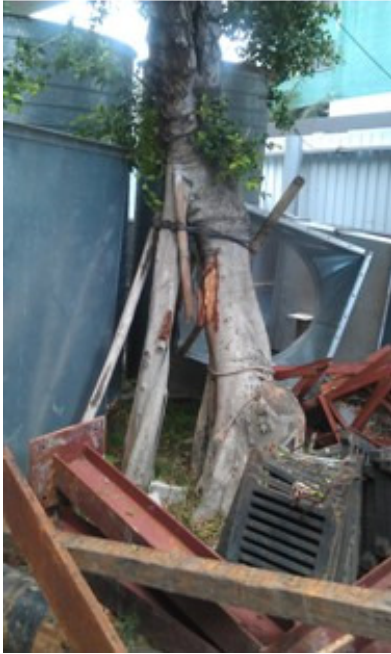
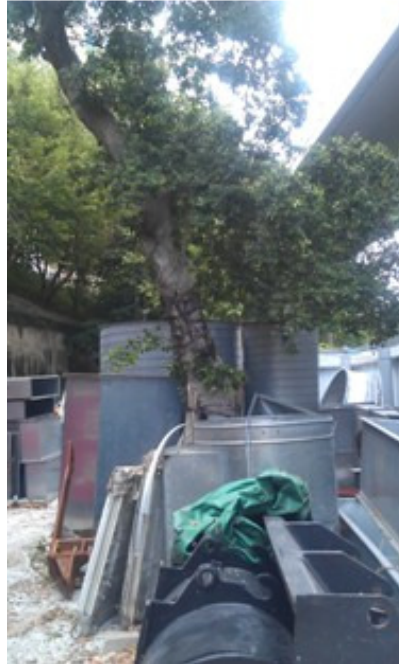
Photos 2 and 3 Construction materials were stored too close to the tree (T003 (T)) in Storage area

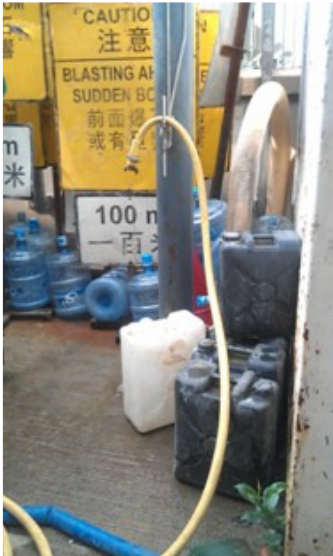
Photo 1 Non-use containers were found next to First Aid Station

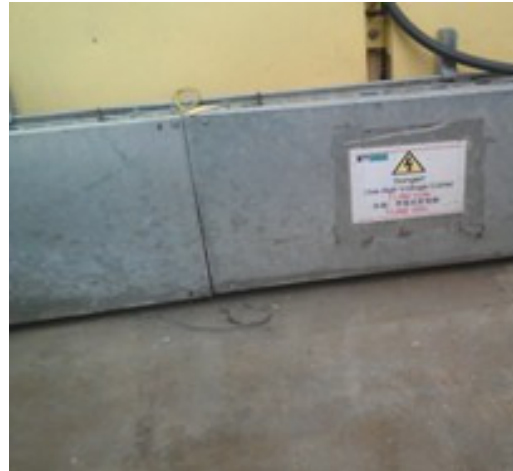
Photo 2 Water accumulation was found on path next to noise enclosure.

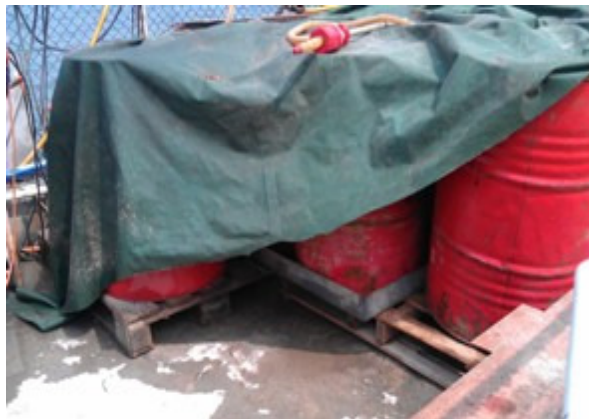
Photo 2 Chemical barrels were found to be without drip trays outside the noise enclosure area.

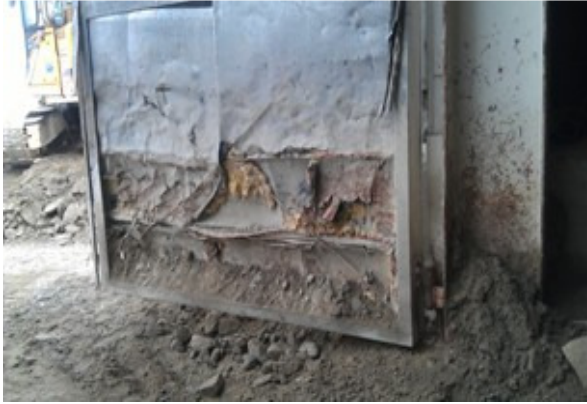
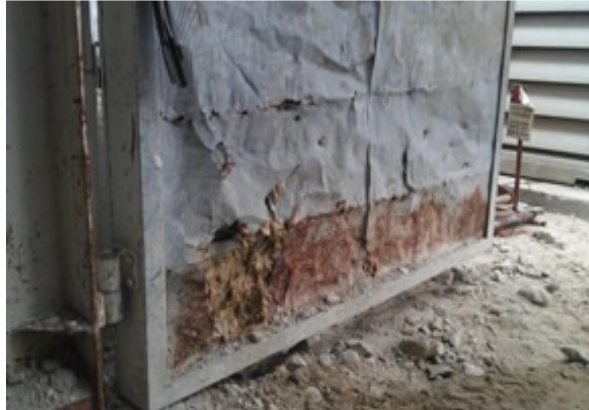
Photos 3 and 4 Door of noise enclosure were broken since last inspection.

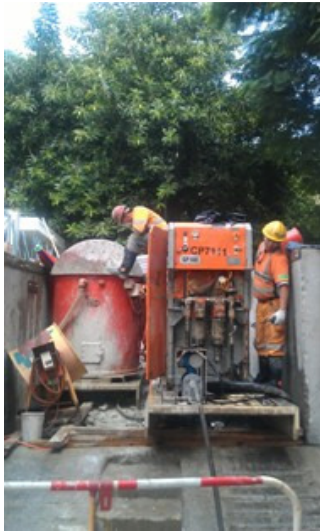
Photo 1 The preparation work for cement mixing was found during the site inspection.

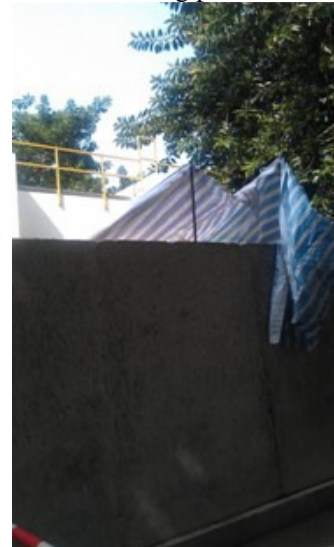
Photo 2 The cover for cement mixing plant was found not properly cover the top and 3 sides of cement mixing plant.

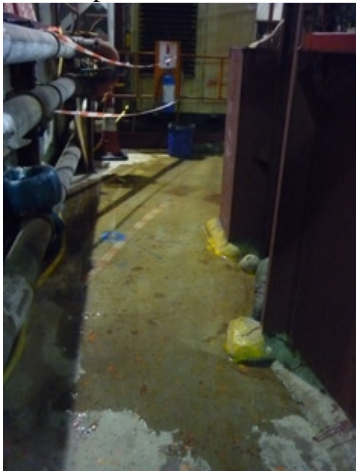
Photo 3 Water accumulation was found next to air compressor in noise enclosure

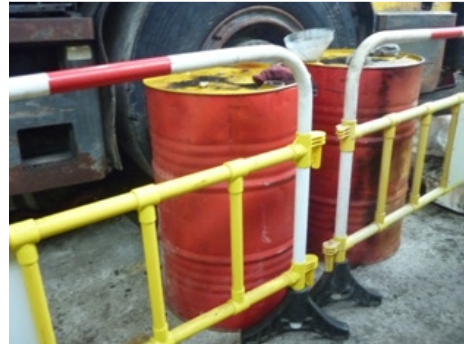
Photos 1 and 2 Some chemical barrels were found without drip tray next to chemical storage.

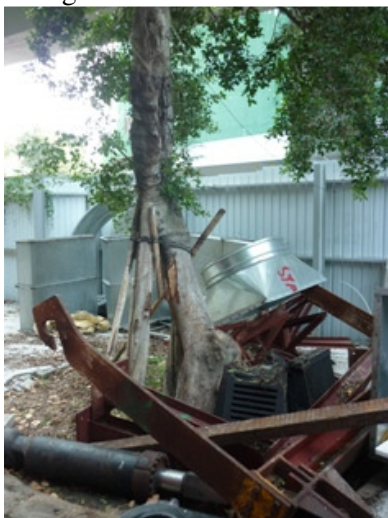
Photo 1 Construction materials were stored too close the tree (T003(T)) in storage area

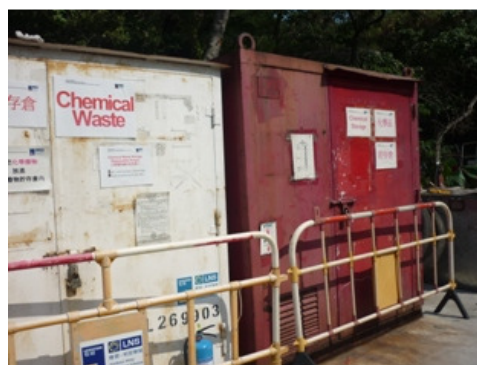
Photo 2 The chemical storage was found without chemical storage list.

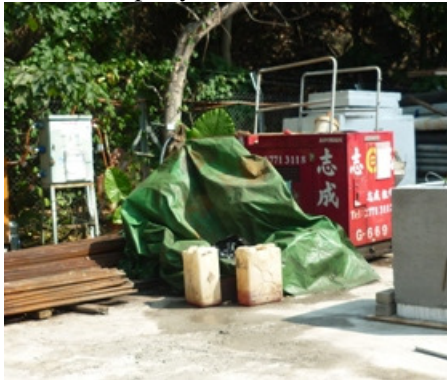
Photo 3 Some known chemical containers were found next to the generator without drip tray and labels.

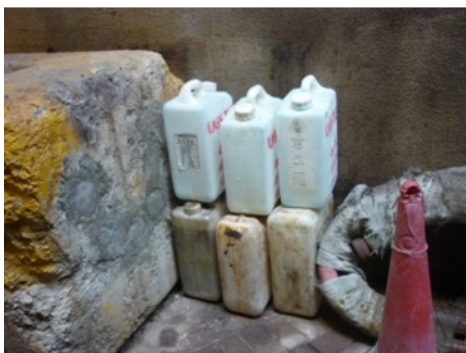
Photo 1 Some unknown chemicals were found near the noise enclosure.

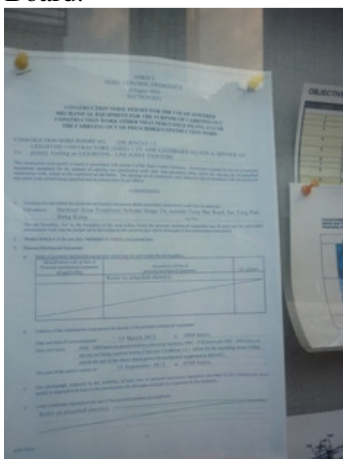
Photo 1 An invalid CNP was found on Notice Board.

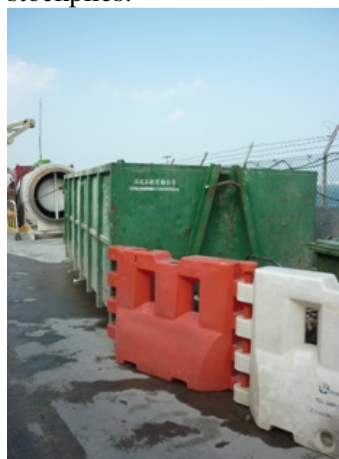
Photo 2 A broken skip was found next to the stockpiles.

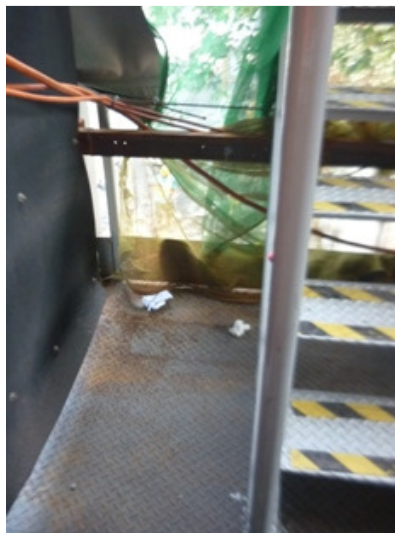
Photo 8 Some trashes were found next to the stairs in PTW

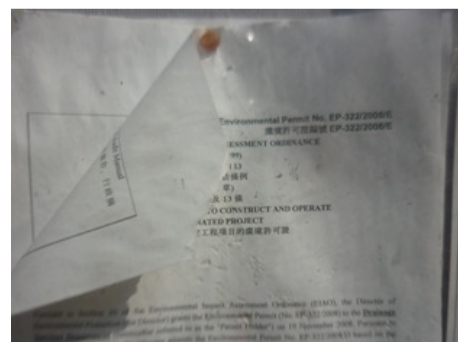
Photo 2 Invalid EP was found in Notice Board

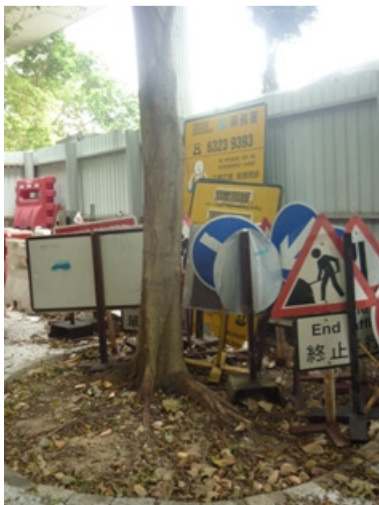
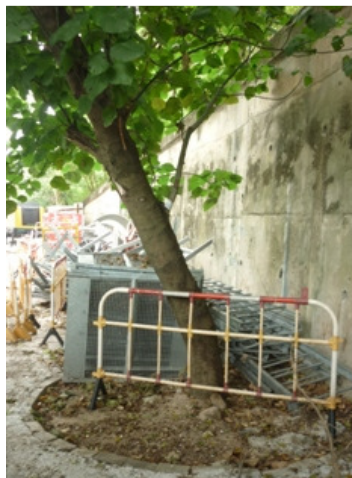
Photos 1 and 2 Construction materials were stored too close to the an un tag tree next to tree (T005 (T)) and tree (T84(R)) in storage area

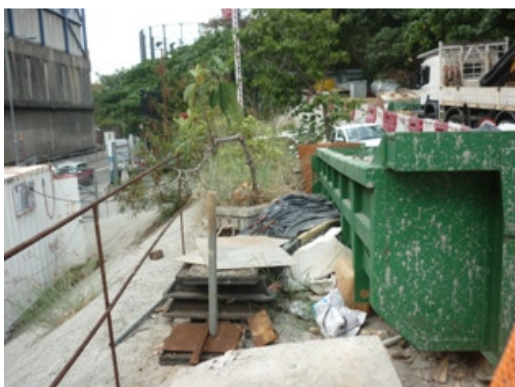
Photo 5 Some trashes were found near the rubbish skip in storage area since last inspection

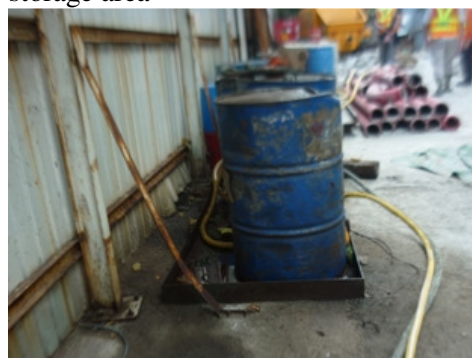
Photo 6 Accumulated of water was found in drip tray of oil barrels near the stockpiles in storage area

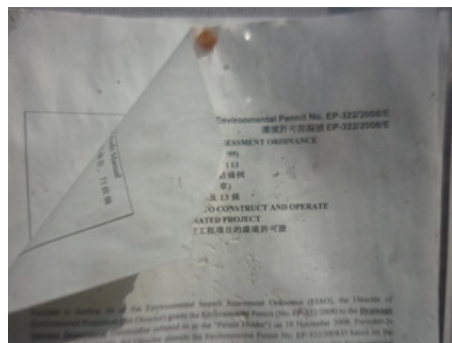
Photo 2 Invalid EP was found in Notice Board

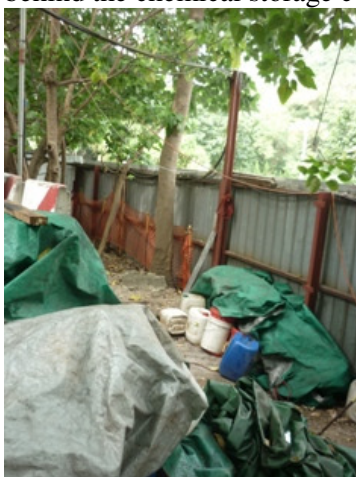
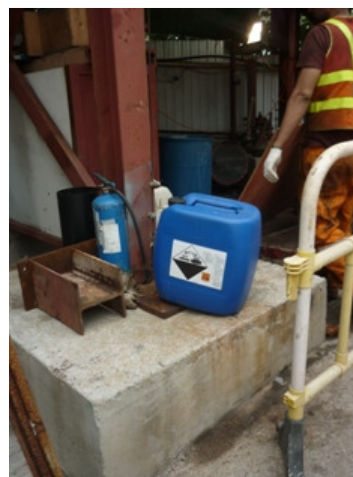
Photos 3 and 4 Some chemical barrels were found without drip tray next to Plants zone and near the site hoarding behind the chemical storage container

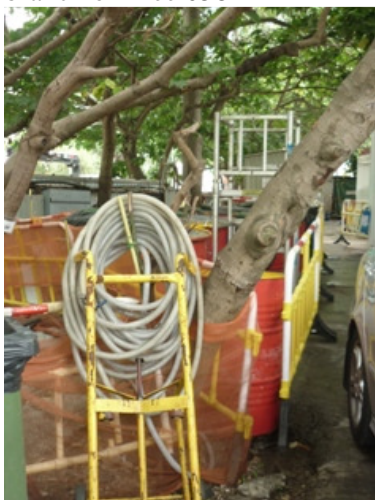
Photo 5 Non-use water plastic pipe hang from the branch of Tree 038

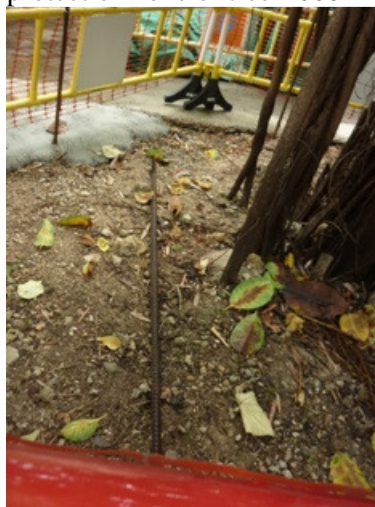
Photo 6 A metal bar was found inside the tree protection zone of tree T006

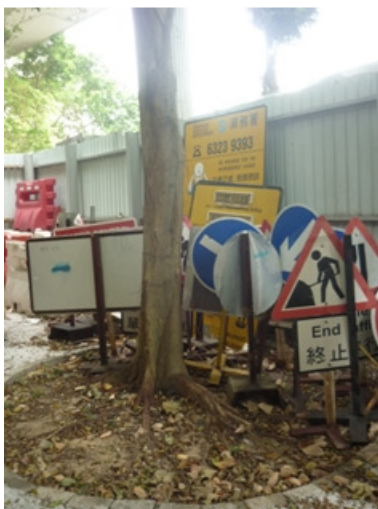
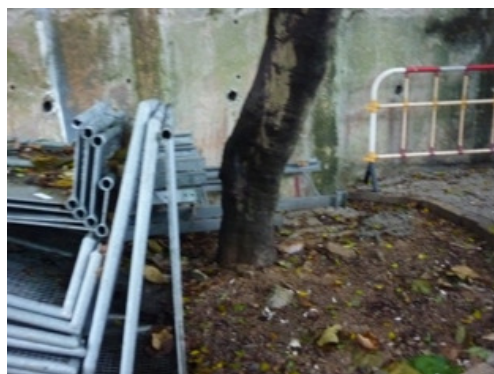
Photos 1 and 2 Construction materials were stored too close to the an un tag tree next to tree (T005 (T)) and tree (T84(R)) in storage area

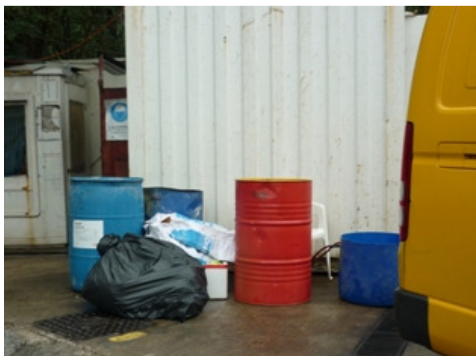
Photo 5 Some chemical barrels were found in PTW without drip tray near the entrance gate

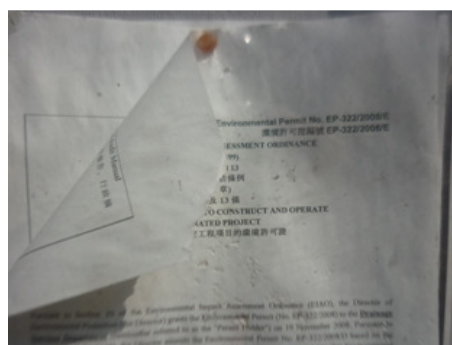
Photo 2 Invalid EP was found in Notice Board

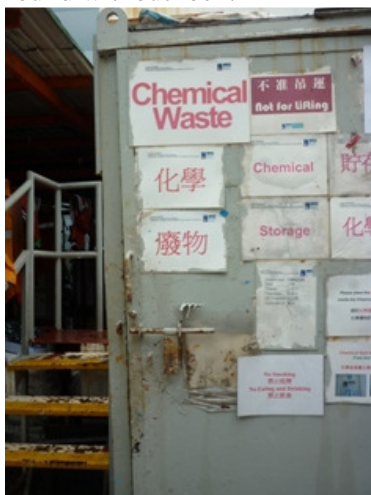
Photo 3 The Chemical Storage container was found without lock.

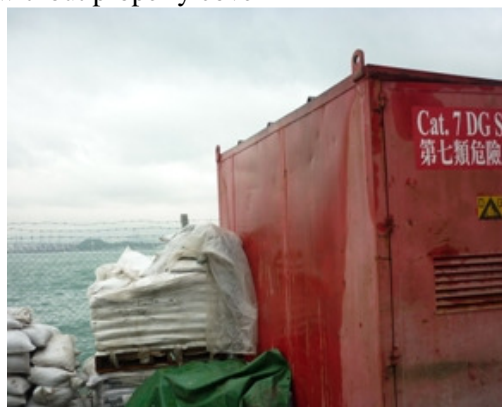
Photo 4 Some dusty material were found without properly cover

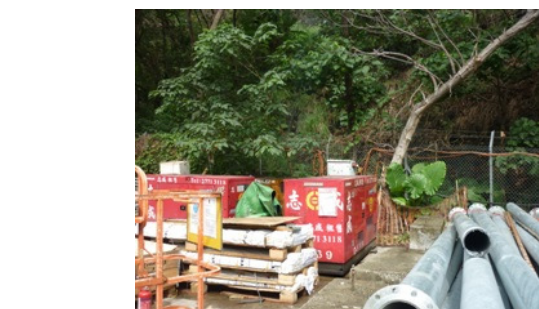
Photo 7 Some white smoke was observed from generator in storage zone.

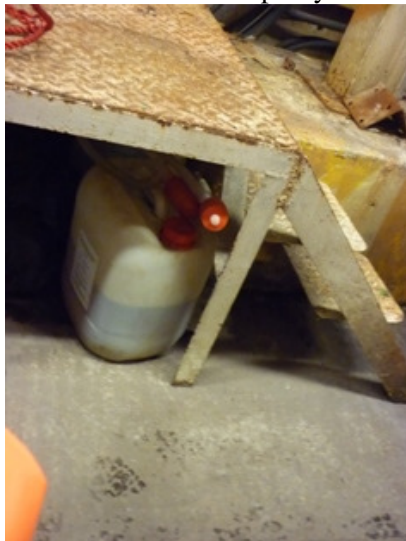
Photo 1 A chemical drum was found without chemical label and drip tray

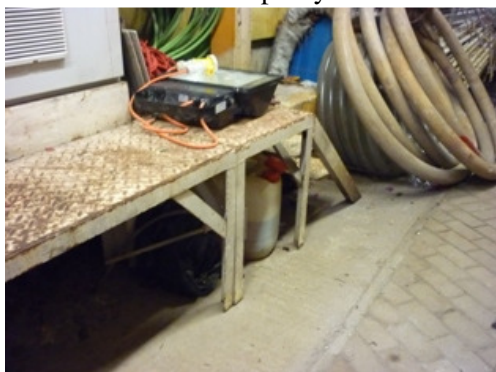
Photo 1 A chemical drum was found without chemical label and drip tray

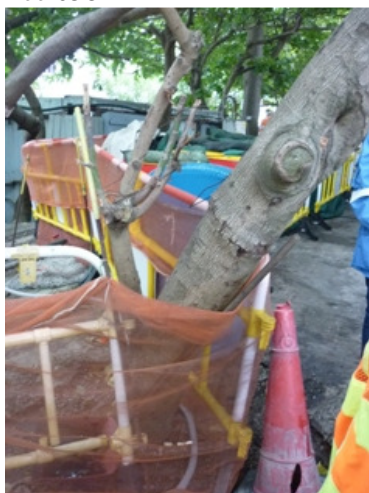
Photo 2 Construction material were found close to Tree 038

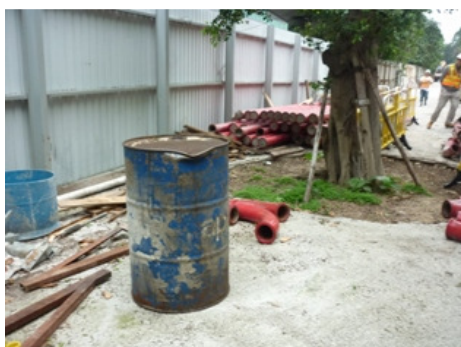
Photo 3 An unknown chemical drum was found near
the tree T005 (T).

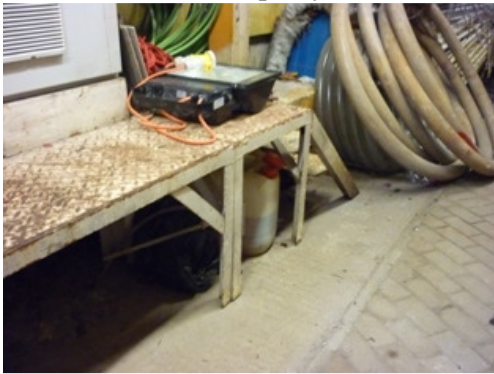
Photo 1 A chemical drum was found without chemical label and drip tray

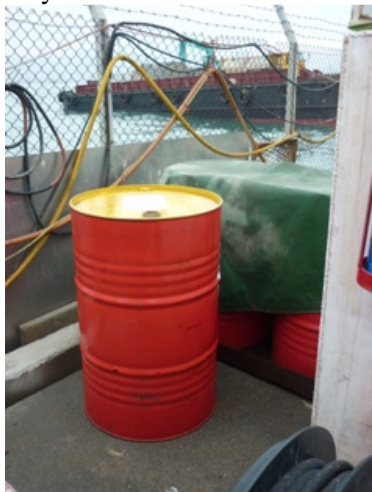
Photo 1 An unknown chemical drum without drip tray was found next to the fuel tank.

The chemical drum was behind the fuel tank.
