**Shatin to Central Link –  
Tai Wai to Hung Hom Section**

Conservation Plan  
for the Old Pillbox  
at the former Tai Hom Village site

# Shatin to Central Link Consultancy Agreement No. C1103 Detailed Design for Diamond Hill Station and Stabling Sidings

Further Structural Survey for the Old Pillbox

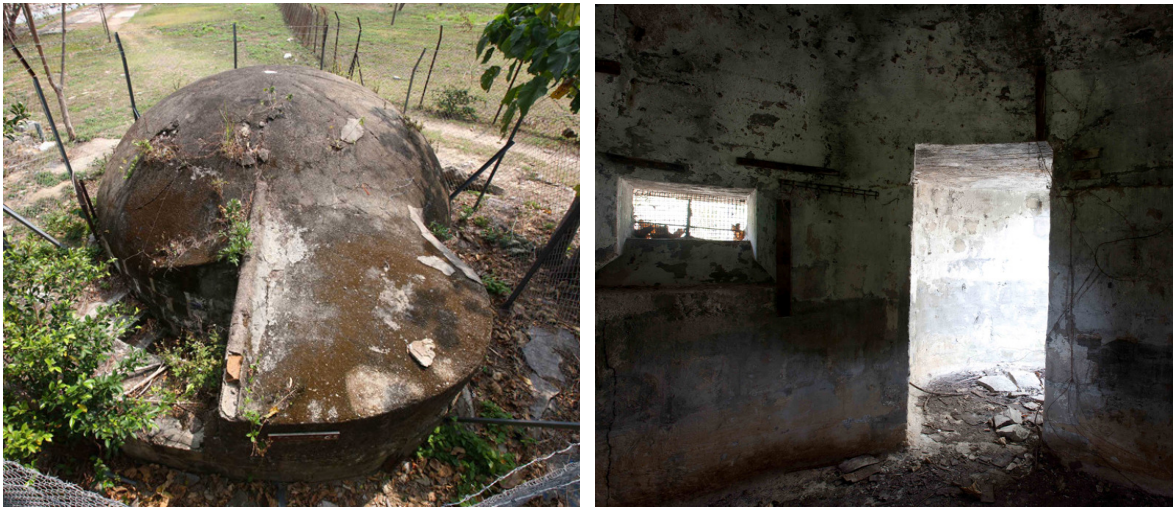
Photo 3.1 & 3.2 The above photos show the outlook and entrance of the pillbox.

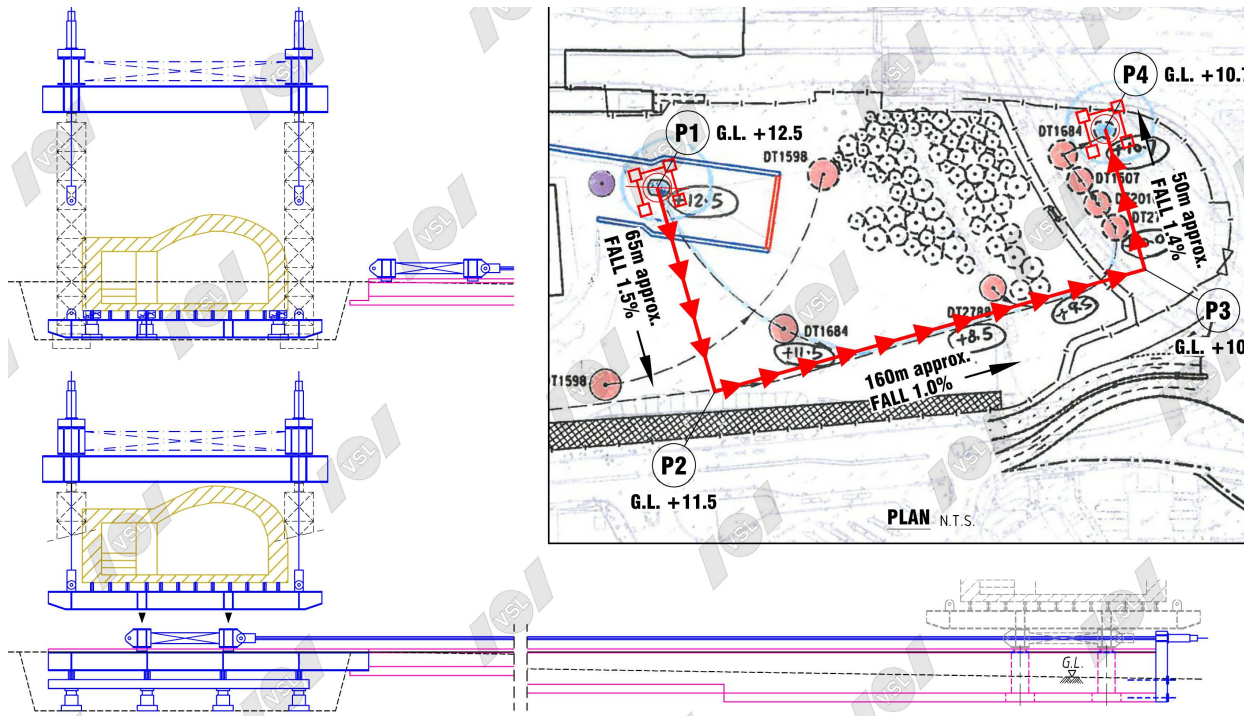
Figure 7.3 Diagrams show the proposed relocation process and tentative route to the temporary storage compound.

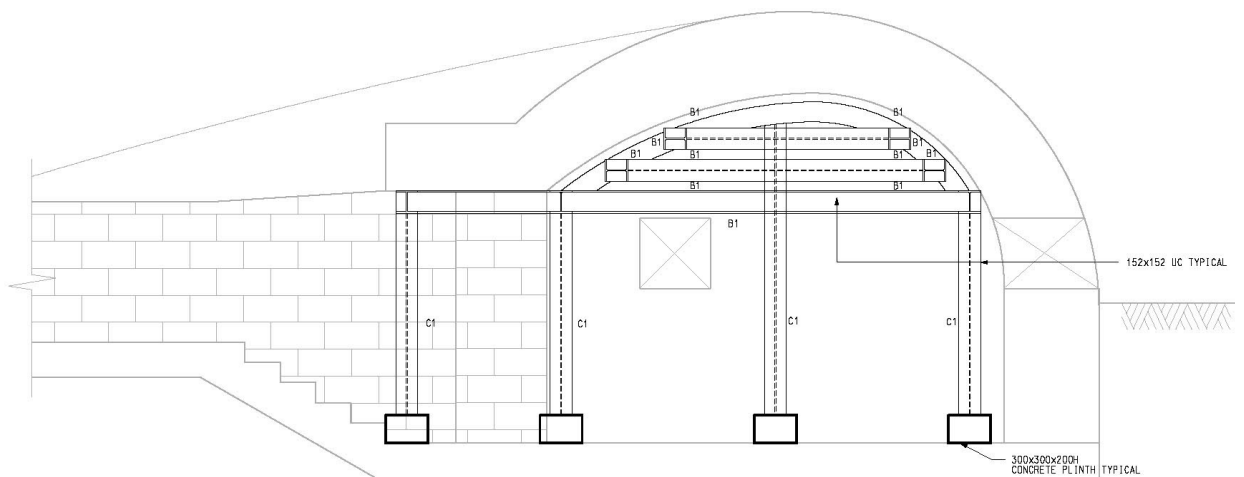
Figure 7.4 Steel framing to be installed inside the pillbox.
