West Island Line Project

Archaeological Watching Brief Report (Rev A)

December 2013

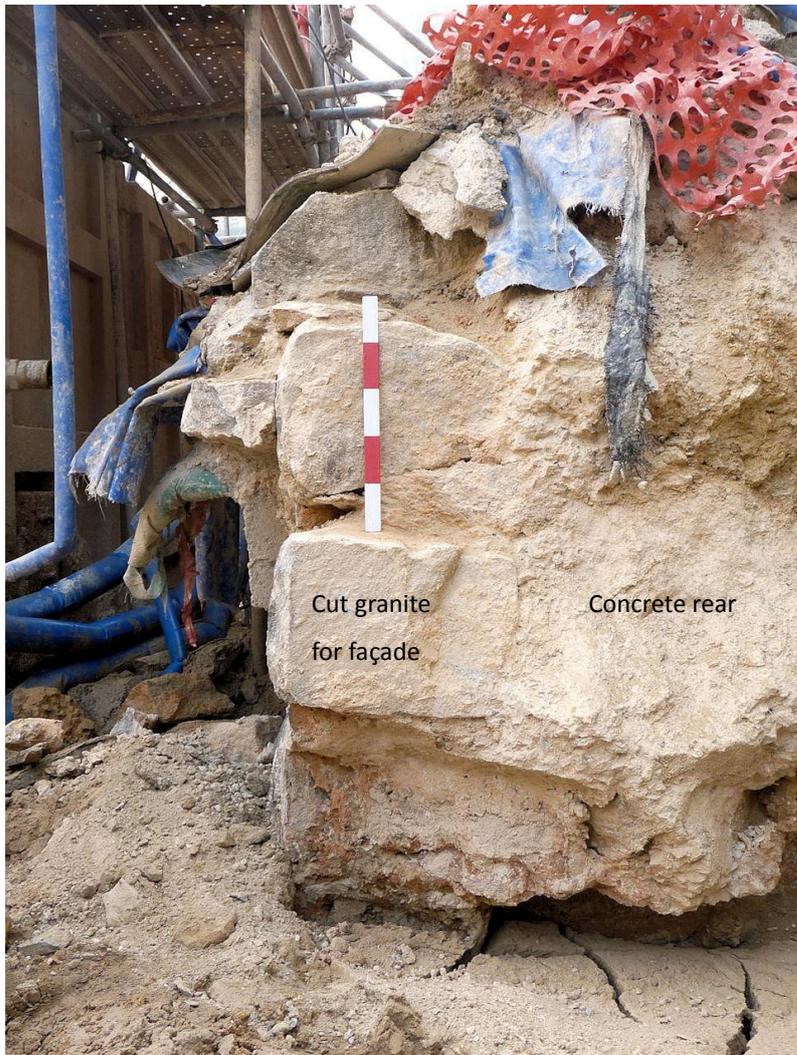
Plate 11.B.2 Photograph showing the section of the southern retaining wall, which shows the concrete backing and cut granite front wall.

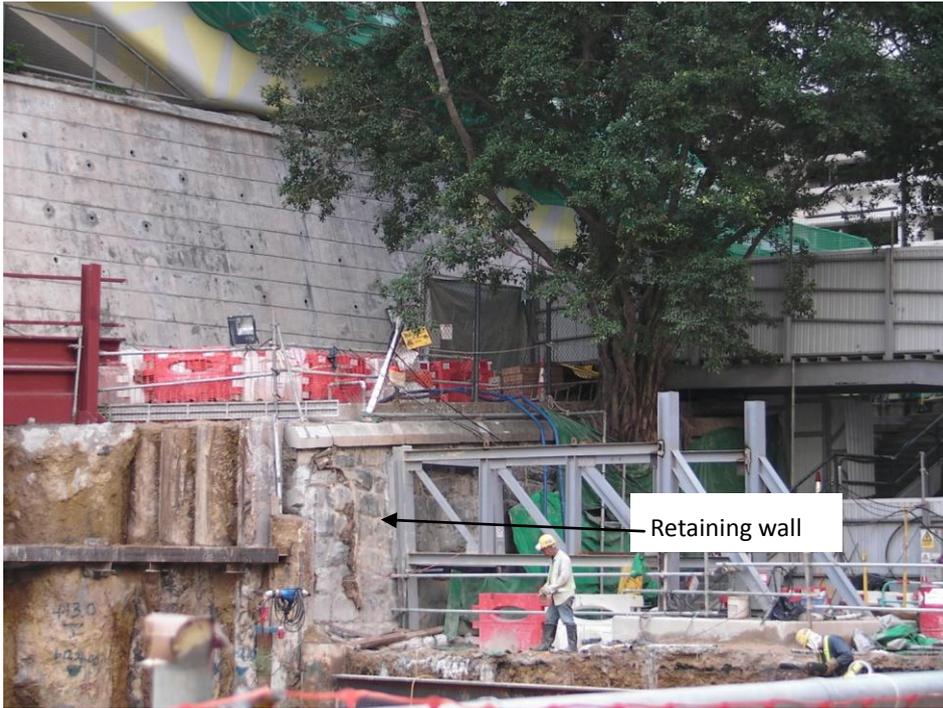
Plate 11.B.3 Photograph showing the retaining wall in the Southwest corner of the works area. The portion will be preserved.

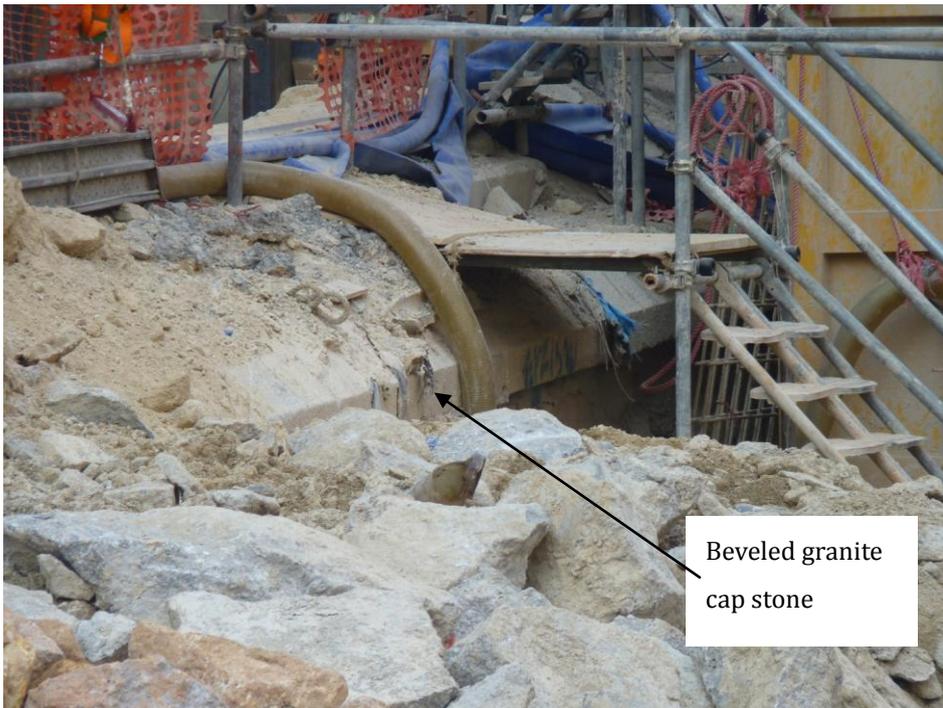
Plate 11.B.4 Photograph showing the top of the retaining wall; notice the beveled granite cap stone.

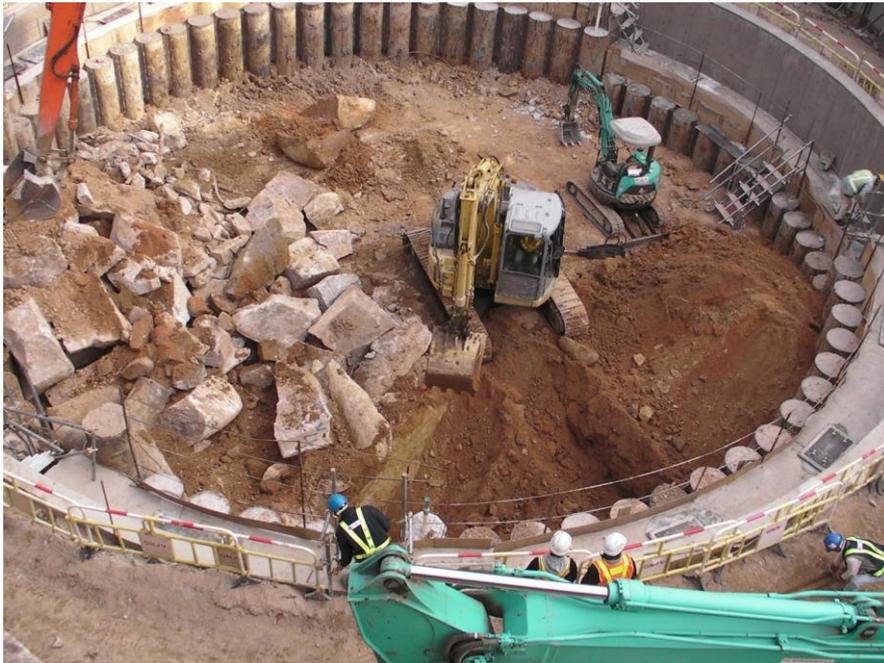
Shaft excavations both at the eastern (Plates 11.B.7-11.B.8) and western end (Plates 11.B.9) of the site confirmed that a thin layer of artificial fill overlays CDG colluviums under the modern surface. No archaeological materials were noted. Within the eastern shaft more construction debris was noted than in the western shaft this is due to the residential back which occupied the eastern part of the site prior to the construction of the fly-over.

Plate 11.B.7 Photograph showing the eastern shaft excavations in progress; note all the boulders on the left of the photo and the large rock being uncovered.

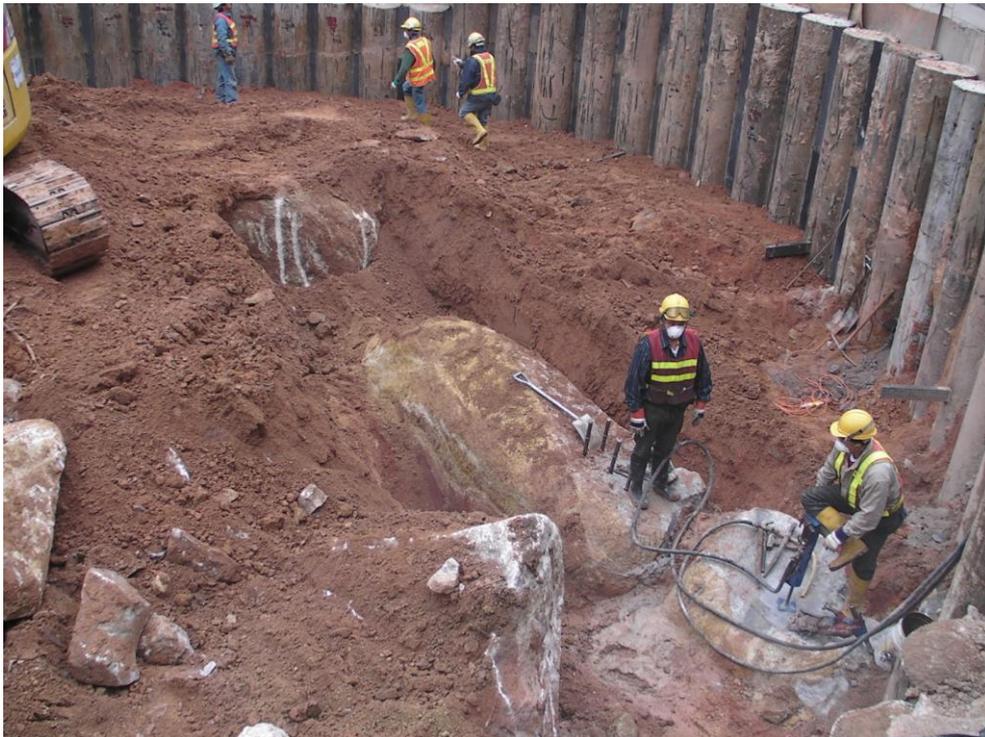
Plate 11.B.8 Rock debris within the eastern shaft at a depth of approx. 2m below the surface.

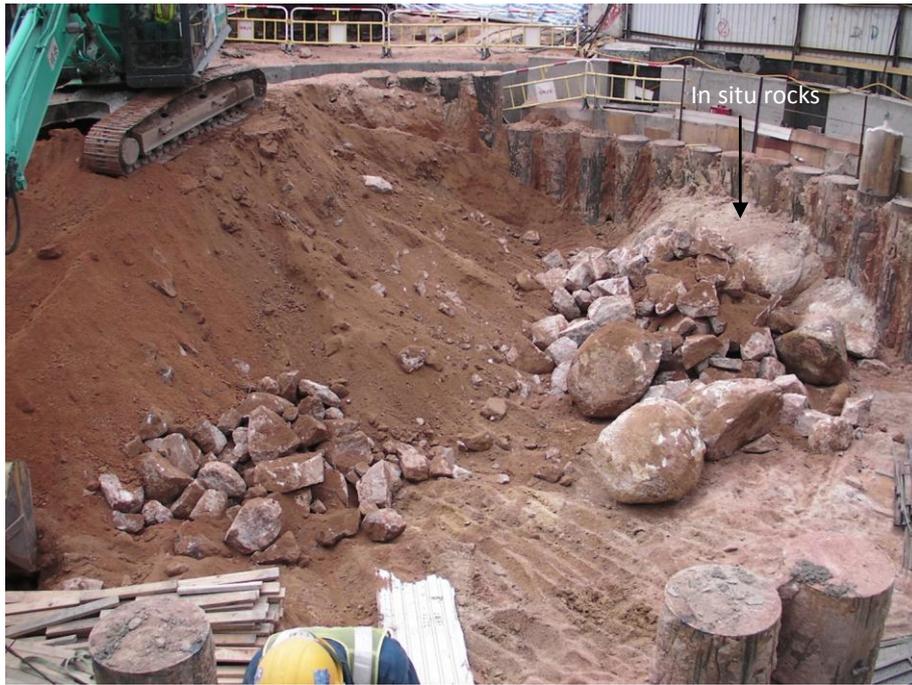
Plate 11.B.9 Photo showing ongoing excavations at the western shaft; note the large rocks appearing to the centre right of the photo at shallow depths

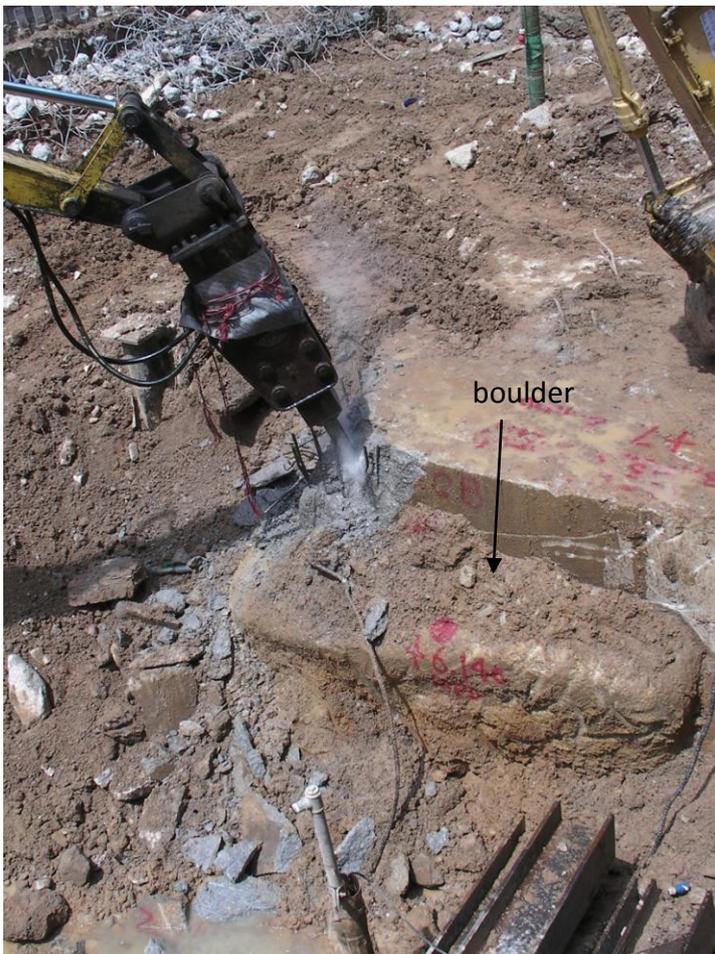
Plate 11.B.12 Photograph which shows the large boulder in the northwest of the works site

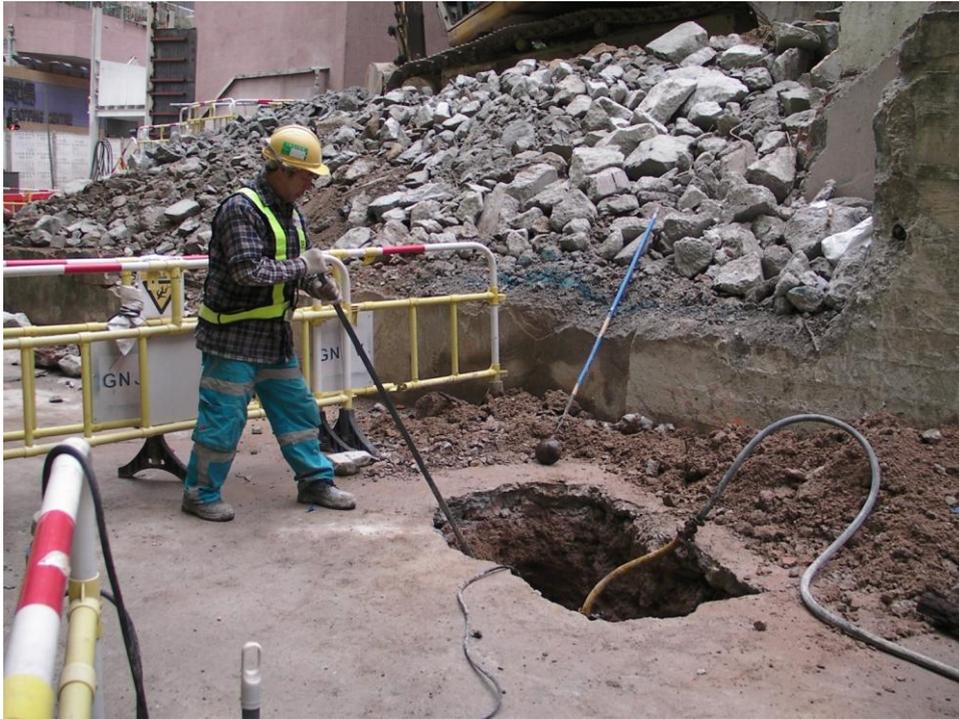
Plate 11.B.13 Photograph showing one of the pits excavated to locate the utilities and a general view north-northeast of the site with the demolition of the public toilets and creation of the artificial ramp needed for piling works

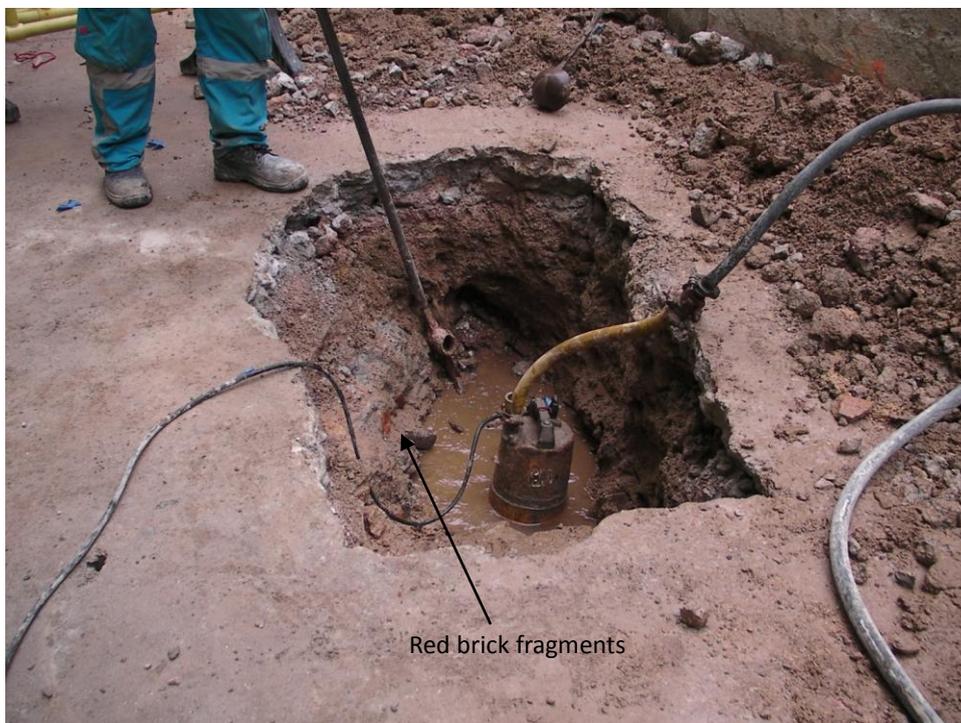
The initial site inspection showed that an artificial ramp was being constructed following the slope of the existing hill to enable piling. A few shallow test pit excavations had been conducted along the west of the site to locate existing utilities (Plate 11.B.13). Despite the fact that these were excavated in the dry season the pits showed water seepage, suggesting the drainage of the area must have significantly changed. The stratigraphy showed red and blue brick fragments along some ceramic pipe fragments: modern mixed with the old, but no material of archaeological interest was noted (Plate 11.B.14).

Plate 11.B.14 Photograph showing a view of the utility pit with some red brick visible in the western section and water seepage

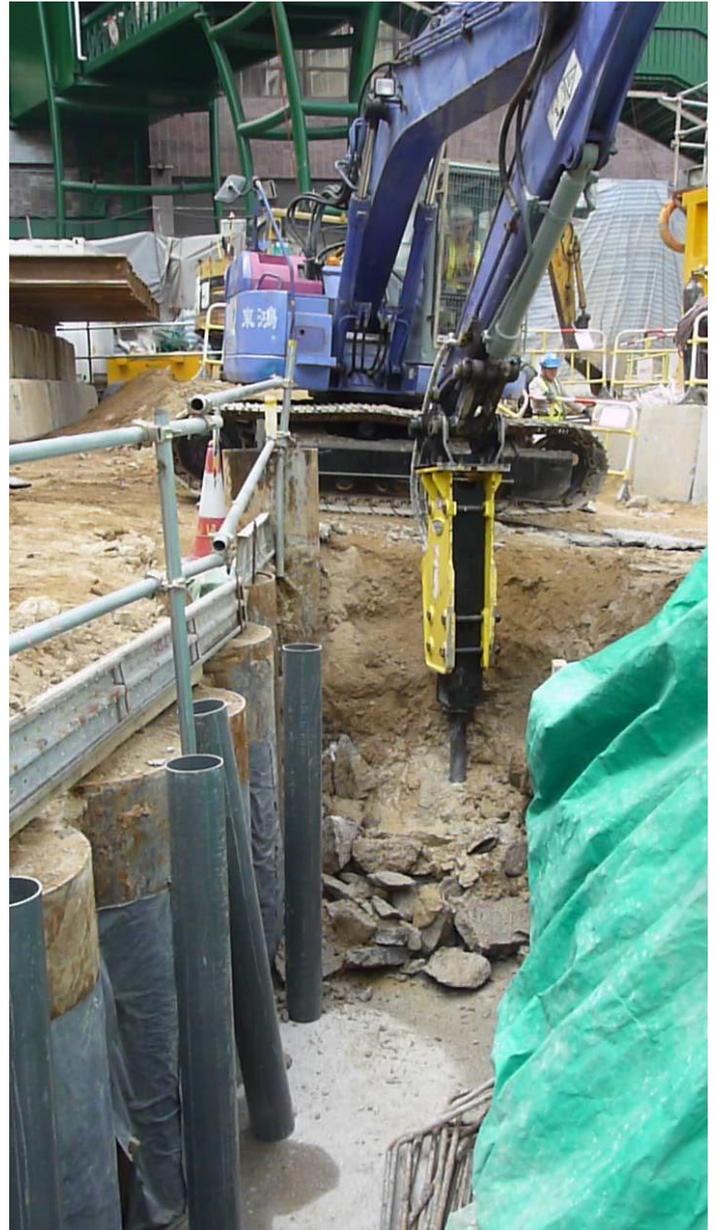
Plate 11.B.18 Photograph showing the drilling of a debris flow boulder to the southwest of the shaft

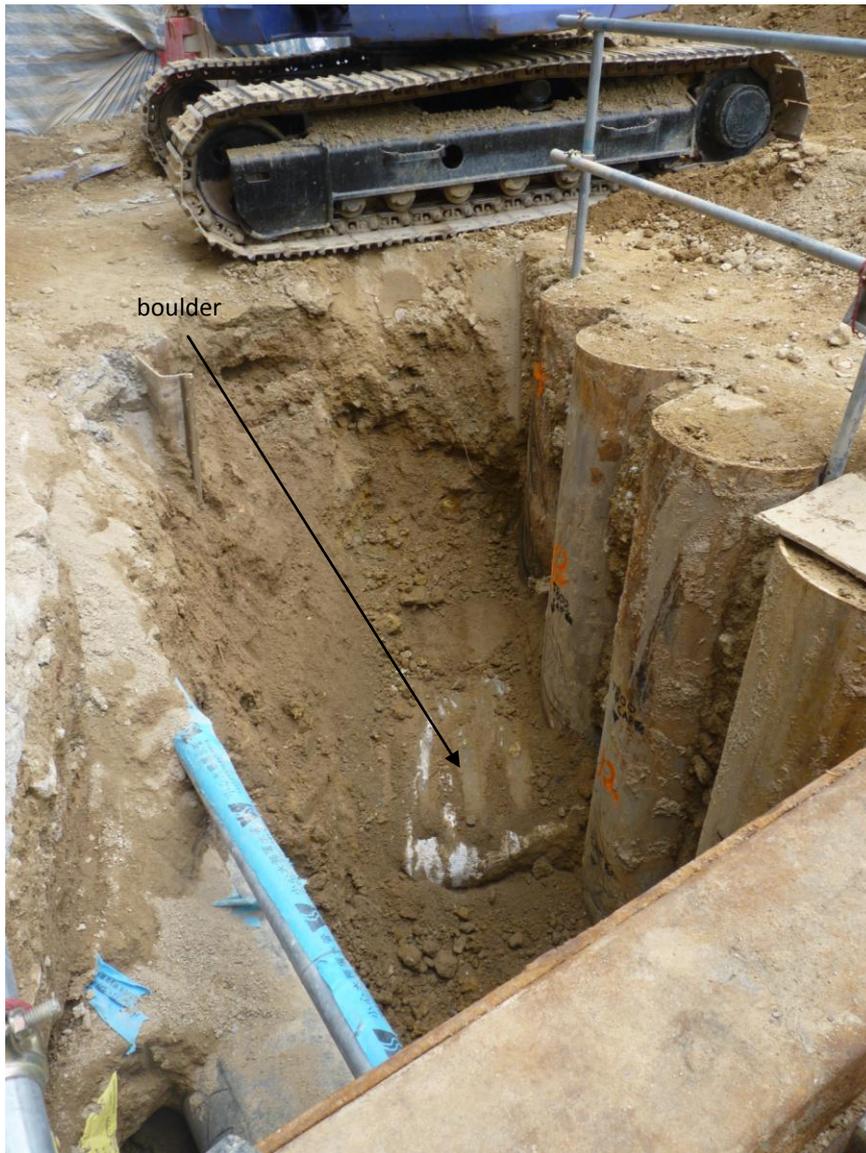
Plate 11.B.19 Photograph showing boulders appearing around 1m below surface set in sterile soils

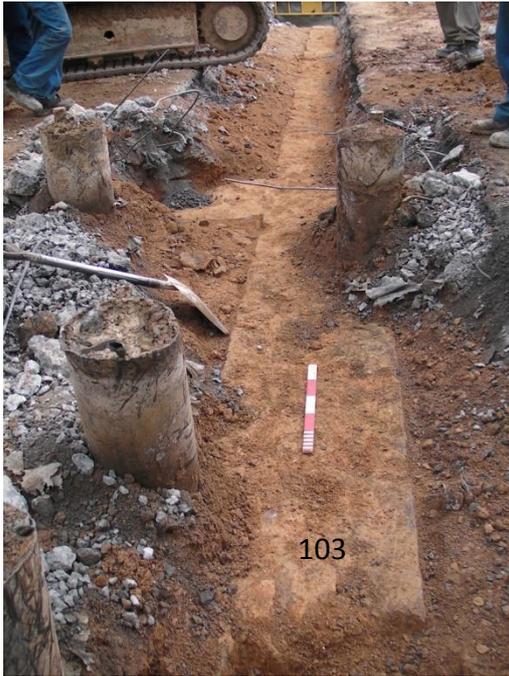
In the **Northeast corner** of the noise enclosure monitoring indicated below modern surface and a sequence of CDG (coarse decomposing granite) fill, a wall foundation of granite blocks [**WF103**] (Plate 11.B.20a and b). The foundation trench for the wall [**104**] cut into pre-existing CDG fill [**105**] and had an east-west orientation. Apart from three undiagnostic red tile fragments (probably 20th-century in date) (Plate 11.B.21) within the foundation cut no other dateable material was noticed. The continuation of wall foundation [**WF103**] was noted in the Northwest corner of Site M (703) and it extended for some 11m west of where it was first discovered. During removal of hardcore layer [**102**], which sealed the wall foundation [**WF103**], a base sherd dated late 19th-century to 20th-century provincial porcelain (Plate 11.B.22) was recovered.

Plate 11.B.20a Granite block wall foundation 103; view looking west

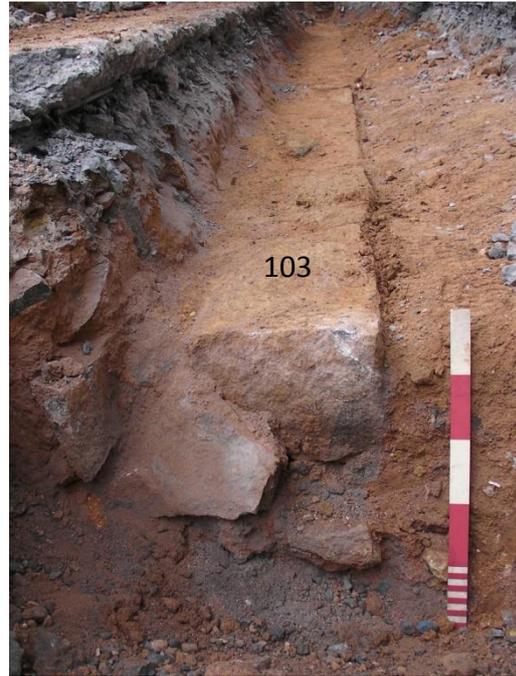
Plate 11.B.20b Photograph showing the granite wall west facing section

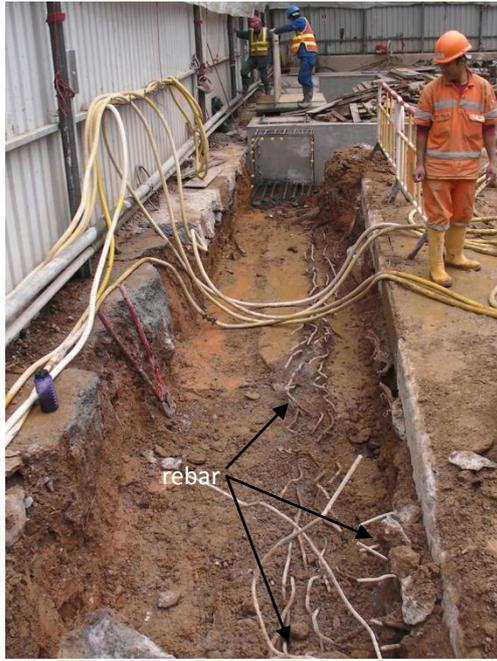
In the northern end of the trench for **TB4**, the presence of deep rebar foundations was noted (Plate 11.B.23). The latter foundations were associated with the basketball court fencing and perimeter drains and extended south along the western side of the site and were still present in the base of excavation at formation level. The depth of disturbance evidenced in TB4 suggested that there would be little chance of archaeological remains surviving along the western edge of the site in TB4 and TB6.

Plate 11.B.23 Photograph showing a view of TB4 trench looking north; note the rebar foundations

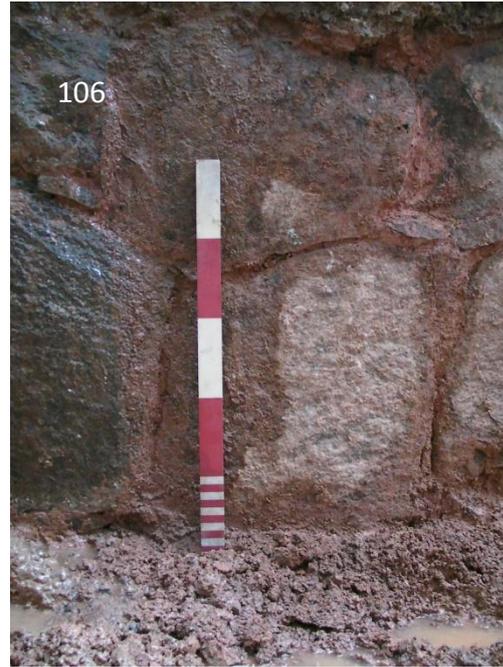
In **MTB1** a substantial and well-made wall foundation (**WF106**) was noted under the west facing section of the trench. **WF106** extended some 6.5m N-S and was 0.65m high at the limit of excavation by 0.63m thick (Plates 11.B.24 and 11.B.25) , like all granite wall foundations at Site M, WF106 was only partially exposed in plan and almost certainly did not survive to its original height. Neither finished ends nor abutments with other wall foundations were visible in the contractor's foundation cuts - so WF106 can be considered to be a substantial fragment of a longer and taller wall/foundation. Moreover, only the mortar/gravel bedding trench and two courses of granite blocks

survived in vertical section and, as shown by the uneven and unfinished upper surface of similar wall foundation **WF103**, which was exposed nearby, one or more courses must have been removed when the site was levelled-up for later development.

Plate 11.B.24 Photograph showing west facing elevation of granite wall foundation 106

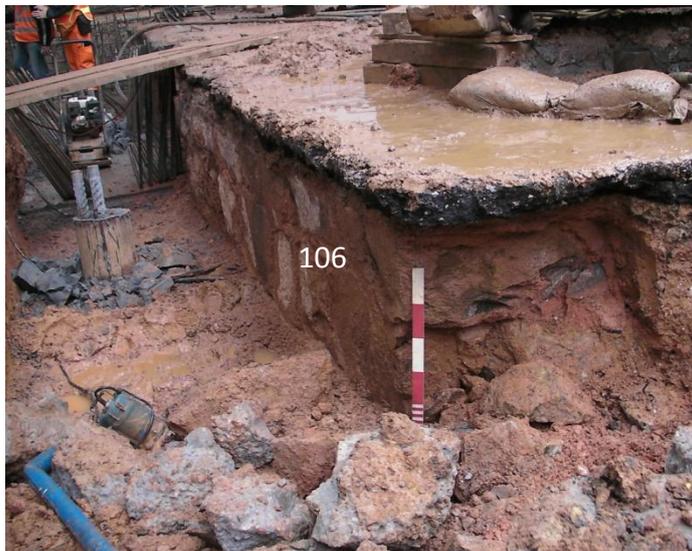
Plate 11.B.25 Photograph showing a view of granite wall foundation 106 looking to the northeast

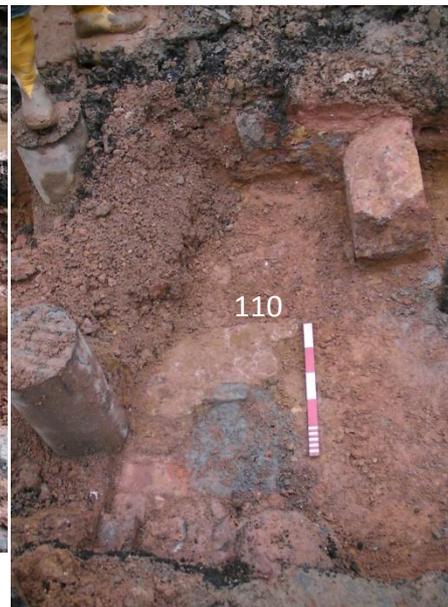
Another N-S orientated wall foundation (**WF110**, Plate 11.B.26) was observed near **CAP 5** in association with a brick foundation (**BF111**, Plate 11.B.27), which appeared to be in alignment with **WF106/108** (Figure 11.B.5). Under the stone and brick foundations a mortar gravel bedding foundation was recorded (**MG115**). It is assumed that wall fragments 106, 108 and 110 and its mortar/gravel bedding 115 are parts of the same wall.

Plate 11.B.26 Photograph showing the wall foundation 110; view looking north

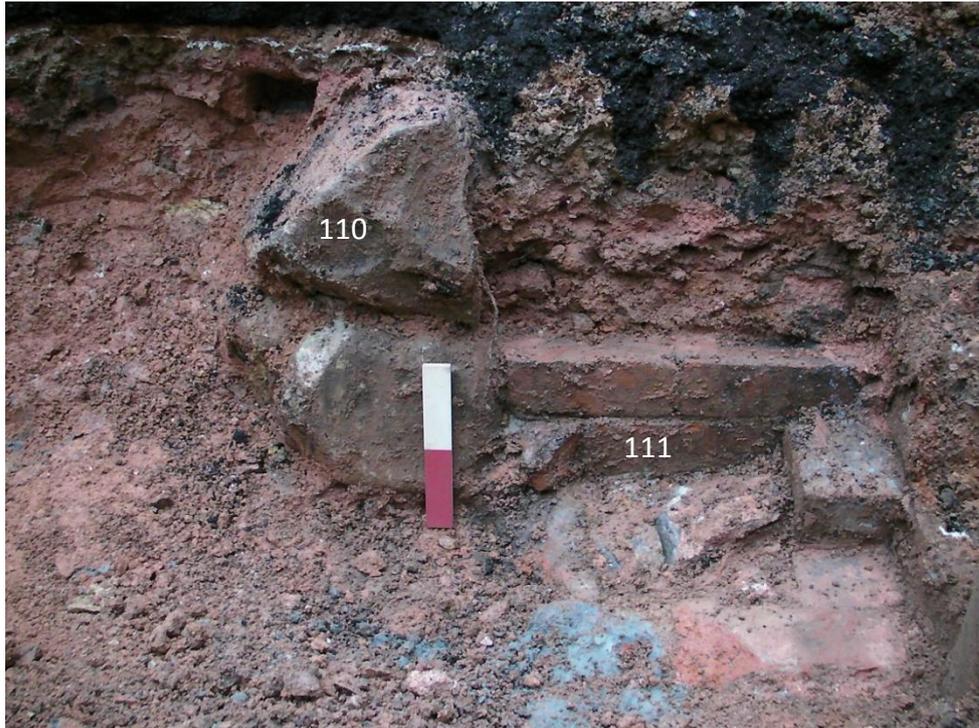
Plate 11.B.27 Photograph showing brick foundation 111 and wall foundation 110; view looking south

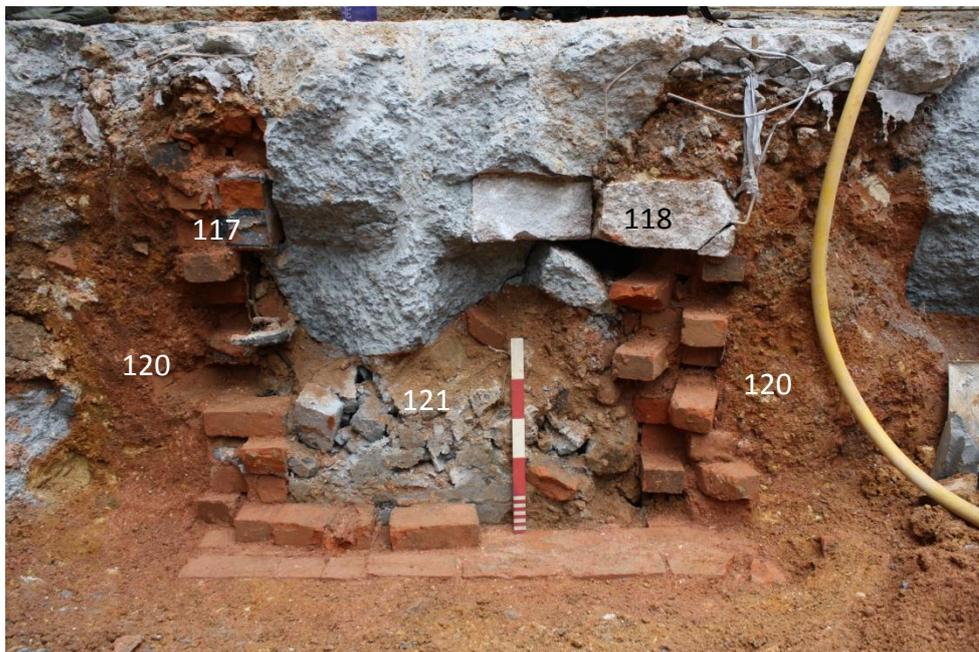
Remains of a brick structure (**BS117**) were identified in the south-east corner of the site near the junction of **CAP 8 and TB7** (Plate 11.B.28). On top of the bricks a couple a granite blocks were recorded (**118**); the purpose of these two blocks or their relationship to the brick structure is unknown (Plates 11.B.28 and 11.B.29). The remains are interpreted as a brick manhole; it is not clear however, if the structure is contemporary with the other wall and brick foundations found at the site.

Plate 11. B.28 Photograph showing brick structure 117; view of north facing section. Note also the two granite blocks on top of the structure (118)

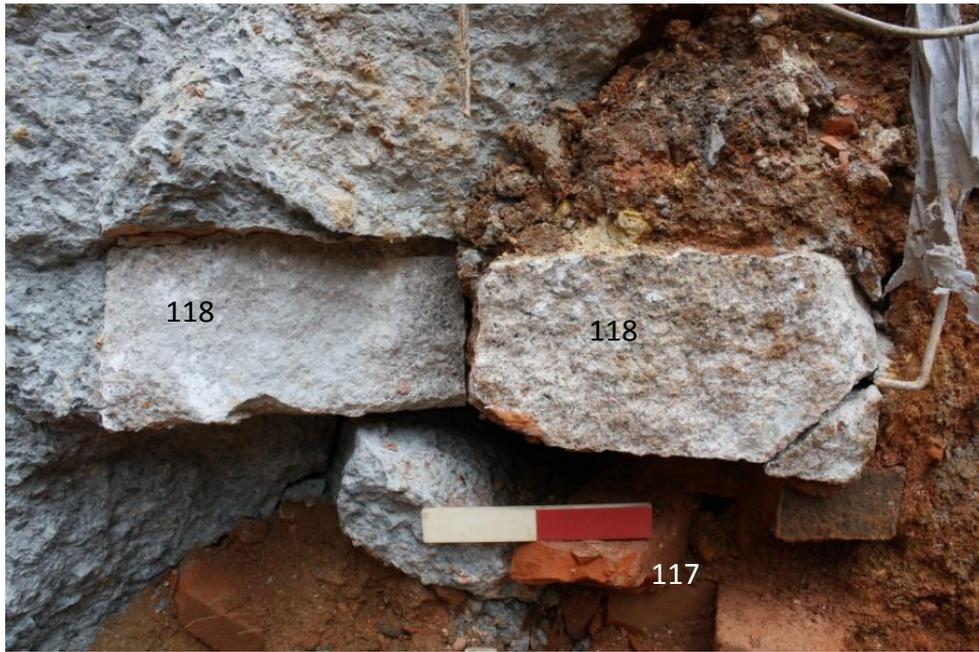
Plate 11.B.29 Photograph showing the 118 granite blocks lying above the brick structure (117).

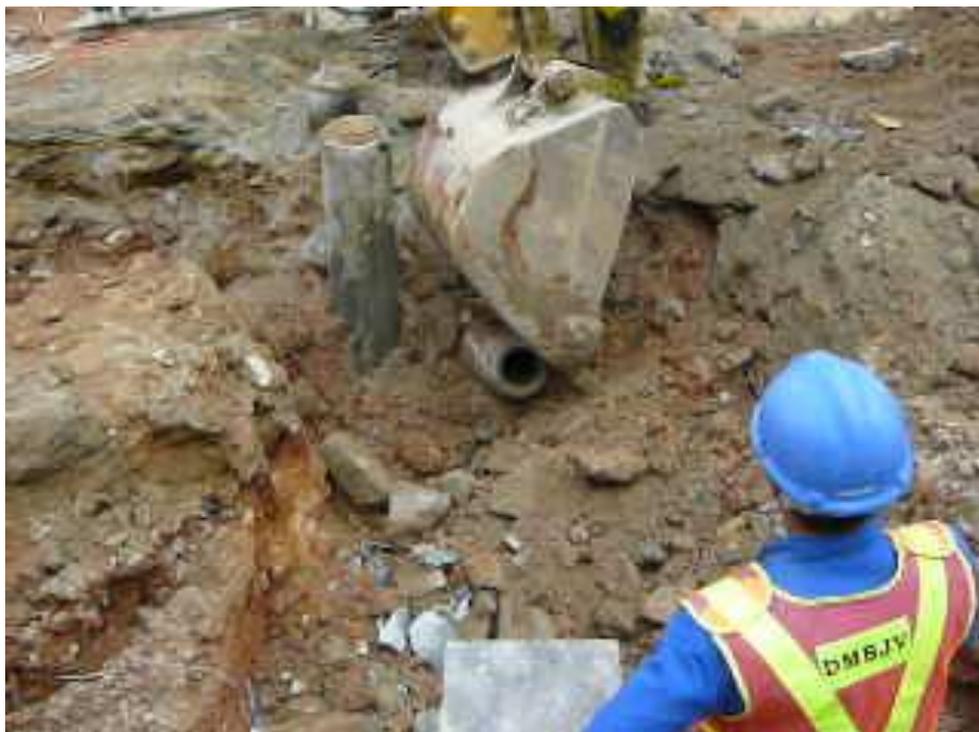
The groundworks for **CAP 7**, the western half of **TB8 and MTB3**, as well as the completed foundation trench for **TB6** evidenced **significant modern disturbance**: from drainage pipes in the case of **TB8 and CAP 7** (Plate 11.B.30), and from rebar foundations in the case of **TB6 and MTB3** (Plate 11.B.31).

Plate 11.B.30 Photograph showing modern pipe disturbance at CAP 7, noise enclosure; view looking east.

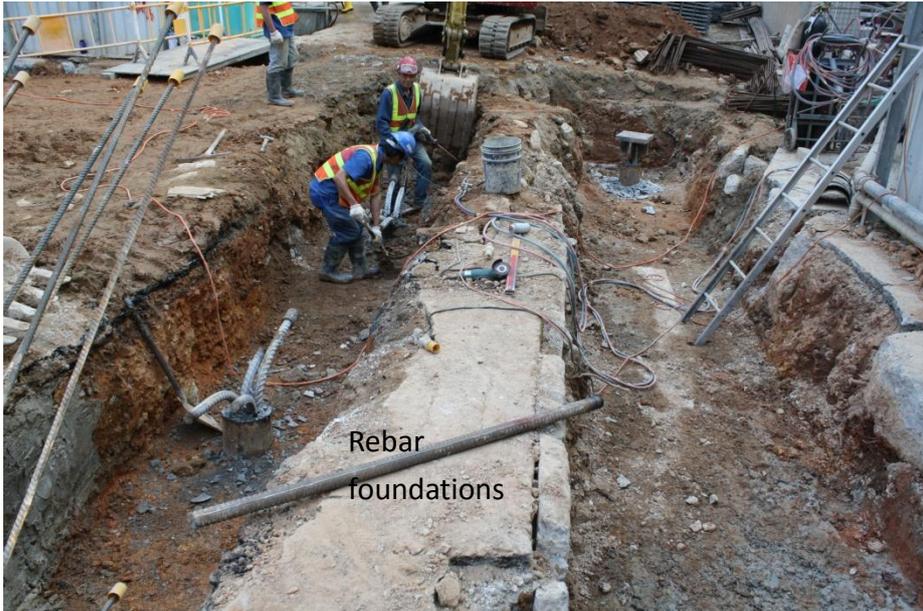
Plate 11.B.31 Photograph showing rebar foundations at TB6 and MTB3; view looking north.

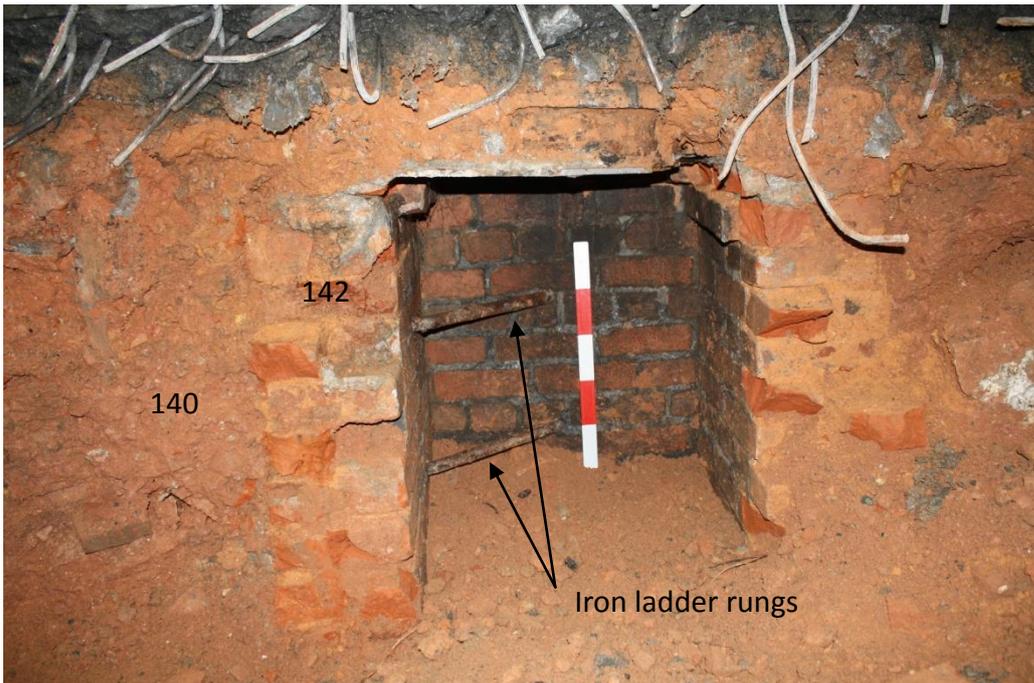
Plate 11.B.38 Photograph of Manhole 142; view looking west; note the iron ladder rungs

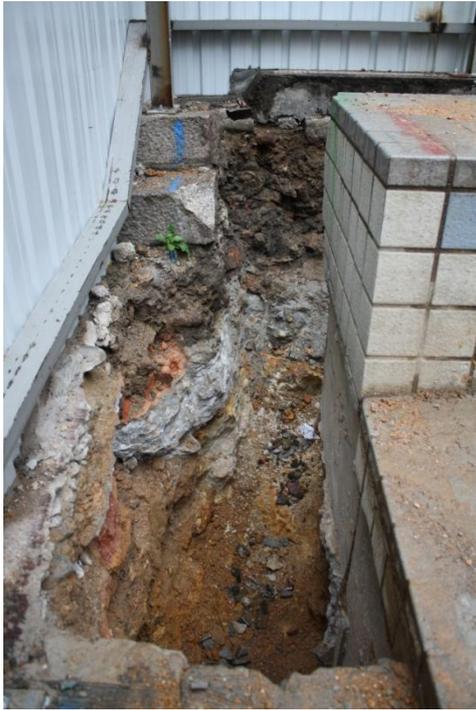
Plate 11.B.43 Photograph of Site M2 showing a deep sequence of rubble fill; view looking south
