Docum	nent Details			
Clie	nt		Drainage Serv	vices Dep	partment		
Proj	ument Title	D	Contract N Harbour Area Treate Construction of Sewa from Aberdee thly Environmental M	ment Sch age Conv n to Sai V	neme Sta veyance Ying Pur	System 1	No. 62
	ument No.		ring the Period from 1	Februar	y2015 to	28 Februa	ary 2015
	y No.	lee	ued To	Copy No.	Issued	To	
	1-02	-	ghton-LNS JV	10		Metcalf & Eddy-AECOM JV	
	03	<u> </u>	tt MacDonald Hong Kong Ltd	10			VI J V
	03	EPI		12	ACL (Project Office)  ACL (Head Office)		
	09	DSI		12	ACL (FI	ACE (Flead Office)	
Sub	mission				Control	llad Cany Na	
		nei			Control	lled Copy No.	
SUBM Ref.  Atkins DC/2007/24/19.10/OC029/OR021/EC/SO Ref.(s)							
Rev	ision His	tory

This is the sixty-second Monthly Environmental Monitoring and Audit Report prepared by Atkins China Ltd (ACL), for Contract No. DC/2007/24 Construction of Sewage Conveyance System from Aberdeen to Sai Ying Pun (hereinafter, the Project), in compliance with the Project EM&A Manual under EP No. EP-322/2008/G. The construction works under the Project was commenced on 23 December 2009. This report summarises the findings and results of the EM&A during the reporting period from 1 February 2015 to

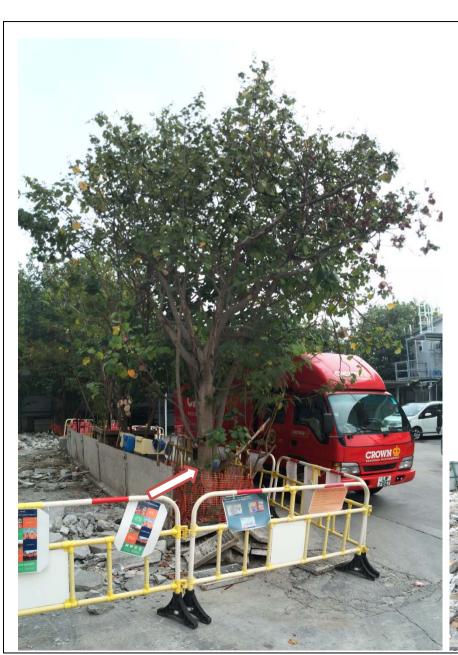
## Photo 1 (Tree no. T065(R)):

• General refuse was found inside the tree protection zones of retained trees T065(R). The Contractor was reminded to remove refuse from the tree protection zone.

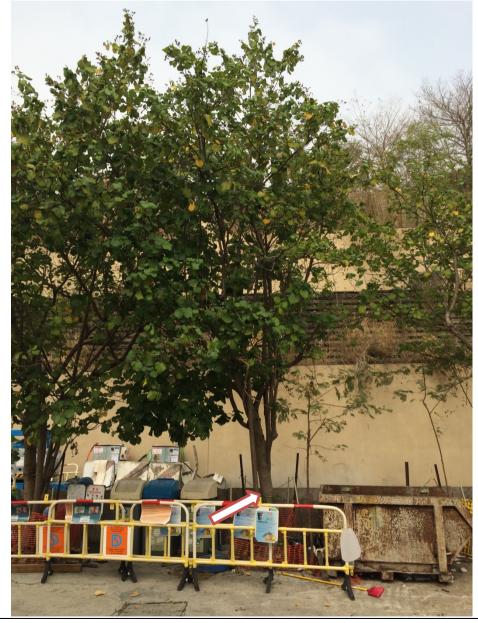
## Photo 2 (Tree no. T066(R)):

General refuse was found inside the tree protection zones of retained trees T066(R). The Contractor was reminded to remove refuse from the tree protection zone.

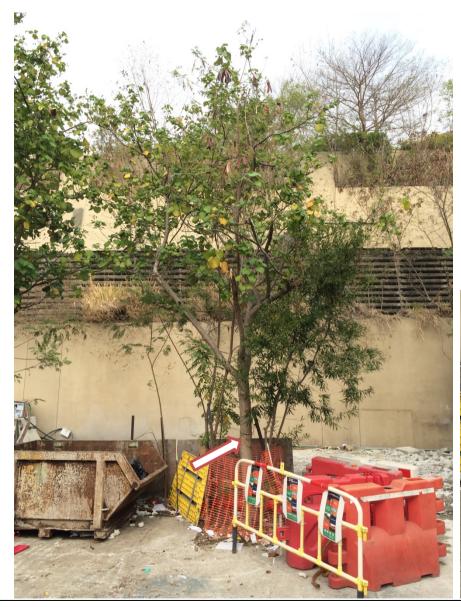
### Photo 3 (Tree no. T068(R)):

In Cyberport site, the condition of the retained tree T068(R) was still observed deteriorating with shrunken leaves. Tree tags for retained trees T065(R), T067(R), T072(R) and T074(R) were observed damaged or missing. General refuse was found inside the tree protection zones of retained trees General refuse was found inside the tree protection zones of retained trees T065(R) and T066(R). The tree protection fence for retained tree T074(R) was observed damaged.

General refuse was removed and lower portion of tree trunk was wrapped by orange net. Tree protection zone of the retained trees T068(R) was established.

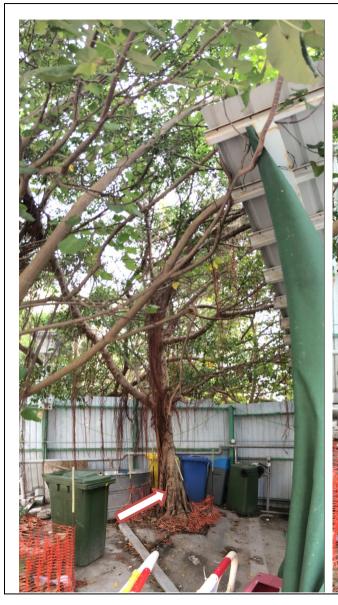
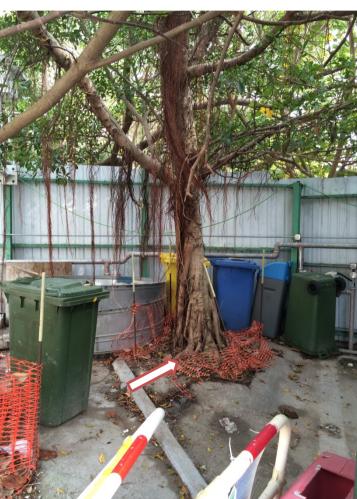
# Photo 4 (Tree no. T074(R)):

The tree protection fence for retained tree T074(R) still was observed damaged (same as last month).
