<u>Landscape and Visual Impact Assessment Checklist for Site Audit – North Point PTW</u>

Inspection Date: 28 March, 2022 Weather: <u>Sunny/ Fine/ Cloudy / Rainy</u>
Time: 10:00 am Wind: <u>Strong/ Breeze/ Light/-Calm</u>

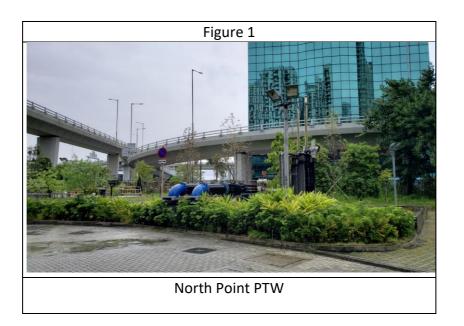
Photo Record:

- No visible irregularities were found

- Contractor was reminded to carry out proper maintenance to plantings.

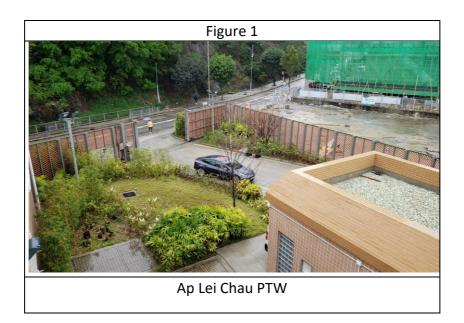
Photo Record:

- No visible irregularities were found

- Contractor was reminded to carry out proper maintenance to plantings and recommended to increase the frequency of watering.

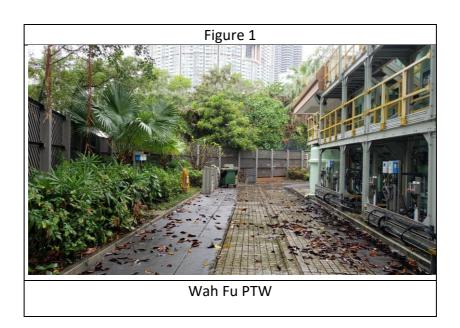
Photo Record:

- No visible irregularities were found

- Contractor was reminded to carry out proper maintenance to plantings.

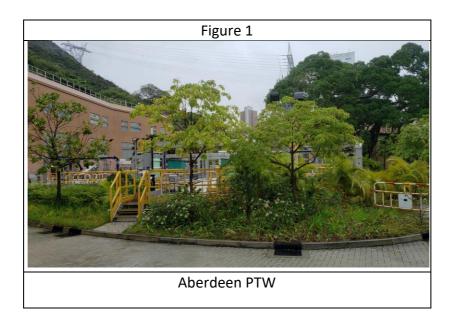
Photo Record:

- No visible irregularities were found

- Contractor was reminded to carry out proper maintenance to plantings.

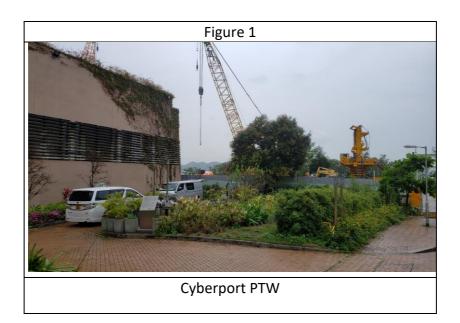
Photo Record:

- No visible irregularities were found

- Contractor was reminded to carry out proper maintenance to plantings and removal of weeds.

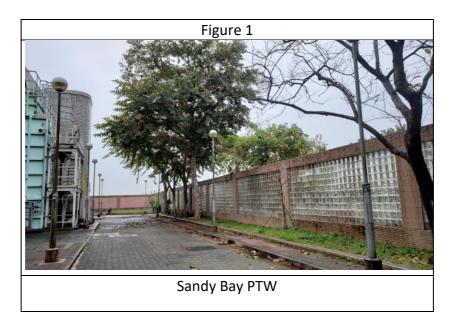
Photo Record:

- No visible irregularities were found

- Contractor was reminded to carry out proper maintenance to plantings and recommended to increase the frequency of watering.

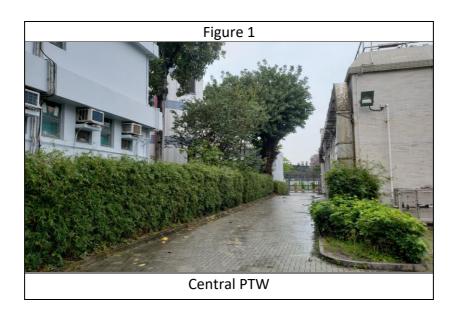
Photo Record:

- No visible irregularities were found

- Contractor was reminded to carry out proper maintenance to plantings.

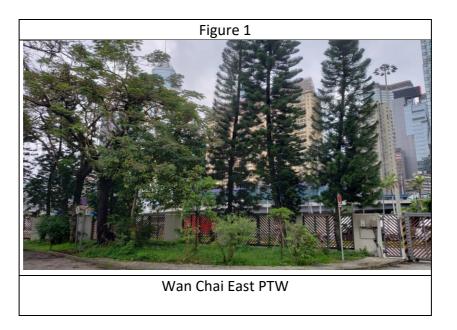
Photo Record:

- No visible irregularities were found

- Contractor was reminded to carry out proper maintenance to plantings and recommended to provide adequate protection to trees adjacent to works area.

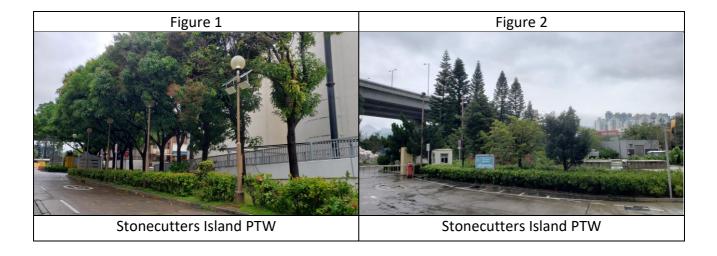
Photo Record:

- No visible irregularities were found

- Contractor was reminded to carry out proper maintenance to plantings and recommended to check any broken branches at trees along roadside.
