Appendix A

L&V Checklist

Landscape and Visual Impact Assessment Checklist for Site Audit – North Point PTW

Inspection Date: 18 May, 2022
Time: 10:30 am

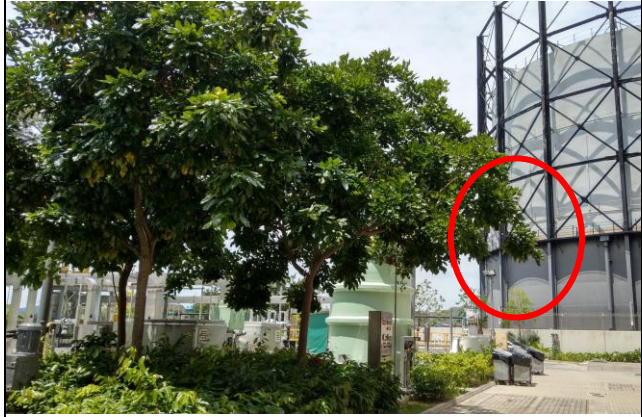
- Contractor was reminded to carry out proper maintenance to plantings and recommended to closely monitor the conditions of the pruned trees. It is also recommended to increase the frequency of watering.
- Some tree branches span over driveway as shown in Figure 2. It is recommended that maintenance party to review if pruning is required.

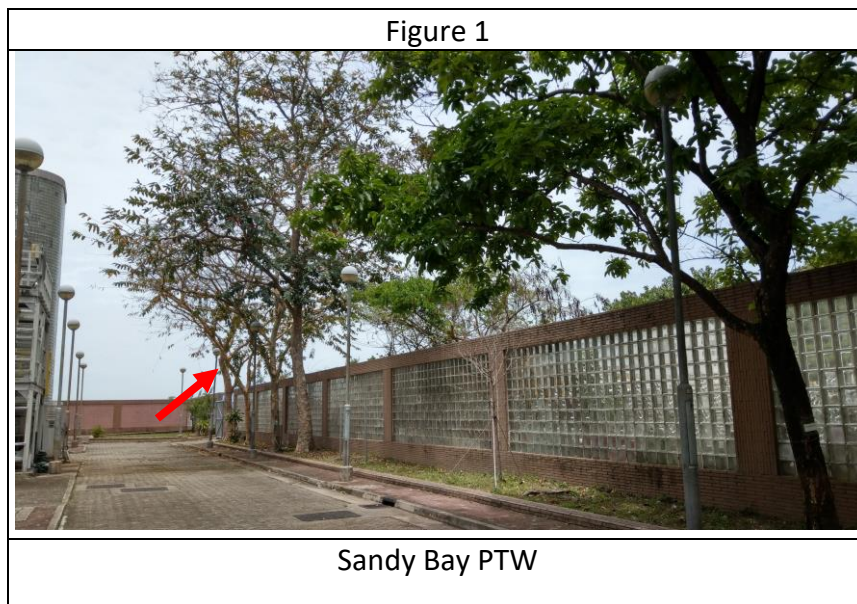
- Contractor was reminded to carry out proper maintenance to plantings and recommended to increase the frequency of watering.
- It was noted that leaves shredded and foliage's colour turns yellow for trees at inner side as shown in Figure 1. Continuous monitoring of the tree condition is required.

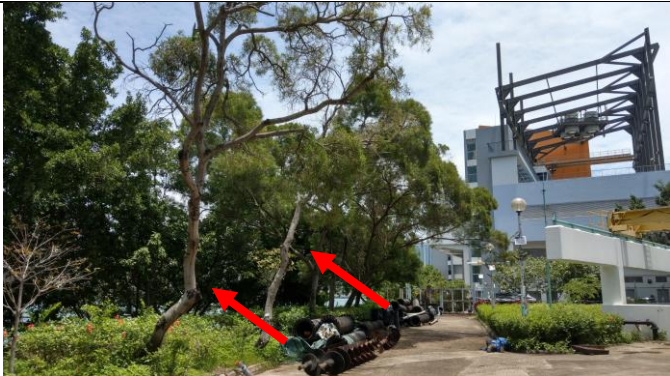
- Vigour of some existing trees (e.g.T110 & T109) as shown in Figure 3 are found to be poor. Close monitoring or tree risk assessment may be required.
- Die back of trees as shown in Figure 4 is noted. It is recommended that the maintenance party to review the situation and to remove the trees to reduce the safety risk if found to be required.

<p data-bbox="325 741 560 770">Tree T110 & T109</p>
