Appendix A

L&V Checklist

Landscape and Visual Impact Assessment Checklist for Site Audit – North Point PTW

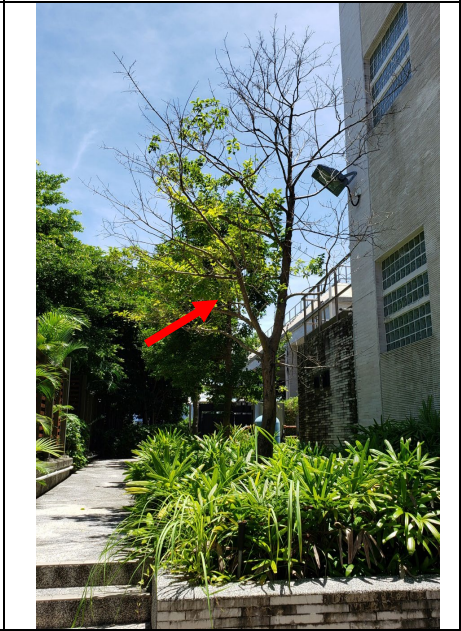
1. The health condition of marked tree (shown in Figure 2) is poor. The Contractor is recommended to carry out remedial action or tree replacement.

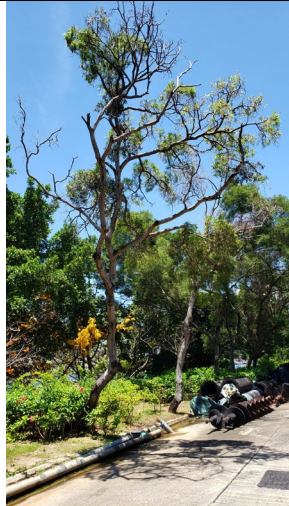
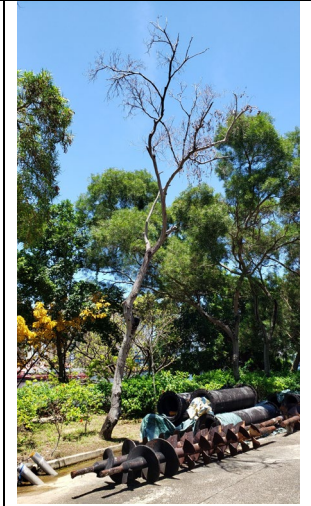
Figure 3	Figure 4	
<p style="text-align: center;">Tree T110 & T109</p>

1. Some trees adjacent to trees T110 & T109 (shown in Figure 3) are severely tilted. The Contractor is recommended to carry out remedial action.
2. Some tree branches span over driveway (shown in Figure 3). The Contractor is recommended to carry out close monitoring or tree assessment.

- Vigour of some existing trees (e.g.T110 & T109) are found to be poor. Some adjacent trees are severely tilted. Close monitoring or tree risk assessment may be required.
- Die back of trees is noted. It is recommended that the maintenance party to review the situation and to remove the trees to reduce the safety risk if found to be required.
