**Landscape and Visual (L&V) Monitoring Report for
Harbour Area Treatment Scheme Stage 2A
(Operational Phase) (July 2022)**

Report No.: OT_2022009

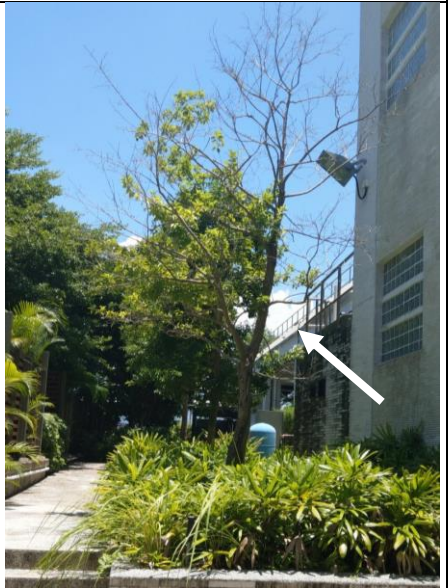
- Improvement of plant conditions of previous marked tree (Figure 2) was observed.

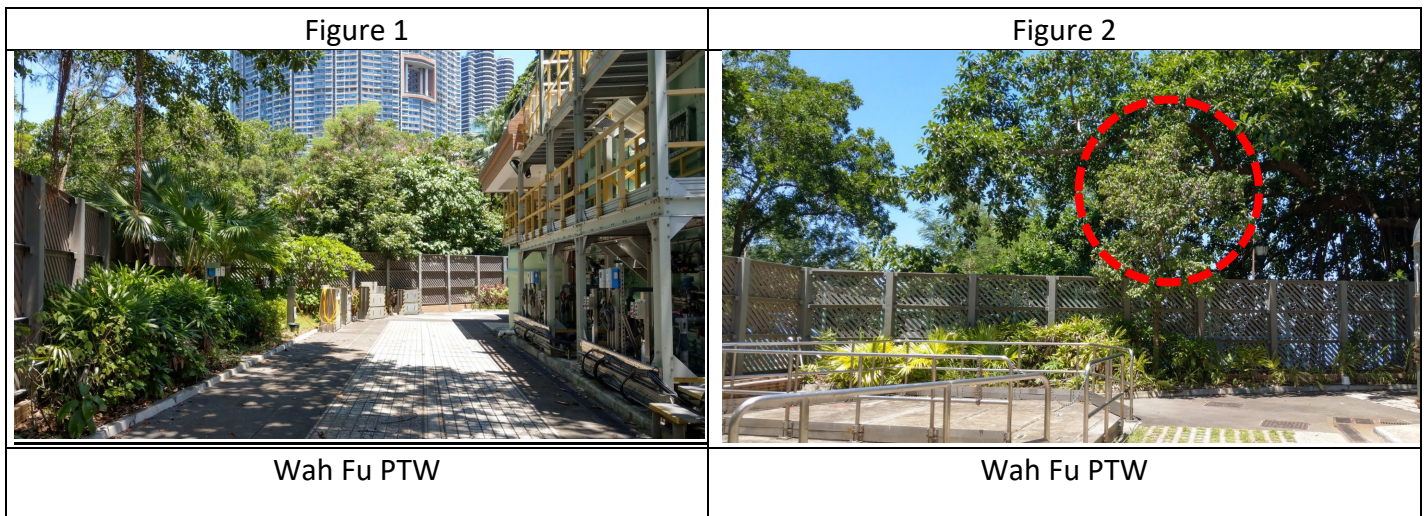
- Trimming of tree crown has been followed up (shown in Figure 2) in response to previous reminder.

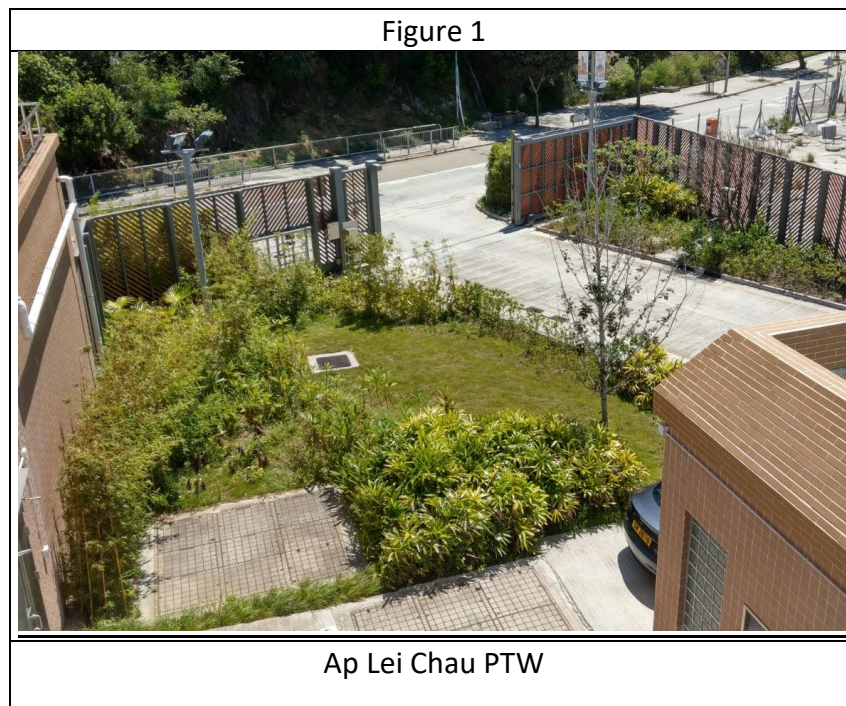
- Contractor was reminded to carry out proper maintenance to plantings and recommended to further increase the frequency of watering in the period of extreme hot weather.
- Contractor was recommended to pay attention to the plant conditions at the planter near vehicular exit.

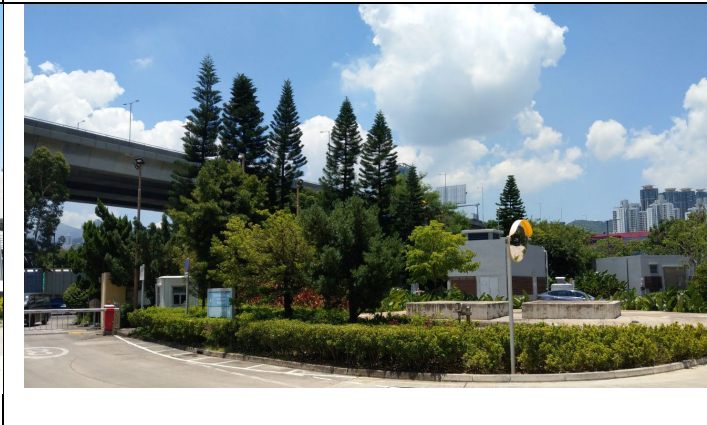
- Trees T110 & T109 have been removed.

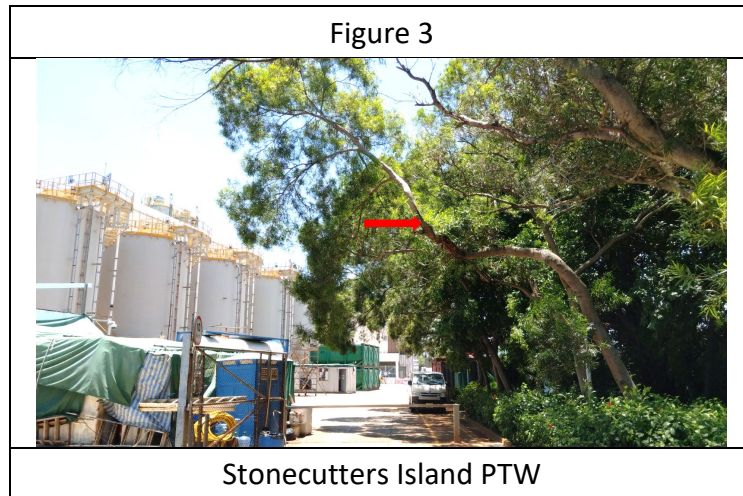
1. Some existing trees adjacent to T110 & T109 are still found severely tilted and span over driveway (shown in Figure 3). It is recommended that maintenance party to review if pruning is required.

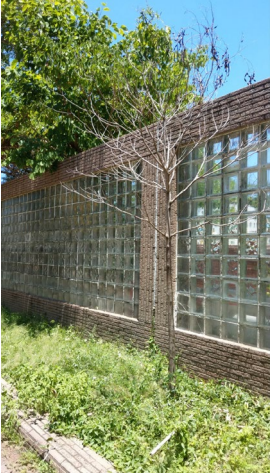
1. Regarding the marked tree (shown in Figure 2), its health condition is still poor. The Contractor is reminded to carry out remedial action or tree replacement.
