Appendix A

Landscape and Visual Impact Assessment Checklist for Site Audit – North Point PTW

Inspection Date: 29/08/2022

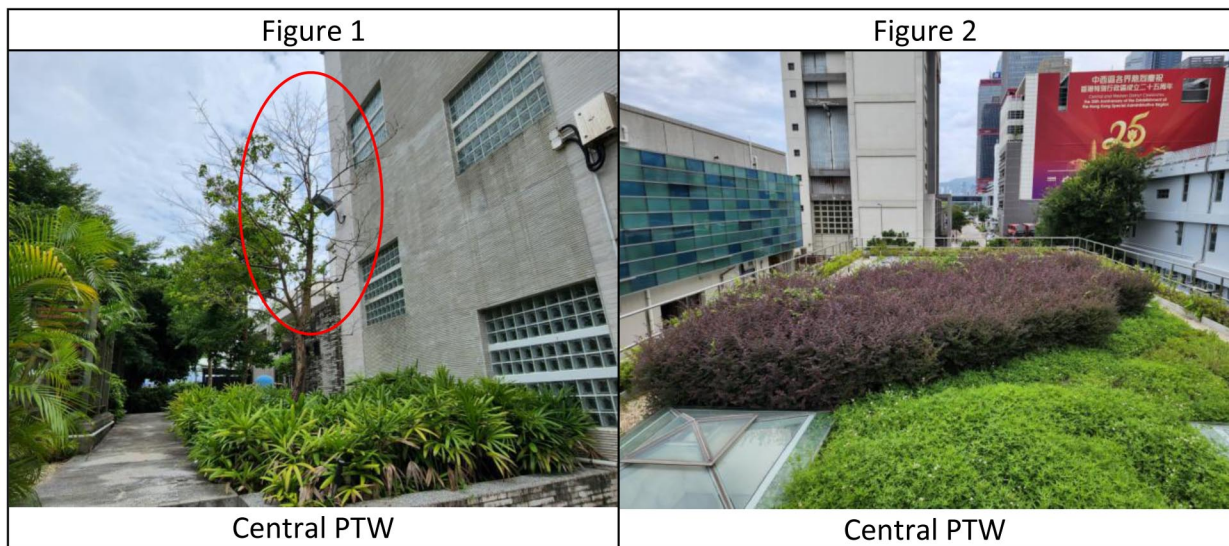
1. Contractor was reminded to keep maintenance and pay attention to the plant conditions on the marked tree (Figure 1) and recommended to further increase the frequency of watering in the period of extreme hot weather.

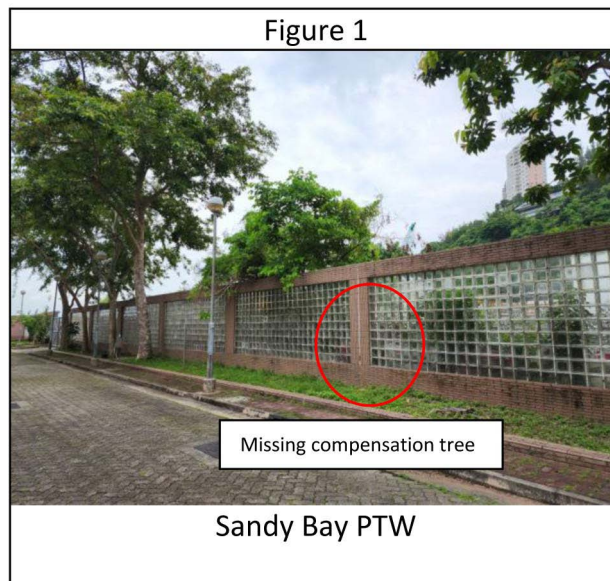
1. Follow up rectification item no.1 on 29/07/2022, the marked tree was removed but the compensation tree is missing. The Contractor is reminded to carry out tree replacement.

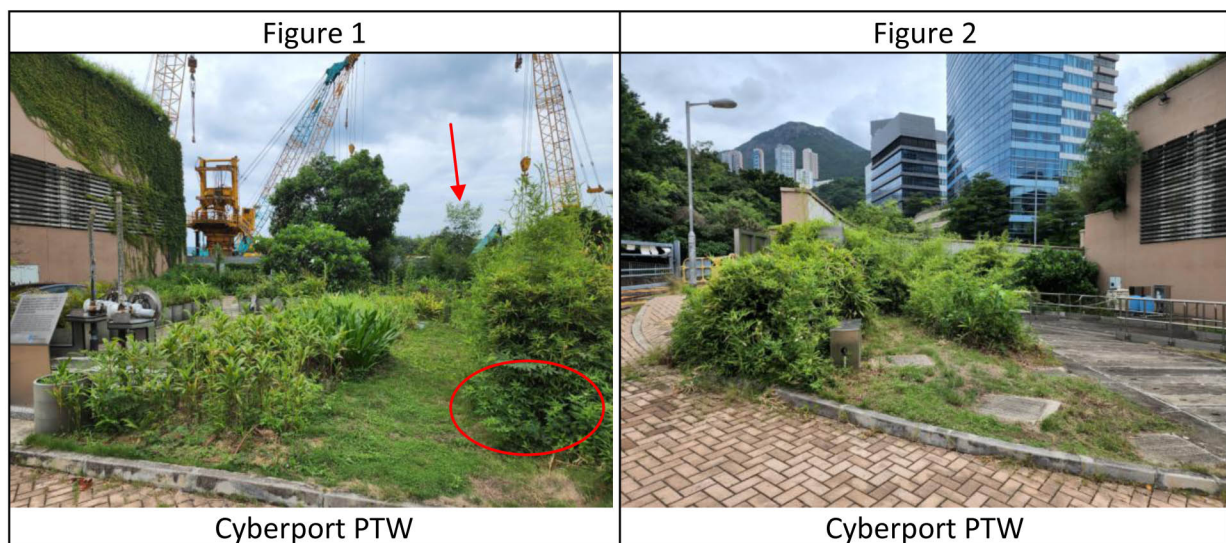
1. Weeds and undesirable species (*Leucaena leucocephala*) were observed among shrubs planting. It is recommended to carry out necessary weeding and maintenance work.

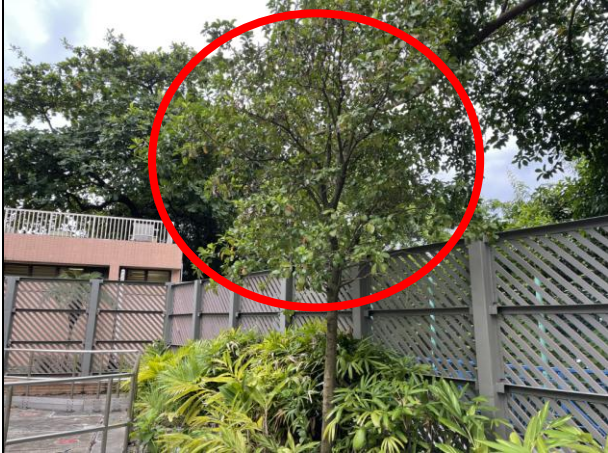
<p>Wah Fu PTW</p>	<p>Wah Fu PTW</p>
<p>Figure 3</p>

1. Dead leaves were observed at the marked tree (as shown in Figure 3). It is recommended that maintenance party to review if pruning is required.

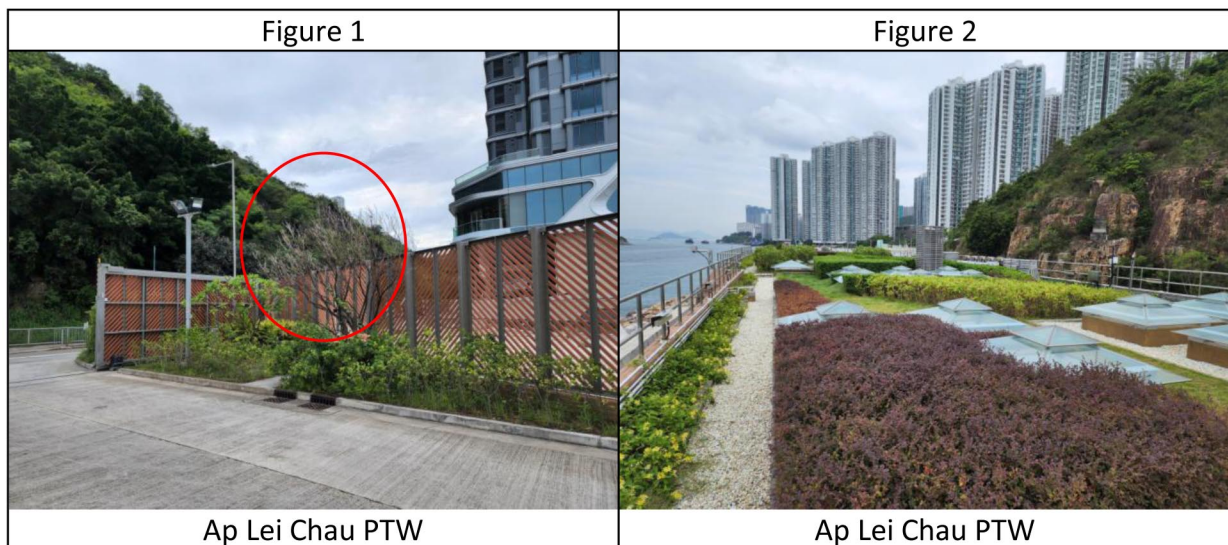
1. Dead tree was observed at entrance area (shown in Figure 1). It is recommended that maintenance party to review if replacement is required.

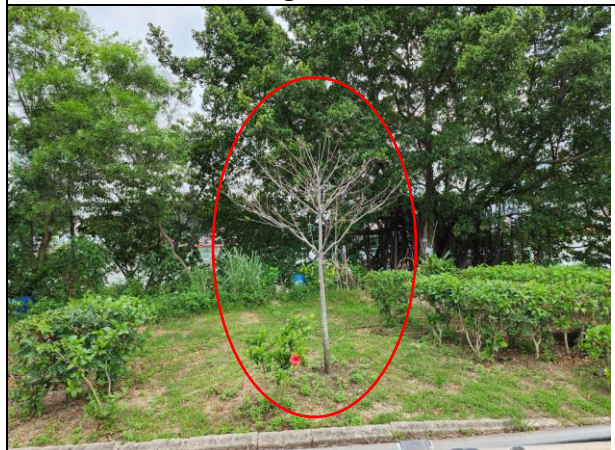
<p style="text-align: center;">Figure 1</p>

- 1: Poor health is observed for replacement tree (shown in Figure 1).
- 2: Dead branches (shown in Figure 2) with fungal growth are observed. Pruning is recommended.

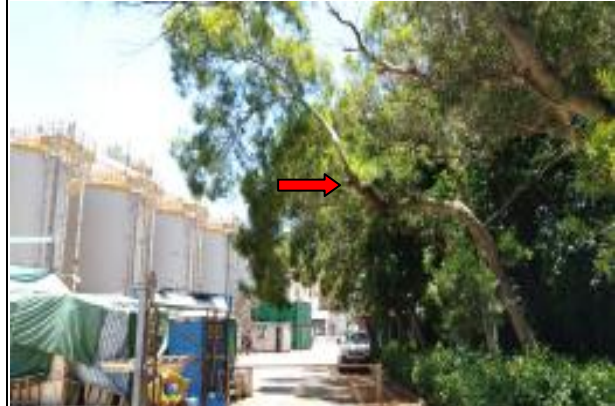
<p style="text-align: center;">Stonecutters Island STW</p>
<p style="text-align: center;">Figure 3</p>

1. Some existing trees adjacent to T110 & T109 are still found severely tilted and span over driveway (shown in Figure 3). It is recommended that maintenance party to review if pruning is required.
