**Landscape and Visual (L&V) Monitoring Report for  
Harbour Area Treatment Scheme Stage 2A  
(Operational Phase) (November 2022)**

Report No.: OT\_2022015

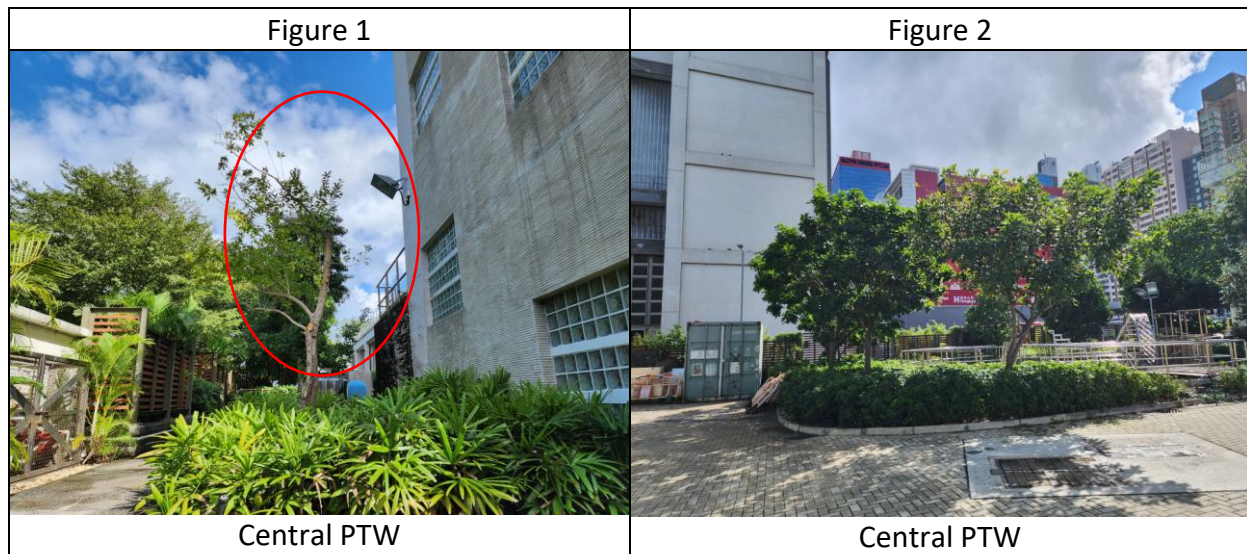
1. Noticed the dead branches of the tree at entrance area have been removed (Figure 1).

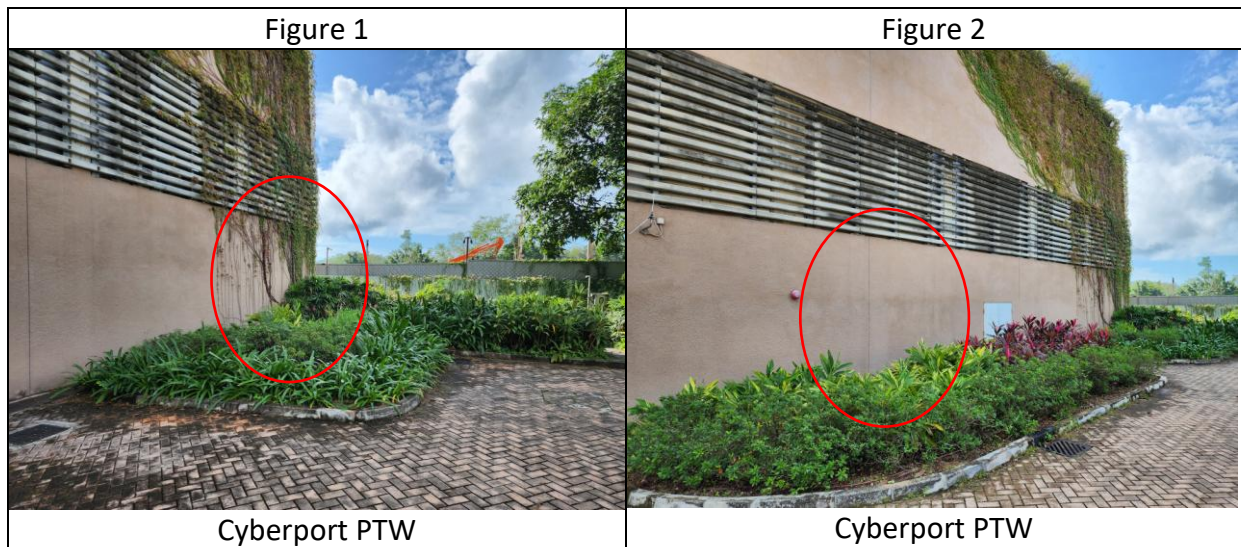
1. Noticed the dead tree of observation item on 26/09/2022 inside the planting area have been removed (Figures 1 & 2).

1. The contractor is recommended to replant the trees as early as possible for compensating the removal of dead tree

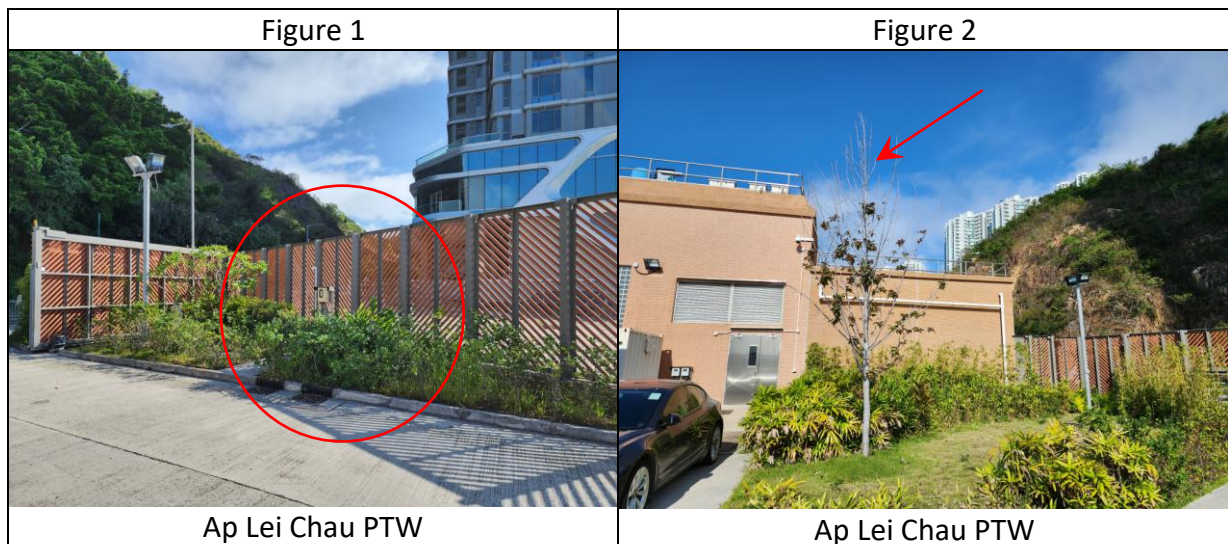
1. Noticed the dead tree of observation item on 29/08/2022 at the entrance area has been removed (shown in Figure 1).

1. Follow up observation item no. on 26/10/2022, die back on twigs was observed at entrance area (shown in Figure 2). It is recommended that maintenance party to provide trimming to the dead twigs.
2. The contractor is recommended to replant the trees as early as possible for compensating the removal of dead tree

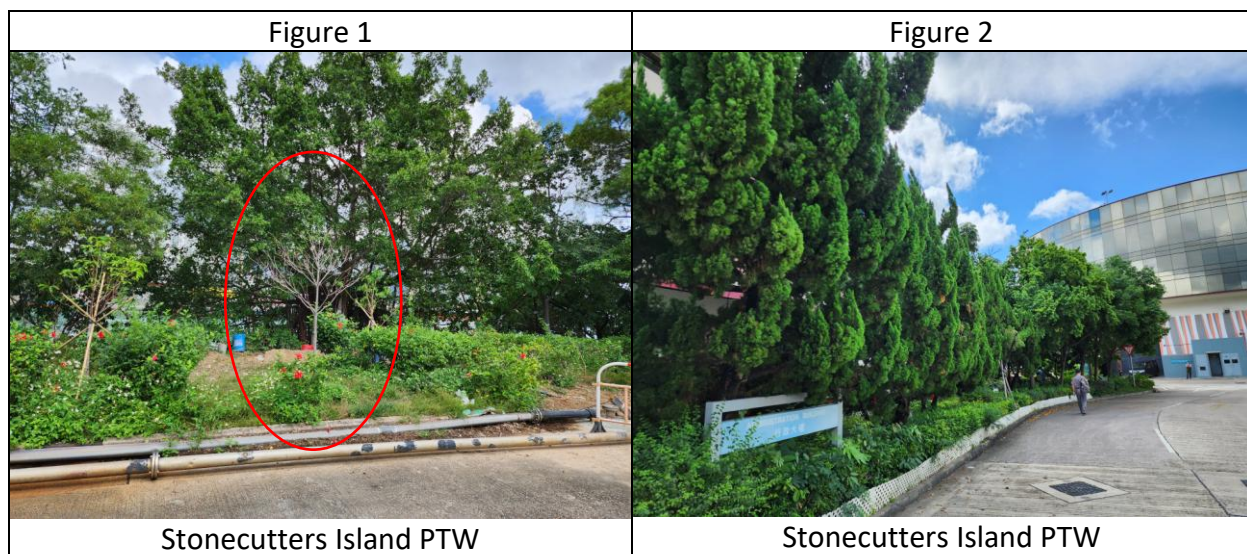
1. Follow up observation item no. 1 on 29/08/2022, Poor health is observed for replacement tree (shown in Figure 1). It is recommended that maintenance party to review if replacement is required.
