**Landscape and Visual (L&V) Monitoring Report for
Harbour Area Treatment Scheme Stage 2A
(Operational Phase) (November 2022)**

Report No.: OT_2022015

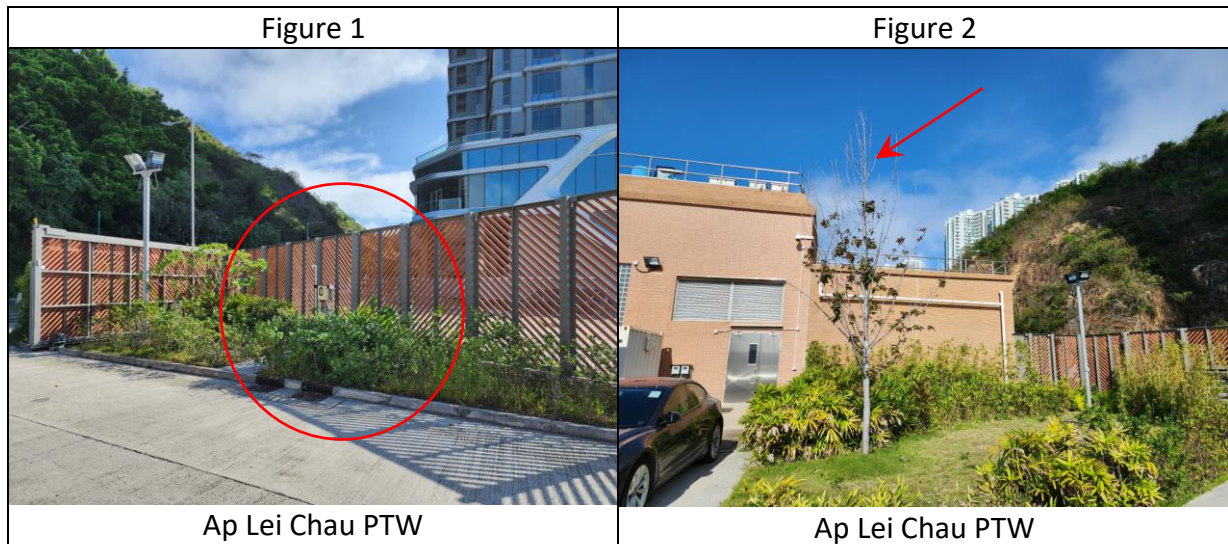
1. Noticed the dead tree of observation item on 29/08/2022 at the entrance area has been removed (shown in Figure 1).

1. Follow up observation item no. on 26/10/2022, die back on twigs was observed at entrance area (shown in Figure 2). It is recommended that maintenance party to provide trimming to the dead twigs.
2. The contractor is recommended to replant the trees as early as possible for compensating the removal of dead tree
