Landscape and Visual (L&V) Monitoring Report for Harbour Area Treatment Scheme Stage 2A (Operational Phase) (December 2022)

Report No.: OT_2022016

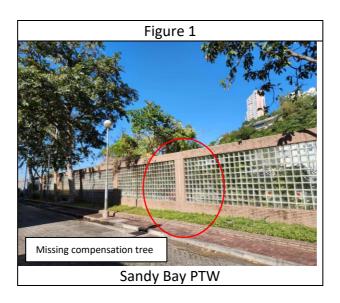
1. Follow up rectification item no.1 on 29/07/2022, the marked tree was removed but the compensation tree is missing. The Contractor is reminded to carry out tree replacement.

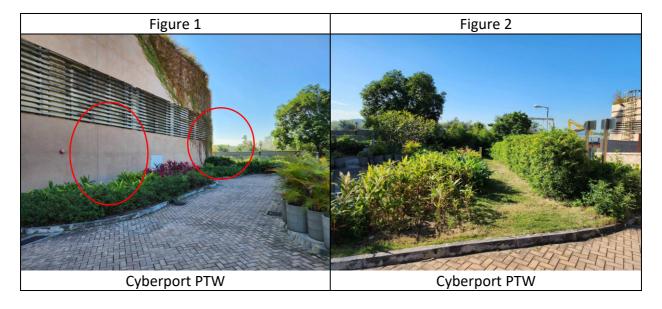
1. Noticed the dead tree of observation item on 26/09/2022 inside the planting area have been removed (Figures 1). The contractor is recommended to replant the trees as early as possible.

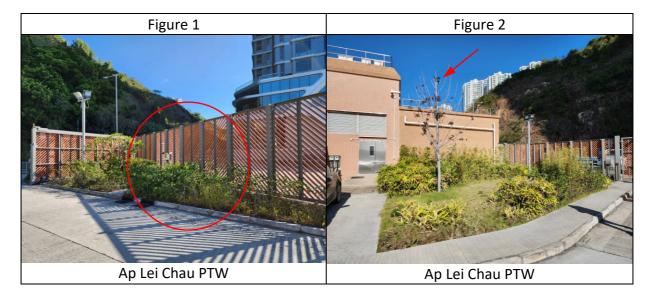
1. Follow up on observation item on 29/08/2022 the dead tree at the entrance area has been removed (shown in Figure 1). The contractor is recommended to replant the tree as early as possible.

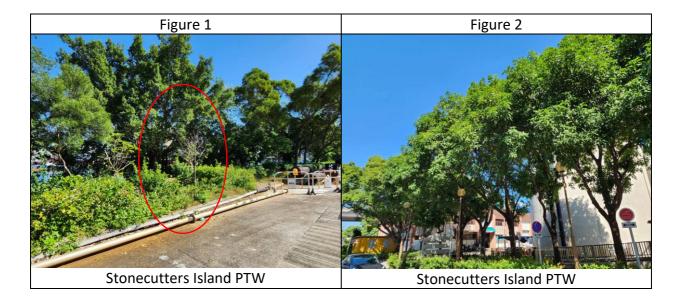
1. Follow up observation item no. 1 on 29/08/2022, Poor health is observed for replacement tree (shown in Figure 1). It is recommended that maintenance party to review if replacement is required.
