Contract No. HY/2011/03

Hong Kong-Zhuhai-Macao Bridge Hong Kong Link Road Section between Scenic Hill and Hong Kong Boundary Crossing Facilities

Monthly EM&A Report No.102 (March 2021)

16 April 2021

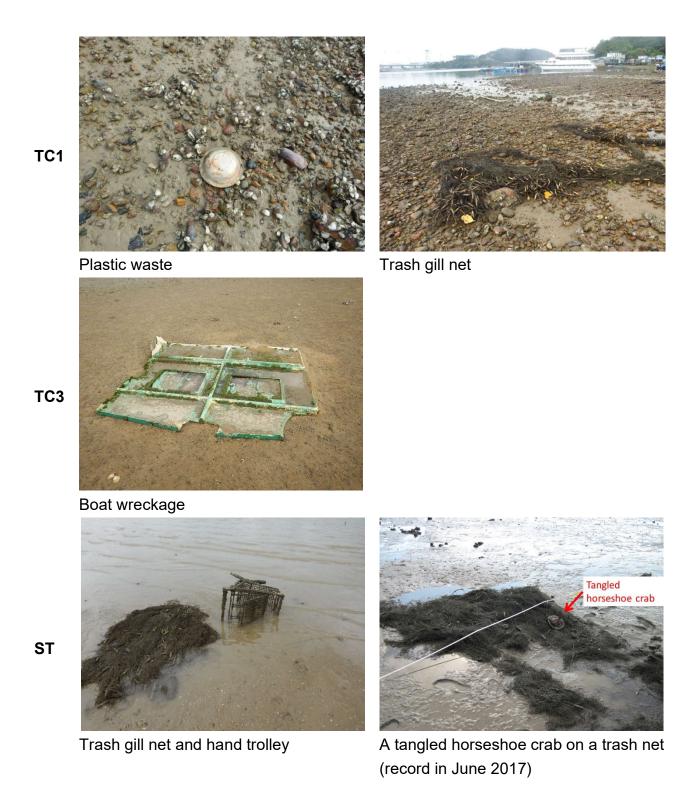
- 6.3.2 Since the field survey of June 2016, increasing number of trashes and even big trashes (**Figure 2.3 of Appendix I**) were found in every sampling zone. It raised a concern about the solid waste dumping and current-driven waste issues in Tung Chung Wan. Respective measures (e.g. manual clean-up) should be implemented by responsible governmental agency units.

Figure 2.3 Examples of photographic record of the big trashes found on the mudflat.
