Contract No. HY/2011/03

Hong Kong-Zhuhai-Macao Bridge Hong Kong Link Road Section between Scenic Hill and Hong Kong Boundary Crossing Facilities

Monthly EM&A Report No.108 (September 2021)

15 October 2021

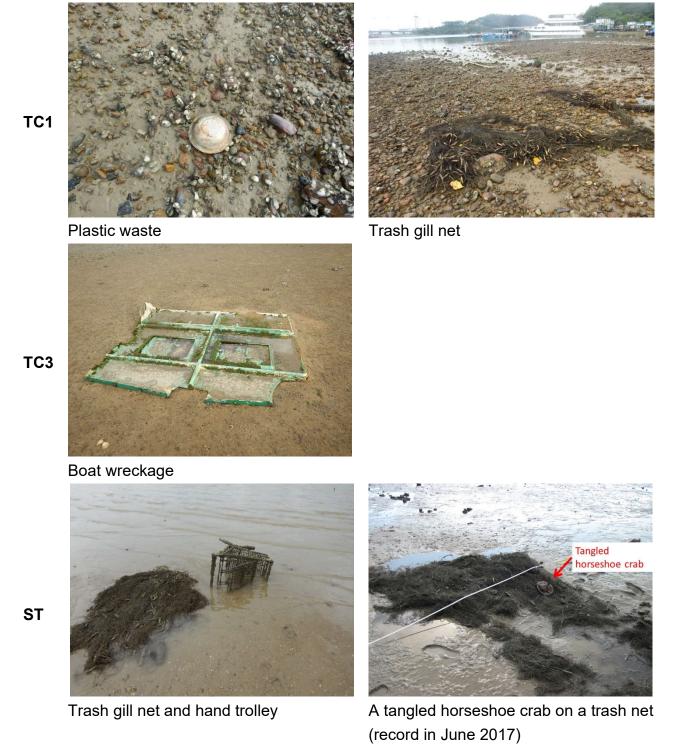
- 6.3.2 Since the field survey of June 2016, increasing number of trashes and even big trashes (**Figure 2.3 of Appendix I**) were found in every sampling zone. It raised a concern about the solid waste dumping and current-driven waste issues in Tung Chung Wan. Respective measures (e.g. manual clean-up) should be implemented by responsible governmental agency units.

Figure 2.3 Examples of photographic record of the big trashes found on the mudflat.

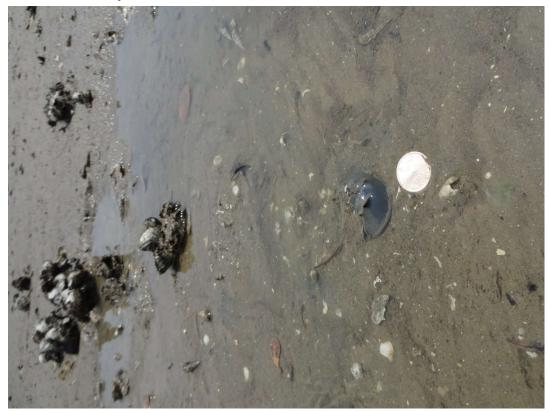
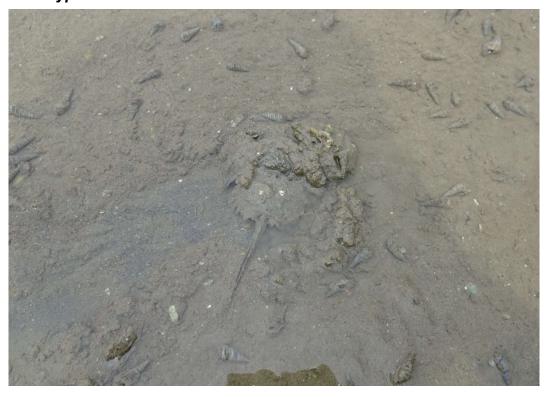
- 6.5.1 In total of 10 and 7 individuals of of *Carcinoscorpius rotundicauda* and *Tachypleus tridentatus* were found in present survey. The recorded individuals were mainly distributed along the shoreline in ST and TC3. All of them were observed on similar substratum (fine sand or soft mud, slightly submerged). Photo records of the observedhorseshoe crab are shown in **Figure 3.1 of Appendix I** and the present survey result regarding horseshoe crab are presented in **Table 3.1 of Appendix I**. The complete survey records are presented in **Annex II of Appendix I**.

Figure 3.1 Examples of photographic records of horseshoe crab (Sep 2021)

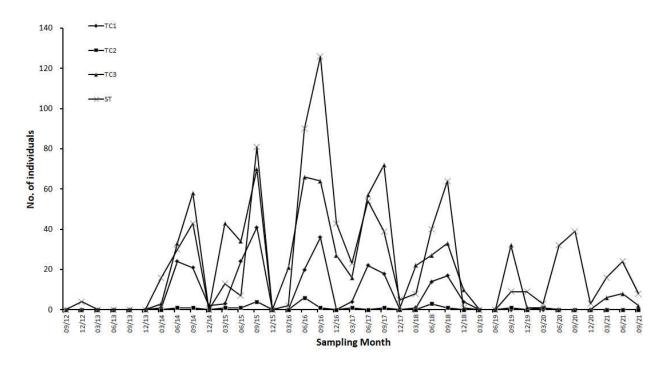
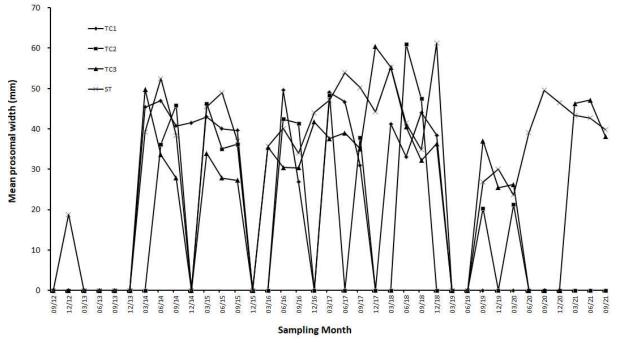
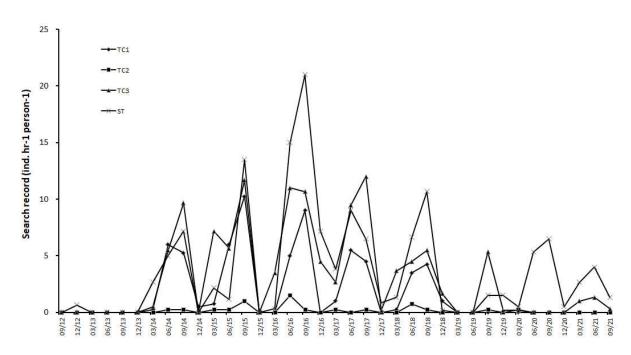
Figure 3.5 Changes of number of individuals mean prosomal width and search record of horseshoe crab Carcinoscorpius rotundicauda in every sampling zone along the sampling months

- 6.5.14 Throughout the monitoring period, the search records of horseshoe crabs were fluctuated and at moderate - very low level in June (Figures 3.5 and 3.6 of Appendix I). Low - Very low search record was found in June 2013, totally 82 individuals of Tachypleus tridentatus and 0 ind. of Carcinoscorpius rotundicauda were found in TC1, TC3 and ST. Compare with the search record of June 2013, the numbers of Tachypleus tridentatus were gradually decreased in June 2014 and 2015 (55 ind. in 2014 and 18 ind. in 2015); the number of Carcinoscorpius rotundicauda raise to 88 and 66 ind. in June 2014 and 2015 respectively. In June 2016, the search record increased about 3times compare with June 2015. In total, 182 individuals of Carcinoscorpius rotundicauda and 47 individuals of Tachypleus tridentatus were noted, respectively. Then, the search record was similar to June 2016. The number of recorded Carcinoscorpius rotundicauda (133 ind.) slightly dropped in June 2017. However, that of Tachypleus tridentatus rapidly increased (125 ind.). In June 2018, the search record was low to moderate while the numbers of Tachypleus tridentatus dropped sharply (39 ind.). In June 2019, 10 individuals of Tachypleus tridentatus were observed in TC3 and ST. All of them, however, were large individuals (prosomal width >100mm), their records are excluded from the data analysis to avoid mixing up with the juvenile population living on intertidal habitat. Until September 2020, the number of Carcinoscorpius rotundicauda and Tachypleus tridentatus gradually increased to 39 ind. and 28 ind., respectively. In December 2020, the number of Carcinoscorpius rotundicauda and Tachypleus tridentatus greatly decreased to 3 ind. and 7 ind., respectively. In September 2021 (present survey), the number of Carcinoscorpius rotundicauda and Tachypleus tridentatus gradually decreased to 10 ind. and 7 ind., respectively in comparing with the September of previous record. The drop of abundance may be related to the hot weather in September 2021. Throughout the monitoring period, similar distribution of horseshoe crabs population were found.

- 6.5.15 The search record of horseshoe crab declined obviously in all sampling zones during dry season especially December (**Figures 3.5 and 3.6 of Appendix I**) throughout the monitoring period. Very low low search record was found in December from 2012 to 2015 (0-4 ind. of *Carcinoscorpius rotundicauda* and 0-12 ind. of *Tachypleus tridentatus*). The horseshoe crabs were inactive and burrowed in the sediments during cold weather (<15 °C). Similar results of low search record in dry season were reported in a previous territory-wide survey of horseshoe crab. For example, the search records in Tung Chung Wan were 0.17 ind. hr¹person¹ and 0.00 ind. hr¹ person¹ in wet season and dry season respectively (details see Li, 2008). Compare
