Contract No. HY/2011/03

**Hong Kong-Zhuhai-Macao Bridge Hong Kong Link Road
Section between Scenic Hill and Hong Kong Boundary Crossing
Facilities**

Monthly EM&A Report No.111 (December 2021)

14 January 2022

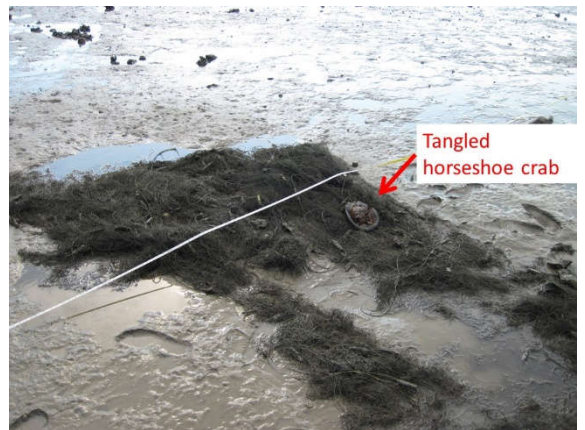
- 6.3.2 Since the field survey of June 2016, increasing number of trashes and even big trashes (**Figure 2.3 of Appendix I**) were found in every sampling zone. It raised a concern about the solid waste dumping and current-driven waste issues in Tung Chung Wan. Respective measures (e.g. manual clean-up) should be implemented by responsible governmental agency units.

A tangled horseshoe crab on a trash net (record in June 2017)

Figure 2.3 *Examples of photographic record of the big trashes found on the mudflat.*

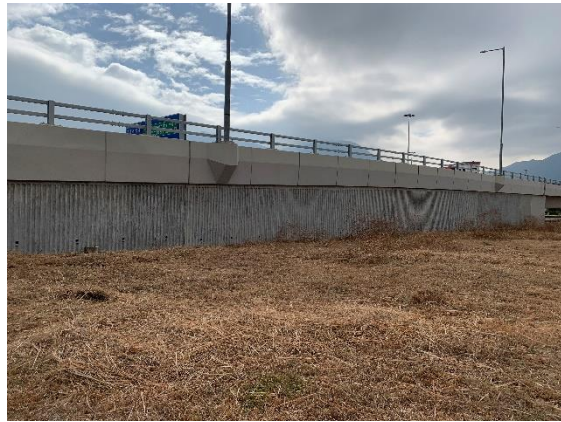
Photo F4 - The weeds were removed and maintenance is in progress.

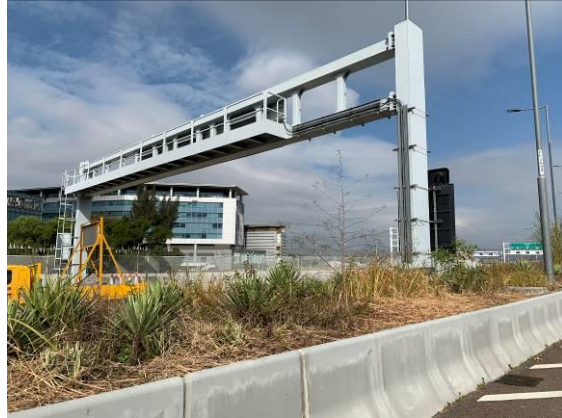
Location	Photo Record		
HyD – Along Expressway of HKLR	<p>Photo P1- Serious weeds affecting planted species were observed.</p>  	<p>Photo P2 - Plants with unsatisfied condition (i.e. unhealthy plants) were observed.</p>

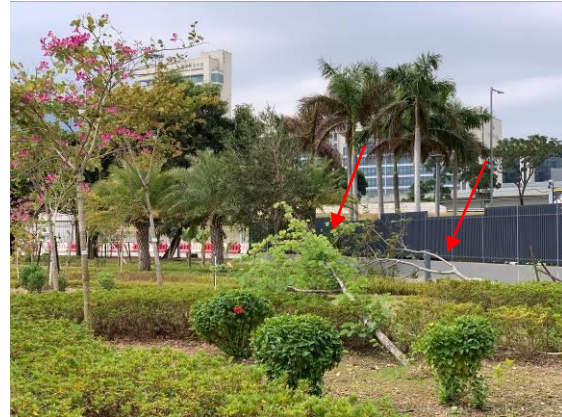
LCSD	<p>Photo P3 - Trees with unsatisfied condition (i.e. fallen tree) were observed.</p>   <p style="text-align: center;">Between Flight Training Centre and HMA</p>	<p>Photo P4 - Trees with unsatisfied condition (i.e. fallen tree) were observed.</p>   <p style="text-align: center;">Between Flight Training Centre and HMA</p>	<p>Photo P5 - Trees with unsatisfied condition (i.e. fallen tree) were observed.</p>

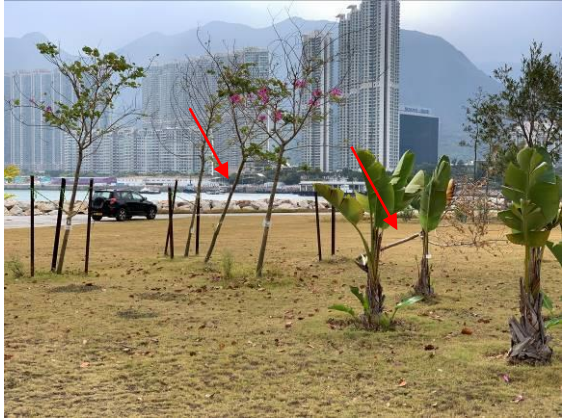
<p>LCSD</p>	<p>Photo P12 - Trees with unsatisfied condition (i.e. fallen tree) were observed.</p>

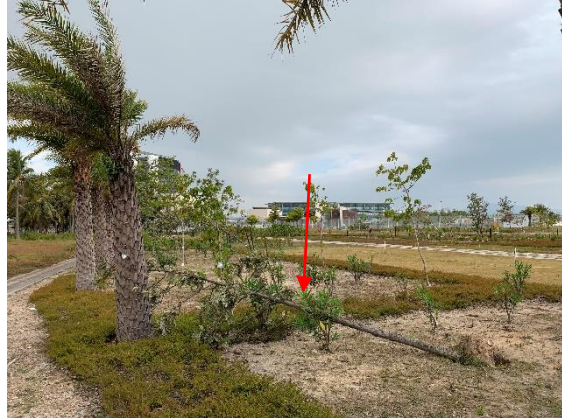
<p>Next to Shaft 3</p>	<p>Photo P13 - Tree with unsatisfied condition (i.e. fallen tree) was observed.</p>

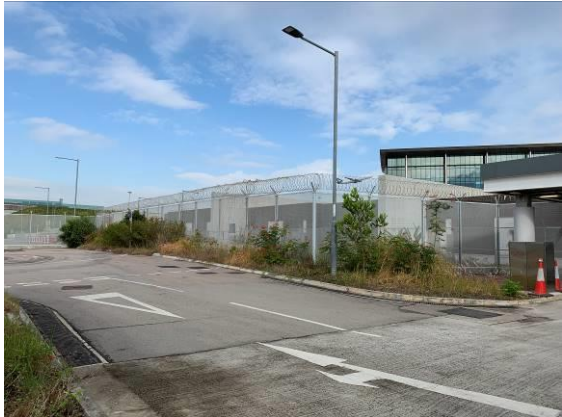
<p>Next to Shaft 3</p>	
<p>TD / Others – Next to HMA Admiration Building</p>	<p>Photo P14 - Serious weeds affecting planted species were observed.</p>

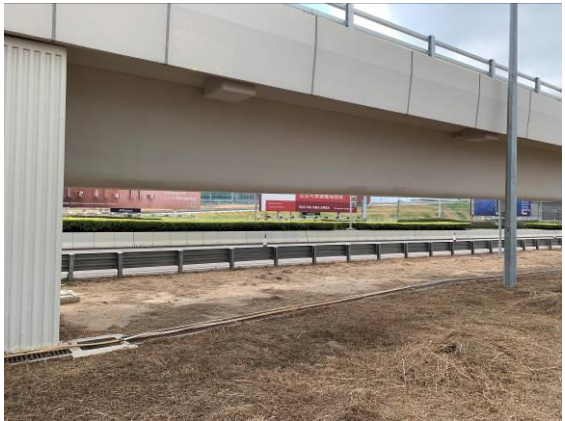
Photo P15 - Plants with unsatisfied condition were
observed.
