Contract No. HY/2011/03

Hong Kong-Zhuhai-Macao Bridge Hong Kong Link Road Section between Scenic Hill and Hong Kong Boundary Crossing Facilities

Quarterly EM&A Report No. 38 (December 2021 to February 2022)

27 April 2022

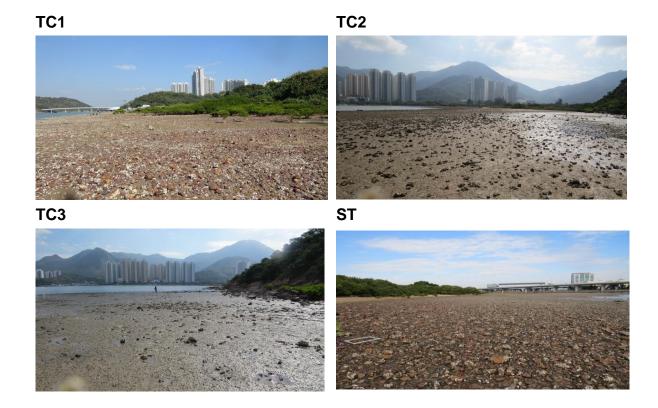
Figure 2.2 Photographic record of the environment in every sampling zone. (December 2021)

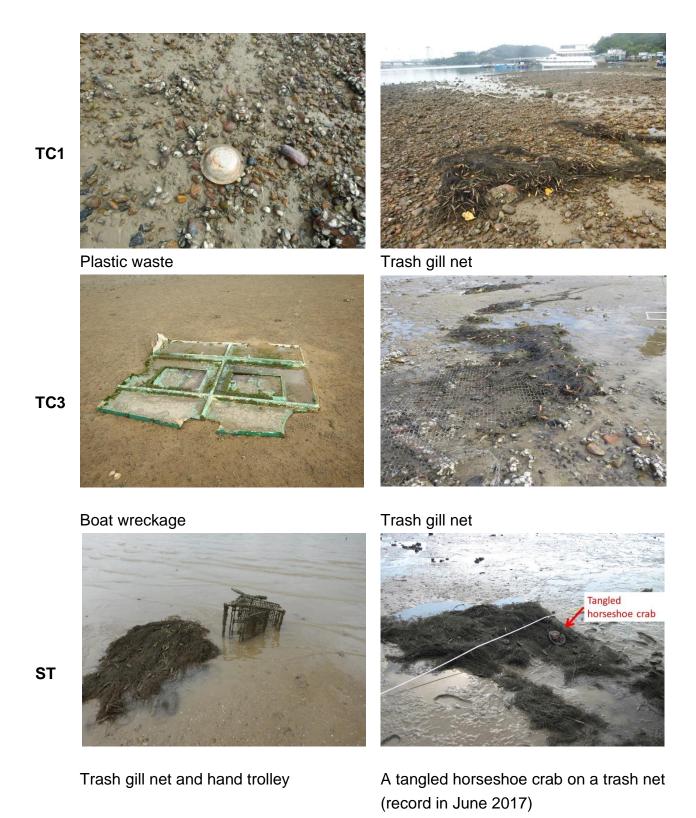
- 3.6.7 Since the field survey of June 2016, increasing number of trashes and even big trashes (Figure 2.3 of Appendix O) were found in every sampling zone. It raised a concern about the solid waste dumping and current-driven waste issues in Tung Chung Wan. Respective measures (e.g. manual clean-up) should be implemented by responsible governmental agency units.

Figure 2.3 Examples of photographic record of the big trashes found on the mudflat.

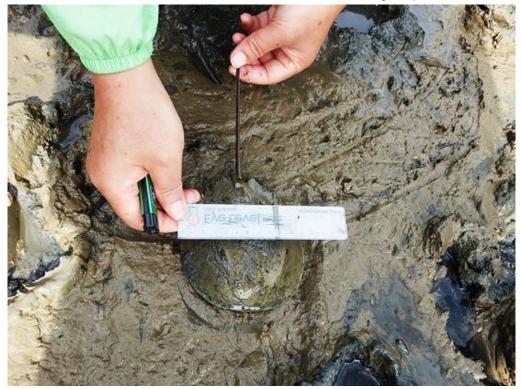
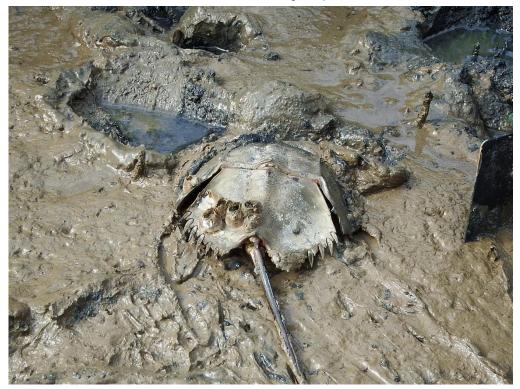
3.6.16 In total of 2 and 1 individuals of adult *Carcinoscorpius rotundicauda* and adult *Tachypleus tridentatus* were found in present survey. The recorded individuals were mainly distributed along the shoreline in ST and TC3. No juvenile specimen was recorded. All of them were observed on similar substratum (fine sand or soft mud, slightly submerged). Since all found target fauna were large audit individuals (prosomal width >100mm), their records are excluded from the data analysis to avoid mixing up with juvenile population living on intertidal habitat. Photo records of the observed horseshoe crab are shown in **Figure 3.1 of Appendix O** and the present survey

- 3.6.17 For *Carcinoscorpius rotundicauda*, one adult was found in ST with 108mm body size, and one adult was found in TC3 with 104.3mm body size. No *Carcinoscorpius rotundicauda* was recorded in TC1 and TC2 in present survey.

- 3.6.18 For *Tachypleus tridentatus*, one adult was found in ST with 108mm body size. No *Tachypleus tridentatus* was found in TC1, TC2 and TC3 in present survey.

Figure 3.1 Examples of photographic records of horseshoe crab (Dec 2021) **Table 3.1**. Summary of juvenile horseshoe crab survey in every sampling zone

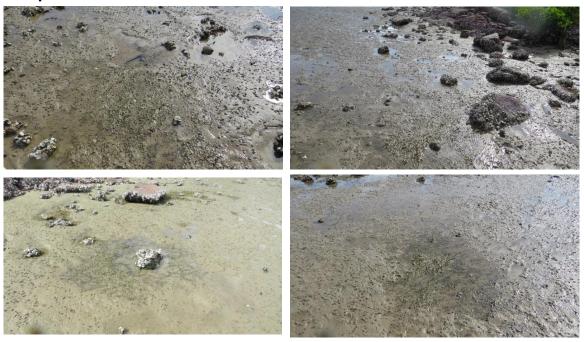
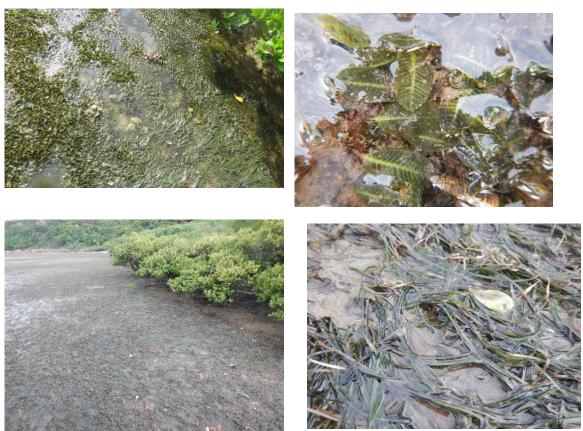
- Two seagrass species Halophila ovalis and Zostera japonica were found in present survey. Halophila ovalis was found in TC3 and ST and Zostera japonica was found in ST. In ST, there were three small sized and three large sized of Halophila ovalis found at tidal zone 1.5m above C.D nearby mangroves plantation. The larger strand had area ~240m² in moderate vegetation coverage (40 - 60%), ~220m² in moderate vegetation coverage (30 - 50%) and ~180m² in low to moderate vegetation coverage (40 - 60%). At close vicinity, three small sized (~2m² -30m²) of Halophila ovalis beds were observed at tidal zone 1.5m above C.D. All the small sized of Halophila ovalis beds were in moderate vegetation coverage ranging from 40 – 60%. In TC3, 1 large patch and 2 small patches of Halophila ovalis were found at tidal zone 1.5m above C.D. The larger strand had area $\sim 280 \text{m}^2$ in moderate vegetation coverage (40 - 60%), while two small patches with area size in ~20m² and 50m² had low to moderate coverage (30 to 60%). In ST, another seagrass species Zostera japonica was found at tidal zone 2.0m above C.D nearby mangroves plantation with ~10m² in low to moderate vegetation coverage (30 - 60%). Table 3.2 of Appendix O summarizes the results of present seagrass beds survey and the photograph records of the seagrass are shown on Figure 3.9 of Appendix O. The complete record throughout the monitoring period is presented in Annex III of Appendix O.

Figure 3.9 Photographic record of seagrass beds in present survey.
