TUEN MUN - CHEK LAP KOK LINK
CONTRACT NO. HY/2013/12 –
NORTHERN CONNECTION TOLL PLAZA AND
ASSOCIATED WORKS

13TH MONTHLY ENVIRONMENTAL MONITORING AND
AUDIT (EM&A) REPORT – NOVEMBER 2015

PREPARED FOR
CRBC AND KADEN JOINT VENTURE

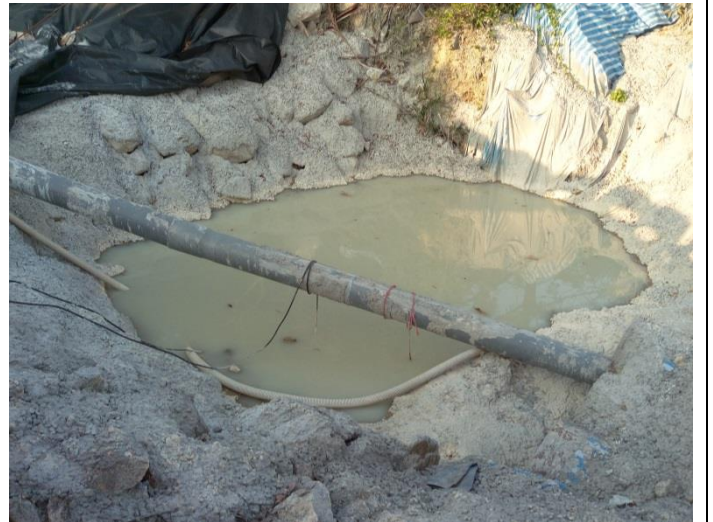
Stream A Outfall: pumped muddy water and discharged after treatment.

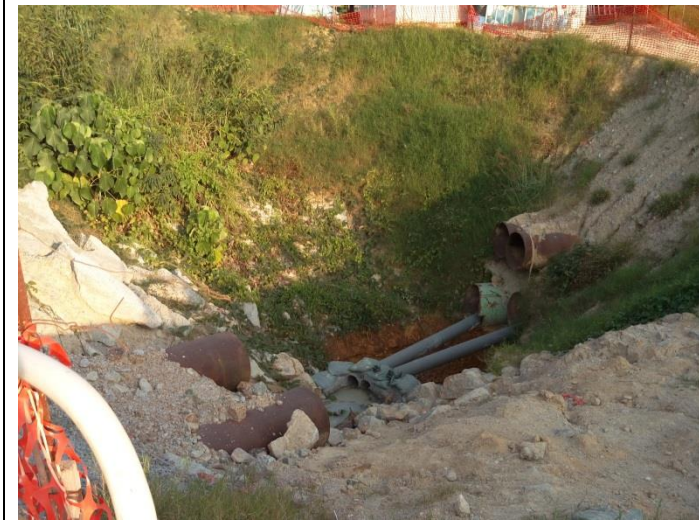
Stream B Pit 1: in normal condition.

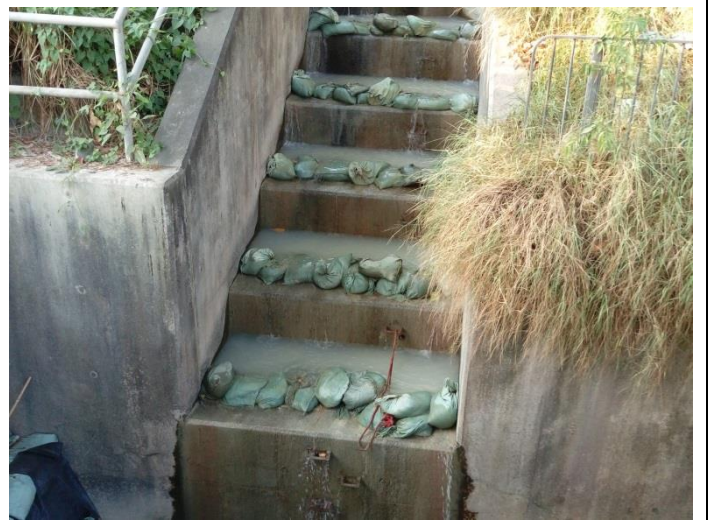
Stream B Pit 2: Treated water was directly discharged to downstream bypass.

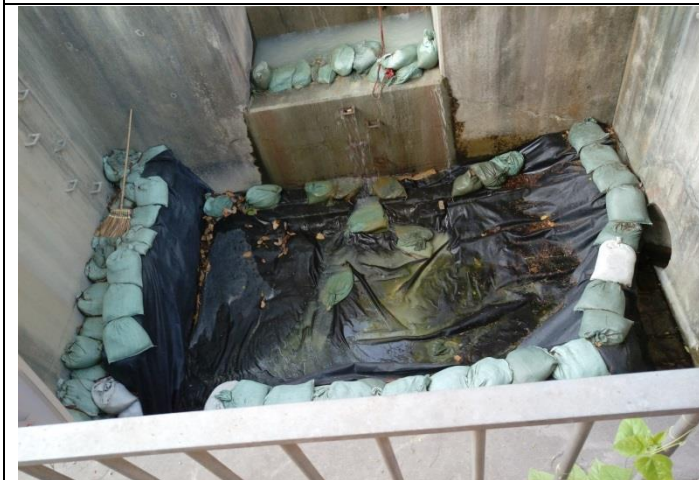
Stream B Outfall: Cascade step channel condition

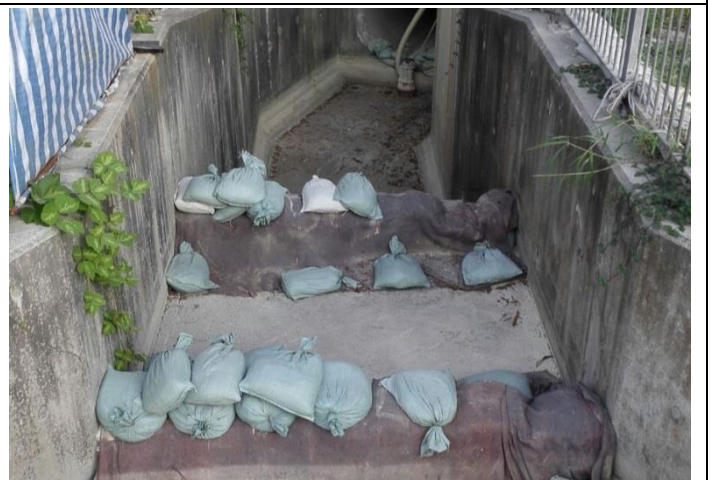
Stream B Outfall: Cascade was in normal condition.

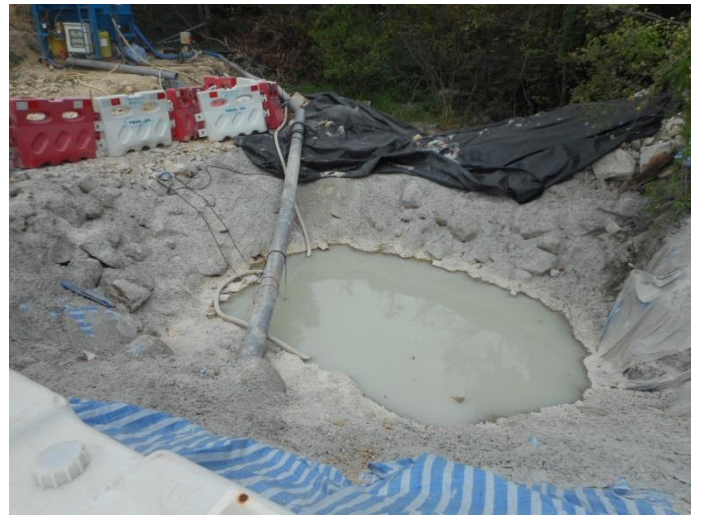
Stream A Outfall: pumped muddy water and discharged after treatment.

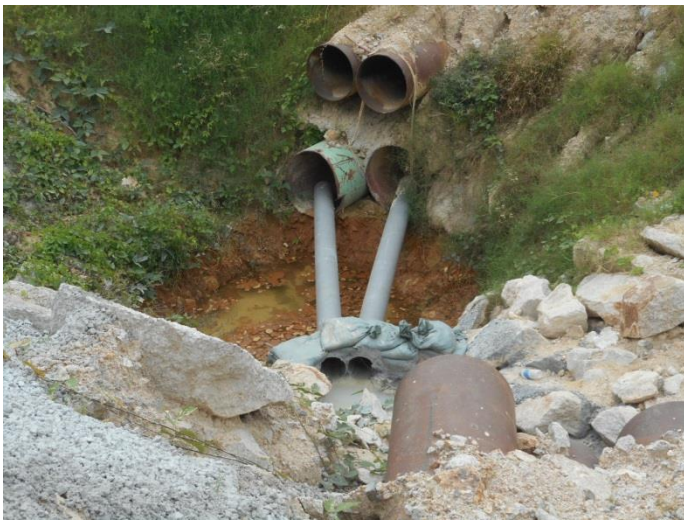
Stream B Pit 1: in normal condition.

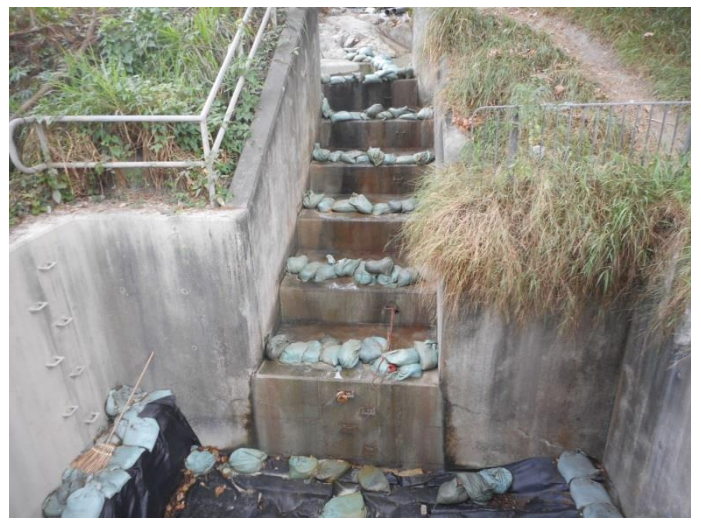
Stream B Pit 2: Treated water was directly discharged to downstream bypass.

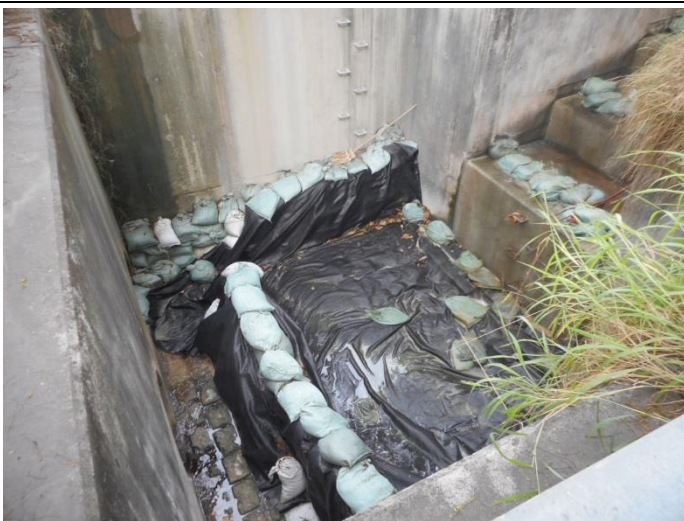
Stream B Outfall: Cascade step channel condition

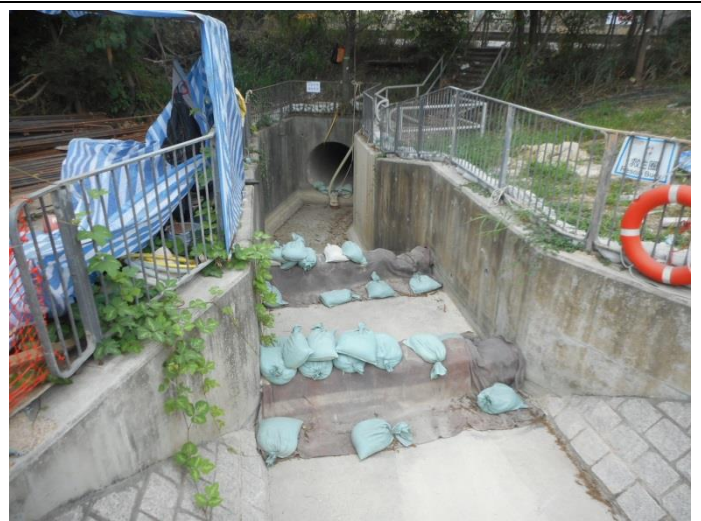
Stream B Outfall: Cascade was in normal condition.

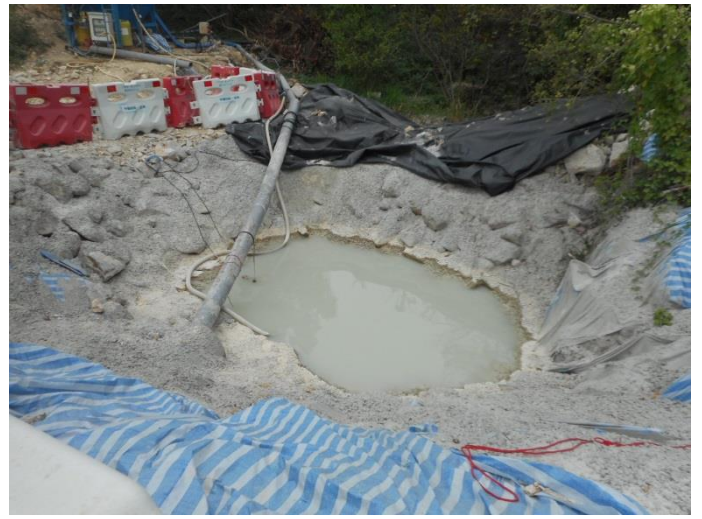
Stream A Outfall: pumped muddy water and discharged after treatment.

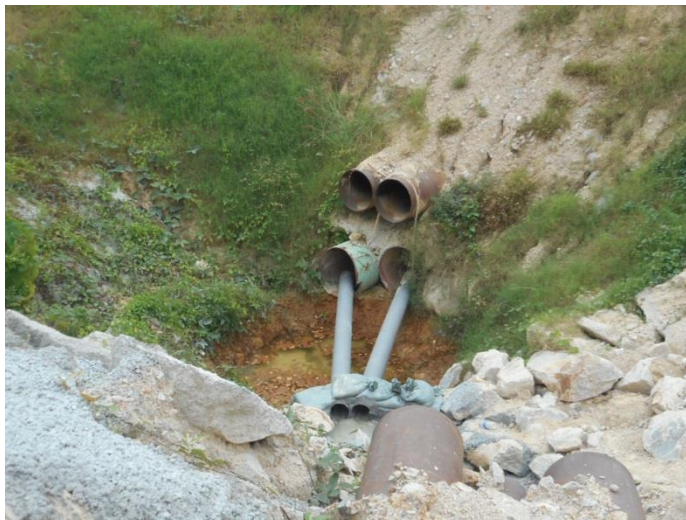
Stream B Pit 1: in normal condition.

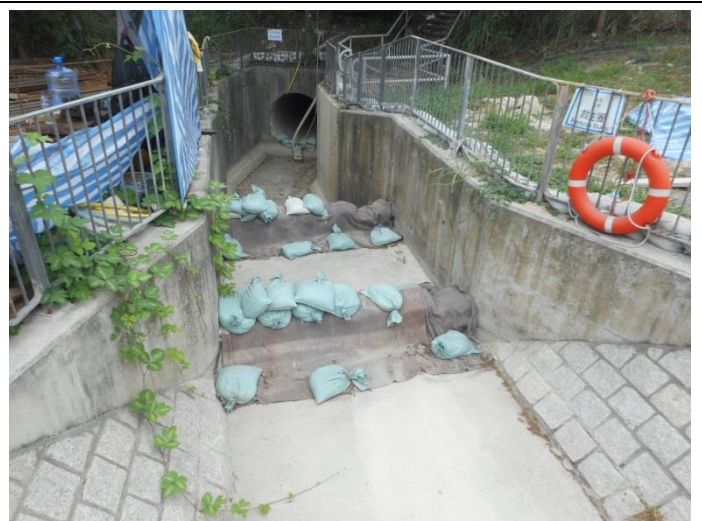
Stream B Outfall: Cascade was in normal condition.

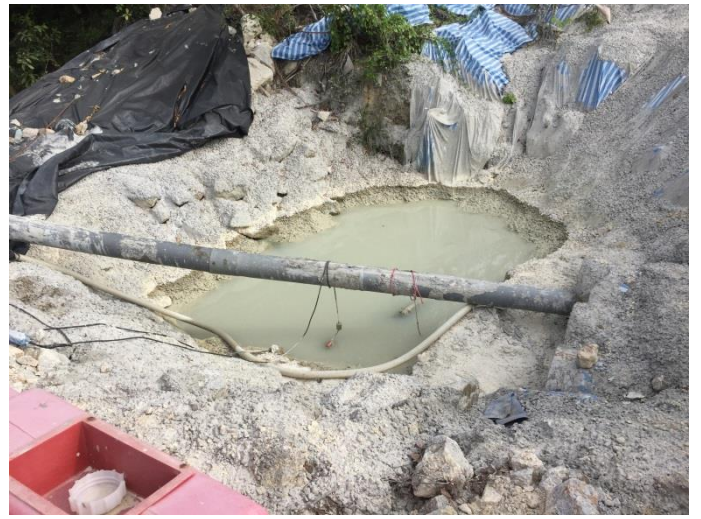
Stream A Outfall: pumped muddy water and discharged after treatment.

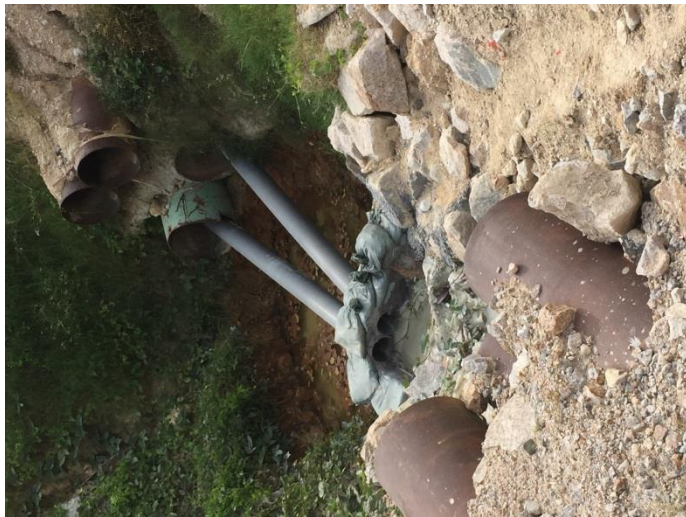
Stream B Pit 1: in normal condition.

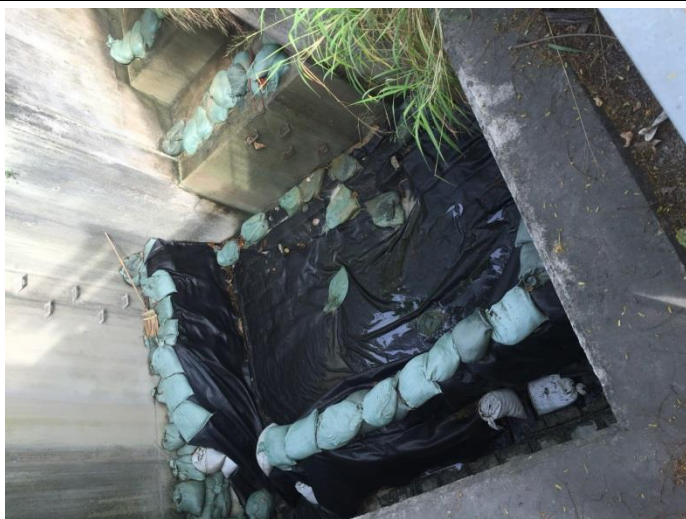
Stream B Outfall: Cascade step channel condition

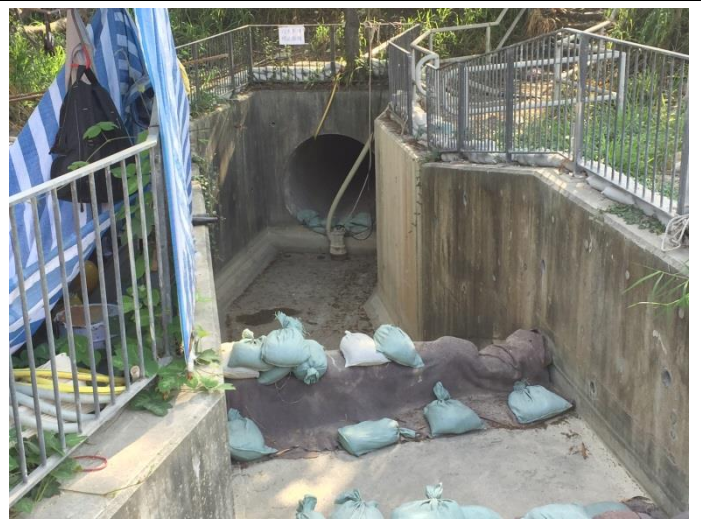
Stream B Outfall: Cascade was in normal condition.

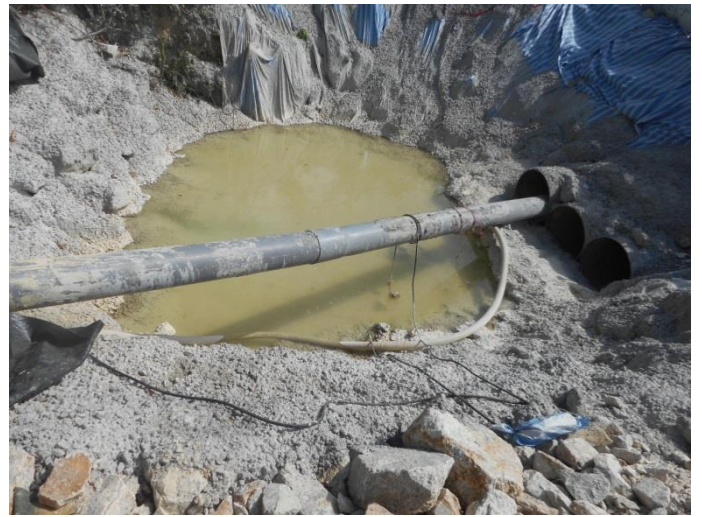
Stream A Outfall: pumped muddy water and discharged after treatment.

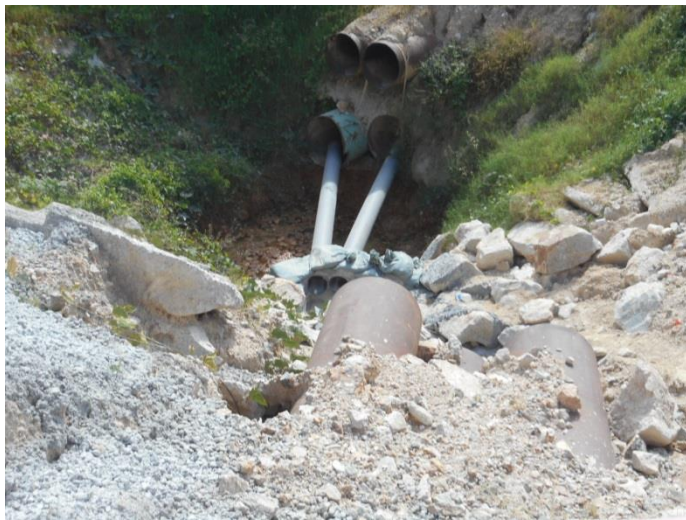
Stream B Pit 1: in normal condition.

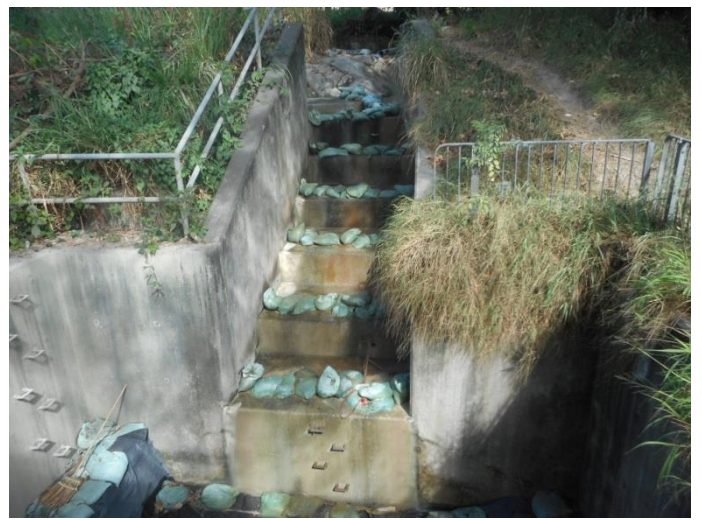
Stream B Pit 2: Treated water was directly discharged to downstream bypass.

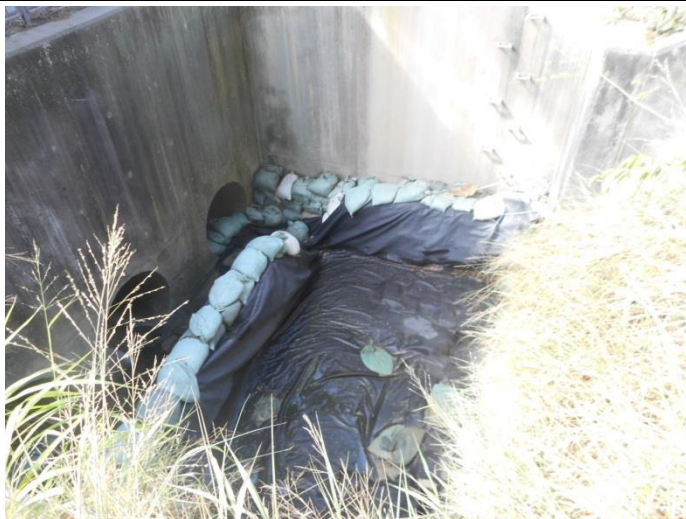
Stream B Outfall: Cascade step channel condition

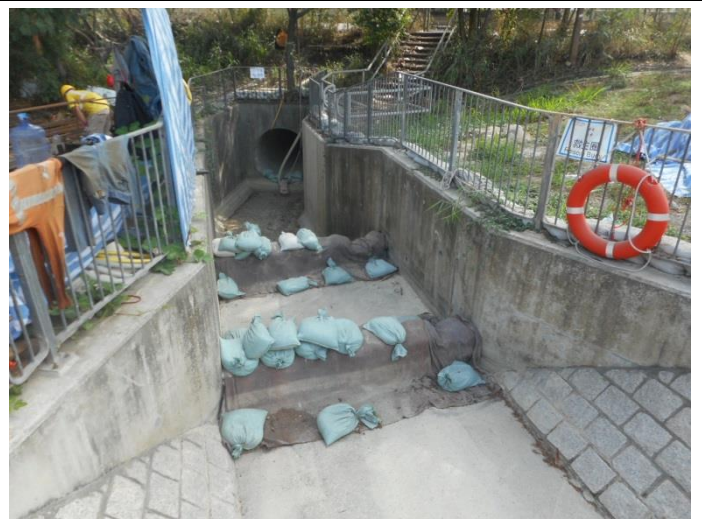
Stream B Outfall: Cascade was in normal condition.

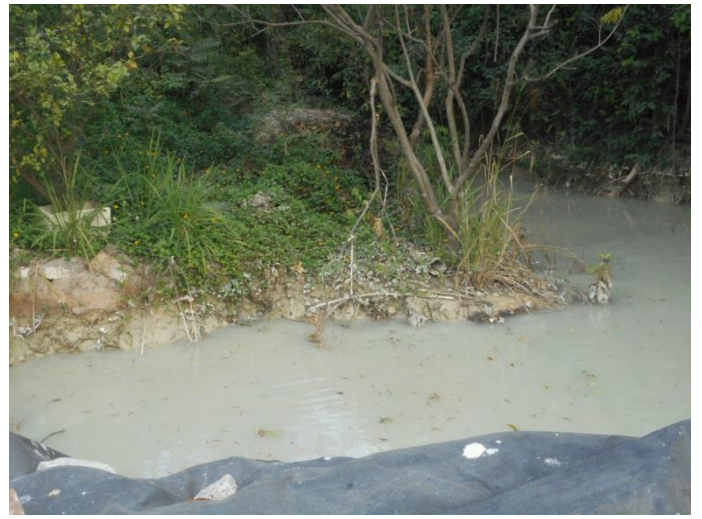
Stream A Outfall: pumped muddy water and discharged after treatment.

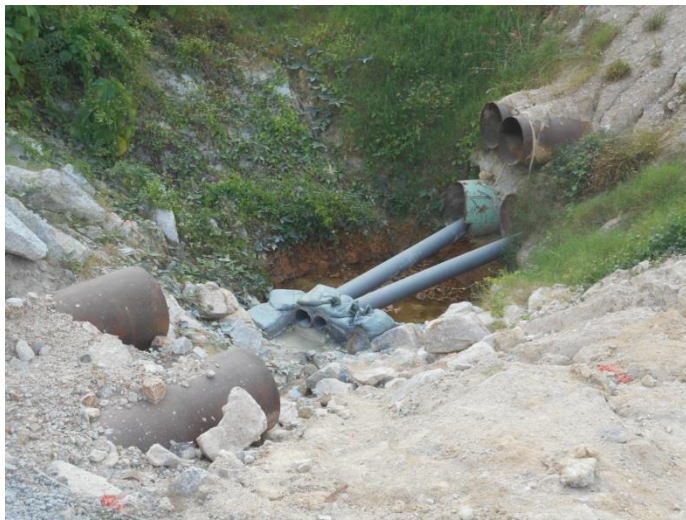
Stream B Pit 1: in normal condition.

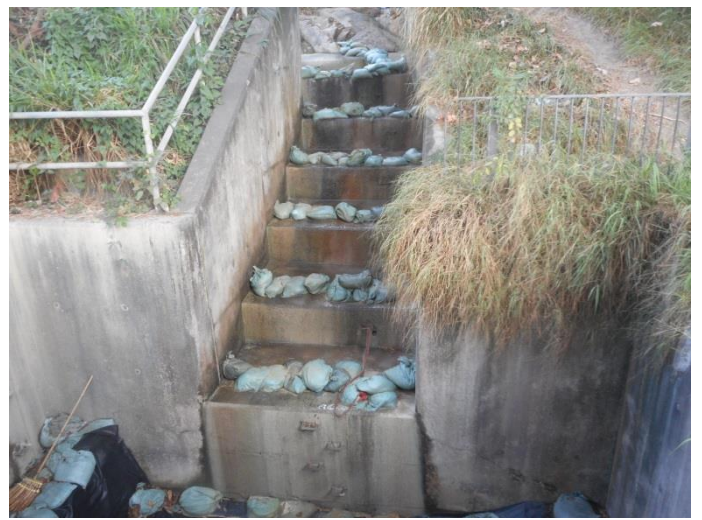
Stream B Pit 2: Treated water was directly discharged to downstream bypass.

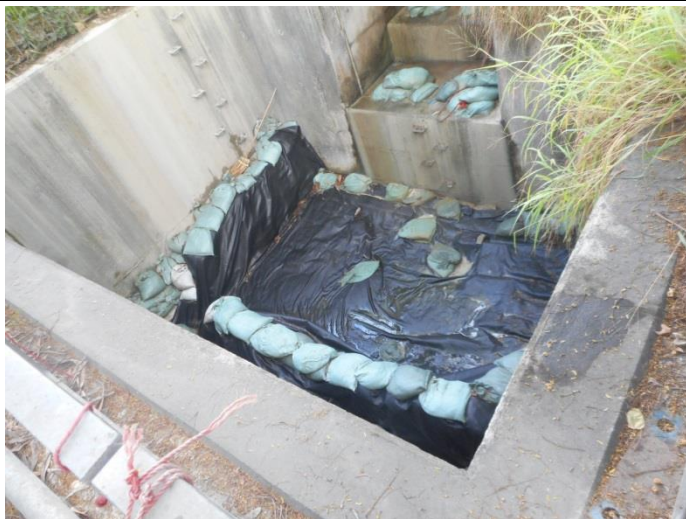
Stream B Outfall: Cascade step channel condition

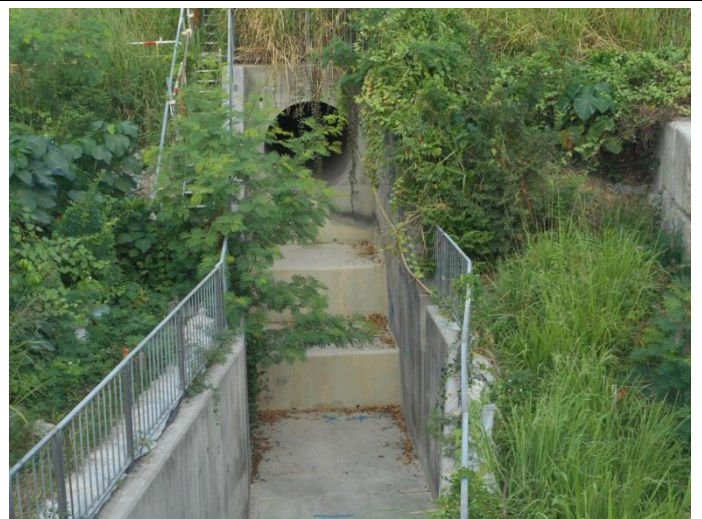
Stream B Outfall: Cascade was in normal condition.

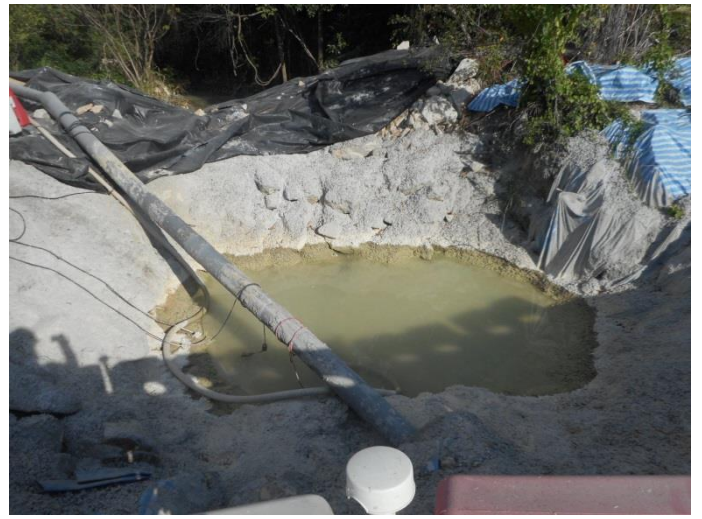
Stream A Outfall: pumped muddy water and discharged after treatment.

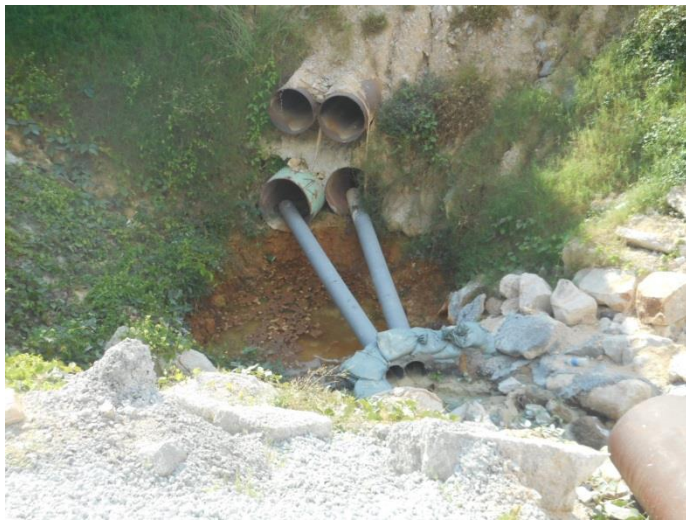
Stream B Pit 1: in normal condition.

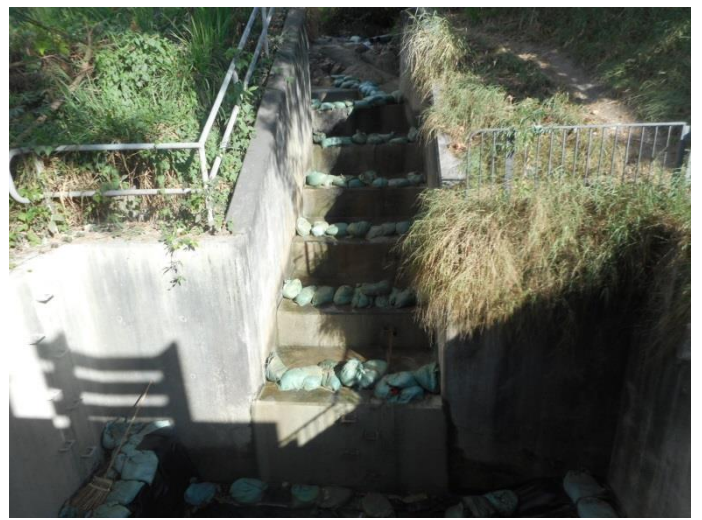
Stream B Pit 2: Treated water was directly discharged to downstream bypass.

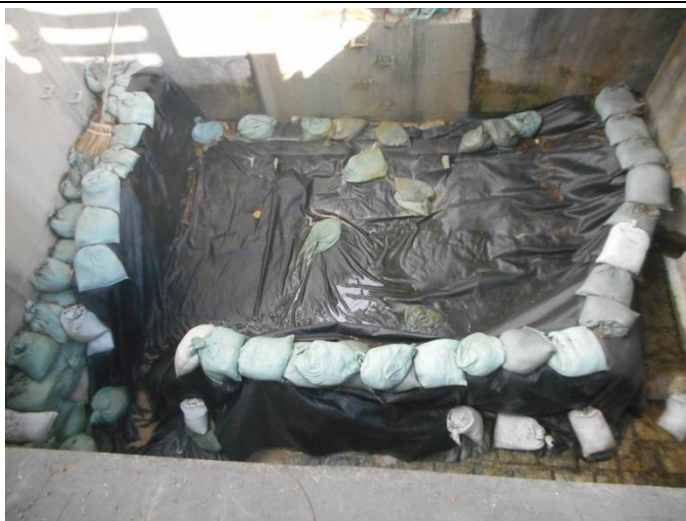
Stream B Outfall: Cascade step channel condition

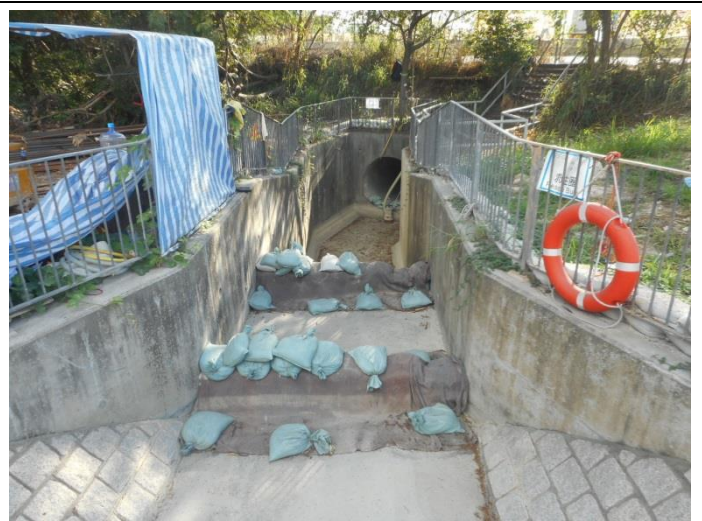
Stream B Outfall: Cascade was in normal condition.

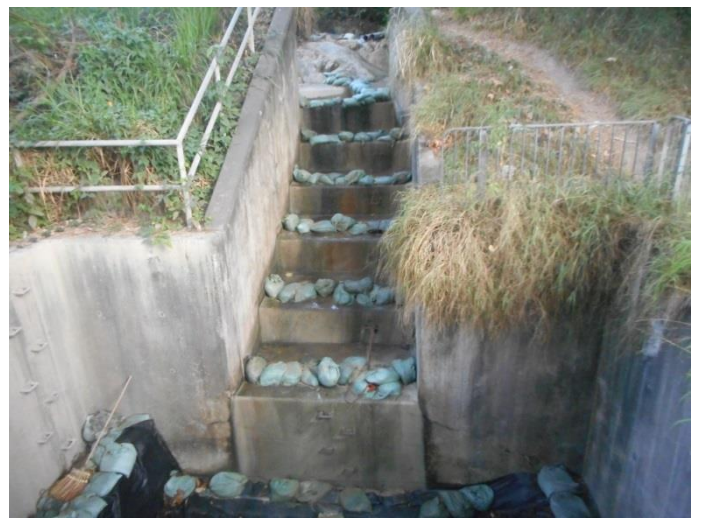
Stream B Pit 2: Treated water was directly discharged to downstream bypass.

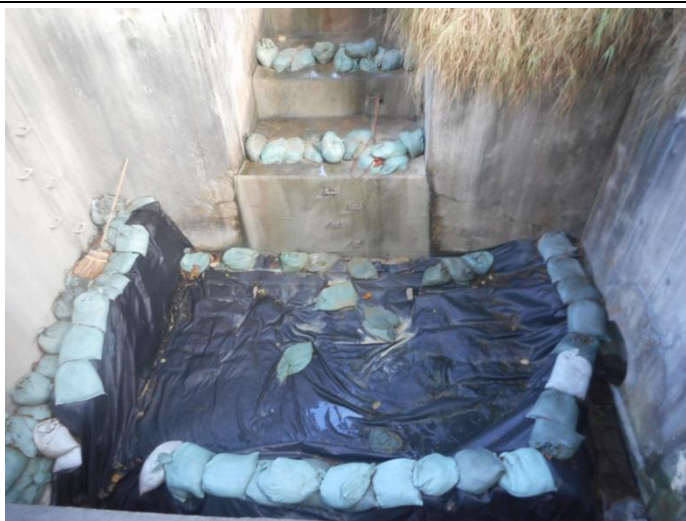
Stream B Outfall: Cascade step channel condition

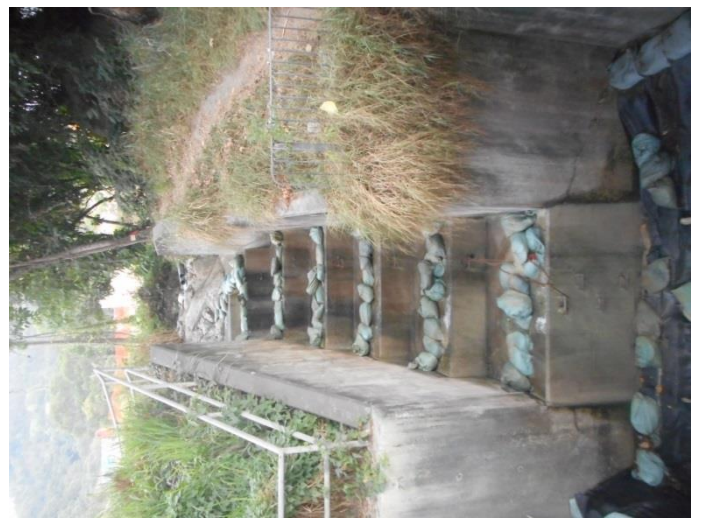
Stream B Pit 2: Treated water was directly discharged to downstream bypass.

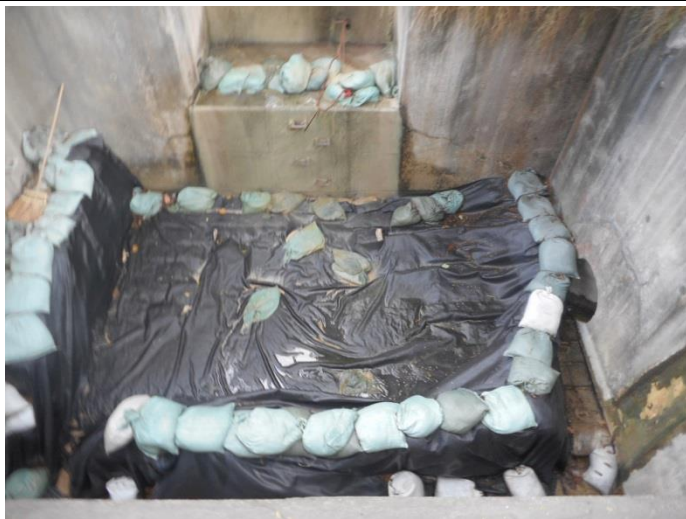
Stream B Outfall: Cascade step channel condition

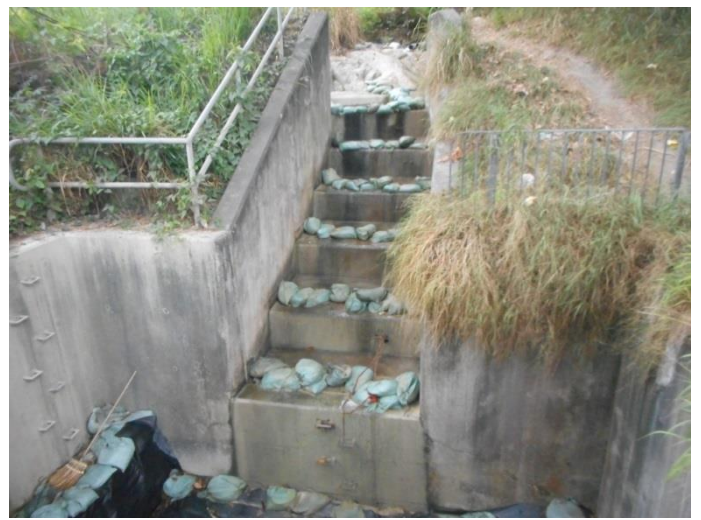
Stream B Pit 2: Treated water was directly discharged to downstream bypass.

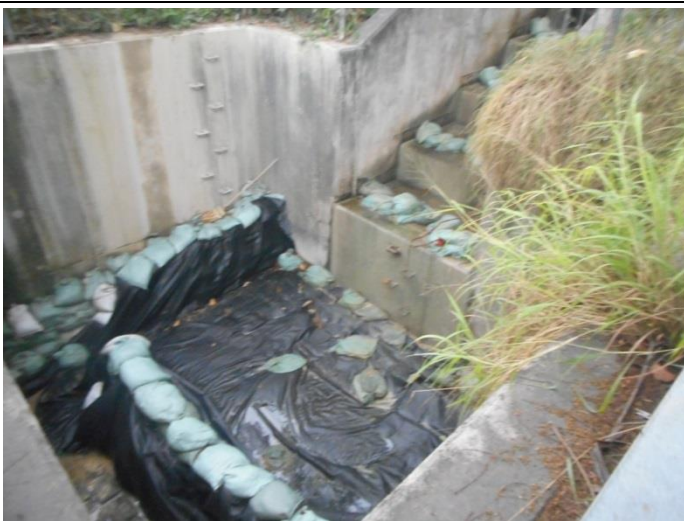
Stream B Outfall: Cascade step channel condition

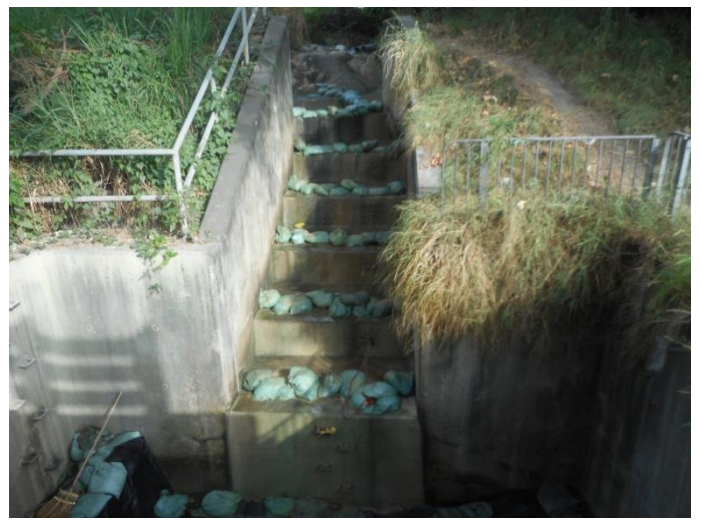
Stream B Pit 2: Treated water was directly discharged to downstream bypass.

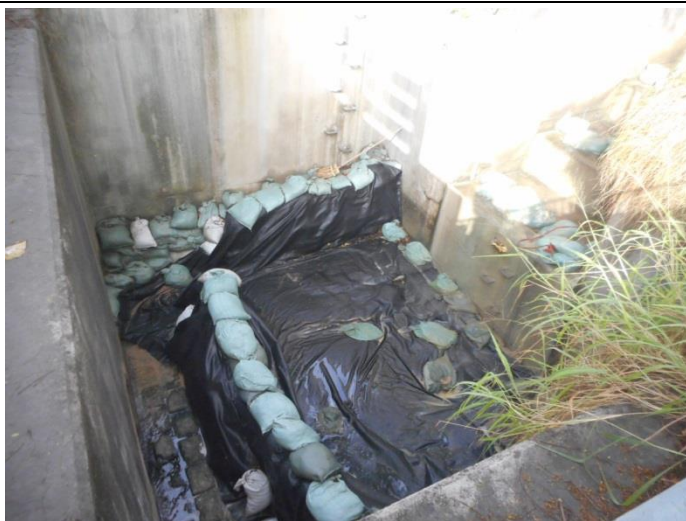
Stream B Outfall: Cascade step channel condition

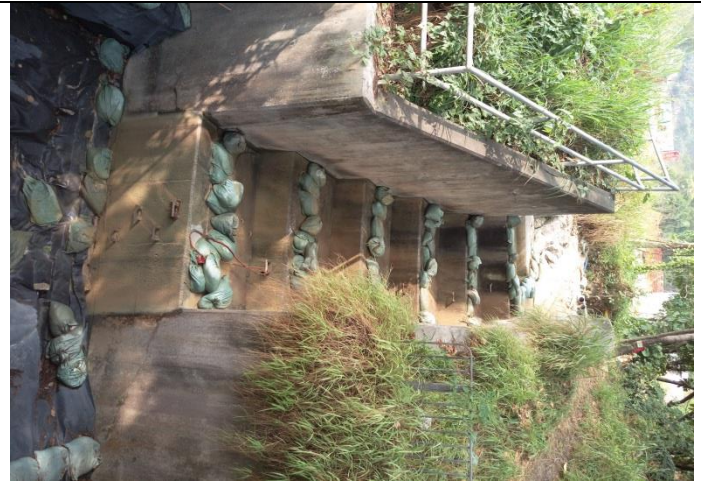
Stream B Pit 2: Treated water was directly discharged to downstream bypass.

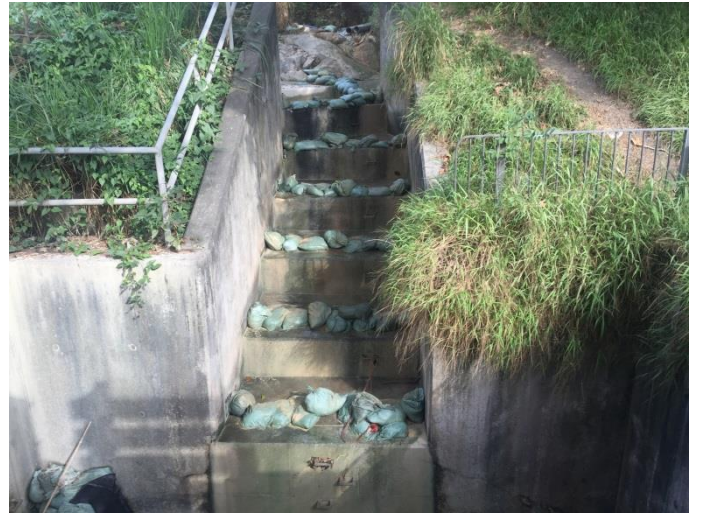
Stream B Pit 2: Treated water was directly discharged to downstream bypass.

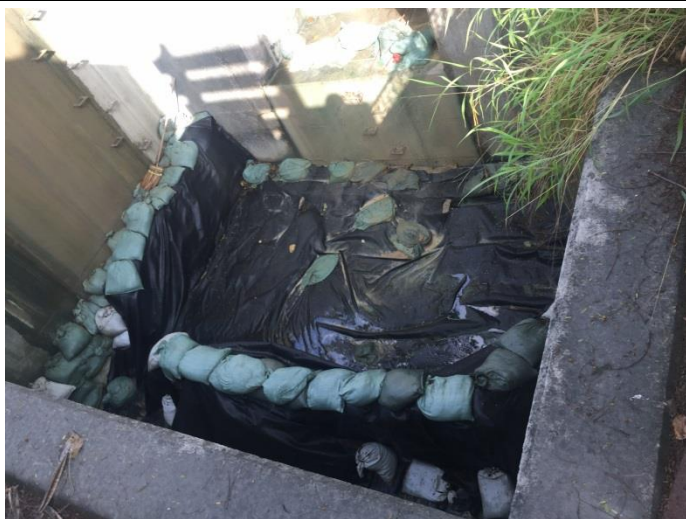
Stream B Outfall: Cascade step channel condition

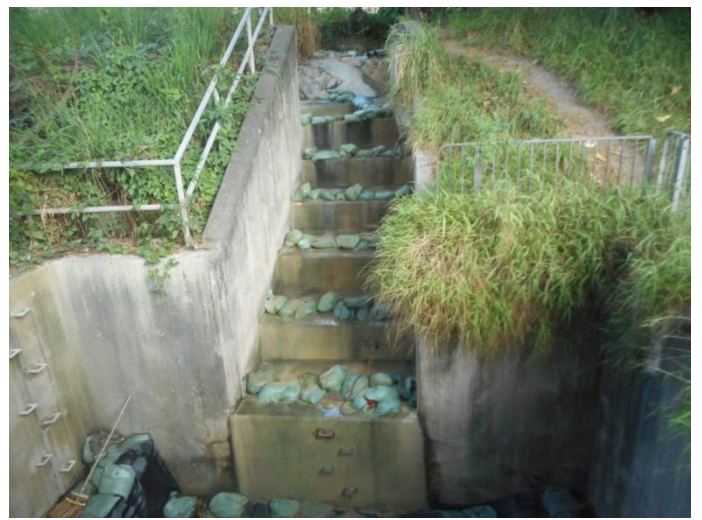
Stream B Pit 2: Treated water was directly discharged to downstream bypass.

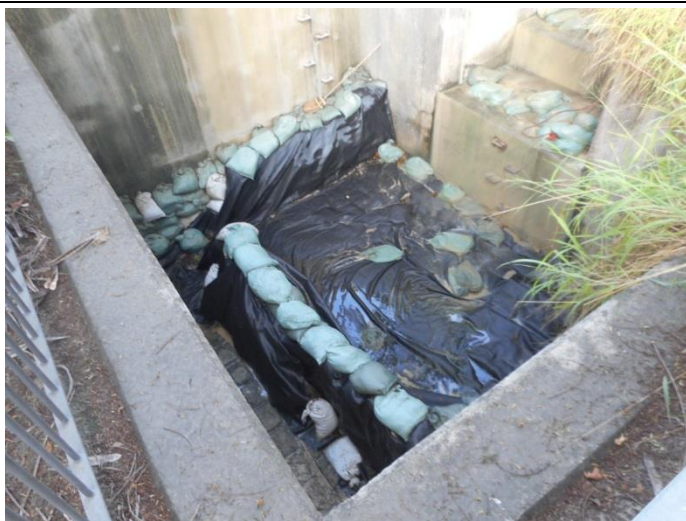
Stream B Outfall: Cascade step channel condition

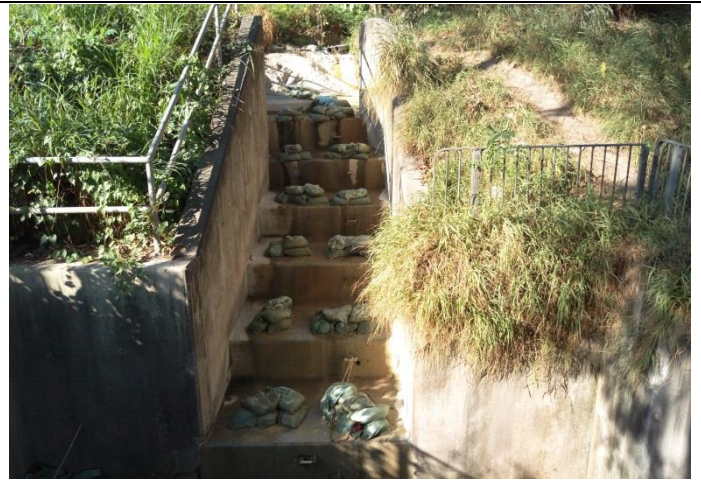
Stream B Pit 2: Treated water was directly discharged to downstream bypass.

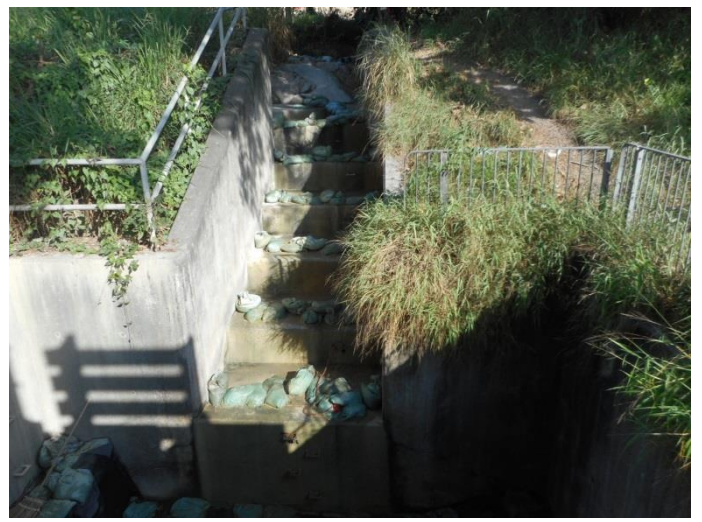
Stream B Pit 2: Treated water was directly discharged to downstream bypass.

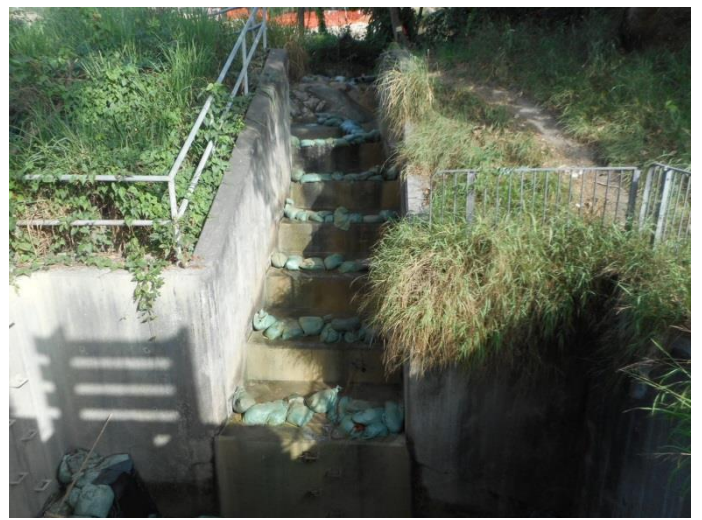
Stream B Pit 2: Treated water was directly discharged to downstream bypass.

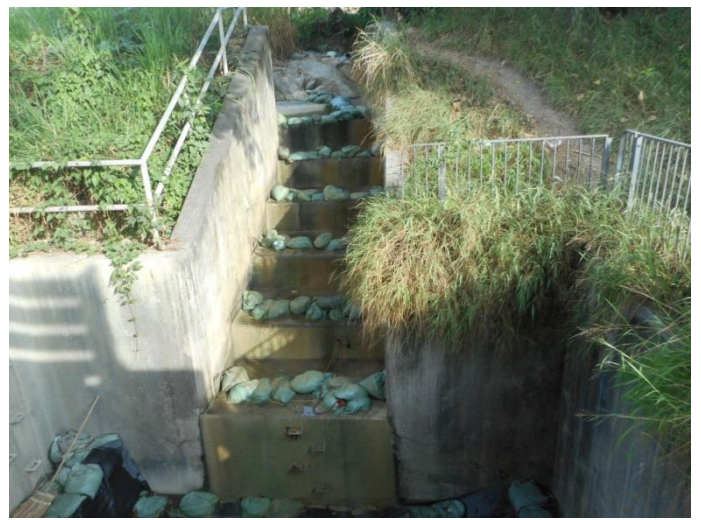
Stream B Pit 2: Treated water was directly discharged to downstream bypass.

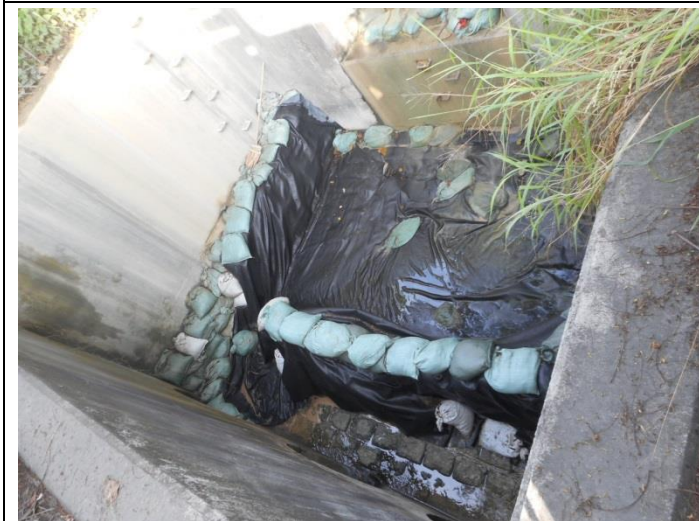
Stream B Outfall: Cascade step channel condition

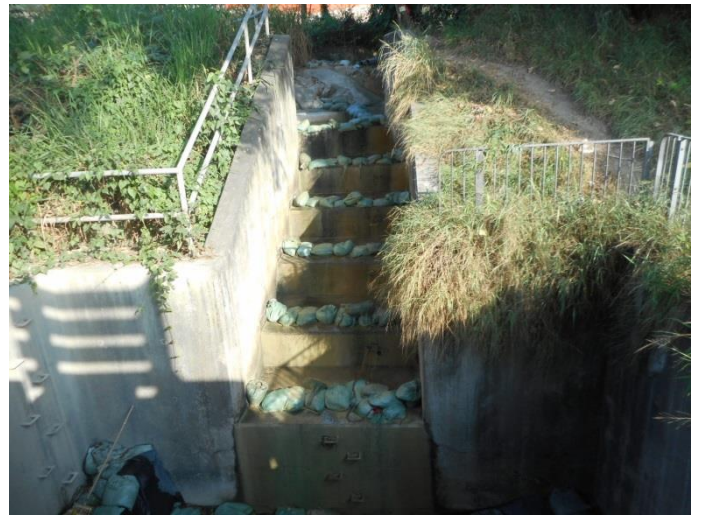
Stream B Pit 2: Treated water was directly discharged to downstream bypass.

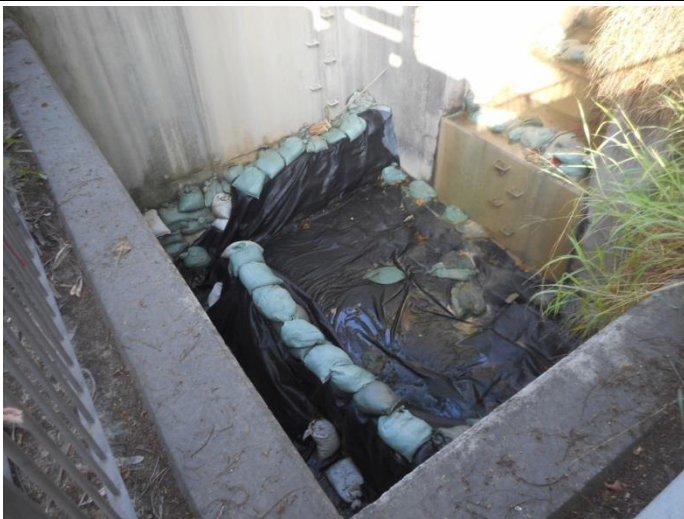
Stream B Outfall: Cascade step channel condition

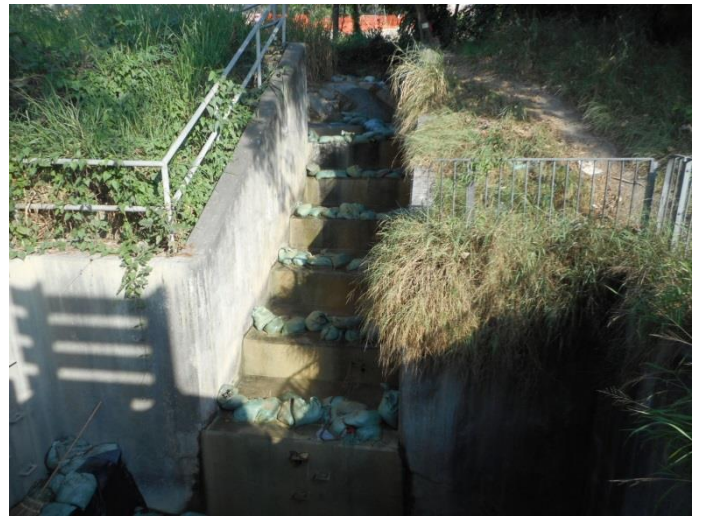
Stream B Pit 2: Treated water was directly discharged to downstream bypass.

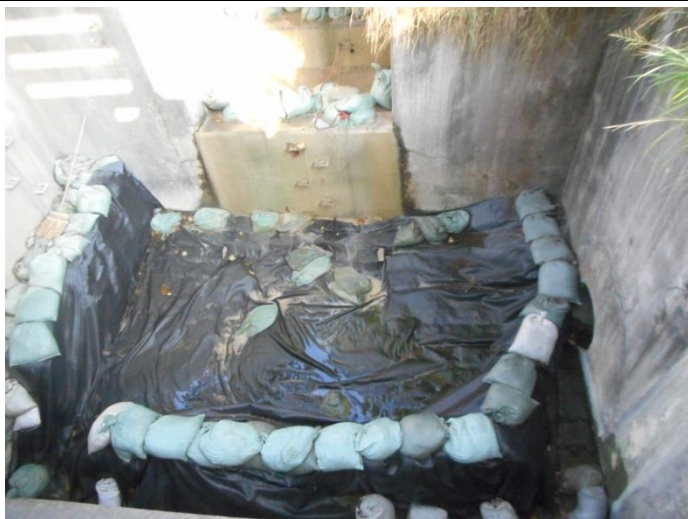
Stream B Outfall: Cascade step channel condition

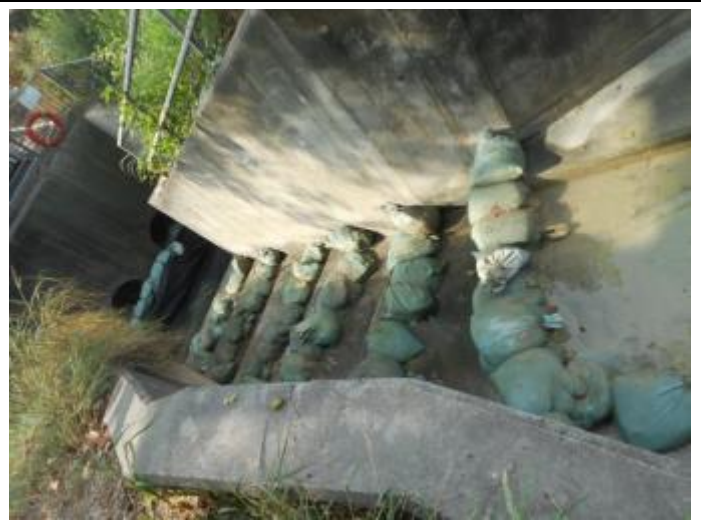
Stream B Pit 2: Treated water was directly discharged to downstream bypass.

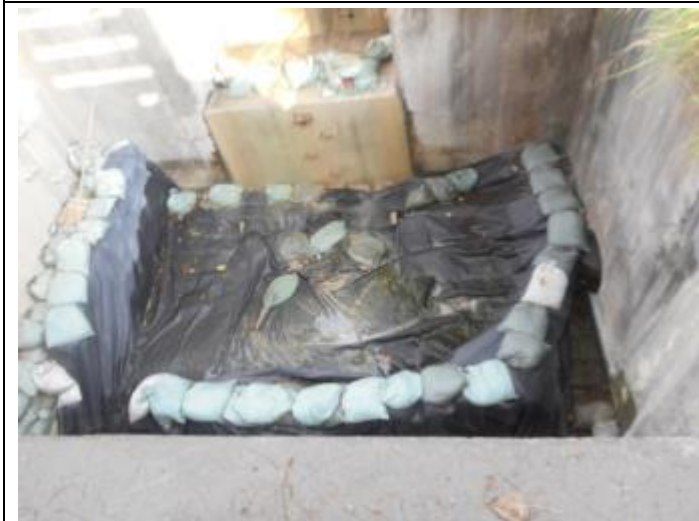
Stream B Outfall: Cascade step channel condition

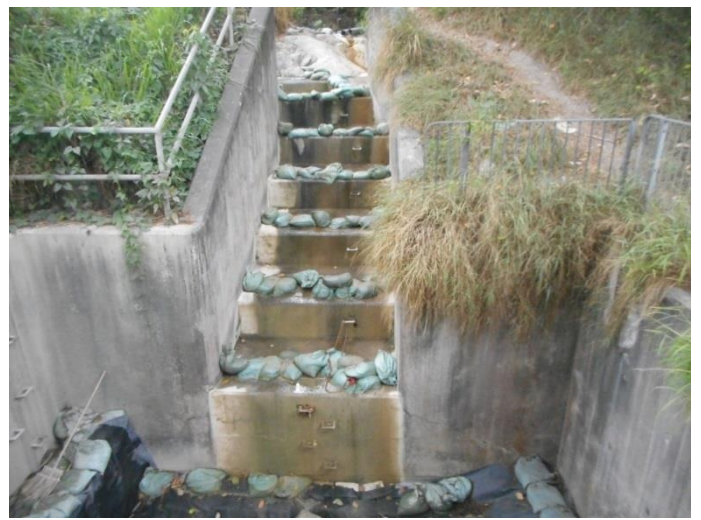
Stream B Pit 2: Treated water was directly discharged to downstream bypass.

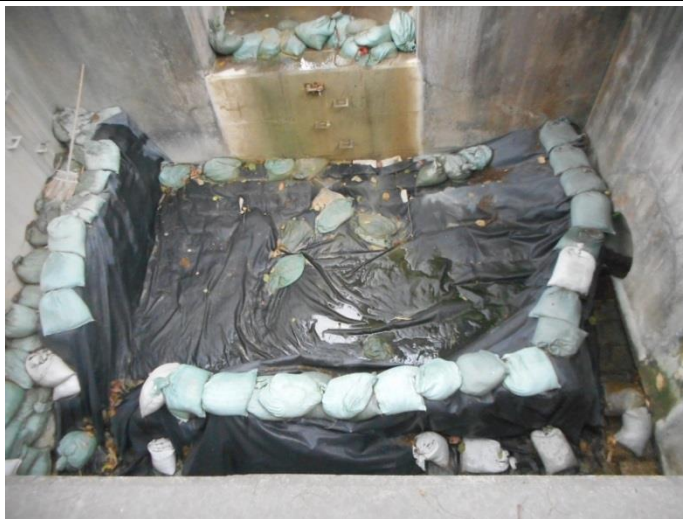
Stream B Outfall: Cascade step channel condition

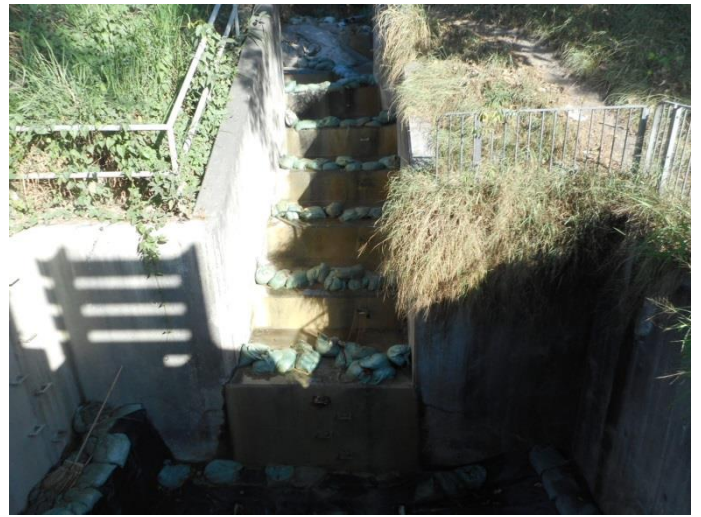
Stream B Pit 2: Treated water was directly discharged to downstream bypass.

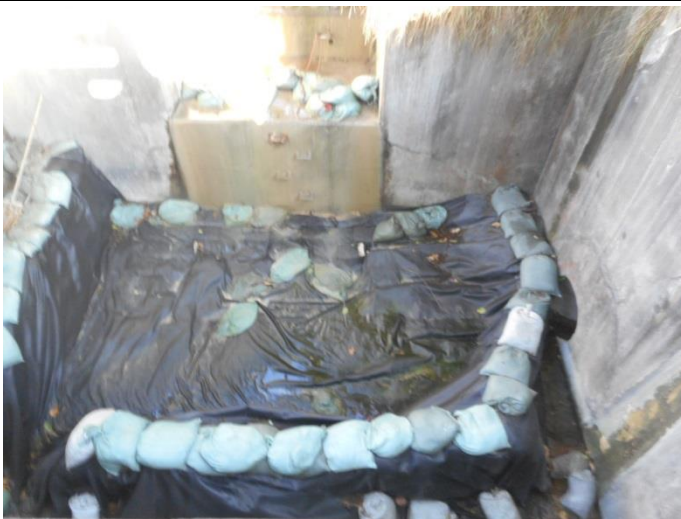
Stream B Outfall: Cascade step channel condition

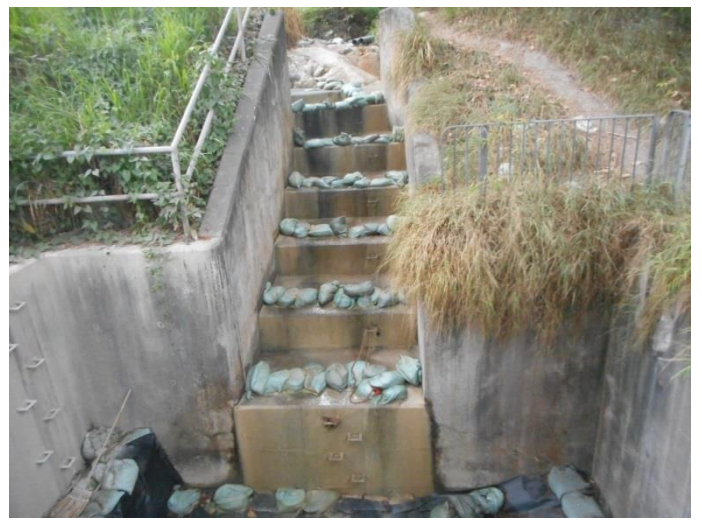
Stream B Pit 2: Treated water was directly discharged to downstream bypass.
