TUEN MUN - CHEK LAP KOK LINK
CONTRACT NO. HY/2013/12 –
NORTHERN CONNECTION TOLL PLAZA AND
ASSOCIATED WORKS

13TH MONTHLY ENVIRONMENTAL MONITORING AND
AUDIT (EM&A) REPORT – NOVEMBER 2015

PREPARED FOR
CRBC AND KADEN JOINT VENTURE

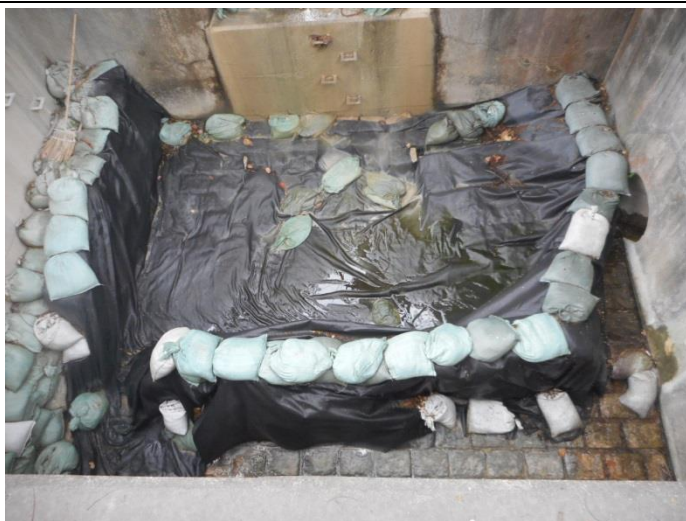
Stream B Outfall: Cascade step channel condition
