Alternative Ground Decontamination Works at the Proposed Kennedy Town Comprehensive Development Area Site

Review Report for New World First Bus Depot

June 2018

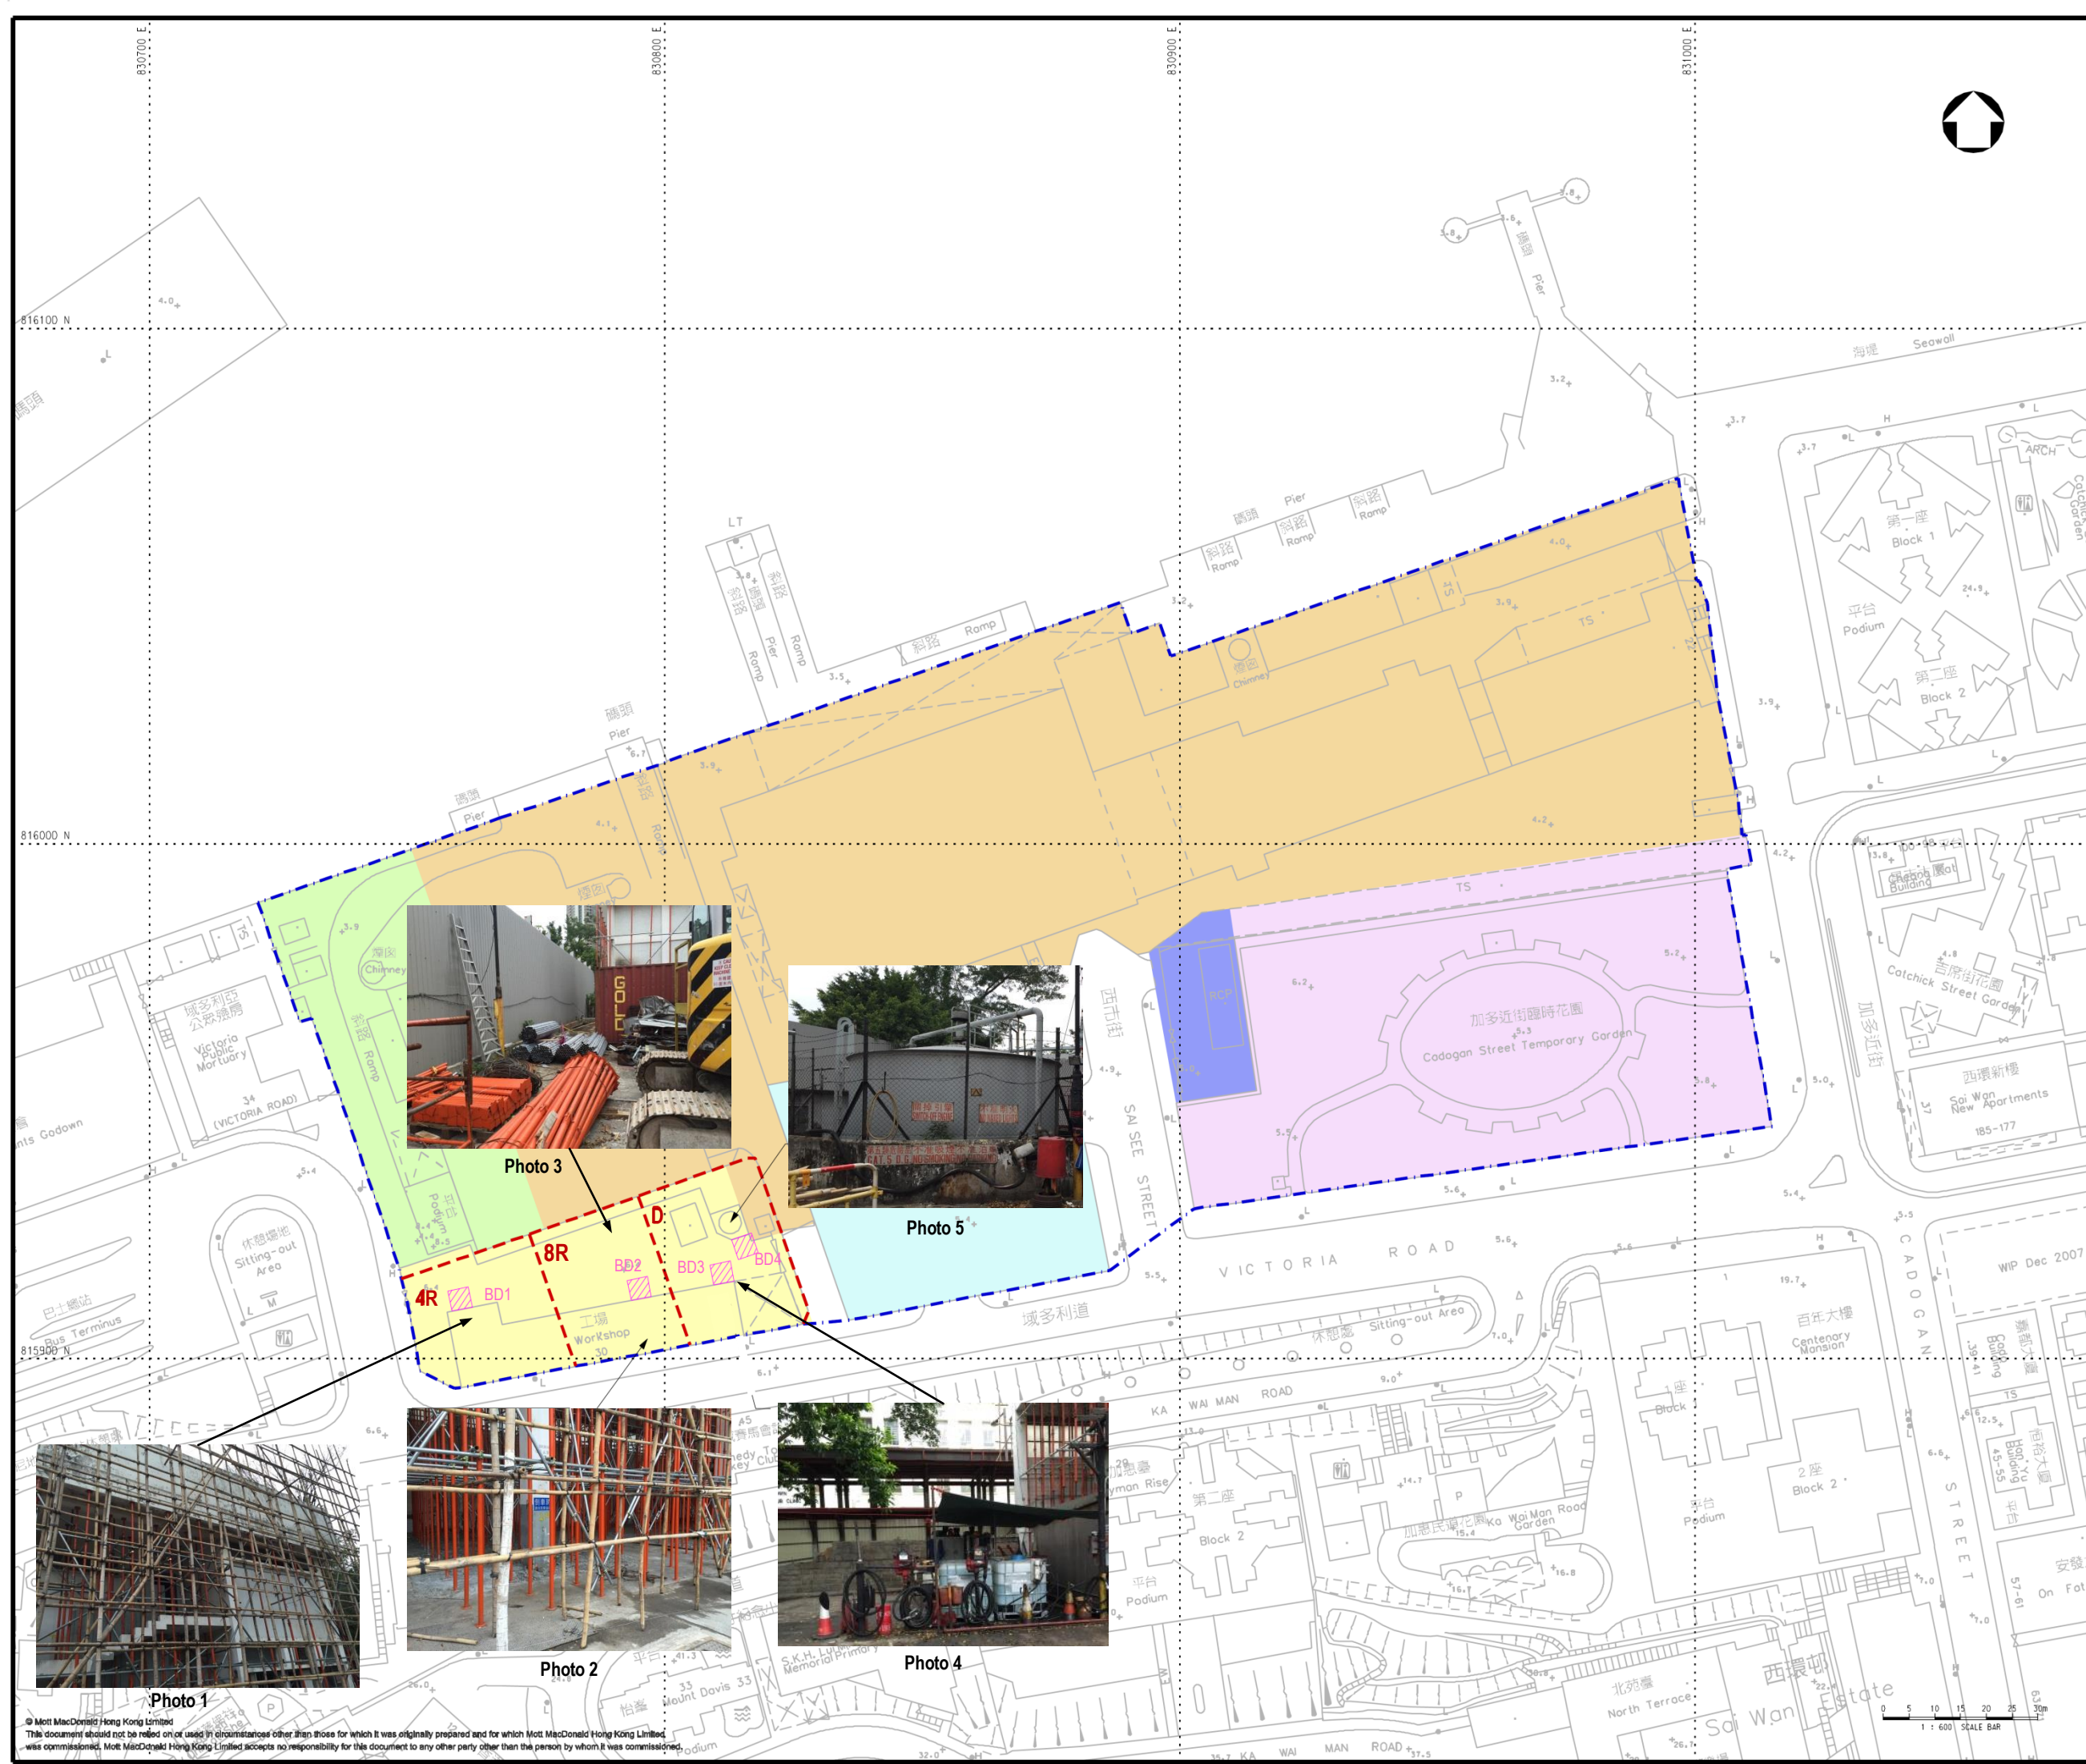
FIGURE 2.1

During the interim site appraisal, it was observed that refuelling was the only operation in the Bus Depot and was the same activity as the previous site appraisal in May 2012. The other activities found during the supplementary EIA stage such as vehicle washing and parking were no longer in place. No further potentially contaminative land uses and no signs of further land contaminative activities were observed in the Bus Depot.

Also, it was observed that the ground surfaces of Bus Depot were fully paved with intact concrete and no apparent stains were found (including the area near the above-ground fuel tank). The ground

condition of the Bus Depot has not changed since the supplementary EIA stage. Since there are no additional operation activities in the Bus Depot, no new potential source of contamination is anticipated since the site appraisal in 2012.

As mentioned in **Section 2.2.2 and 2.2.3**, the activities found during the supplementary EIA stage such as vehicle washing and parking were no longer in place. These activities were located in Grids 4R and 8R (see **Figure 2.1**). During the site appraisal in June and July 2016, refuelling activity was no longer in place and the aboveground fuel tank was removed from the Bus Depot. It was also observed that the ground surfaces of Bus Depot were fully paved with intact concrete and no apparent stains were found at the surfaces (including the area near the removed above-ground fuel tank). The ground condition of the Bus Depot has not changed since the supplementary EIA stage. No further potentially contaminative land uses and no signs of further land contaminative activities were anticipated after the SI carried out in 2013. Since there is no change of operation activities in the Bus Depot, no new potential source of contamination is anticipated after the SI carried out in 2013. In addition, confirmatory sampling will be carried out during the ground decontamination works as required by the EP Conditions to further ascertain the extent of contamination within the site. Given the above, no further SI is considered necessary for the Bus Depot and the findings of the approved CAP for the Bus Depot should remain valid.

According to the approved CAR, the SI for the Bus Depot was conducted between 19 July 2013 and 7 August 2013. The 4 sampling locations (see **Figure 2.1**) were located around the potential land contamination areas as identified in the approved CAP. According to the laboratory analysis, exceedances of the relevant Risk-Based Remediation Goals (RBRGs) (for Urban Residential / Rural Residential) in lead, mercury, PCR and benzo(a)pyrene were found in some of the soil samples. All the groundwater analysis results were below the relevant RBRGs and solubility limits.

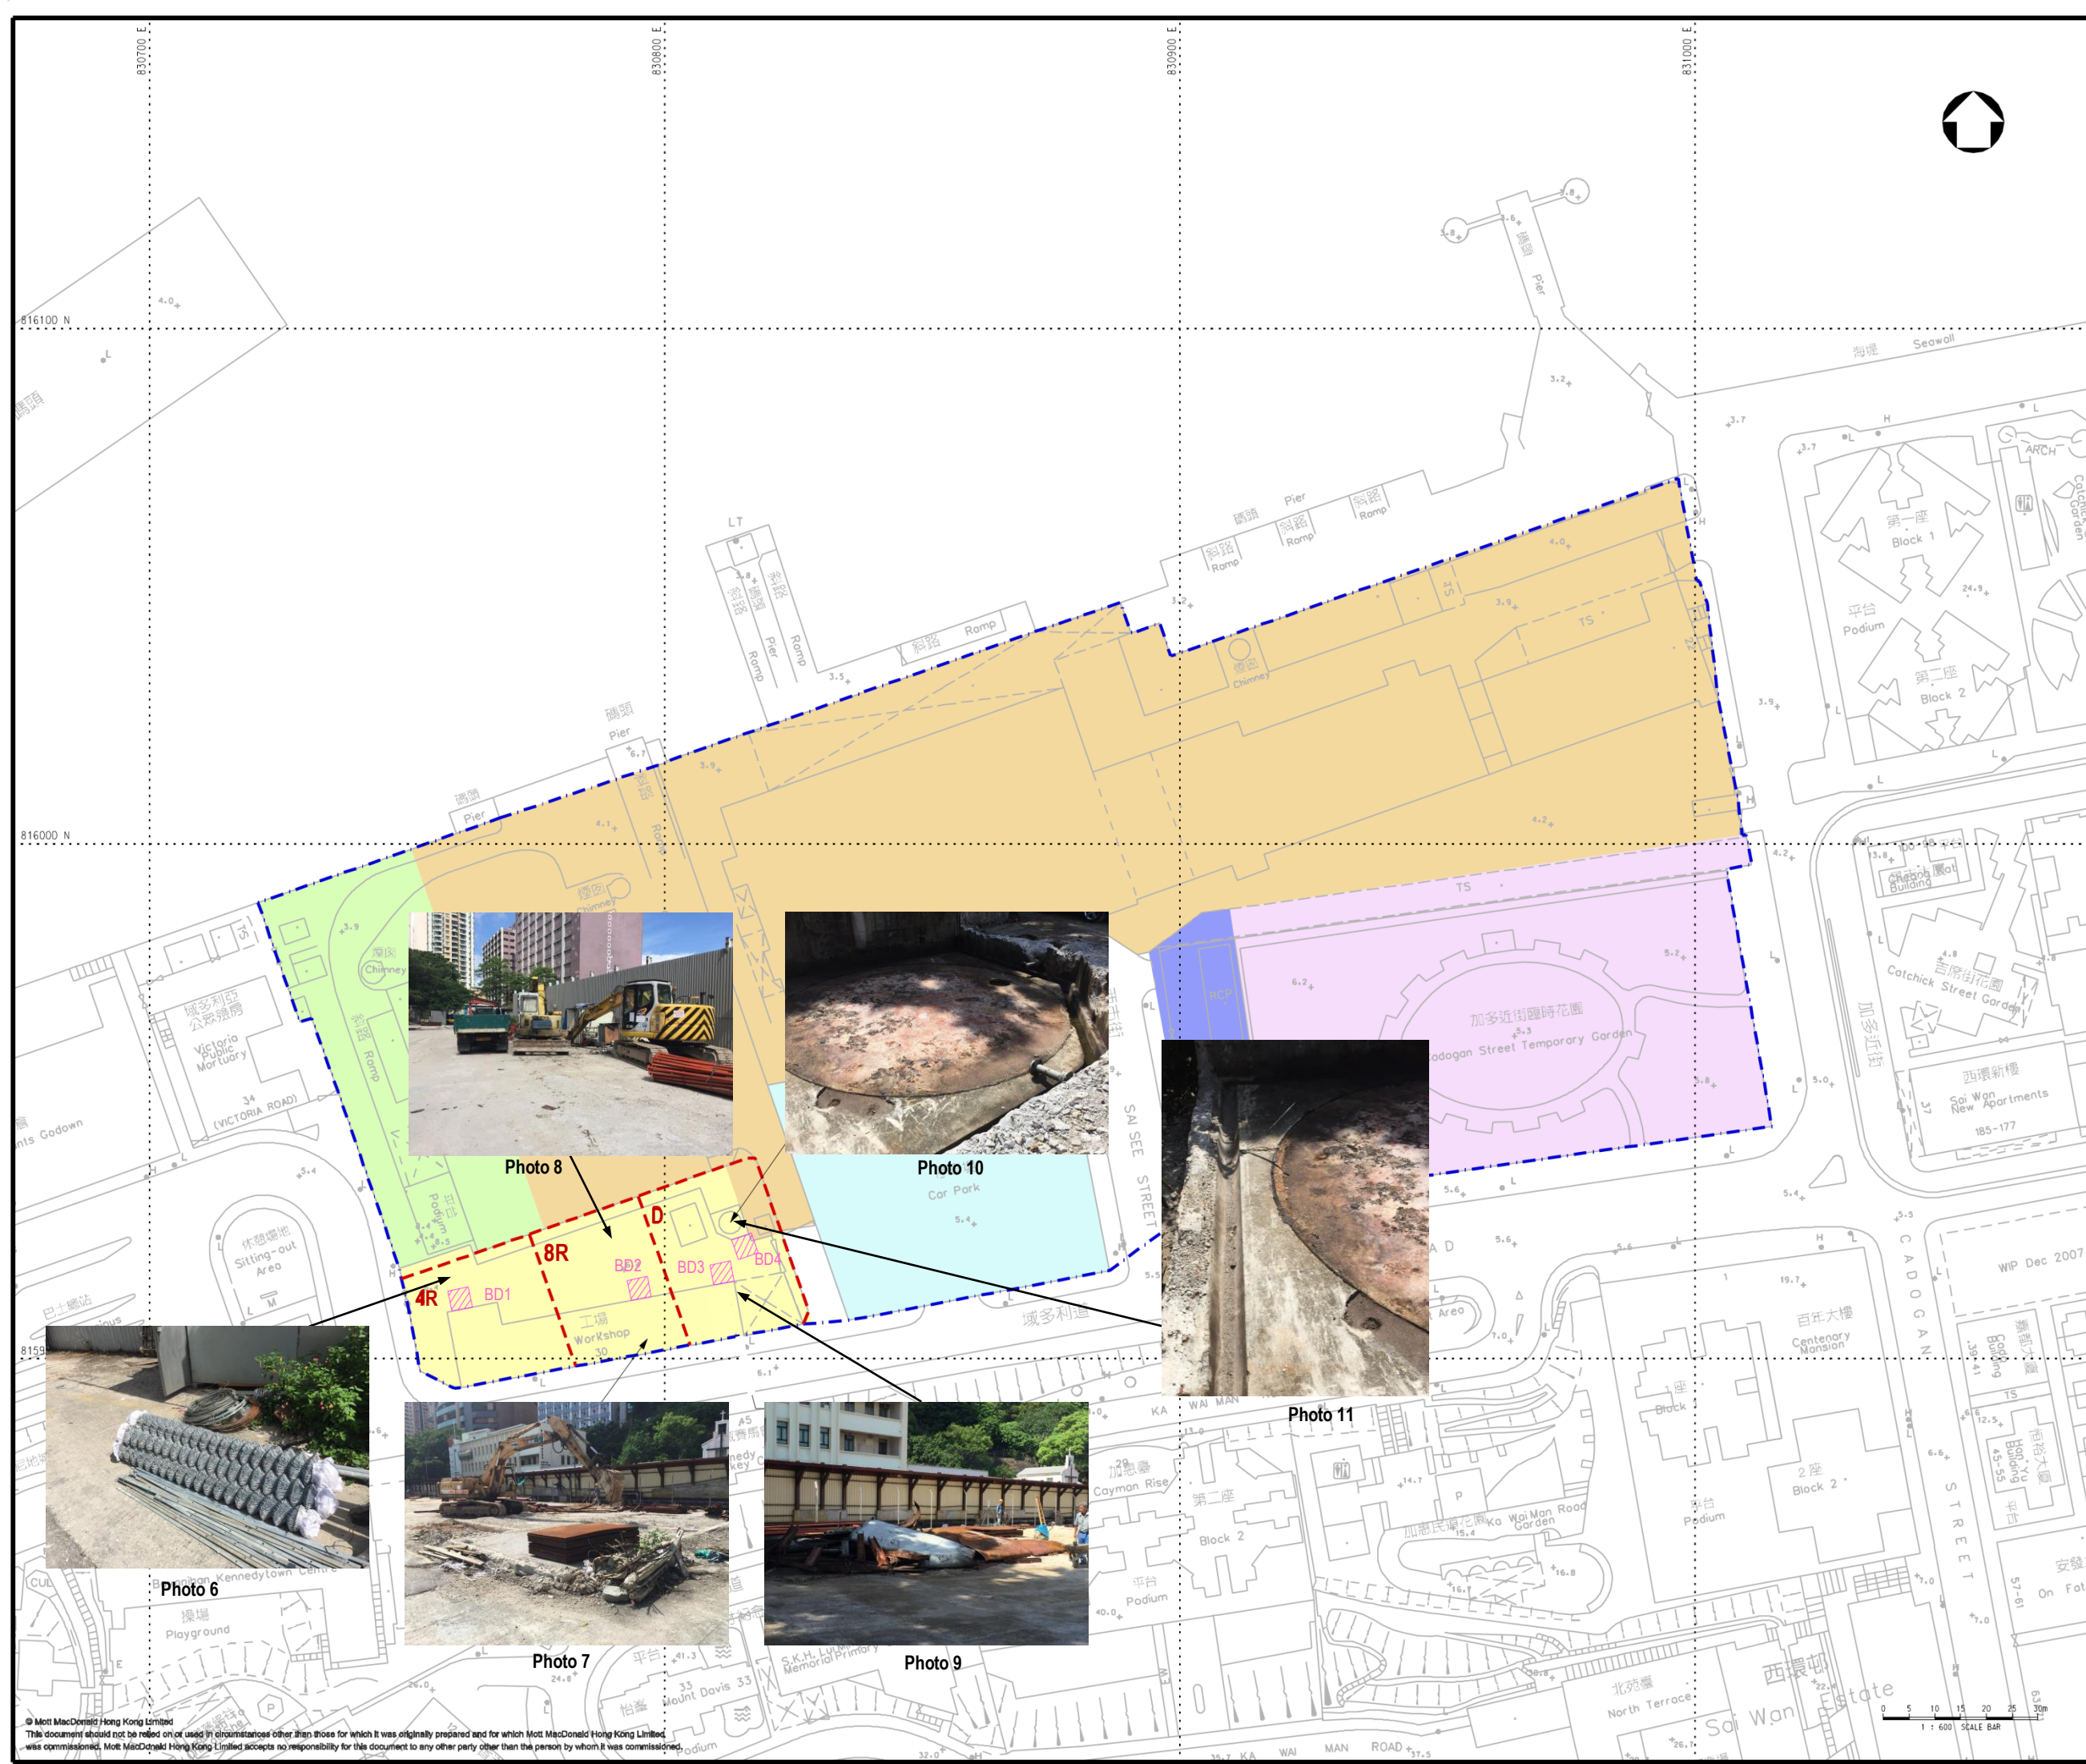
During the site appraisal on 20 June 2016, it was observed that no activity was being carried out in the Bus Depot. No further potentially contaminative land uses and no signs of new potential source of contamination were observed in the Bus Depot. It was also observed that the ground surfaces of Bus Depot were fully paved with intact concrete and no apparent stains were found at the surfaces (including the area near the above-ground fuel tank). The ground condition of the Bus Depot has not changed since the site appraisal in December 2015.

During the final site appraisal in 18 July 2016, it was observed that only minor site clearance works were being carried out in the Bus Depot. All the building structure including the aboveground fuel tank were removed from the Bus Depot. It was also observed that the ground surfaces of Bus Depot were fully paved with intact concrete and no apparent stains were found at the surfaces (including the area near the removed above-ground fuel tank). Therefore, no further potentially contaminative land uses and no signs of new potential source of contamination were observed in the Bus Depot.
