**WANCHAI DEVELOPMENT PHASE II AND CENTRAL
WANCHAI BYPASS
SAMPLING, FIELD MEASUREMENT AND TESTING WORK
(STAGE 4)**

ENVIRONMENTAL PERMIT NO. EP-122/2002/E

FINAL ENVIRONMENTAL MONITORING & AUDIT REPORT

**Re: Wan Chai Development Phase II and Central-Wan Chai Bypass
Verification of Final EM&A Report under EP-122/2002/E**

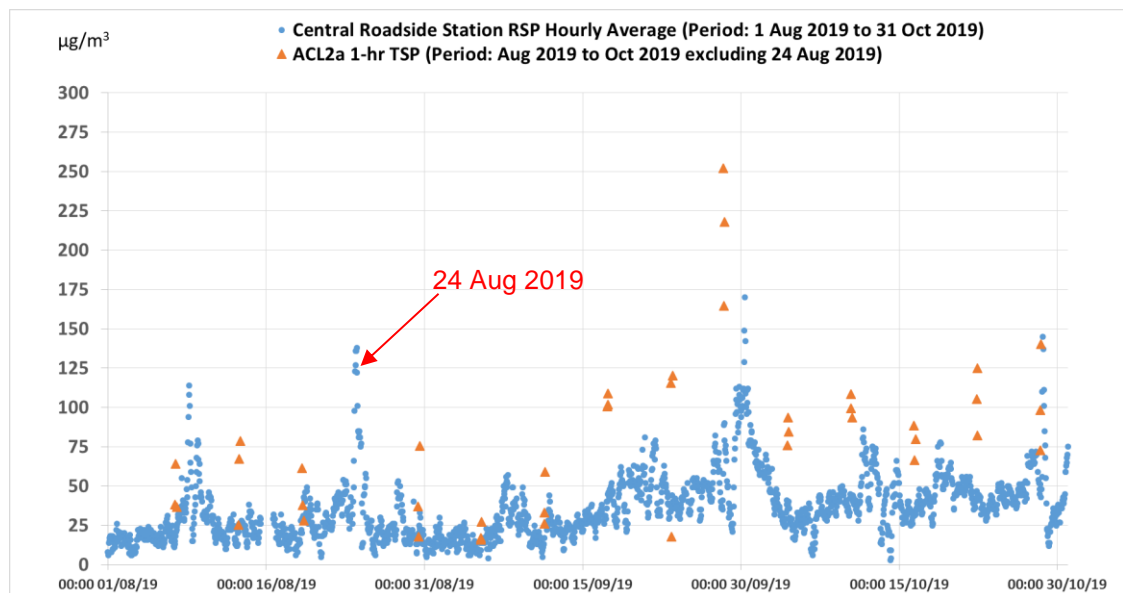
Chart 4.1 Comparison between Central Roadside Station RSP Hourly Average and ACL2a 1-hr TSP

4.2.16 It shall be taken into account that the elevated Air Quality Health index (AQHI) (From Level 5 to Level 7) was recorded on 24 August 2019 at EPD Central/Western General Station, Central Roadside Station and Causeway Bay Roadside Station. Chart 4.1 showed that high RSP hourly average at Central Roadside Station was recorded on 24 August 2019 as well. The average level of 1-hr TSP between August and October 2019 excluding 24 August 2019 at ACL2a was 79.95 $\mu\text{g}/\text{m}^3$, which was very close to the baseline level (77.1 $\mu\text{g}/\text{m}^3$). Comparing the RSP hourly average recorded between August to October 2019 at Central roadside station with 1-hr TSP recorded between August to October 2019 excluding 24 August 2019 at ACL2a in Chart 4.1, it showed that the fluctuation of 1-hr TSP level at ACL2a was similar with hourly average RSP level at Central Roadside Station. Therefore, it can be concluded that the air quality was generally return to baseline condition.
