**Monthly EM & A Record for Landscape and Visual Impact**  
**(July 2015)**

Prepared By:  
**ADI Limited**

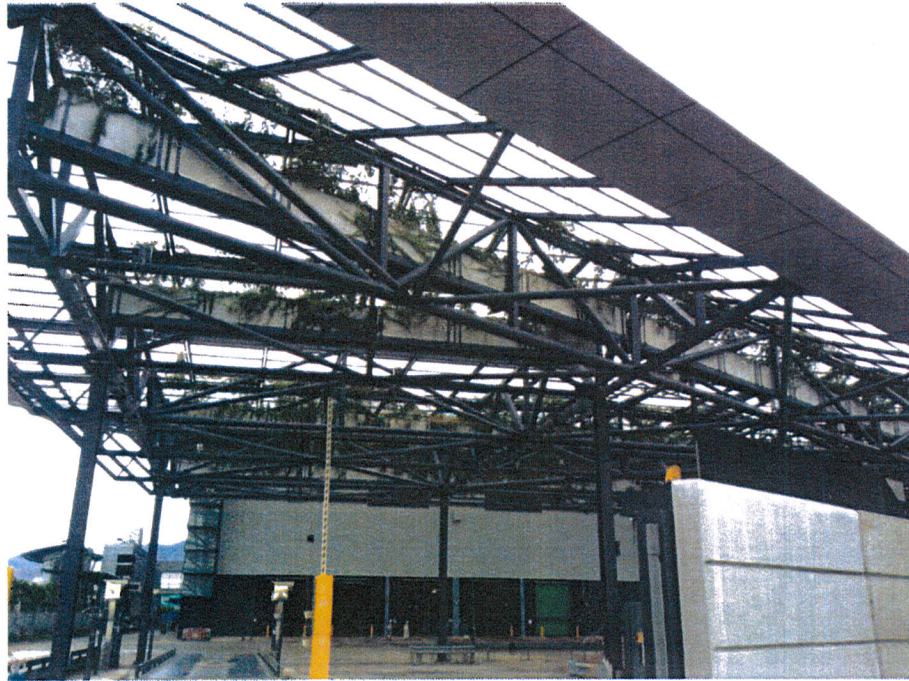
The climber planting on pergola is being established to soften edge the structural element.

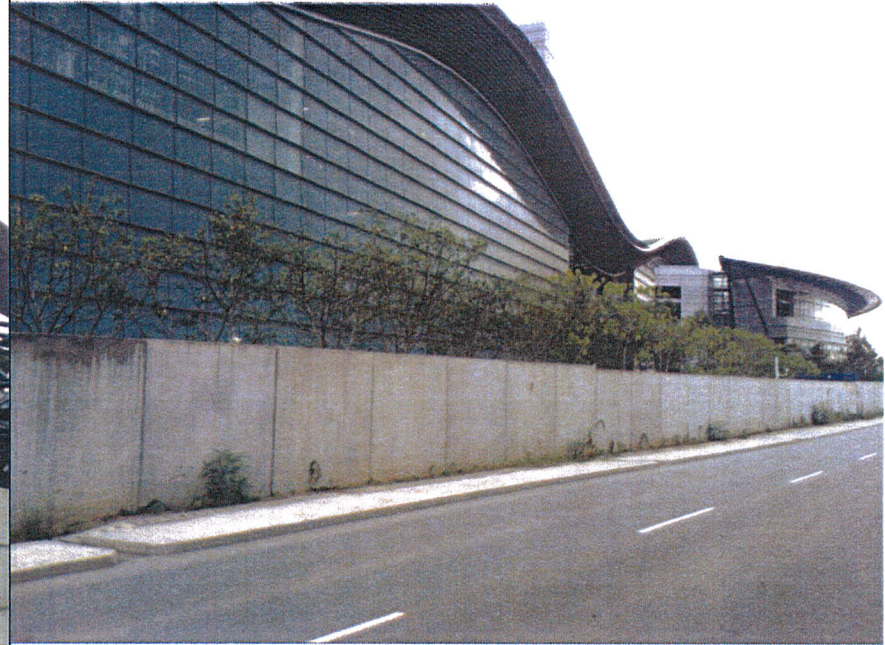
The main building is now more sinuously profiled with an elegant and pleasing form and more sympathetic to the environment. The used of recessive colors results in scheme which is less visually prominent.

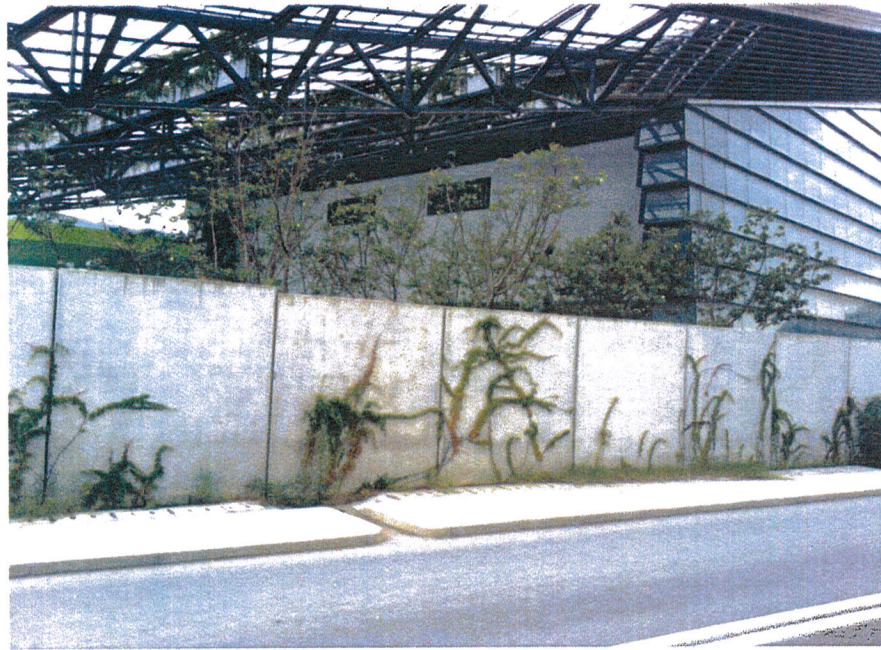
The proposed climbing planting along the boundary fence wall is being established.

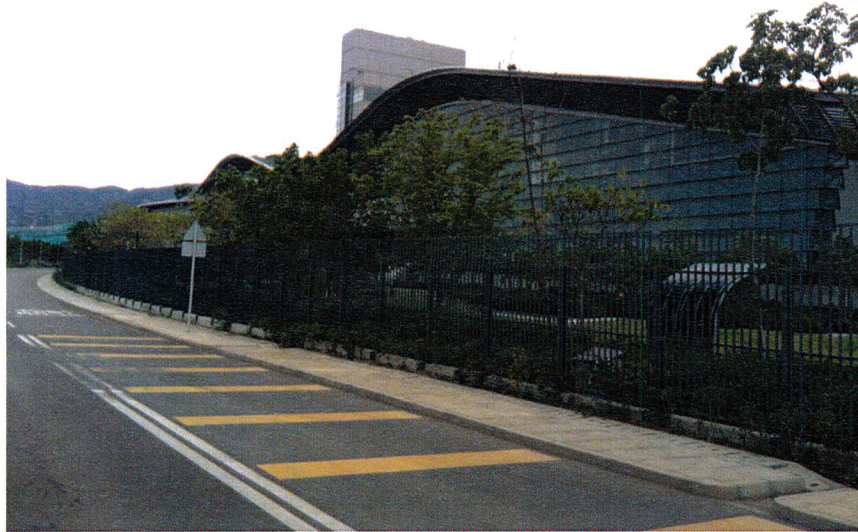
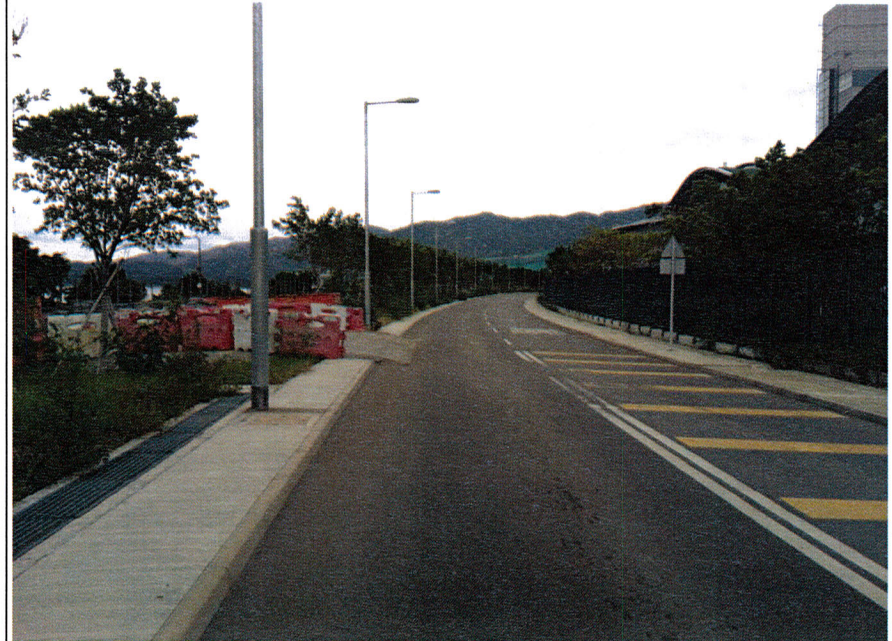
Heavy standard tree plantings have been planted and well established along the entrance road to screen the structures and enhance the environment.

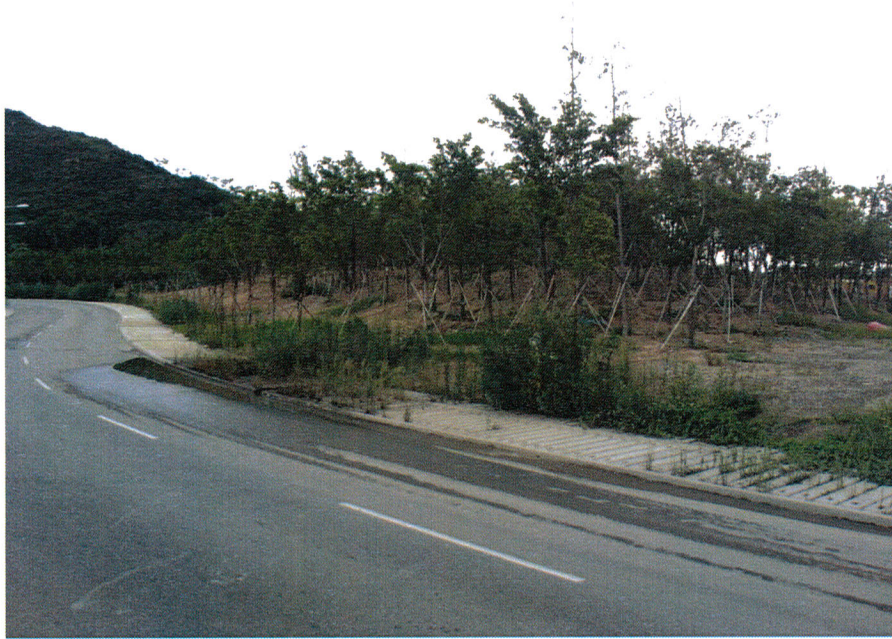
The disturbed area has been reinstated with heavy standard tree planting.  
The trees are being established

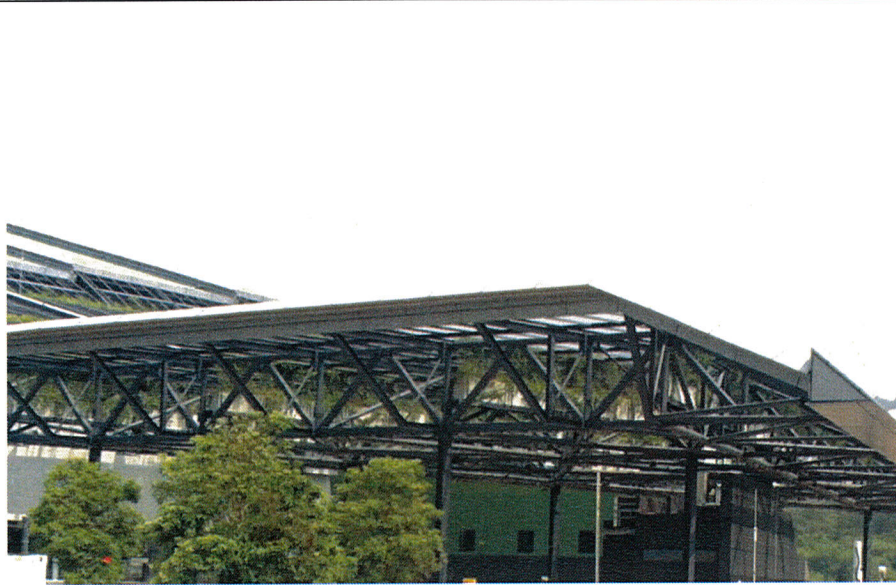
The climber planting on pergola is being established to soften edge the structural element.

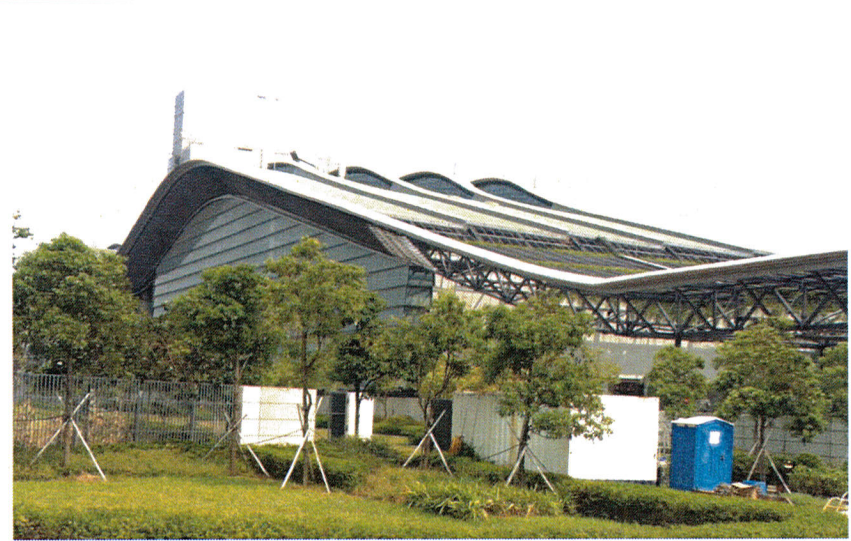
The trellis roof profile sits more sympathetically with the peaks and mounds of the surrounding mountainous terrain. The used of recessive colors results in scheme which is less visually prominent.

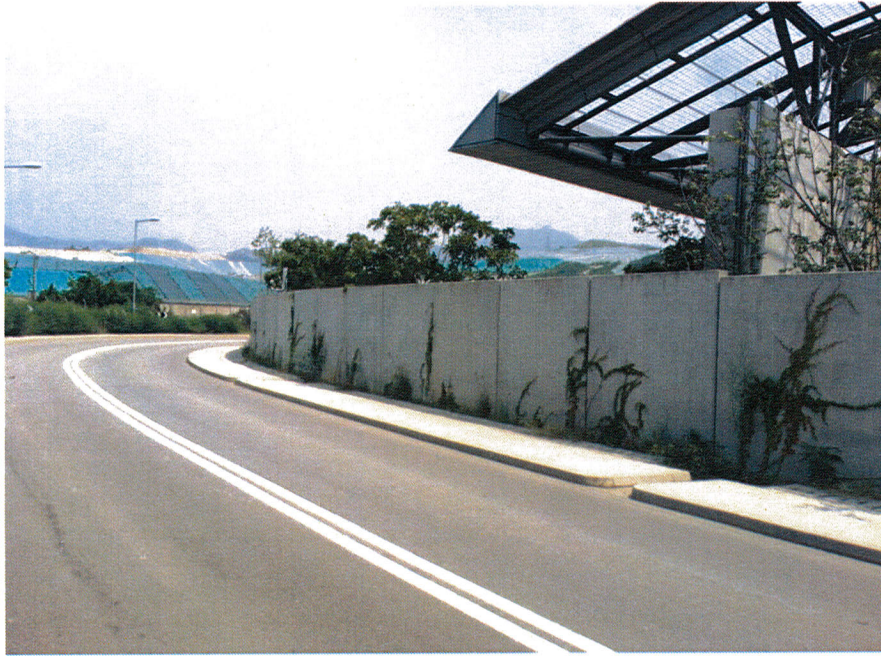
The proposed climbing planting along the boundary fence wall is being established.

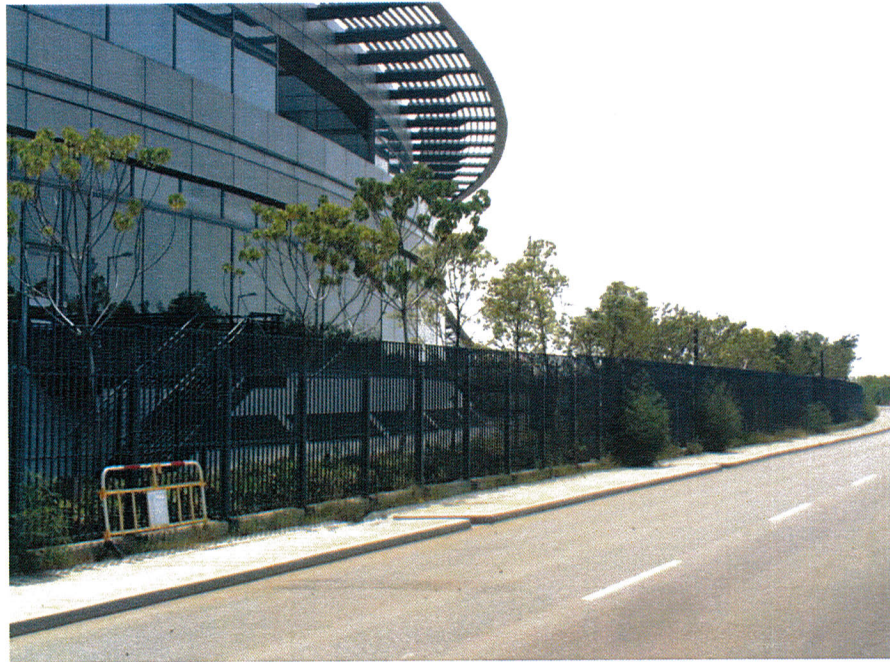
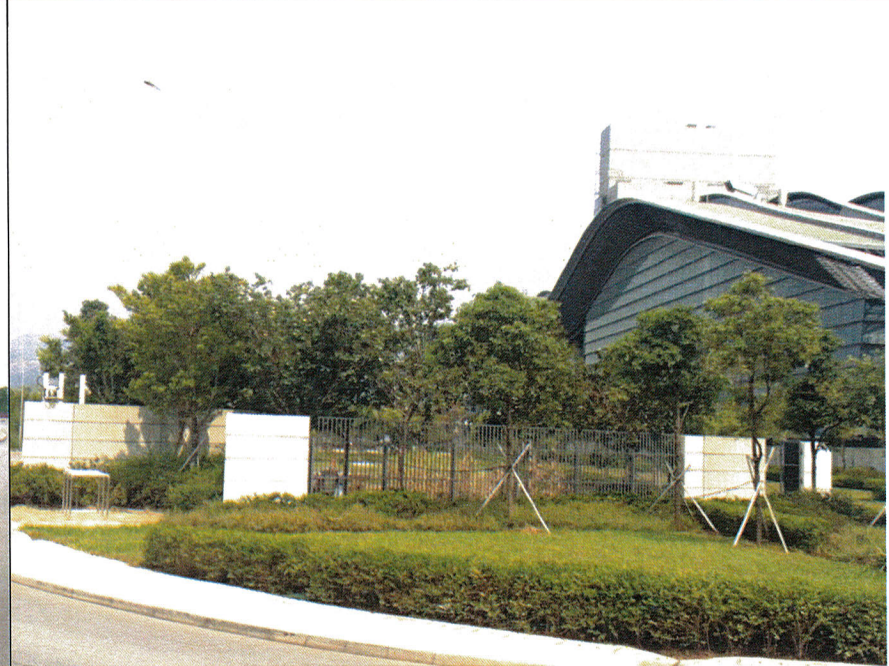
Heavy standard tree plantings have been planted and well established along the entrance road to screen the structures and enhance the environment.

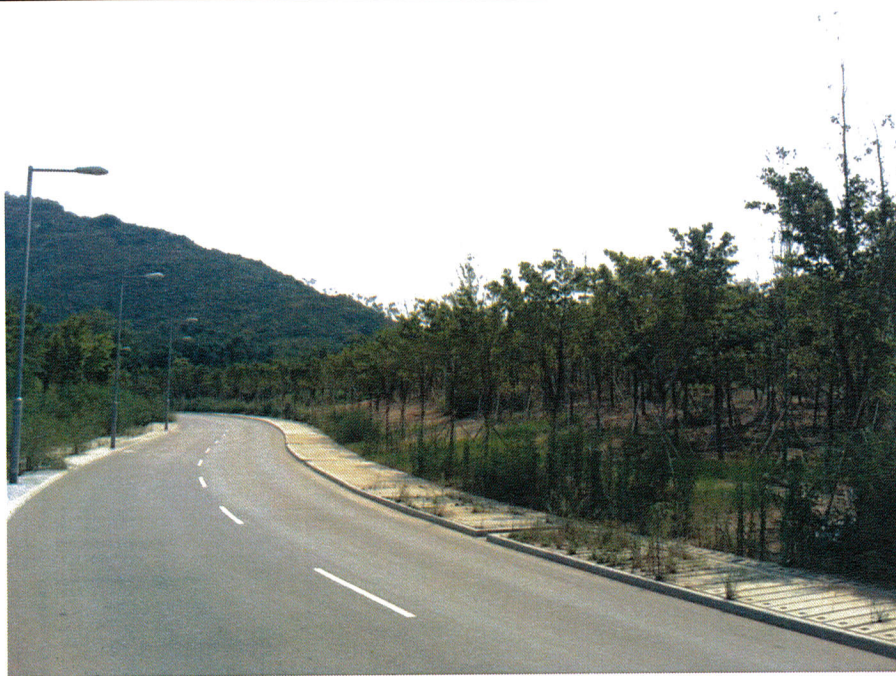
The disturbed area has been reinstated with heavy standard tree planting.  
The trees are being established

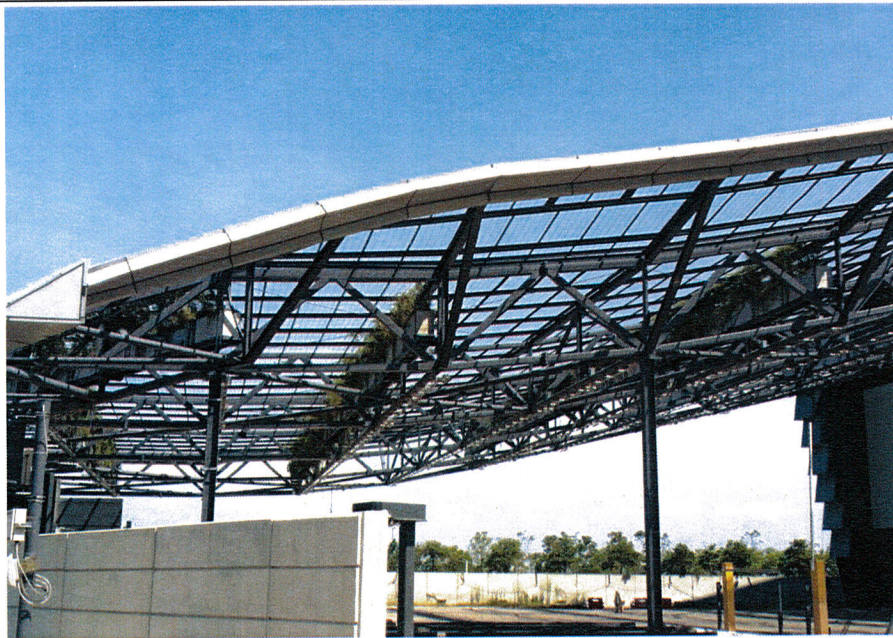
The climber planting on pergola is being established to soften edge the structural element.

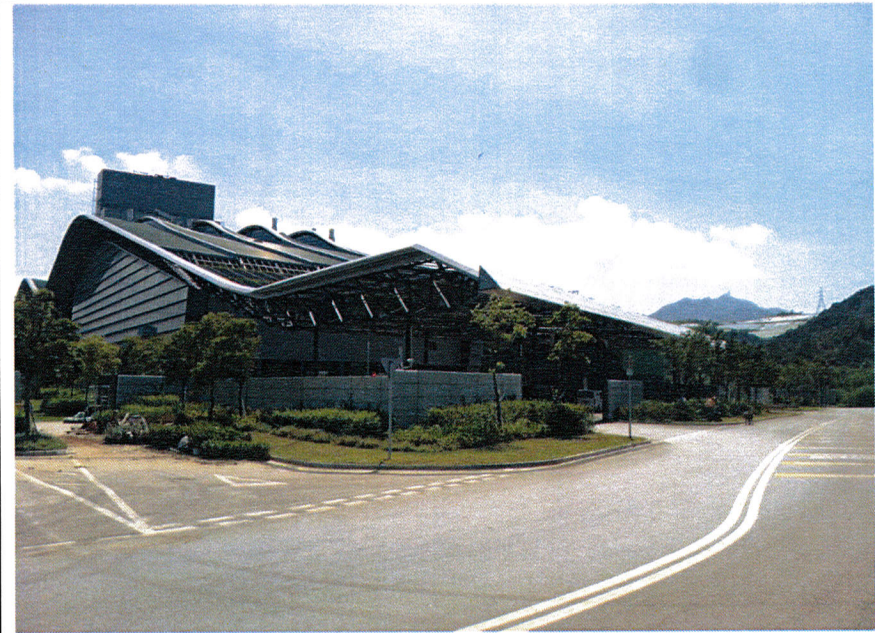
The trellis roof profile sits more sympathetically with the peaks and mounds of the surrounding mountainous terrain. The used of recessive colors results in scheme which is less visually prominent.

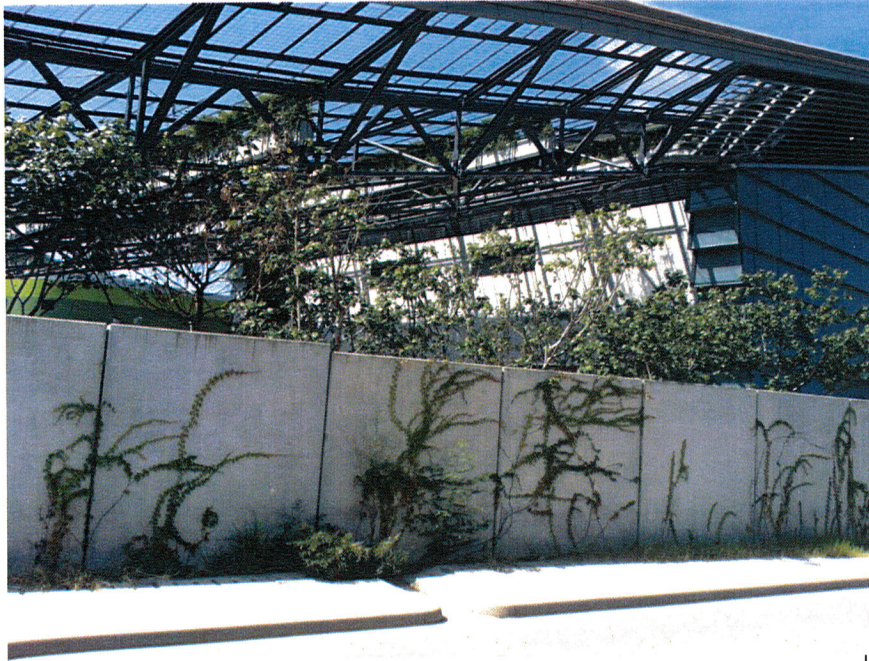
The proposed climbing planting along the boundary fence wall is being established.

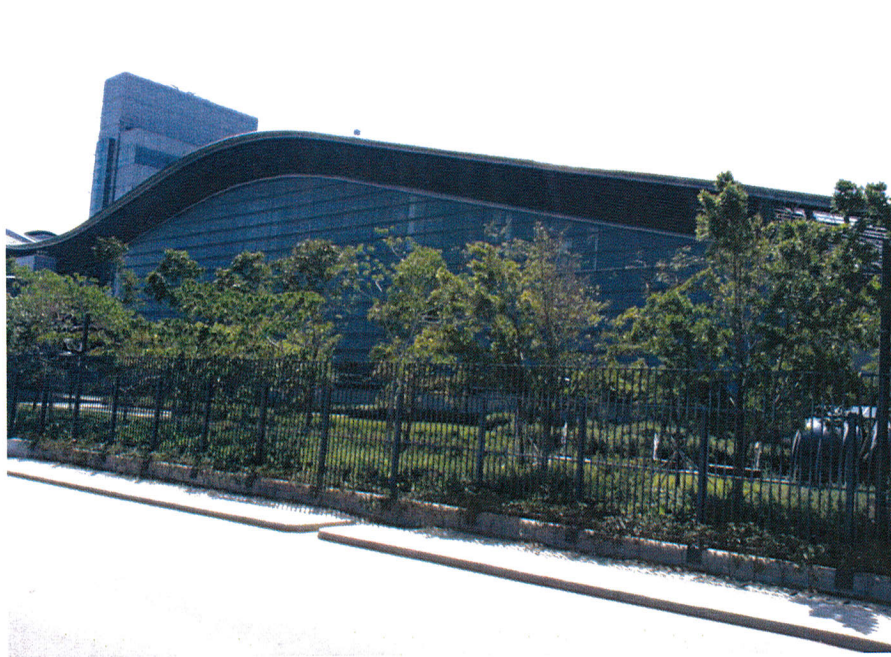
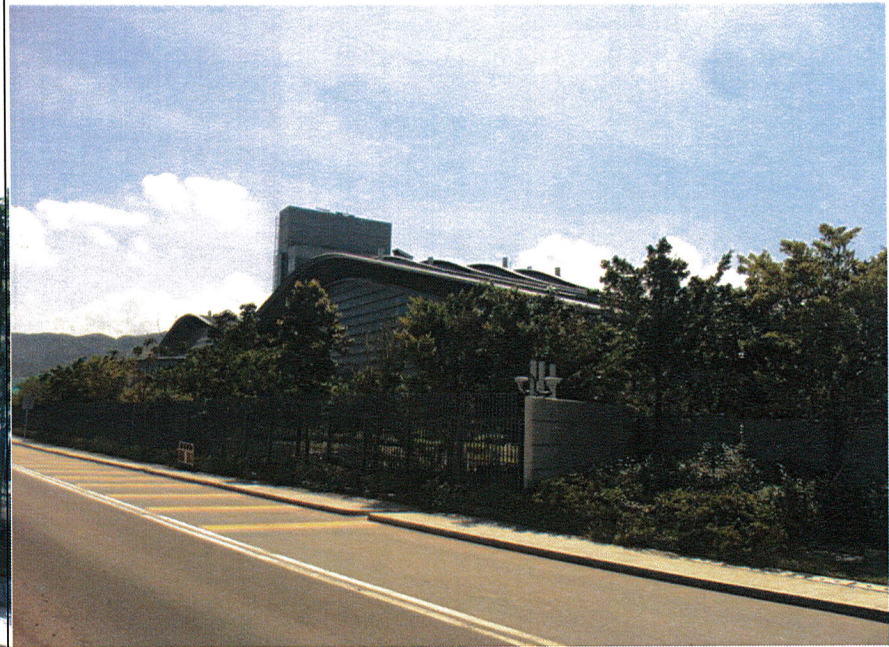
Heavy standard tree plantings have been planted and well established along the entrance road to screen the structures and enhance the environment.

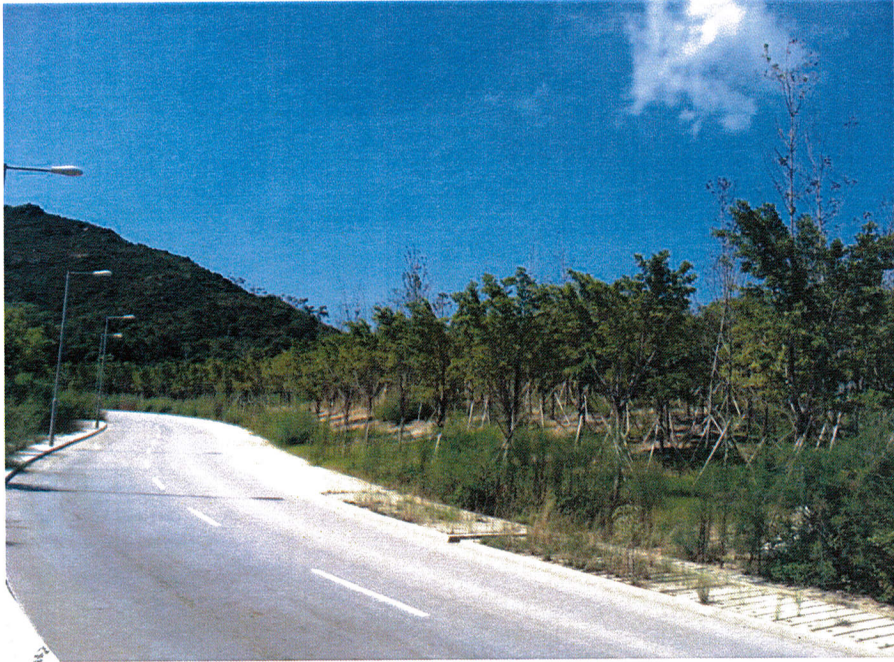
The disturbed area has been reinstated with heavy standard tree planting.  
The trees are being established

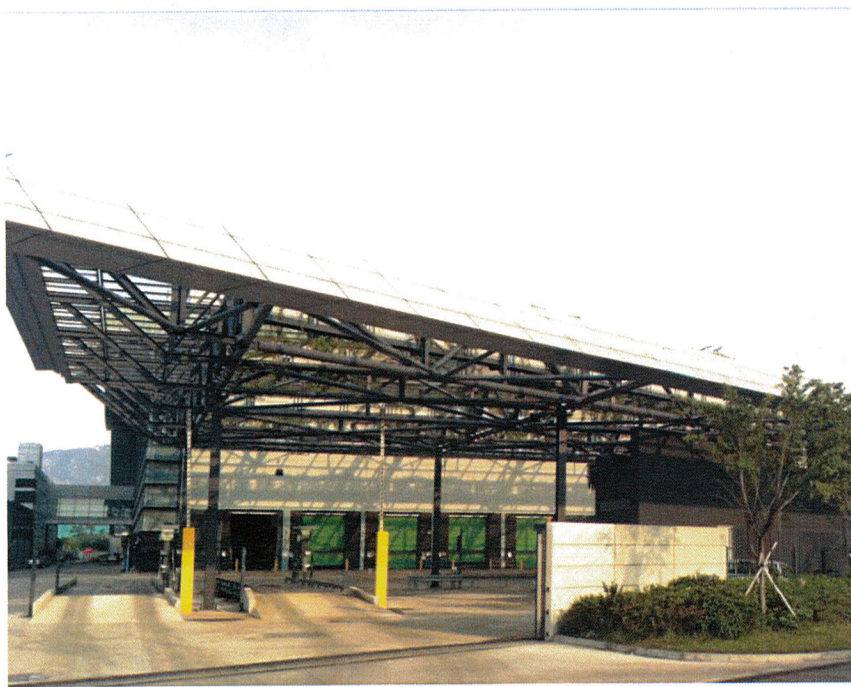
The climber planting on pergola is being established to soften edge the structural element.

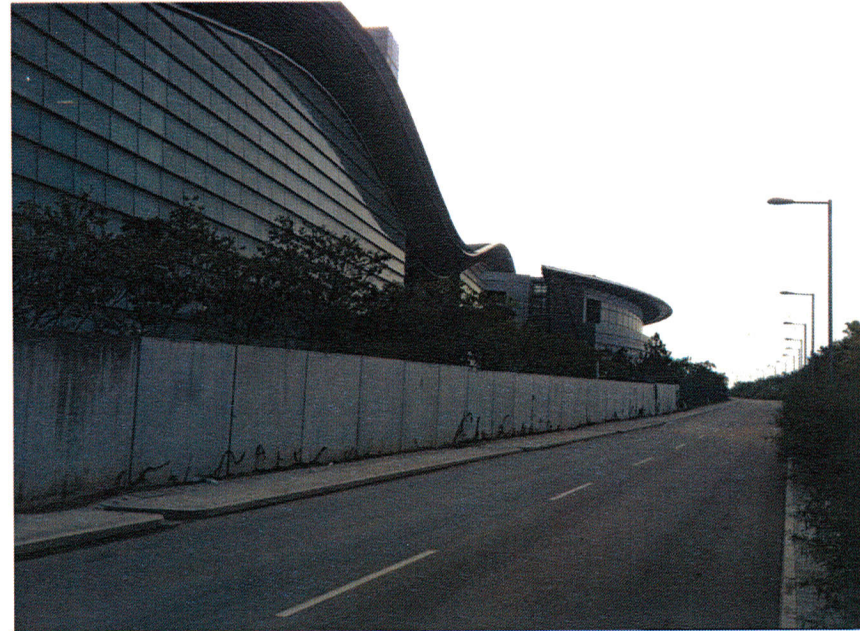
The main building is now more sinuously profiled with an elegant and pleasing form and more sympathetic to the environment. The used of recessive colors results in scheme which is less visually prominent.

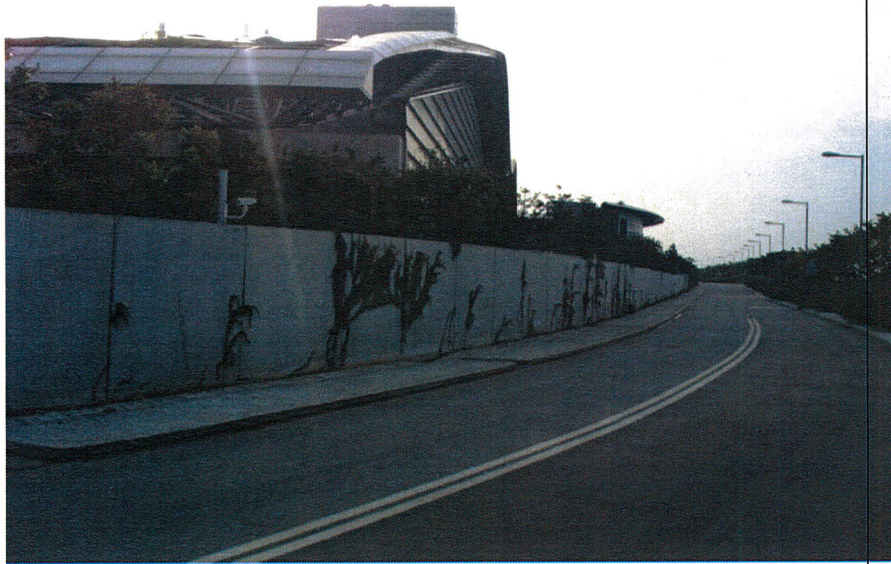
The proposed climbing planting along the boundary fence wall is being established.

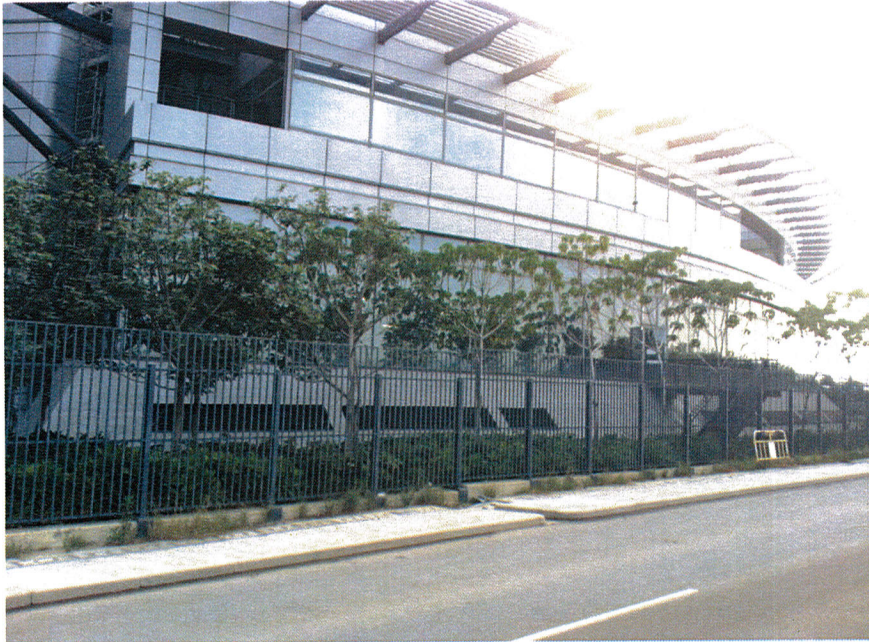
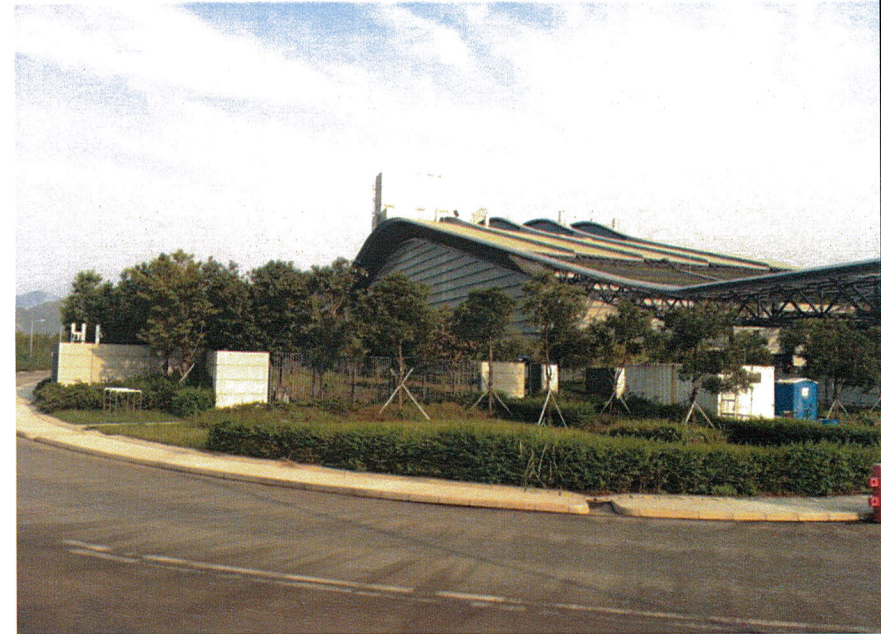
Heavy standard tree plantings have been planted and well established along the entrance road to screen the structures and enhance the environment.

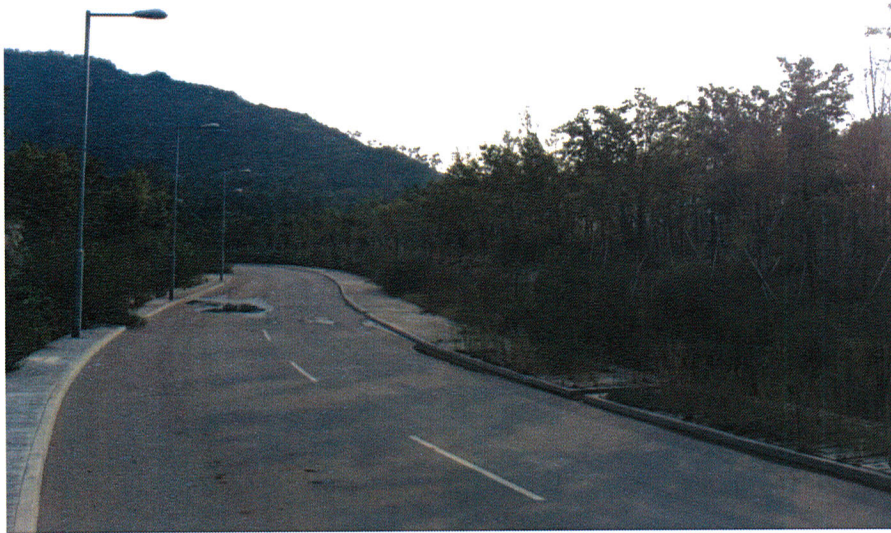
The disturbed area has been reinstated with heavy standard tree planting.  
The trees are being established

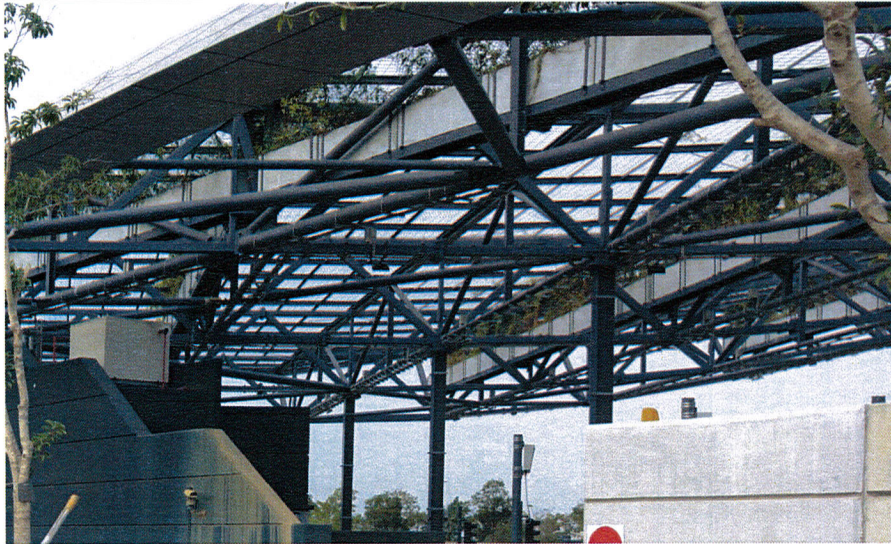
The climber planting on pergola is being established to soften edge the structural element.

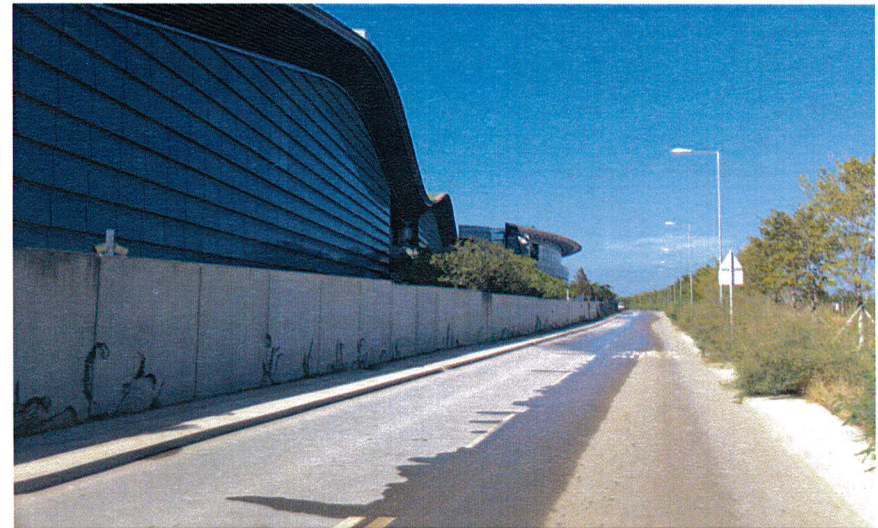
The main building is now more sinuously profiled with an elegant and pleasing form and more sympathetic to the environment. The used of recessive colors results in scheme which is less visually prominent.

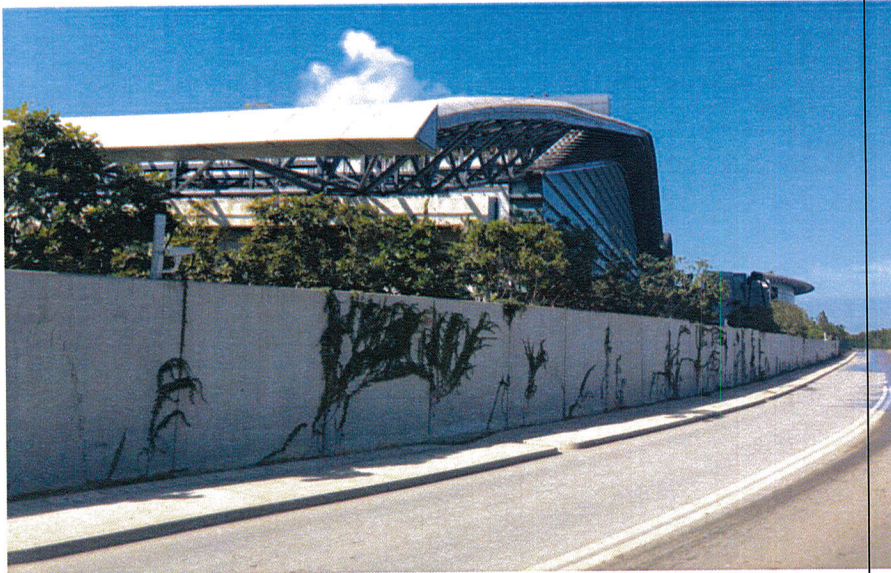
The proposed climbing planting along the boundary fence wall is being established.

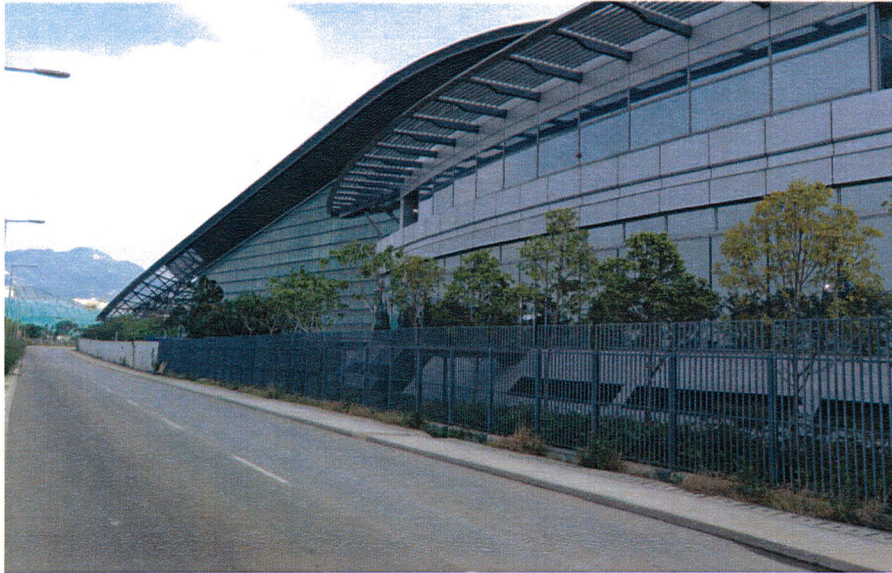
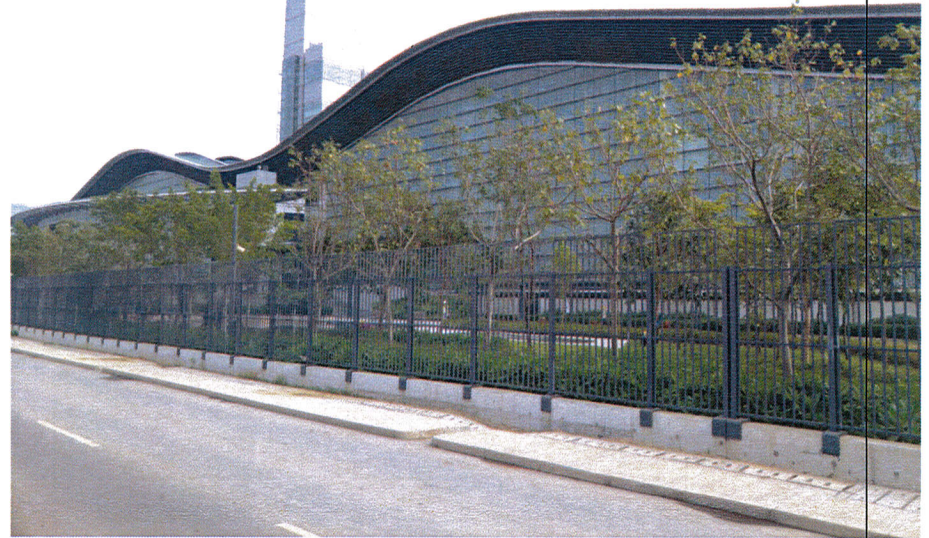
Heavy standard tree plantings have been planted and well established along the entrance road to screen the structures and enhance the environment.

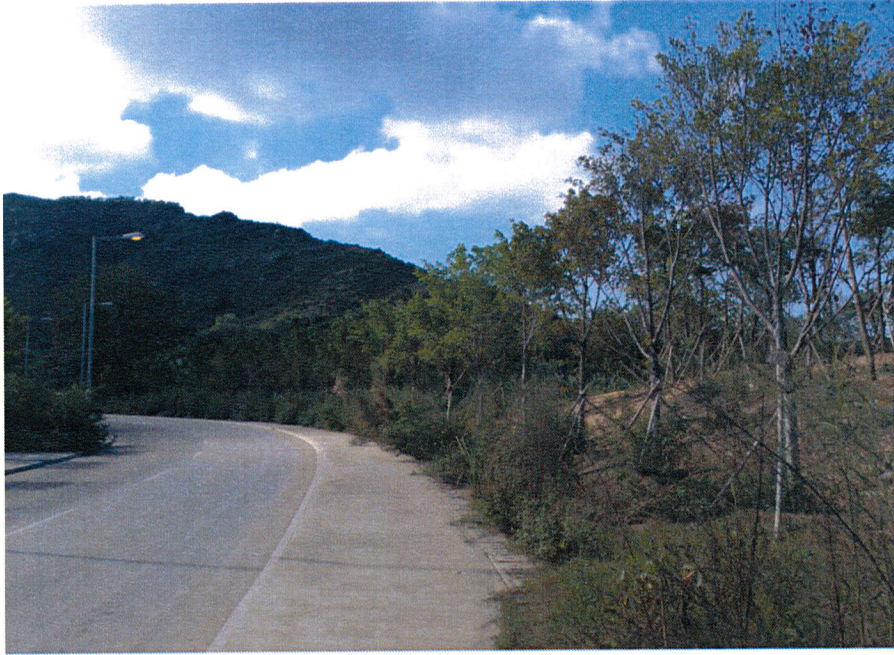
The disturbed area has been reinstated with heavy standard tree planting.  
The trees are being established

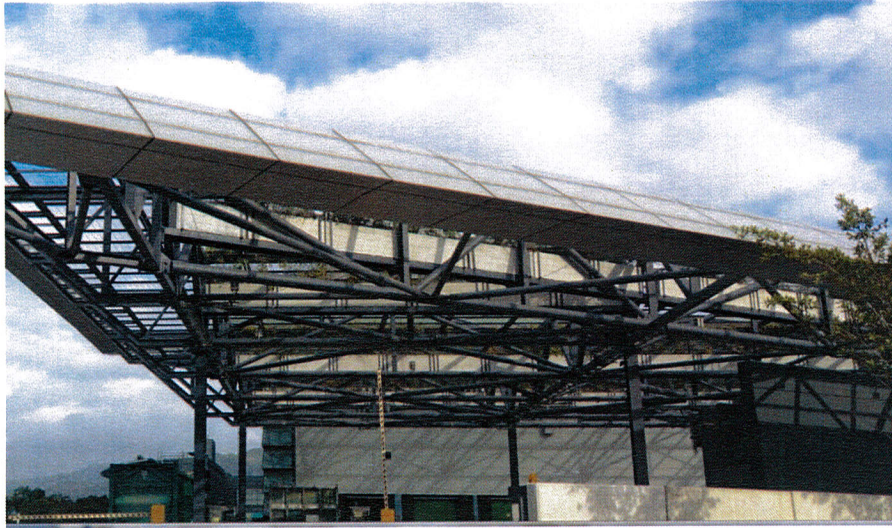
The climber planting on pergola is being established to soften edge the structural element.

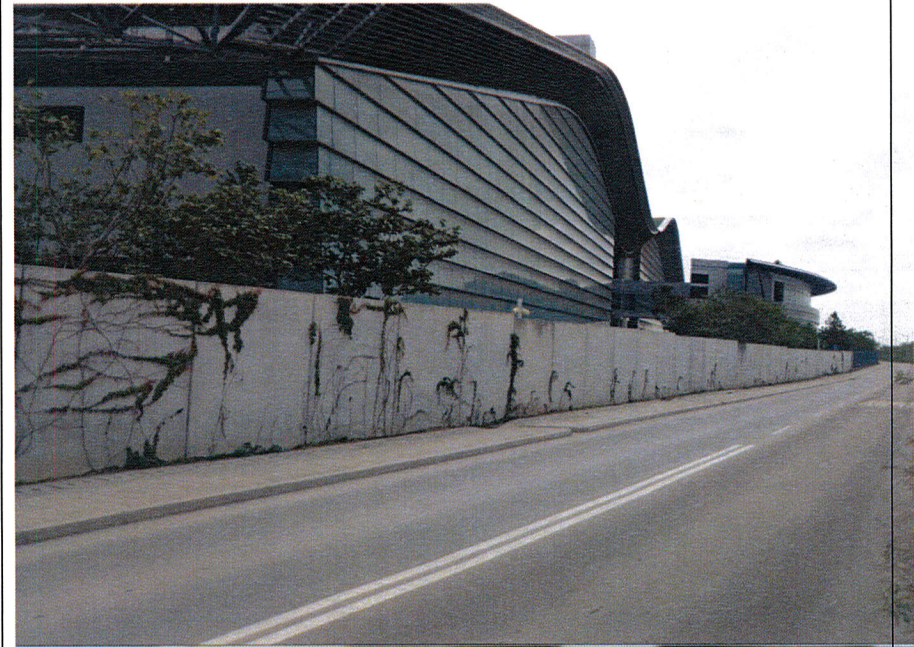
The main building is now more sinuously profiled with an elegant and pleasing form and more sympathetic to the environment. The used of recessive colors results in scheme which is less visually prominent.

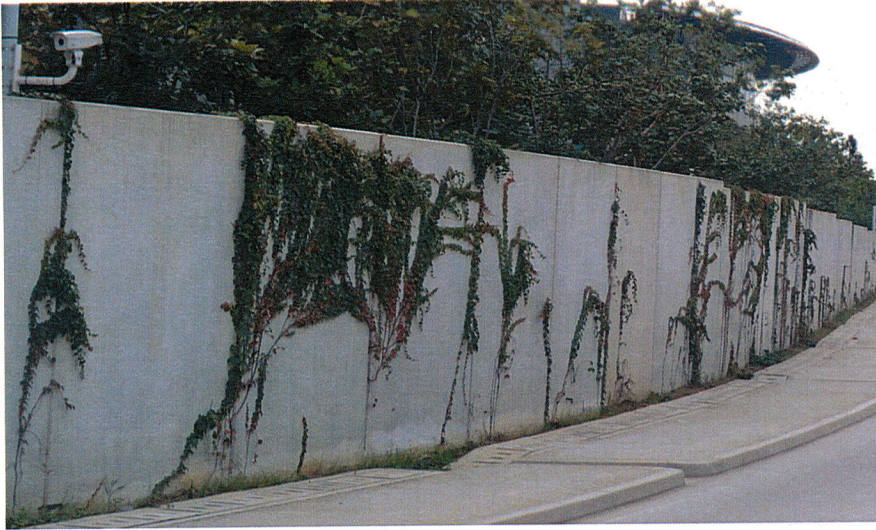
The proposed climbing planting along the boundary fence wall is being established.

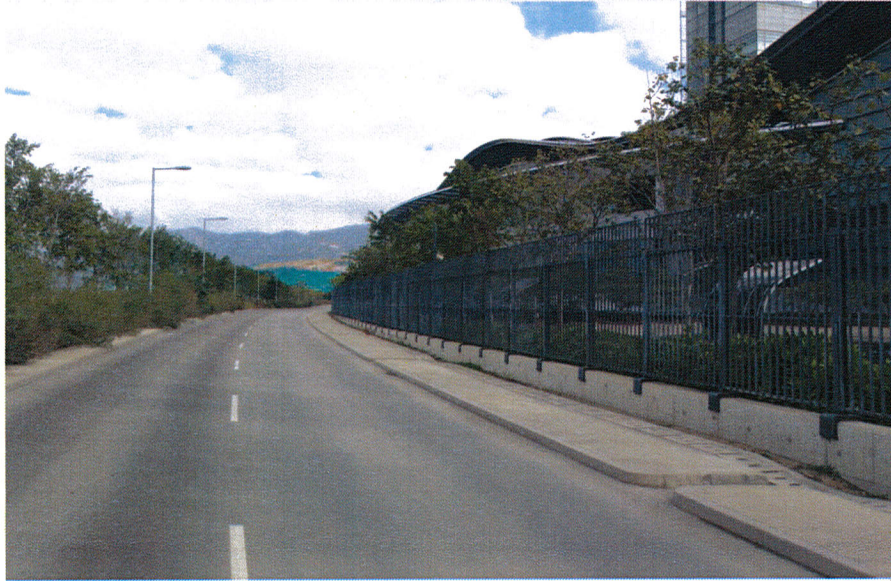
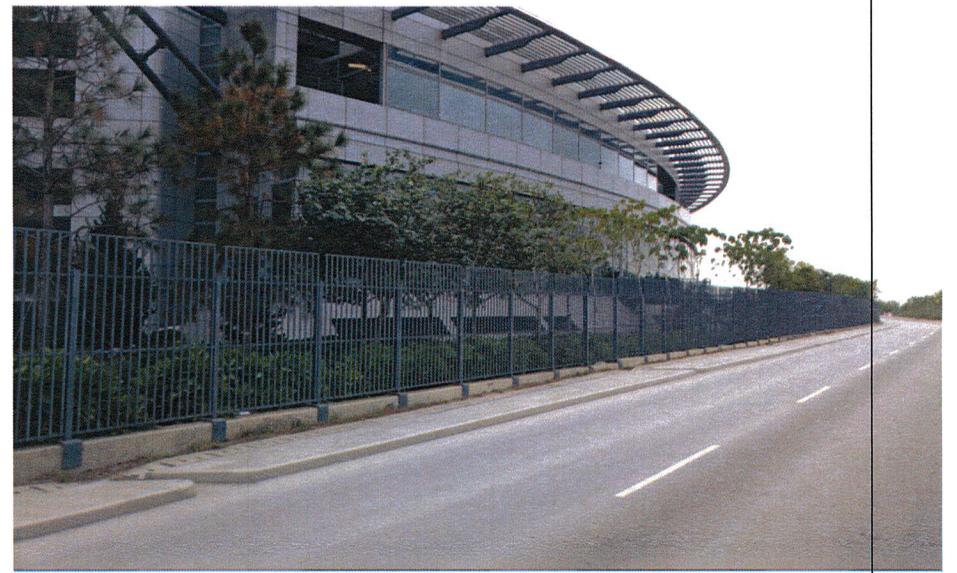
Heavy standard tree plantings have been planted and well established along the entrance road to screen the structures and enhance the environment.

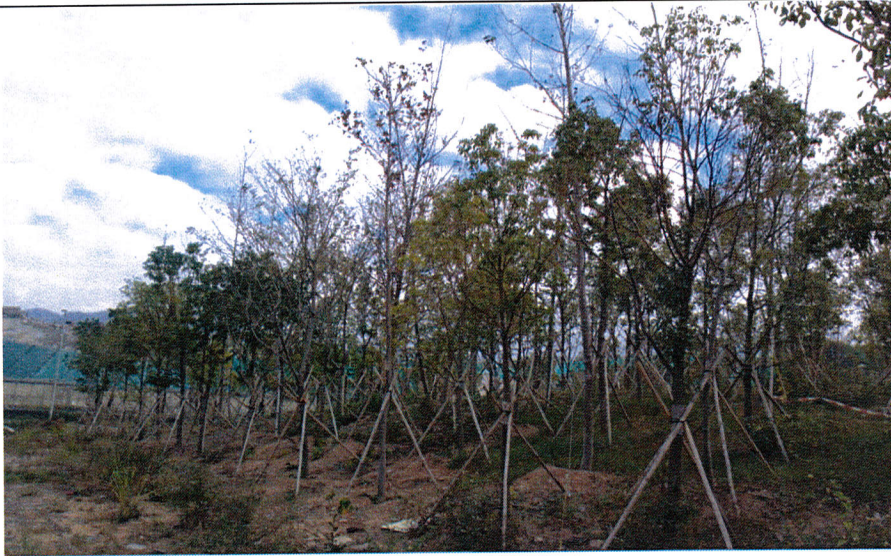
The disturbed area has been reinstated with heavy standard tree planting.  
The trees are being established

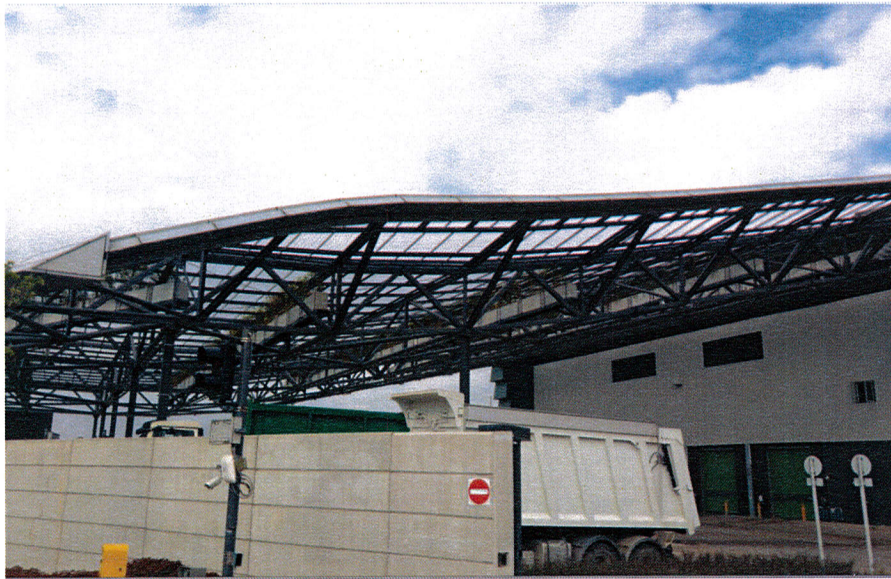
The climber planting on pergola is being established to soften edge the structural element.

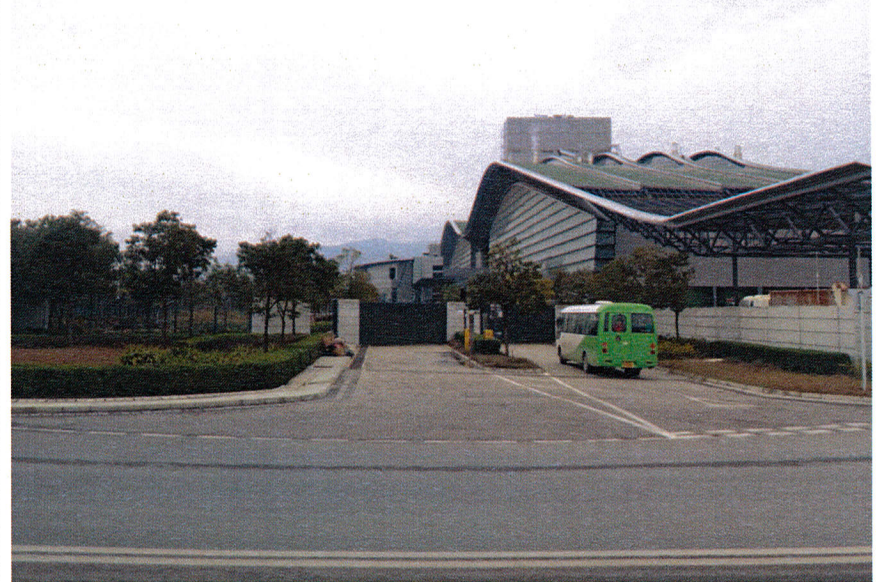
The main building is now more sinuously profiled with an elegant and pleasing form and more sympathetic to the environment. The used of recessive colors results in scheme which is less visually prominent.

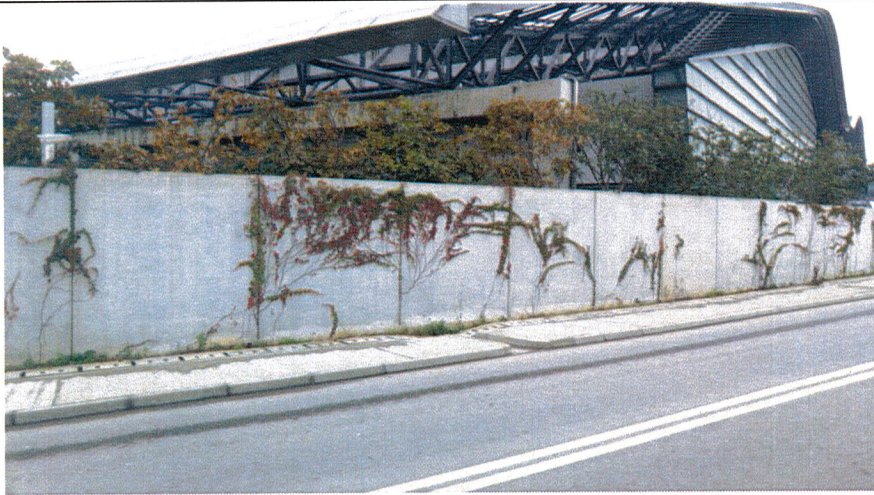
The proposed climbing planting along the boundary fence wall is being established.

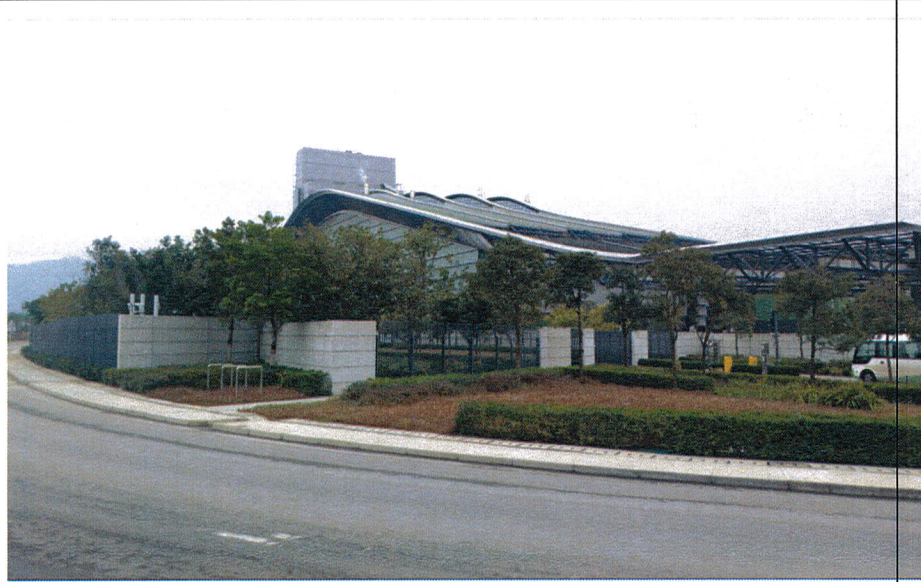
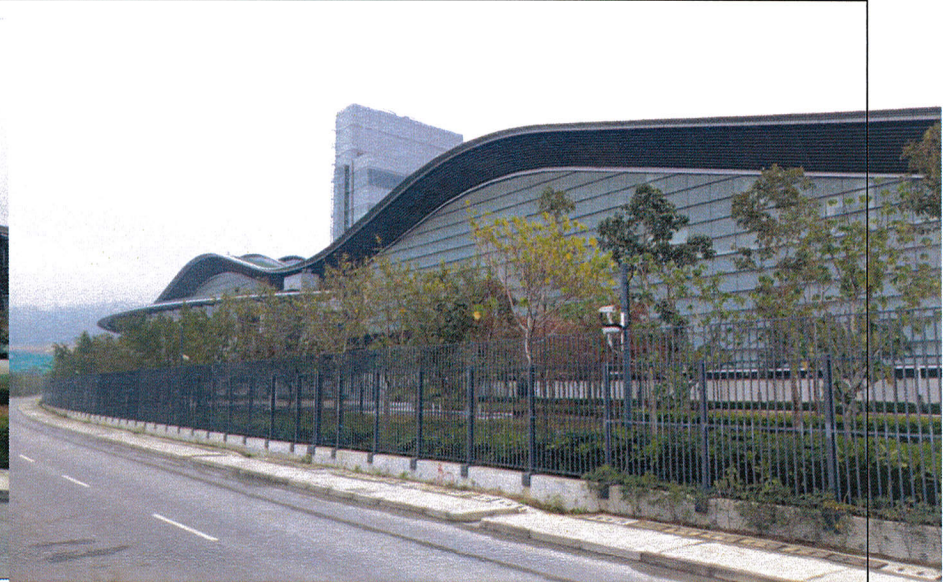
Heavy standard tree plantings have been planted and well established along the entrance road to screen the structures and enhance the environment.
