**Monthly EM & A Record for Landscape and Visual Impact**  
**(July 2015)**

Prepared By:  
**ADI Limited**

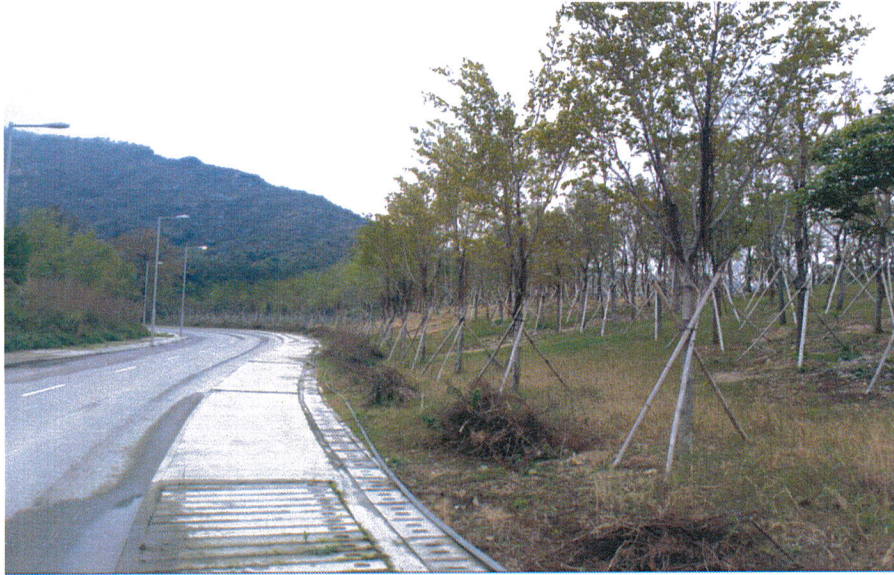
The disturbed area has been reinstated with heavy standard tree planting.  
The trees are being established

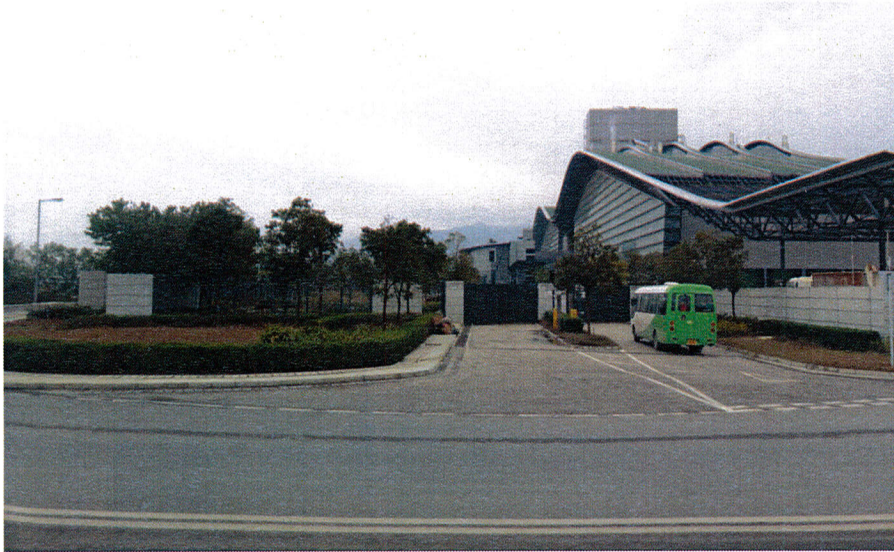
The main building is now more sinuously profiled with an elegant and pleasing form and more sympathetic to the environment. The used of recessive colors results in scheme which is less visually prominent.

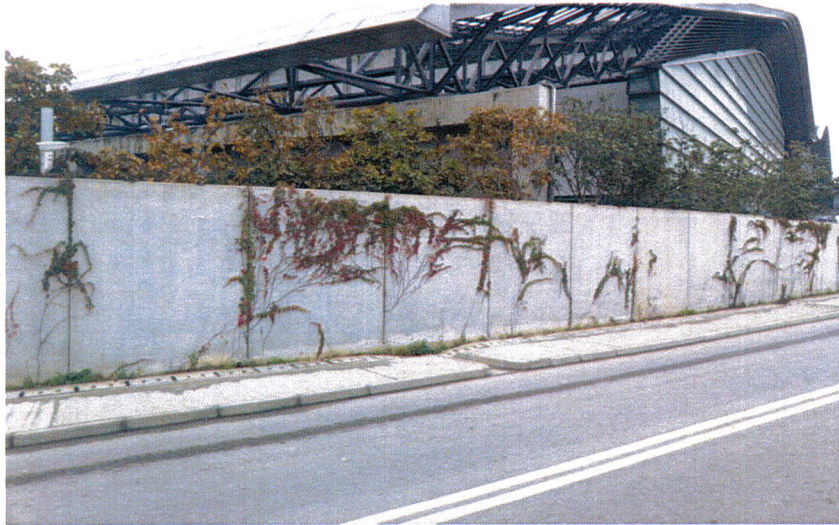
The proposed climbing planting along the boundary fence wall is being established.

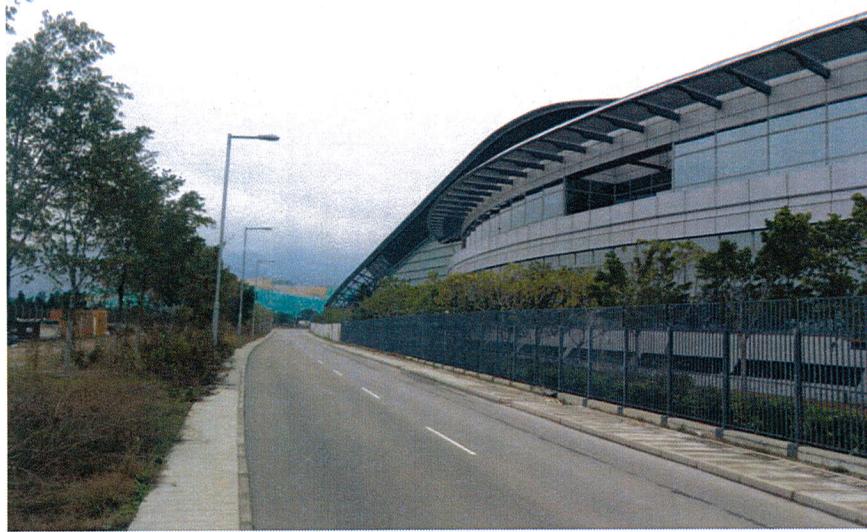
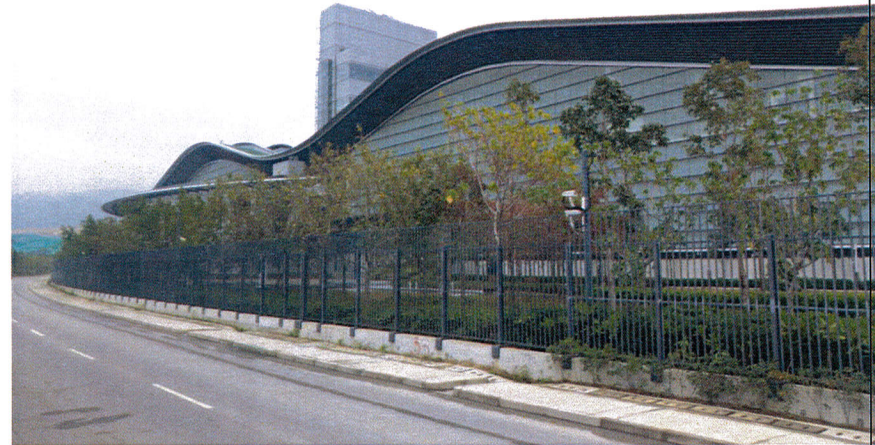
Heavy standard tree plantings have been planted and well established along the entrance road to screen the structures and enhance the environment.

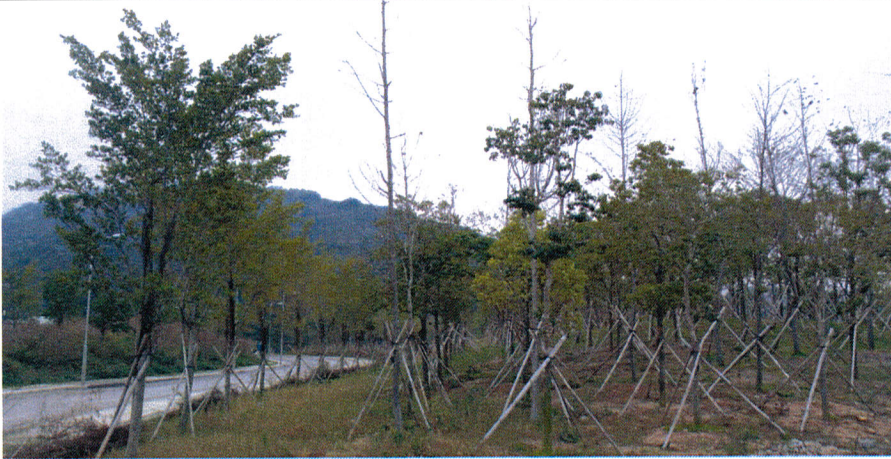
The disturbed area has been reinstated with heavy standard tree planting.  
The trees are being established

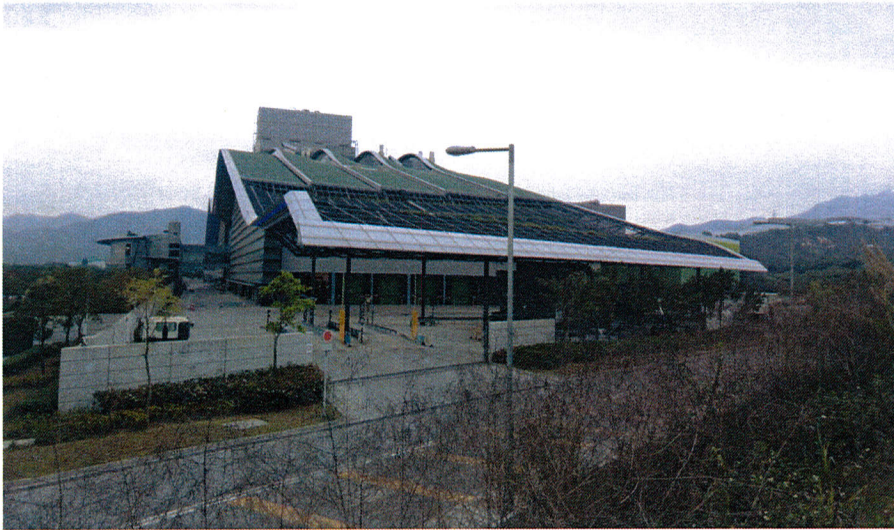
The trellis roof profile sits more sympathetically with the peaks and mounds of the surrounding mountainous terrain. The used of recessive colors results in scheme which is less visually prominent.

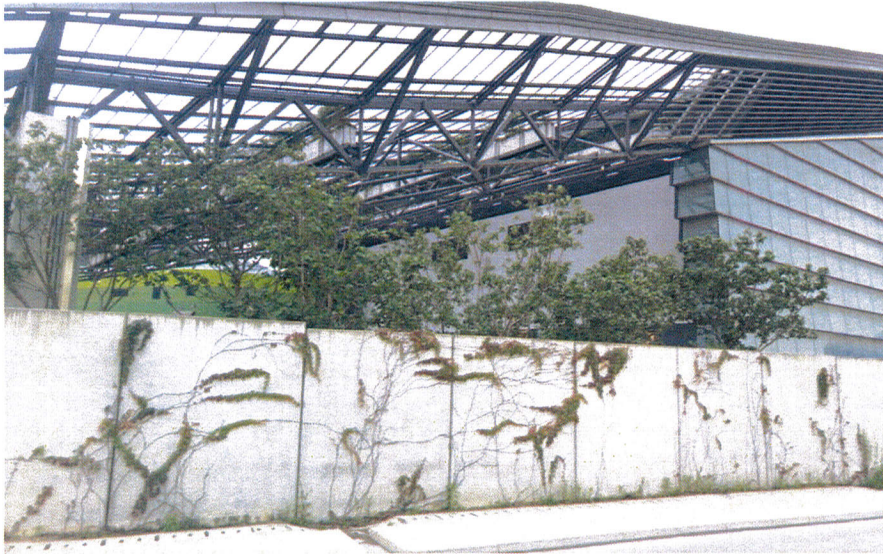
The proposed climbing planting along the boundary fence wall is being established.

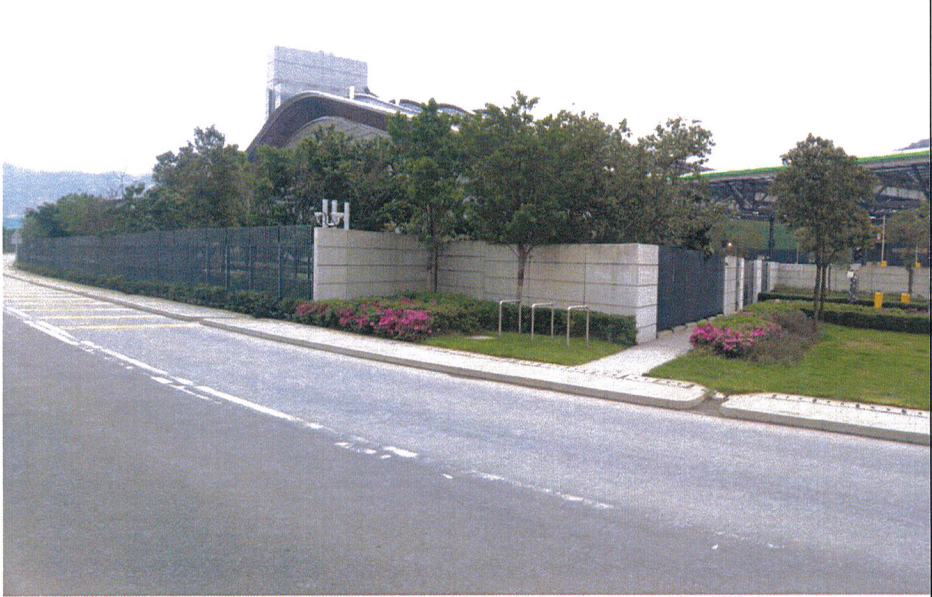
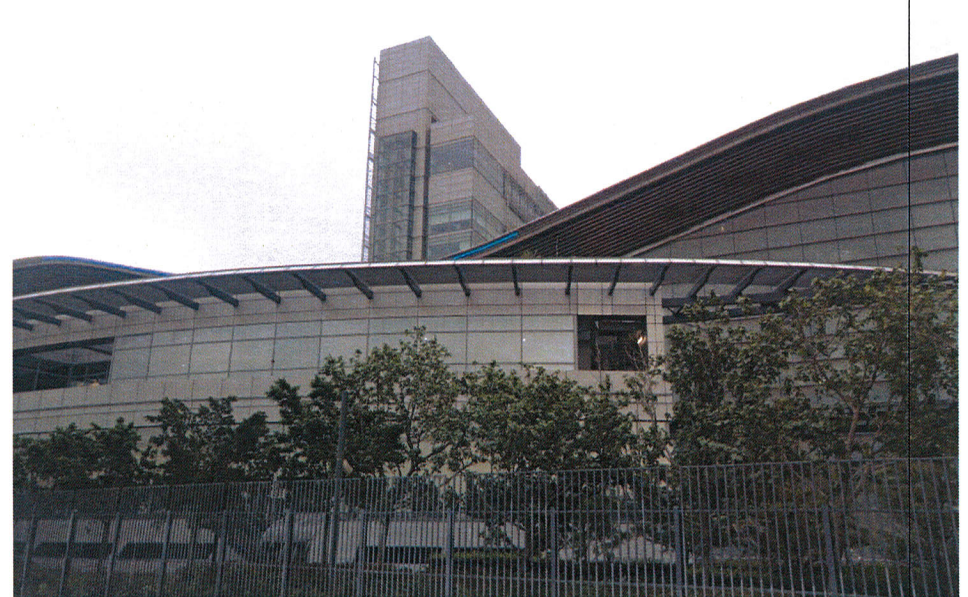
Heavy standard tree plantings have been planted and well established along the entrance road to screen the structures and enhance the environment.

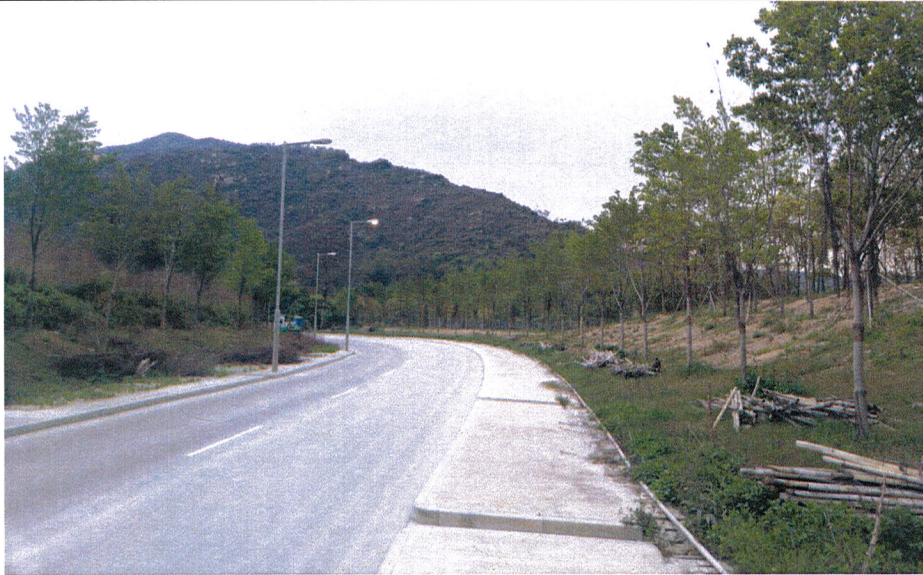
The disturbed area has been reinstated with heavy standard tree planting.  
The trees are being established

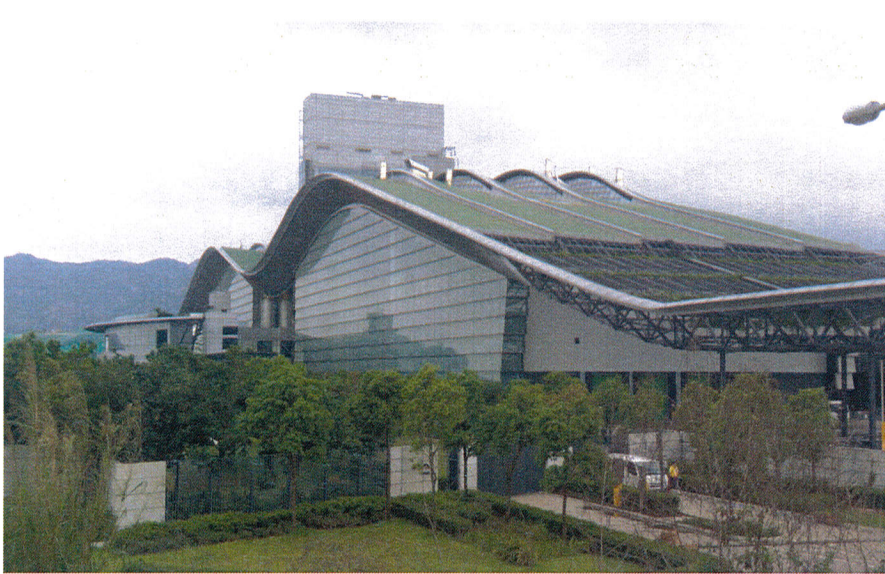
The trellis roof profile sits more sympathetically with the peaks and mounds of the surrounding mountainous terrain. The used of recessive colors results in scheme which is less visually prominent.

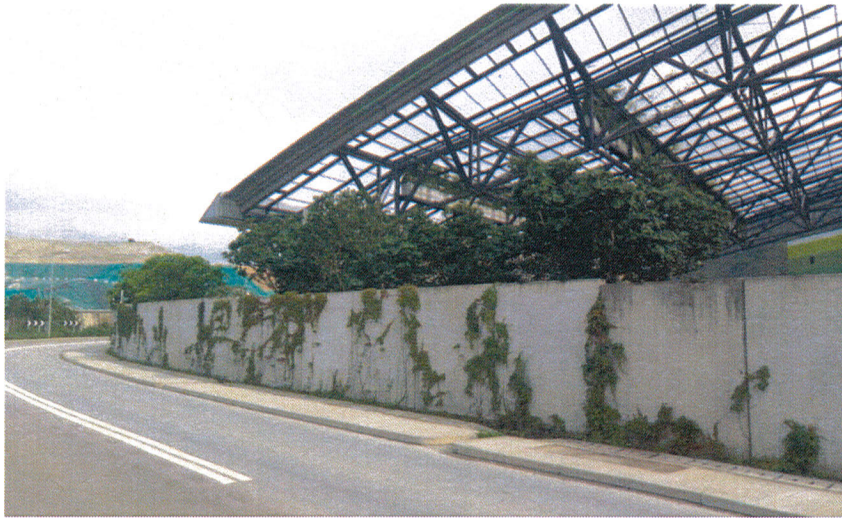
The proposed climbing planting along the boundary fence wall is being established.

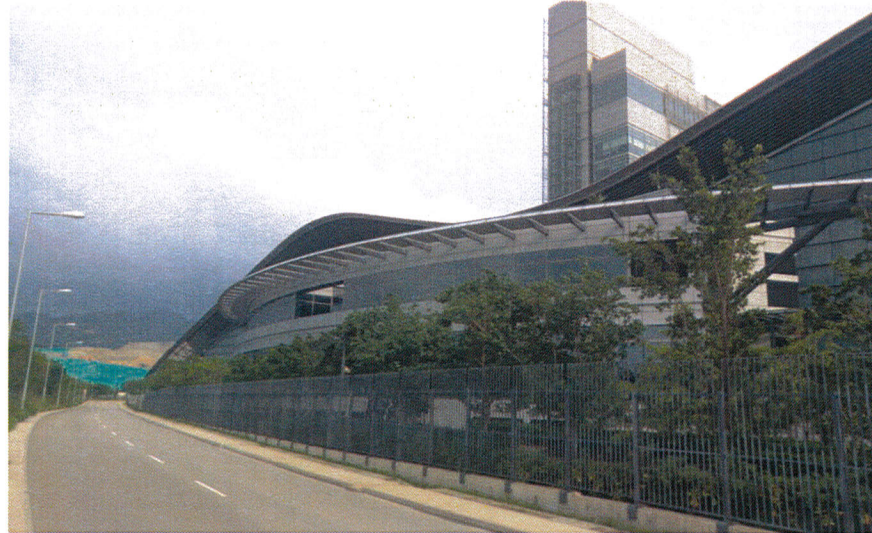
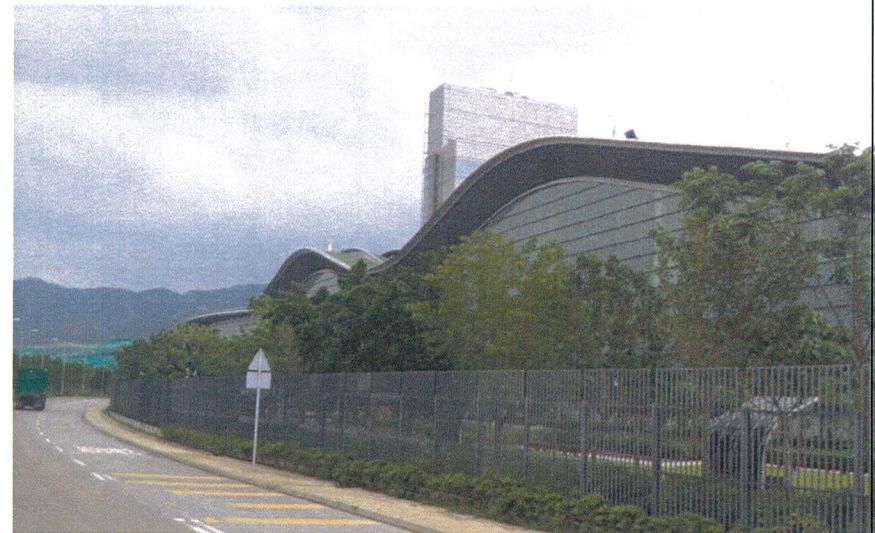
Heavy standard tree plantings have been planted and well established along the entrance road to screen the structures and enhance the environment.

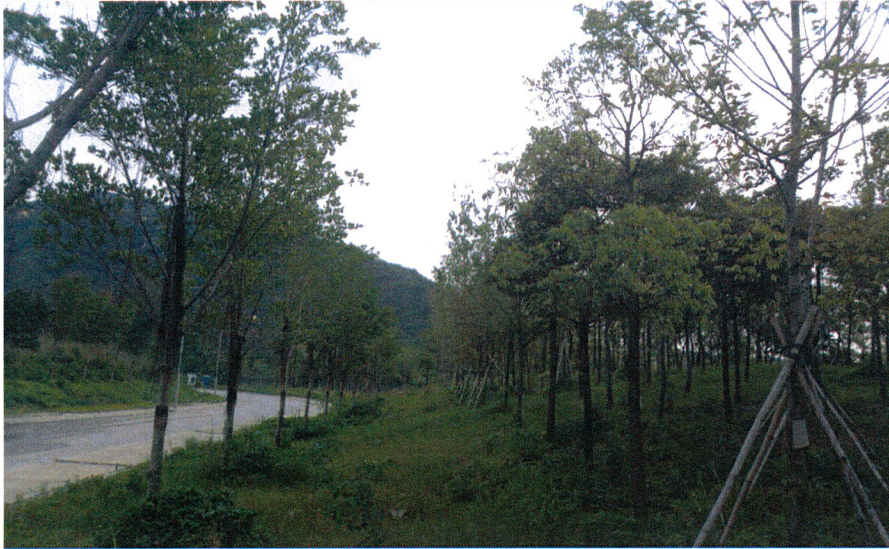
The disturbed area has been reinstated with heavy standard tree planting.

The trees are well established
