**Contract No. EP/SP/58/08 – Sludge Treatment Facilities
Environmental Monitoring Results in Operation Phase – Landscape and Visual Impact
Monitoring Reports – May 2016**

Monthly EM & A Record for Landscape and Visual Impact

(May 2016)

Table 1.1 Record of Implementation of the Proposed Landscape and Visual Mitigation Measures in Operation Phase (May 2016)

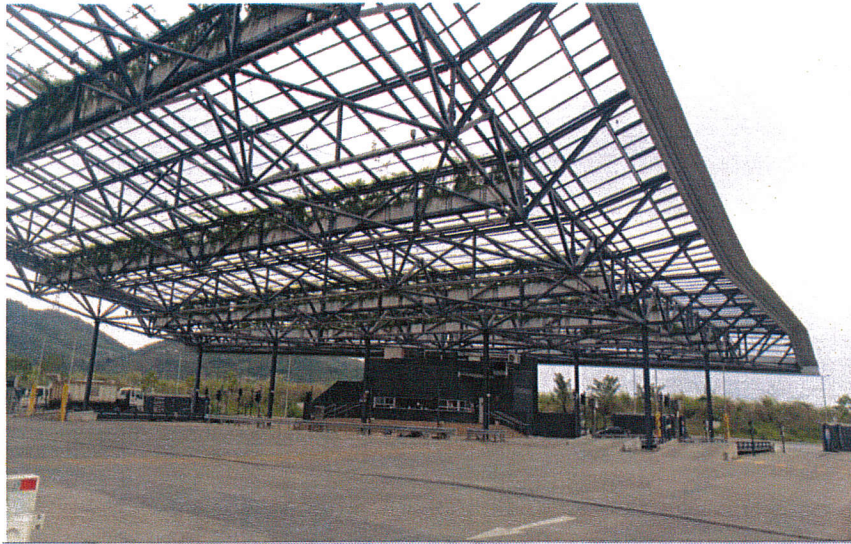
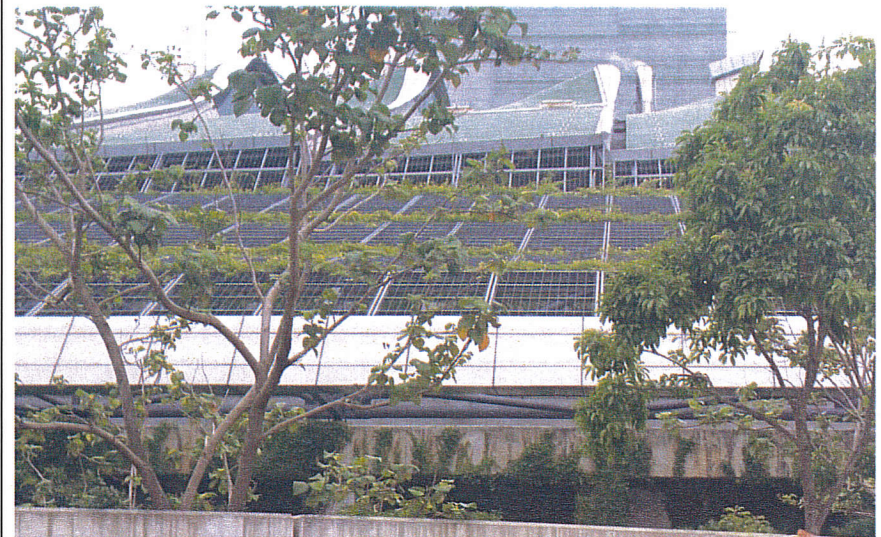
1. Photographic record of main building and climber planting on pergola

The climber planting on pergola is well established and provides a greening effect on the roof.

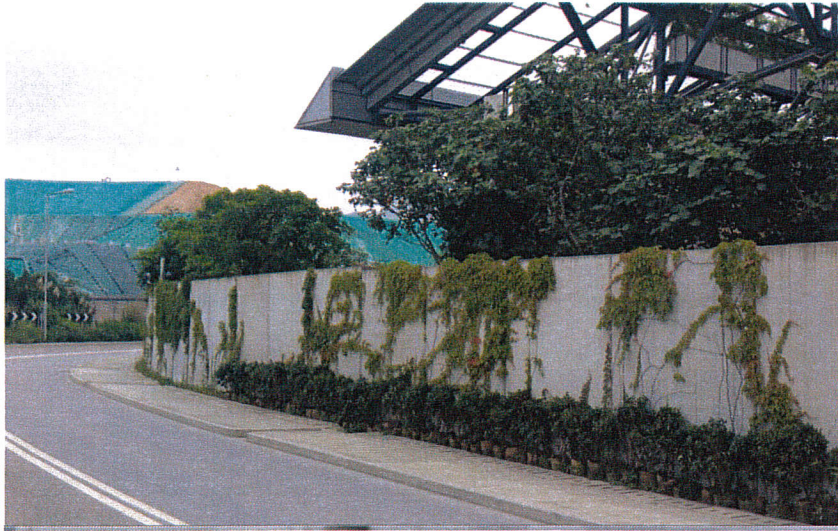
2. Photographic record of climbing planting

The proposed climbing planting along the boundary fence wall is well established, and provide a green screening effect together with tree planting within the site area and shrub planting at the bottom of the fence wall.

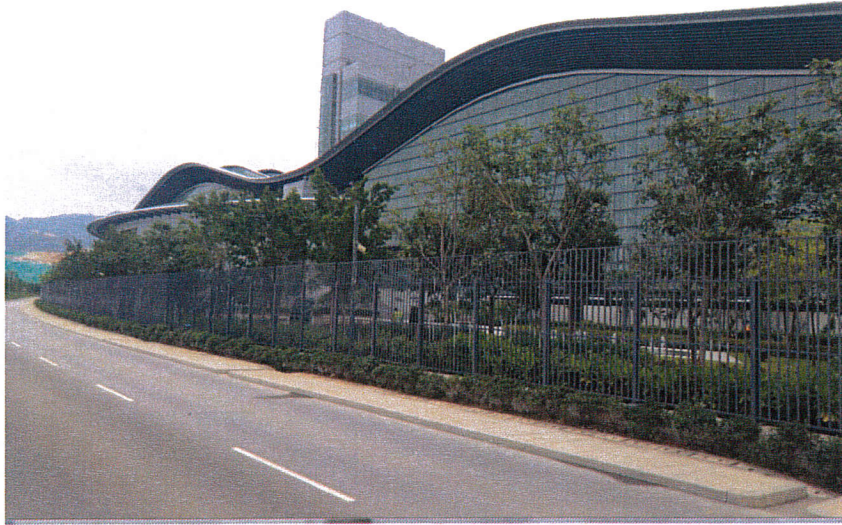
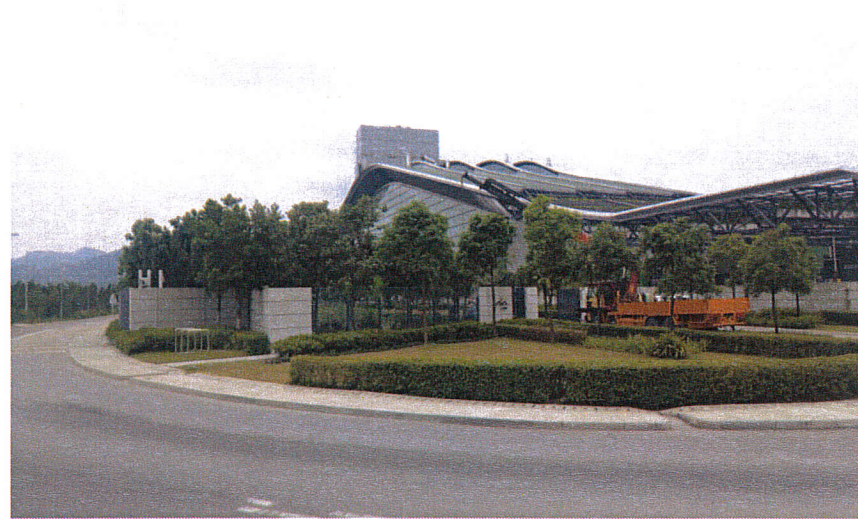
3. Photographic record of the buffer trees

Heavy standard tree plantings have been planted and well established along the entrance road to screen the structures and enhance the environment.

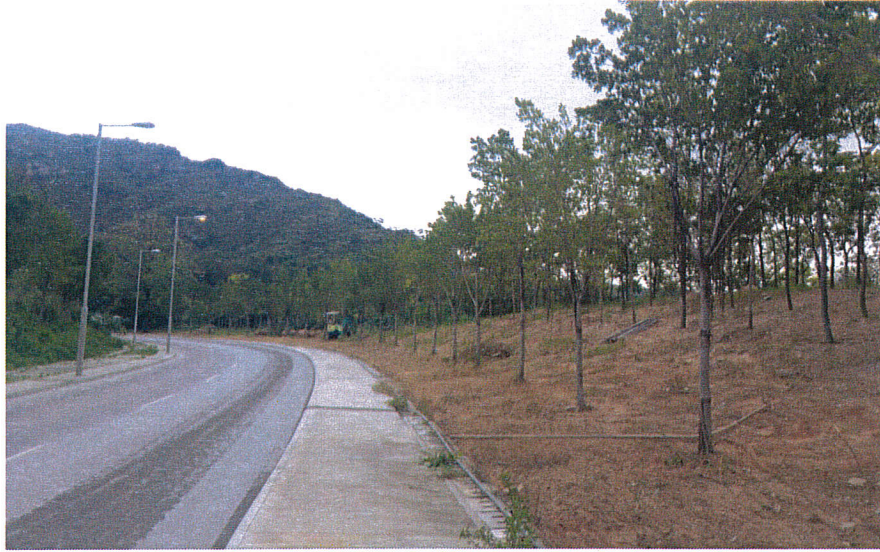
4. Photographic record of reinstated area

The disturbed area has been reinstated with heavy standard tree planting.
The trees are well established
