Contract No. HY/2013/01
Hong Kong – Zhuhai – Macao Bridge
Hong Kong Boundary Crossing Facilities – Passenger Clearance Building
Certification of Quarterly EM&A Report No. 16

**Contract No. HY/2013/01
HZMB HKBCF – Passenger Clearance Building
Quarterly EM&A Report No. 16 for June 2018 to August 2018**

Contract No. HY/2013/01

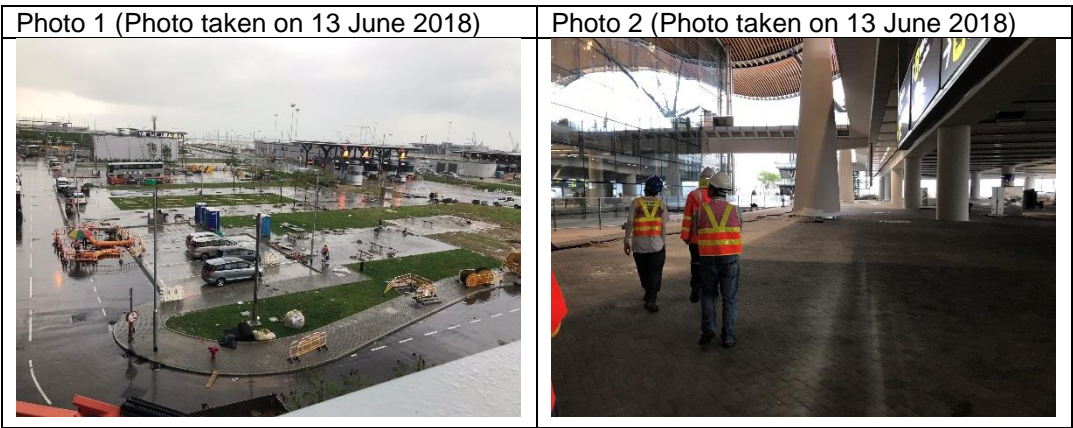
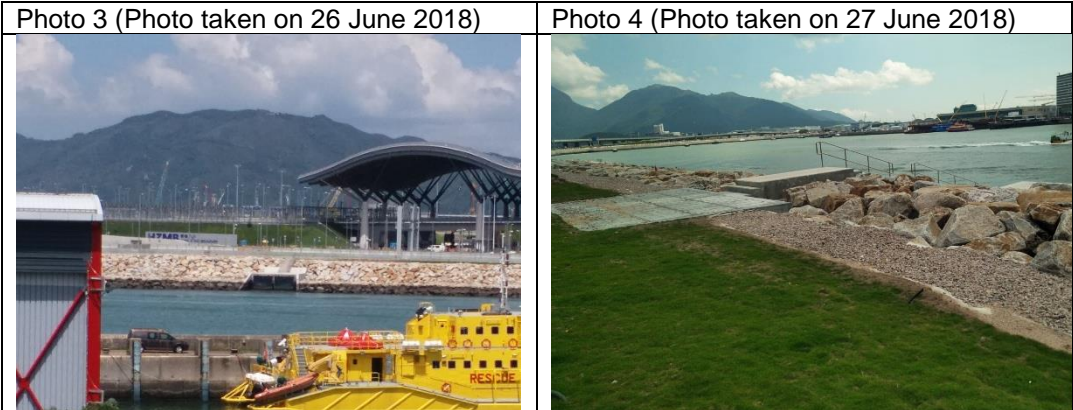
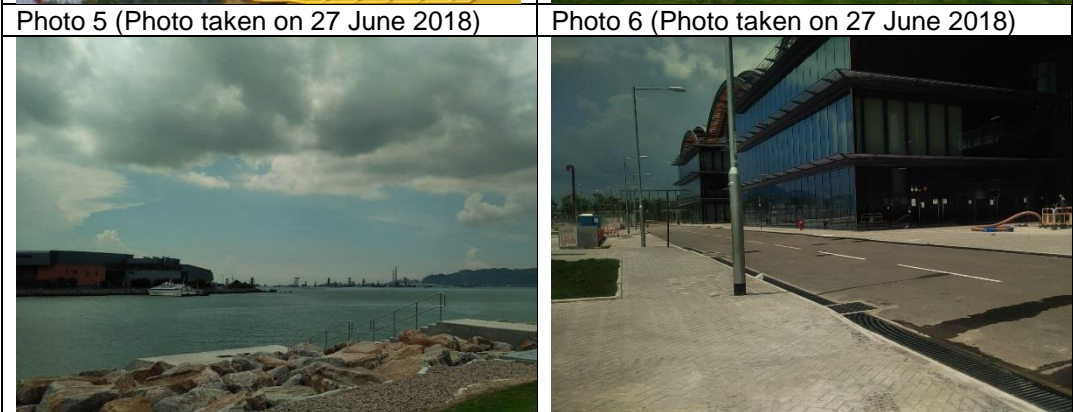
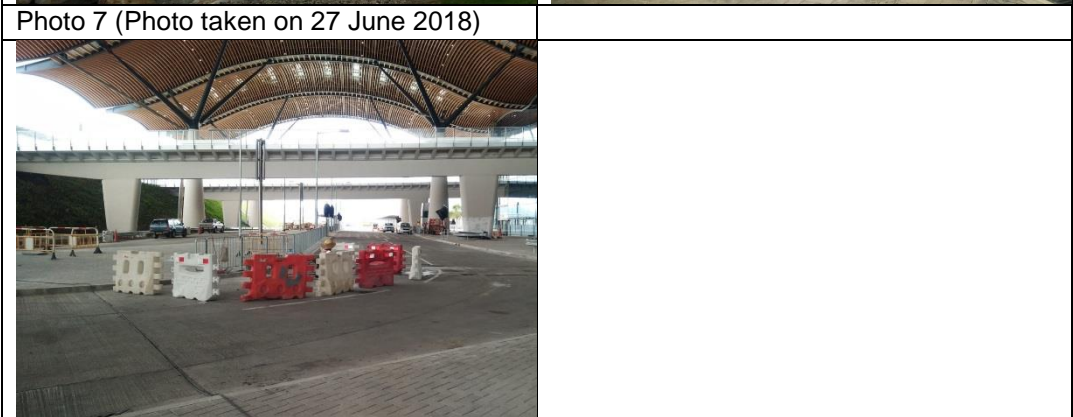
The site investigation was conducted on 26 and 27 June 2018. No muddy water was found near Box Culvert A (Photo 3 to Photo 7). Domestic sewage arising from domestic cleaning was being discharged to domestic sewer which connect to government sewer. The locations where the photos taken are shown in Figure 1.

Based on the investigation results, it is found that the complaint is not related to Contract No. HY/2013/01. No follow up action is required.
