**Contract No. HY/2011/03**

**Hong Kong-Zhuhai-Macao Bridge Hong Kong Link Road  
Section between Scenic Hill and Hong Kong Boundary Crossing  
Facilities**

**Monthly EM&A Report No.105 (June 2021)**

13 July 2021

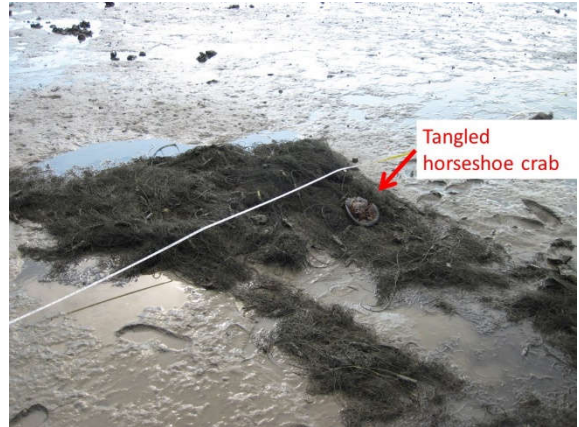
**Figure 2.3** *Examples of photographic record of the big trashes found on the mudflat.*

- 6.3.2 Since the field survey of June 2016, increasing number of trashes and even big trashes (**Figure 2.3 of Appendix I**) were found in every sampling zone. It raised a concern about the solid waste dumping and current-driven waste issues in Tung Chung Wan. Respective measures (e.g. manual clean-up) should be implemented by responsible governmental agency units.

A tangled horseshoe crab on a trash net (record in June 2017)

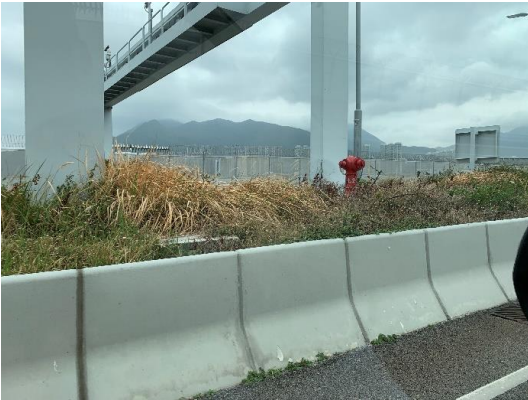
Location	Photo Record		
<p>HyD – Along Expressway of HKLR</p>	<p>Photo P1 - Serious weeds affecting planted species were observed.</p>

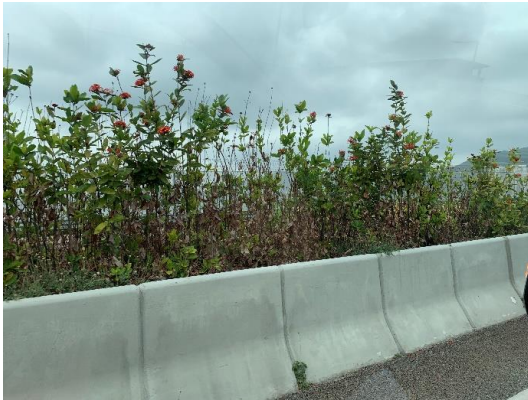
<p>Photo P2 - Plants with unsatisfied condition (i.e. unhealthy plants) were observed.</p>

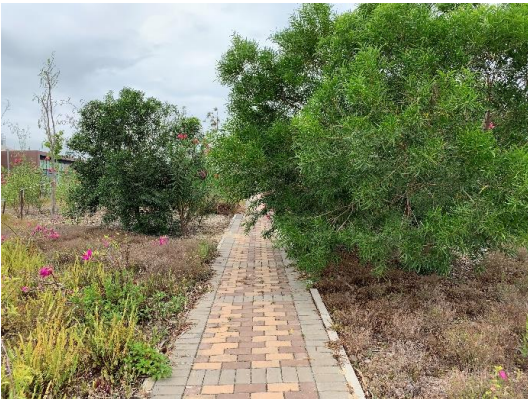
<p>LCSD – Above Tunnel SHT East Portal</p>	<p>Photo P3 - Overhanging branches were observed.</p>

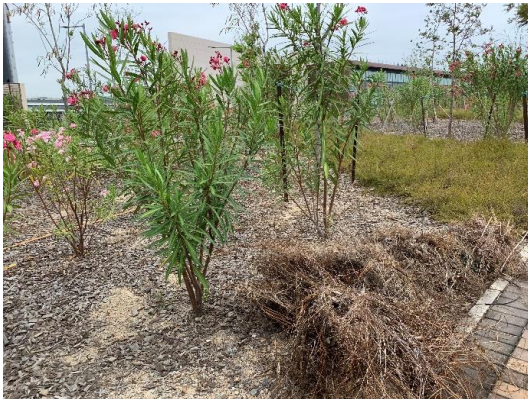
<p>Photo P4 - Plant debris were observed at the site.</p>

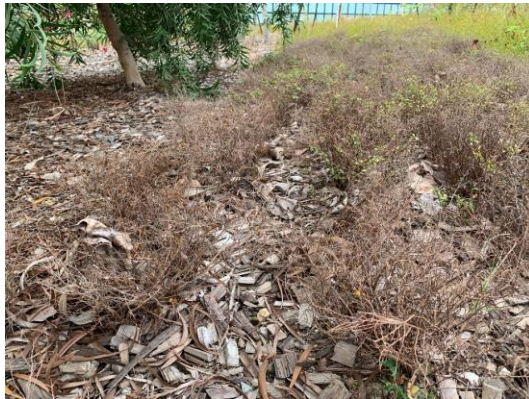
<p>Photo P5 - Plants with unsatisfied condition (i.e. unhealthy plants) were observed.</p>

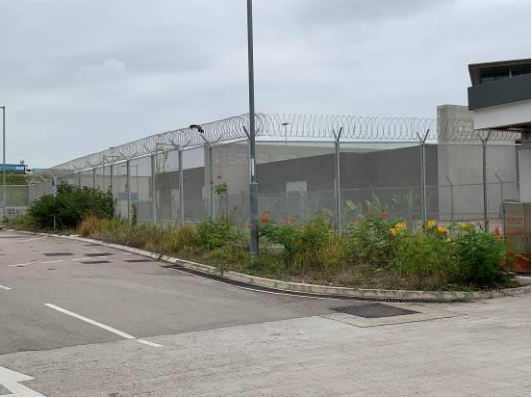
<p>TD / Others – Next to HMA Admiration Building</p>	<p>Photo P6 - Serious weeds affecting planted species were observed.</p>

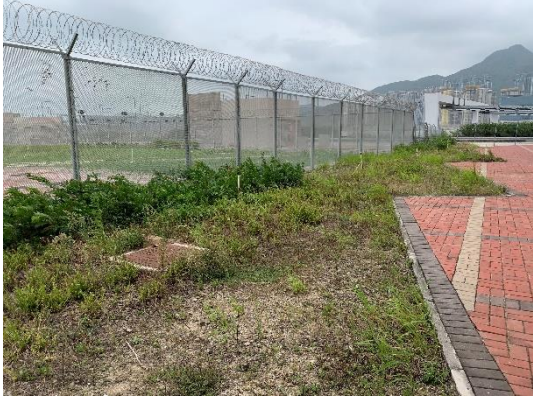
<p>Photo P7 - Plants with unsatisfied condition were observed.</p>

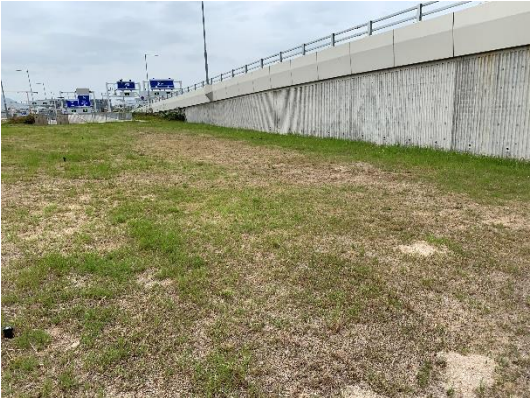
<p>AAHK – Along Airport Road</p>	<p>Photo P8 - Plants with unsatisfied condition were observed.</p>

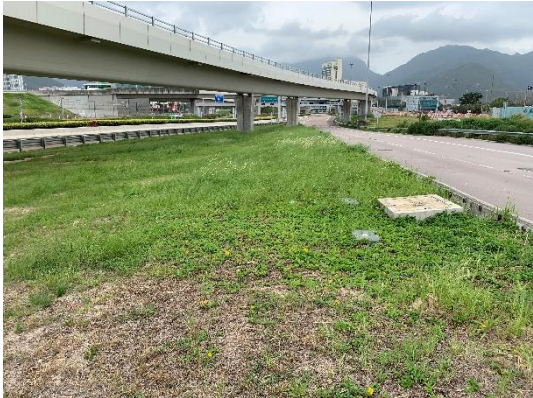
<p>Photo P9 - Serious weeds affecting planted species were observed.</p>
