Central Police Station Conservation
and Revitalisation Project:
5th Annual EM&A Review Report
(1 November 2015 to 31 October
2016)

Issue Date: May 2017

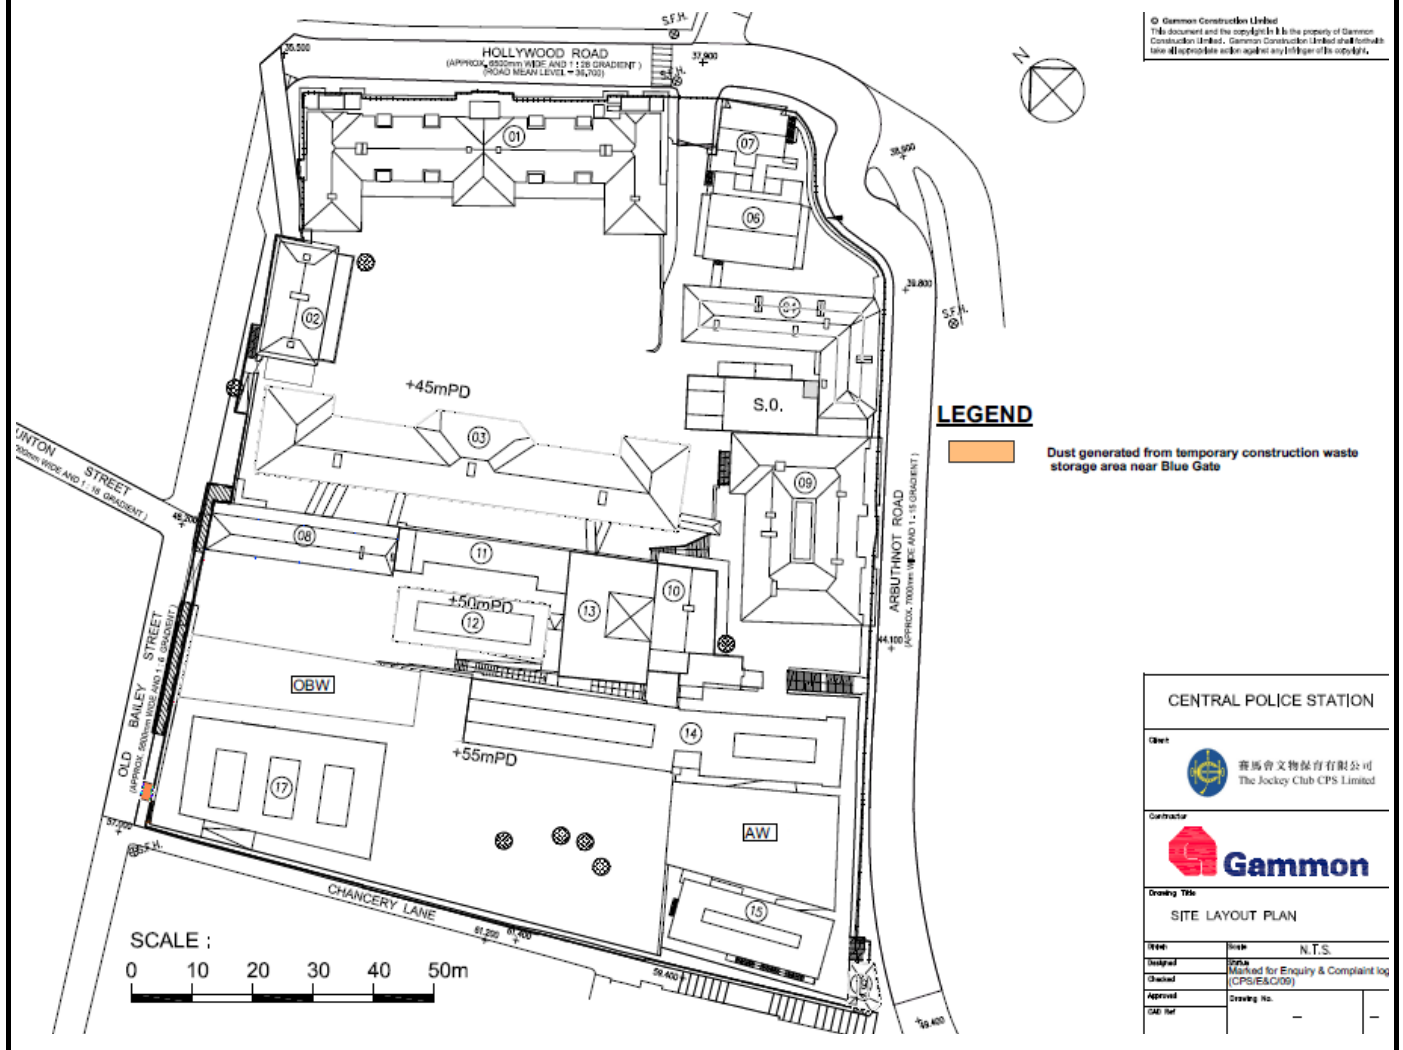
1. EPD has conducted a site visit at the CPS site with representatives from GCL on 19 September 2016. During the site visit, it was observed that a temporary construction waste storage area was located near the site entrance at Old Bailey Street.
2. It is suspected that potential dust emissions may be generated from the temporary construction waste storage area. The location of the temporary construction waste storage area is shown in the figure below.

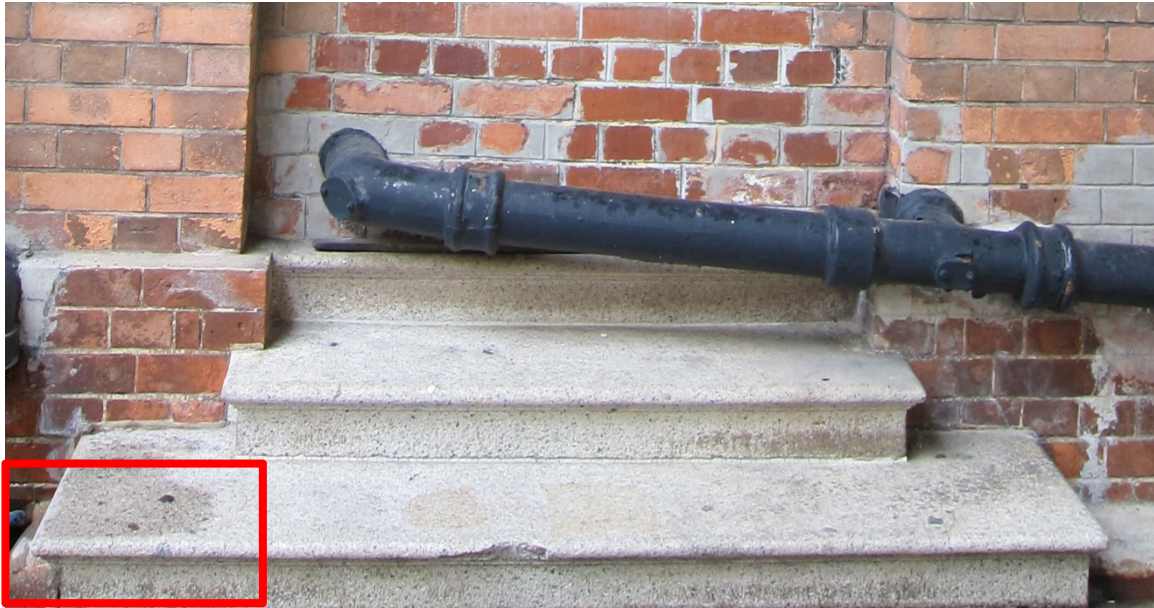
Above, photograph taken on 26th April 2011, showing granite steps at 09/WG/04. The highlighted area was damaged during site works.

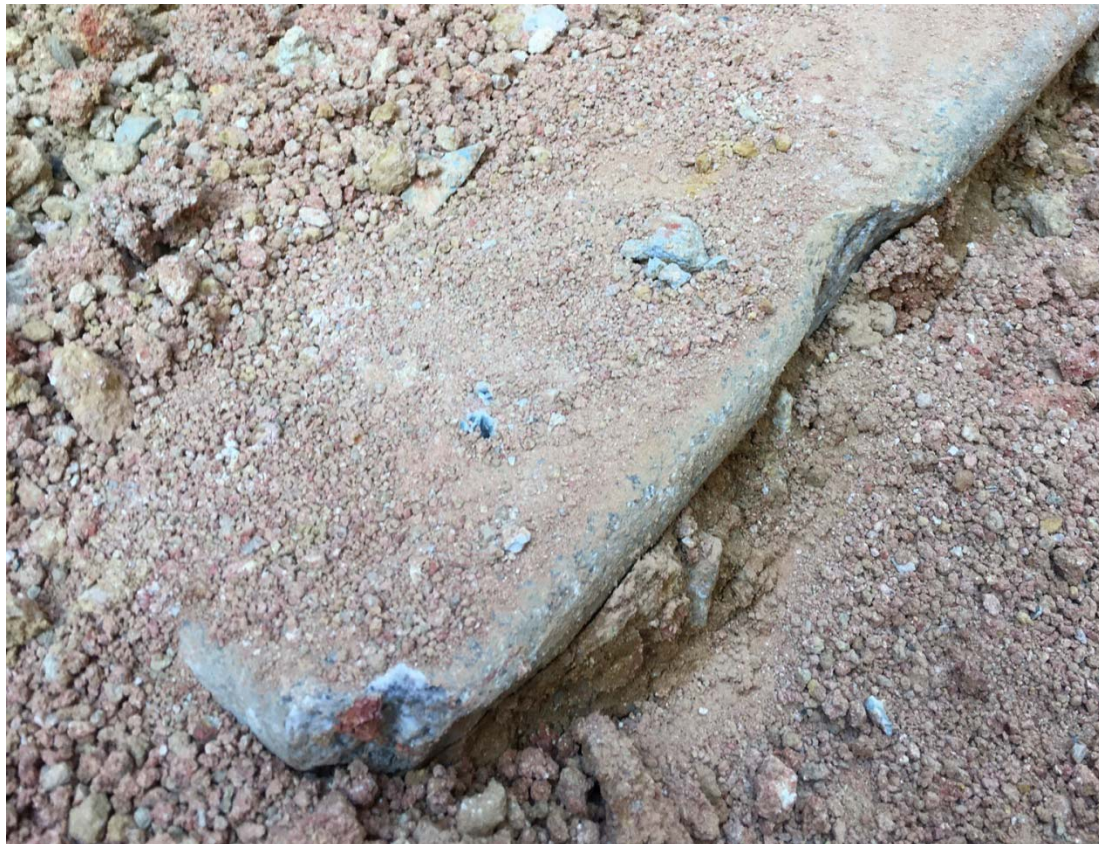
Above, photo taken on 23rd November 2015, showing granite steps at 09/WG/04 damaged by site works.

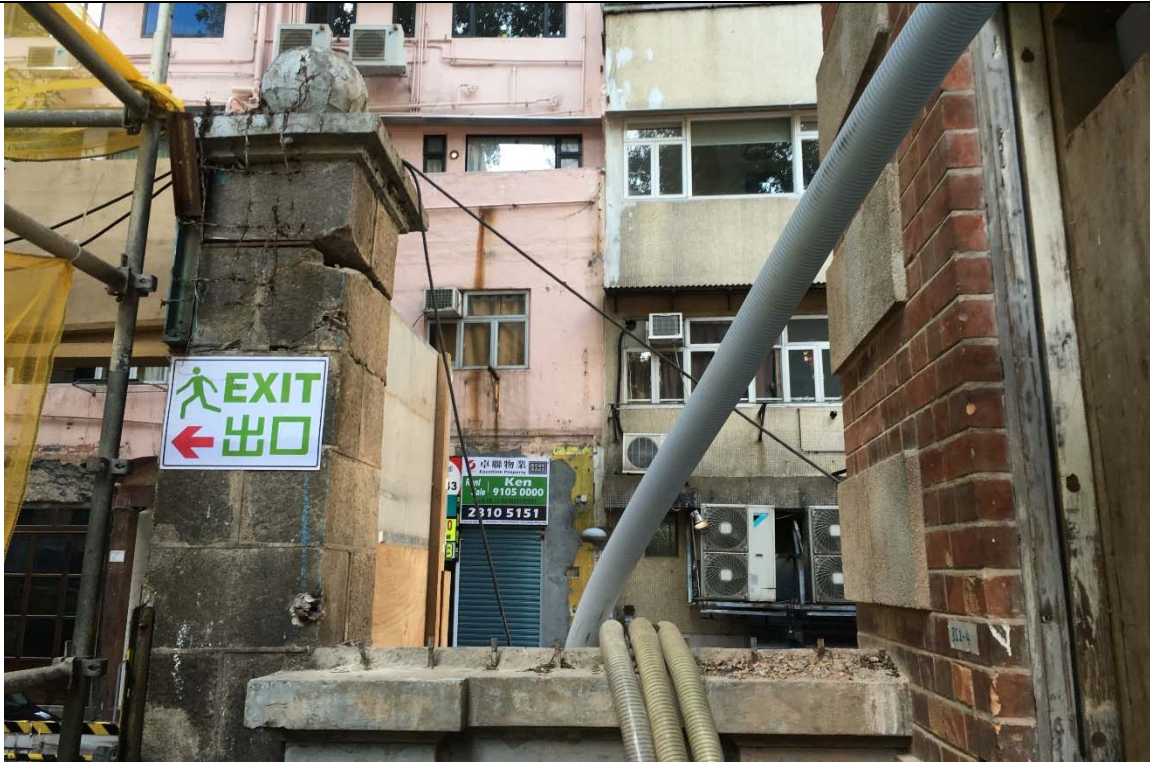
Above, photograph taken on 25th January 2016, showing the fence was missing.

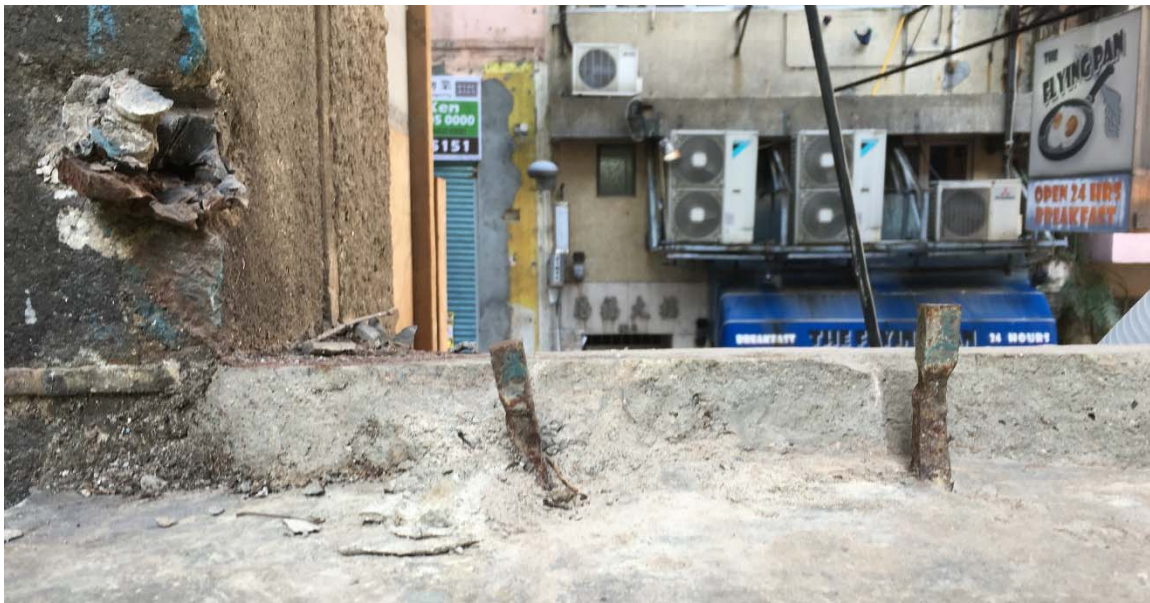
Above, photograph taken on 25th January 2016, showing the balusters of the fence was cut.

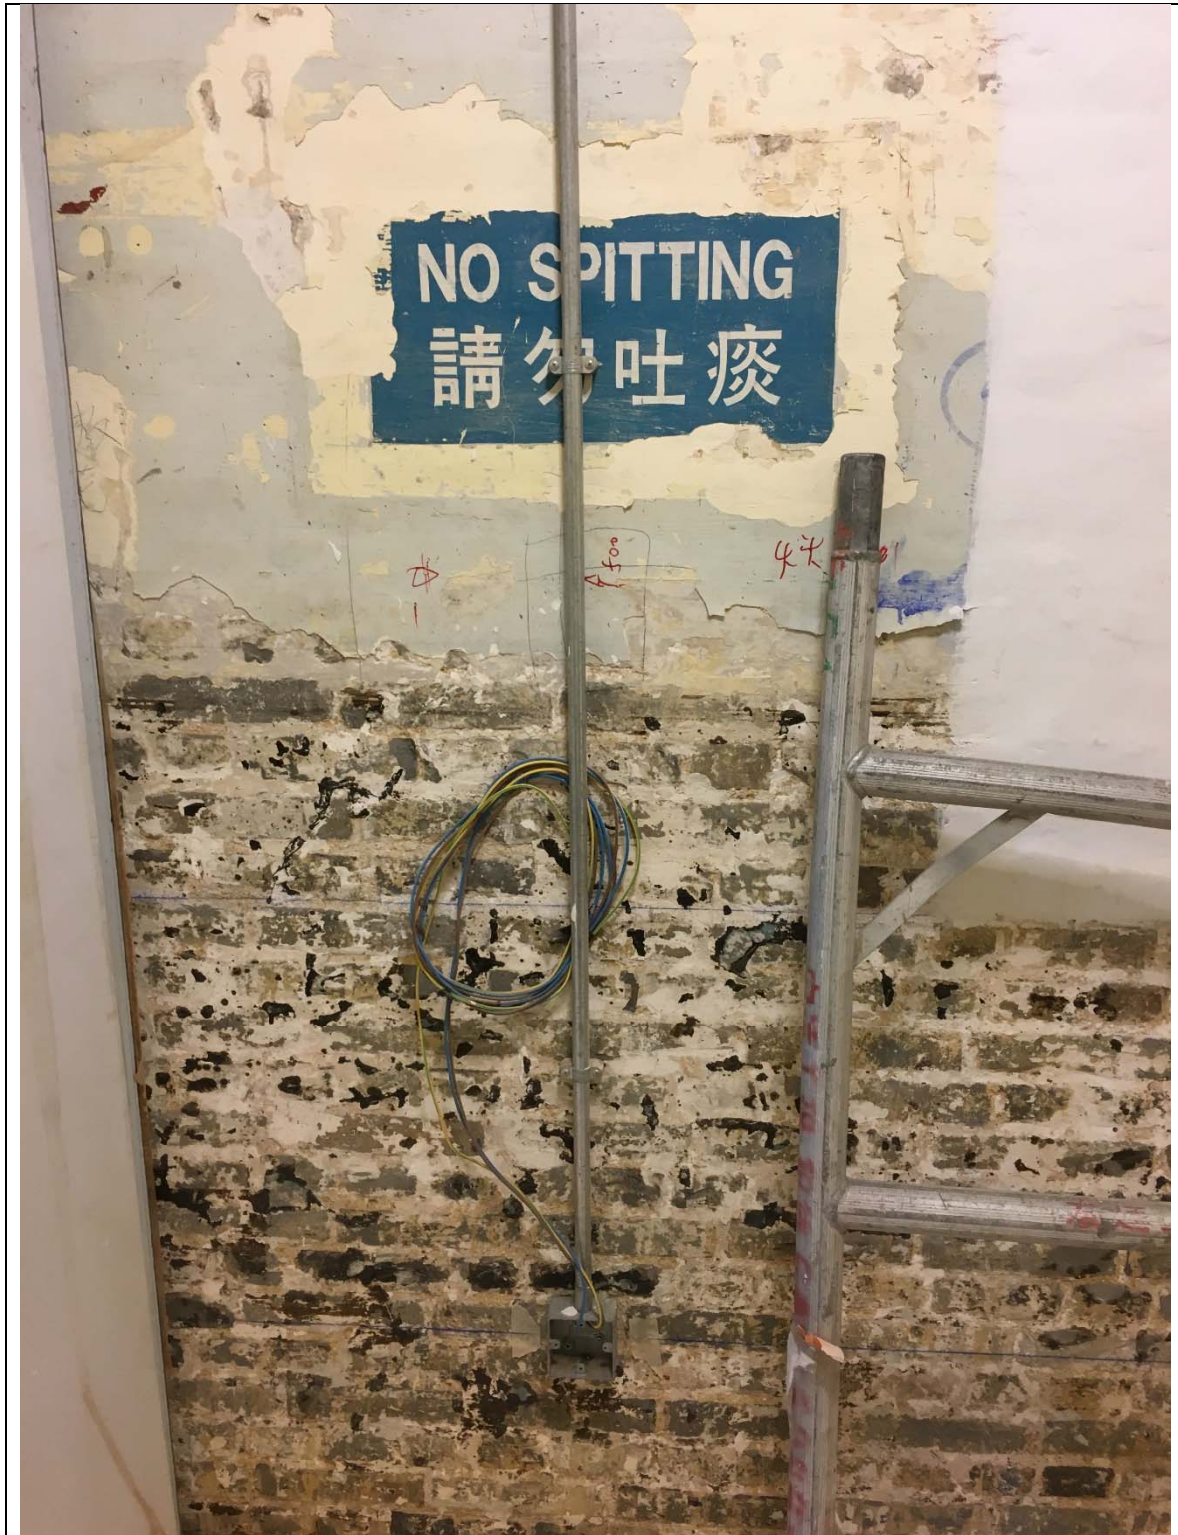
Above, photograph taken on 2nd February 2016, protection to the painted sign “NO SPITTING 請勿吐痰” was removed and a conduit was directly fixed on the painted sign.

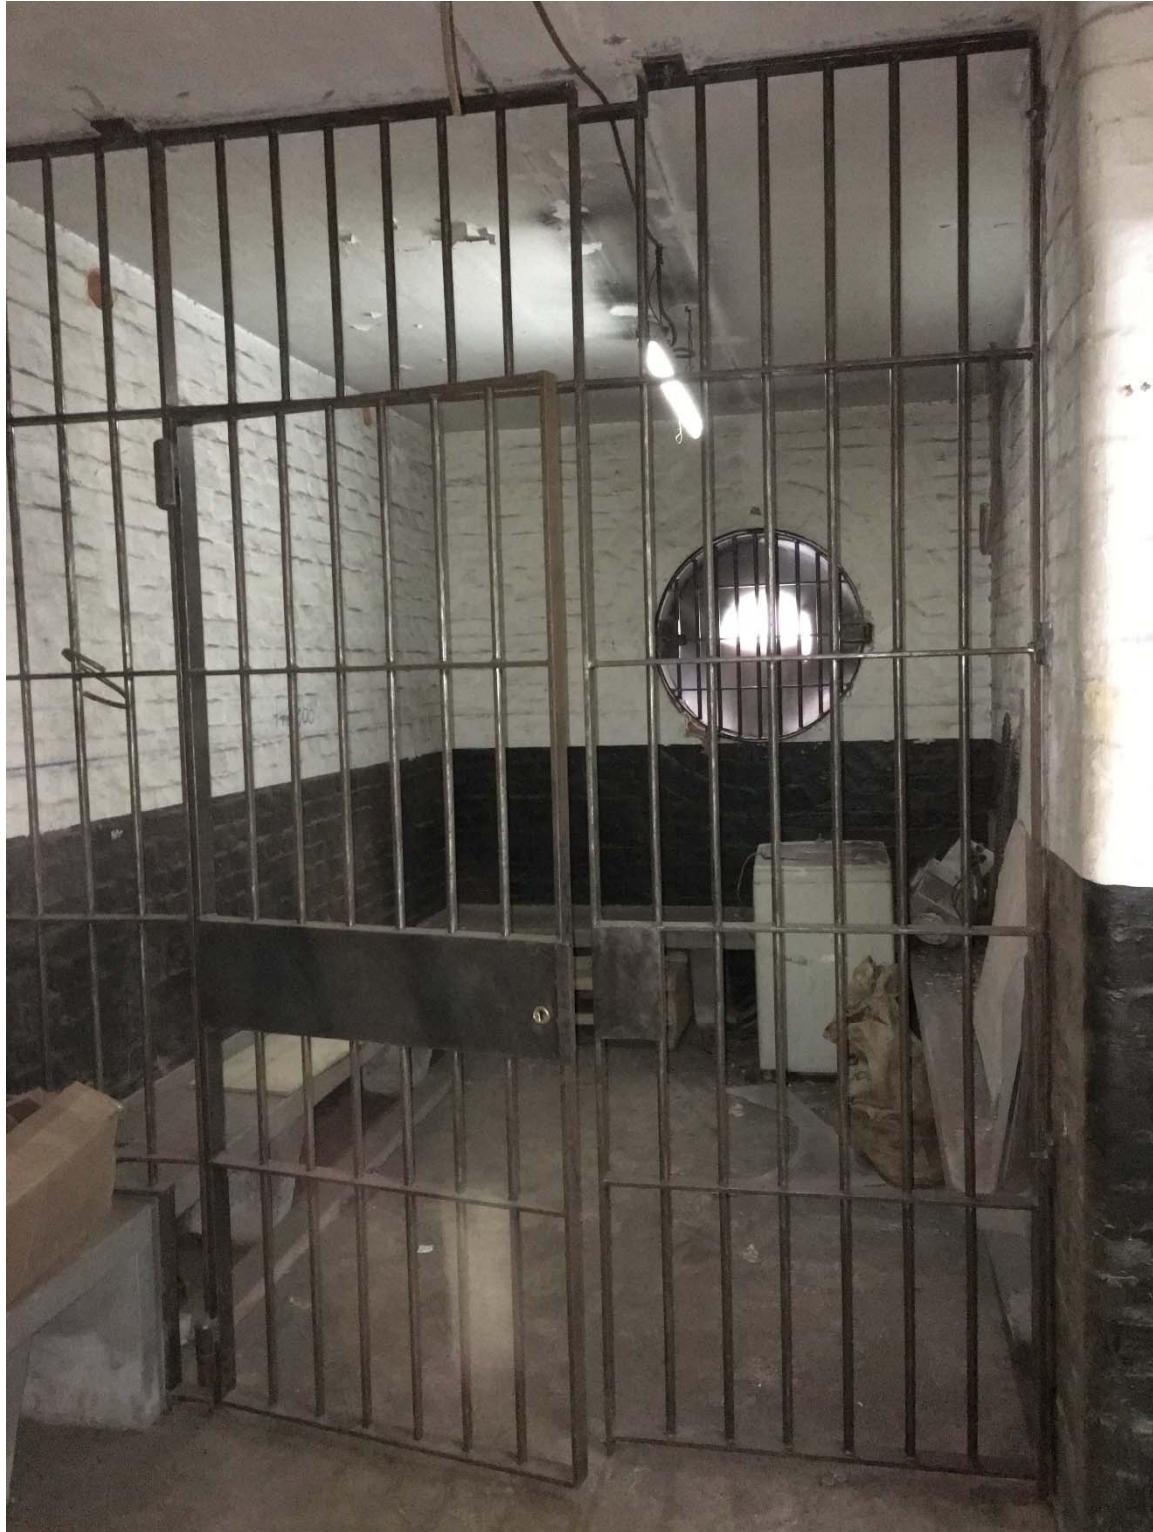
Above, photograph taken on 25th February 2016, the conduits, lighting, mesh and fan on the window, paint on the metal gate were incorrectly removed. Removal of mesh had damaged adjacent brickwork.

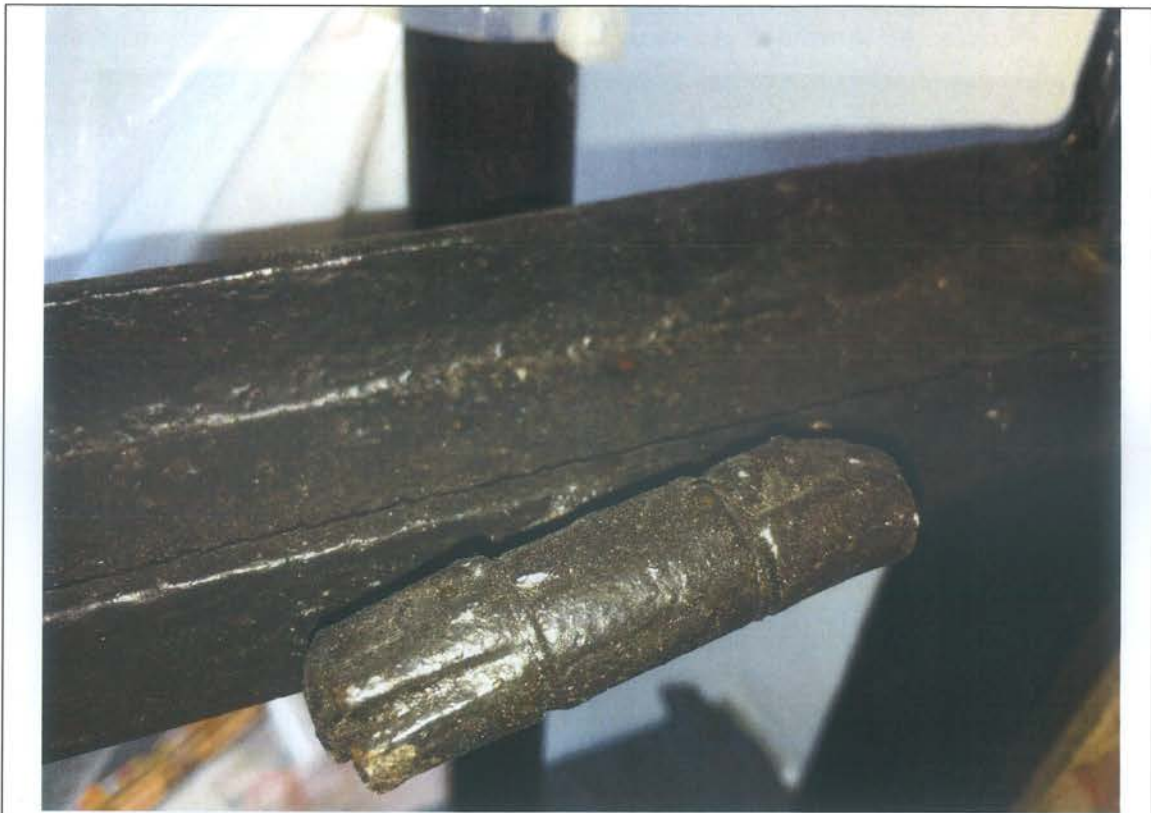
Above, photograph taken on 15th July 2016, showing the casement was cut above the hinge.

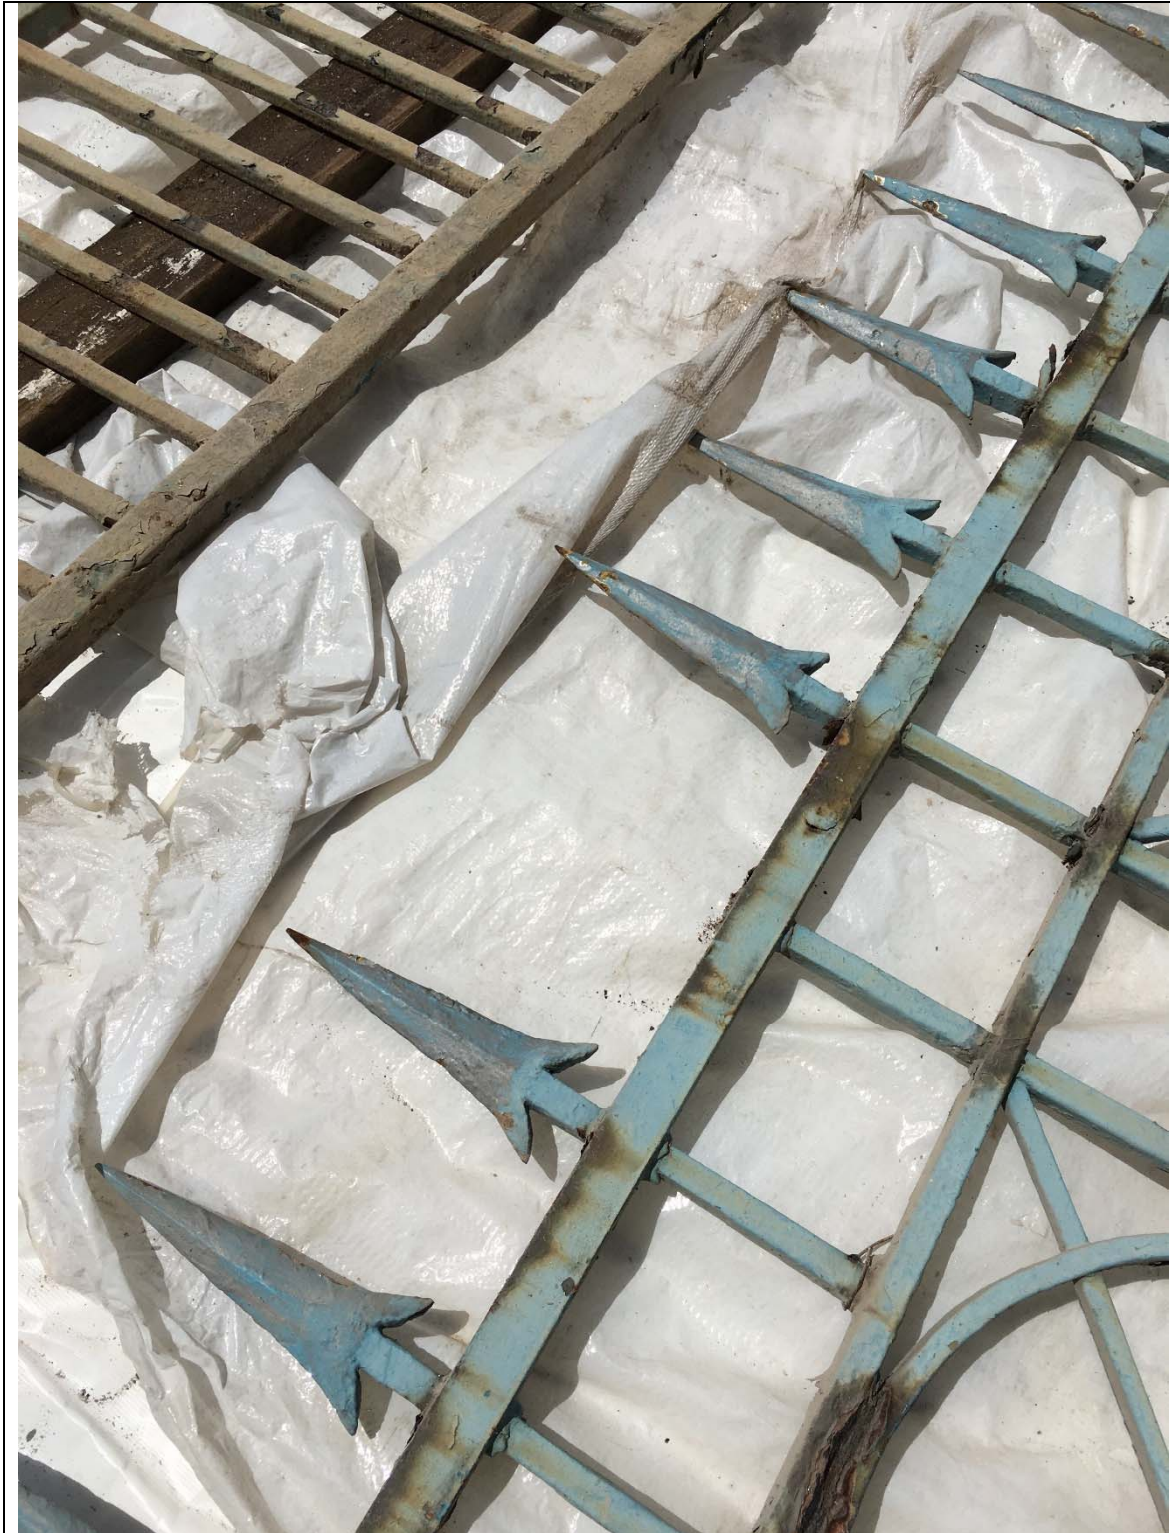
Above, photo taken on 21st July 2016, showing one arrow on left hand side leaf was missing.
