The Jockey Club CPS Limited

Central Police Station Conservation
and Revitalisation Project:
73rd Monthly EM&A Report
(1 November to 30 November 2017)

Environmental Resources Management

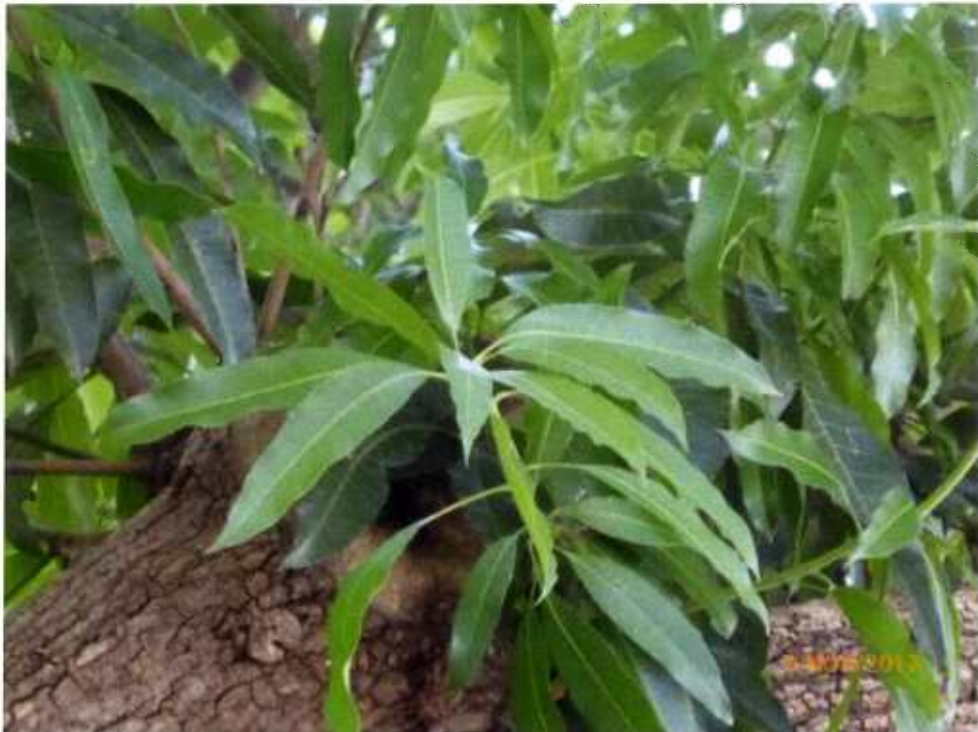
Fig. 9 Signs of Pest (Mealy Bugs 粉狀介殼蟲) are rarely found on the tree due to Pest Control Operation on 26th September 2017.

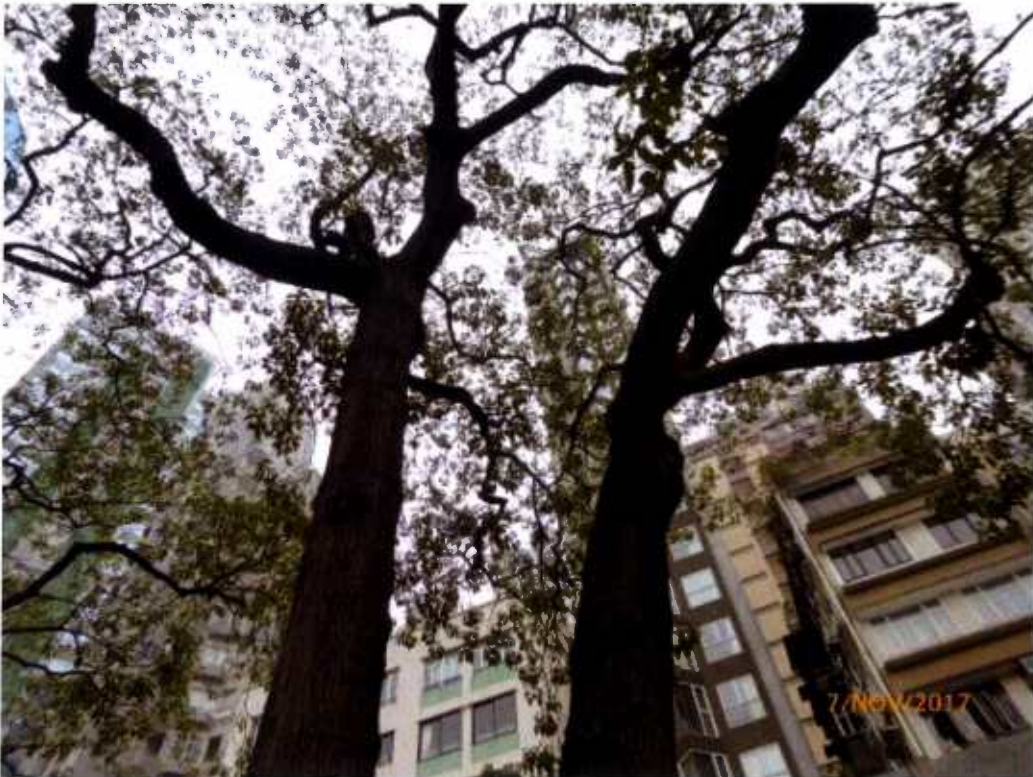
Fig. 6 Leaves on the crown are rather sparse.

1. Cover the bare roots with hessian clothes as soon as possible.
2. Keep close monitoring on the growth of the tree.

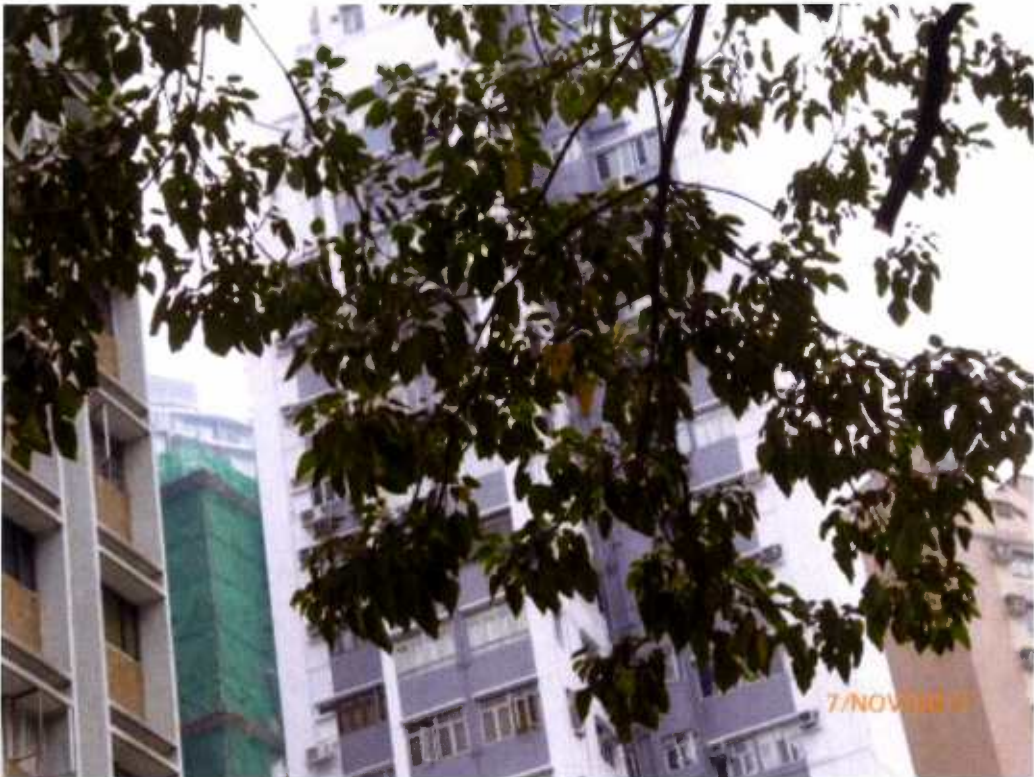
Fig. 8 Signs of Pest “白粉蝨 (*Trialeurodes vaporariorum*)” have apparently reduced due to Pest Control Operation on 3rd & 4th Aug. 2017.

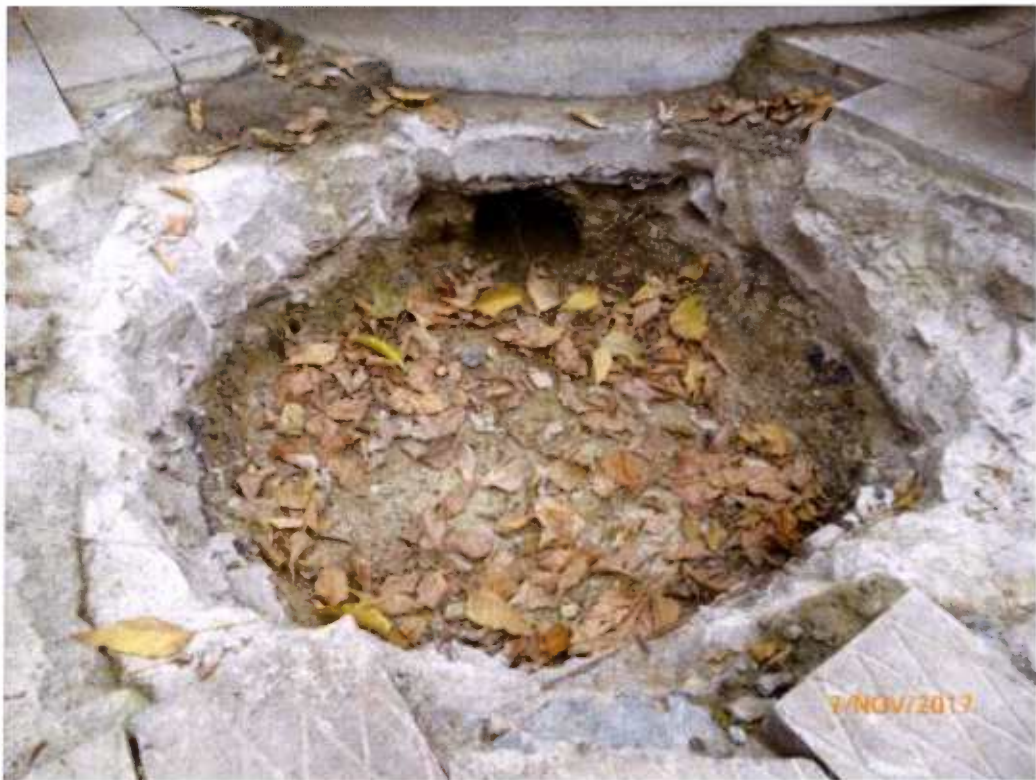
Landscape and visual monitoring has commenced since October 2011 on a monthly basis. The tree inspection was conducted on 7 November 2017 by the arborist during the reporting period. Leaves on Tree 6 and Tree 7 were observed to be rather sparse. Four pits near each of the planter of Tree 6 and Tree 7 were created for ventilation purpose for the trees. Roots were observed exposed from the pits for Tree 6 and Tree 7 and the Contractor was

Fig. 11 Four large pits have been excavated close to the planter.

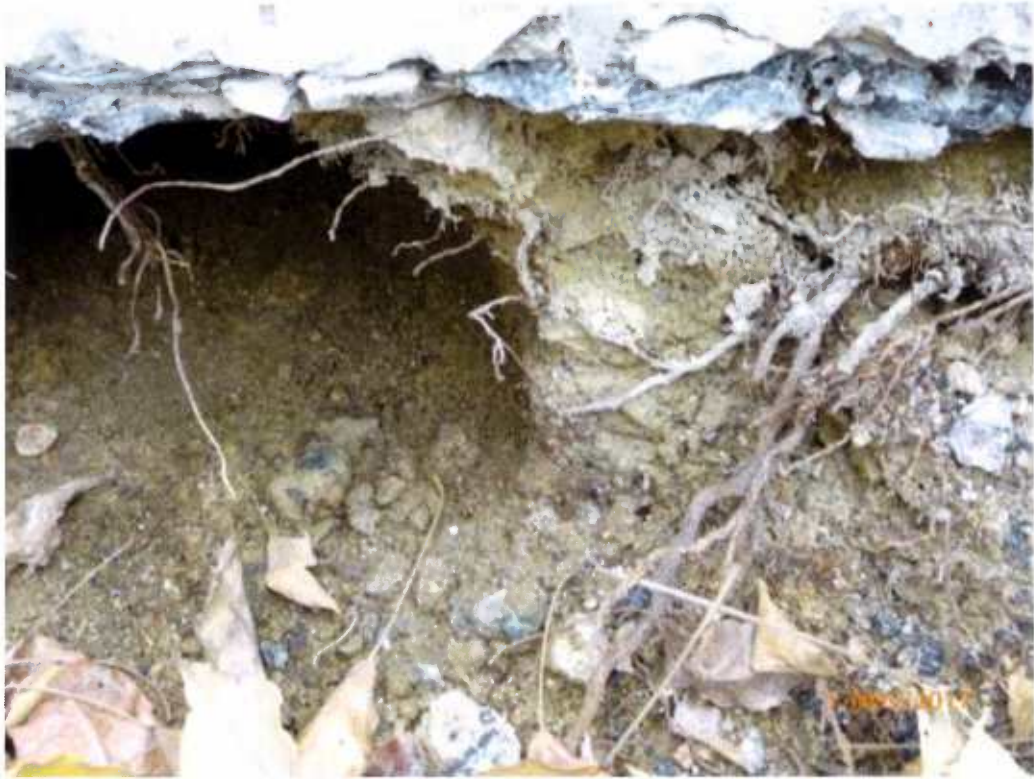
Fig. 12 Many bare roots have exposed to sun, it will seriously affect the growth of the tree.

reminded to cover the exposed roots with hessian clothes as soon as possible to avoid direct exposure of the roots to sunlight. The Contractor was reminded to keep close monitoring of the growth of Tree 6 and Tree 7. The Contractor has provided a temporary shelter for the protection of Tree 11 during the nearby renovation works. Withered leaves were observed on Tree 11. The Contractor should closely monitor the growth of Tree 11 especially during the nearby renovation works are in progress.

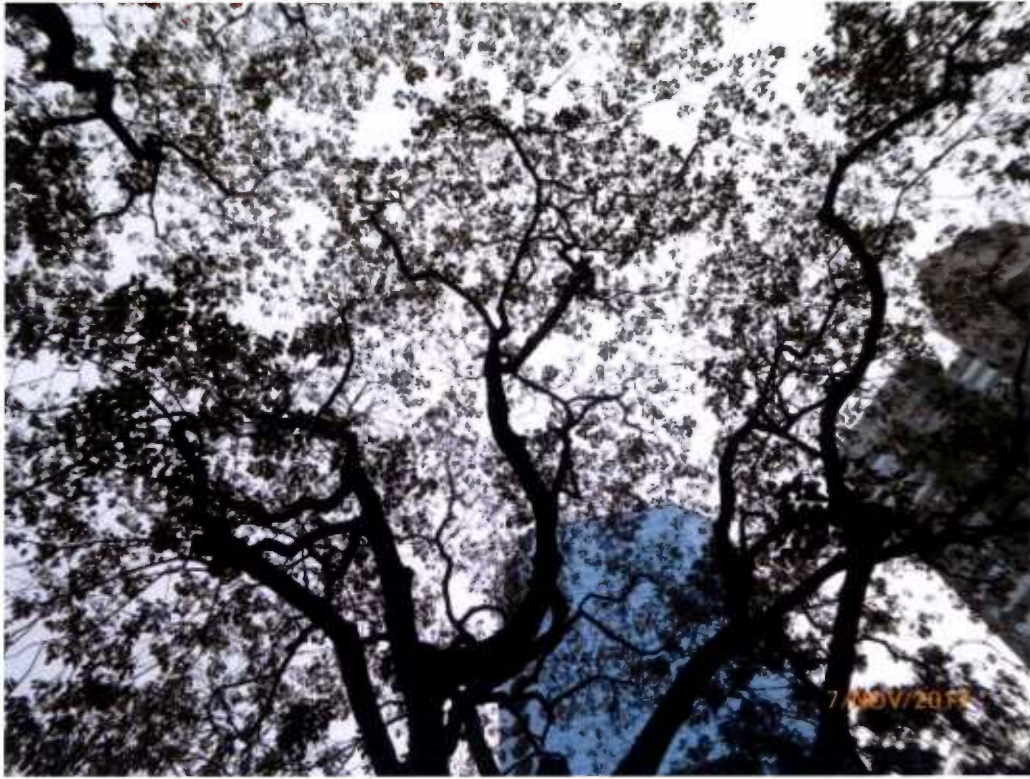
Fig. 6 Leaves on the crown are rather sparse.

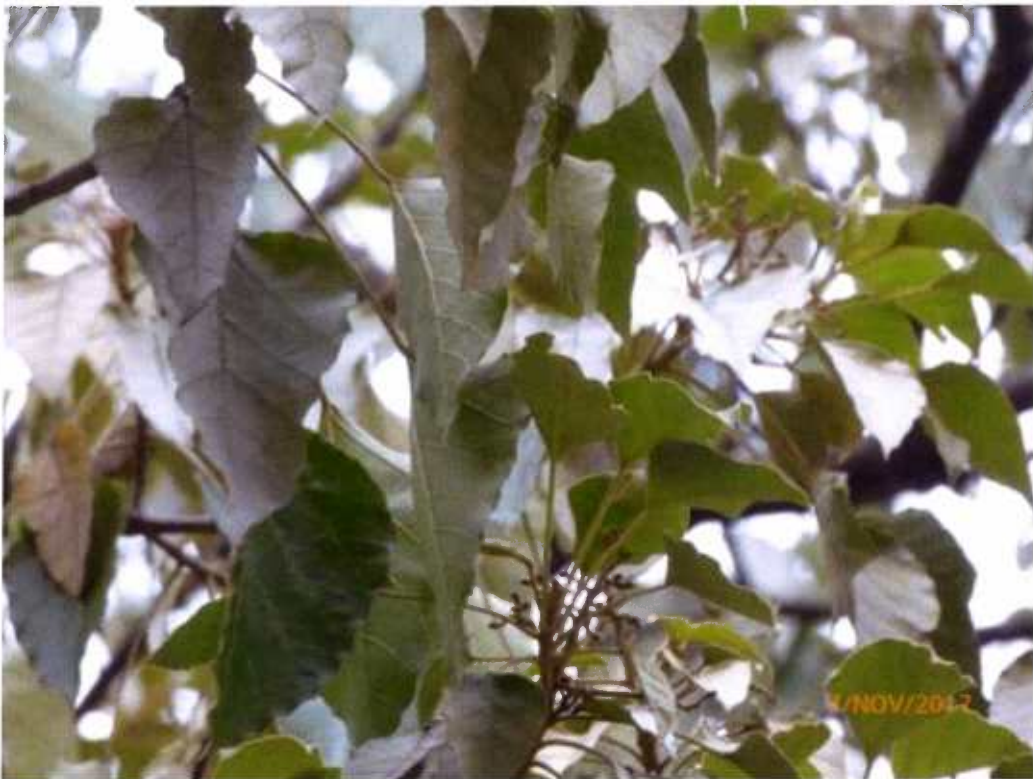
Fig. 9 Signs of Pest “白粉蝨 (*Trialeurodes vaporariorum*)” have apparently reduced due to Pest Control Operation on 3rd & 4th Aug. 2017.

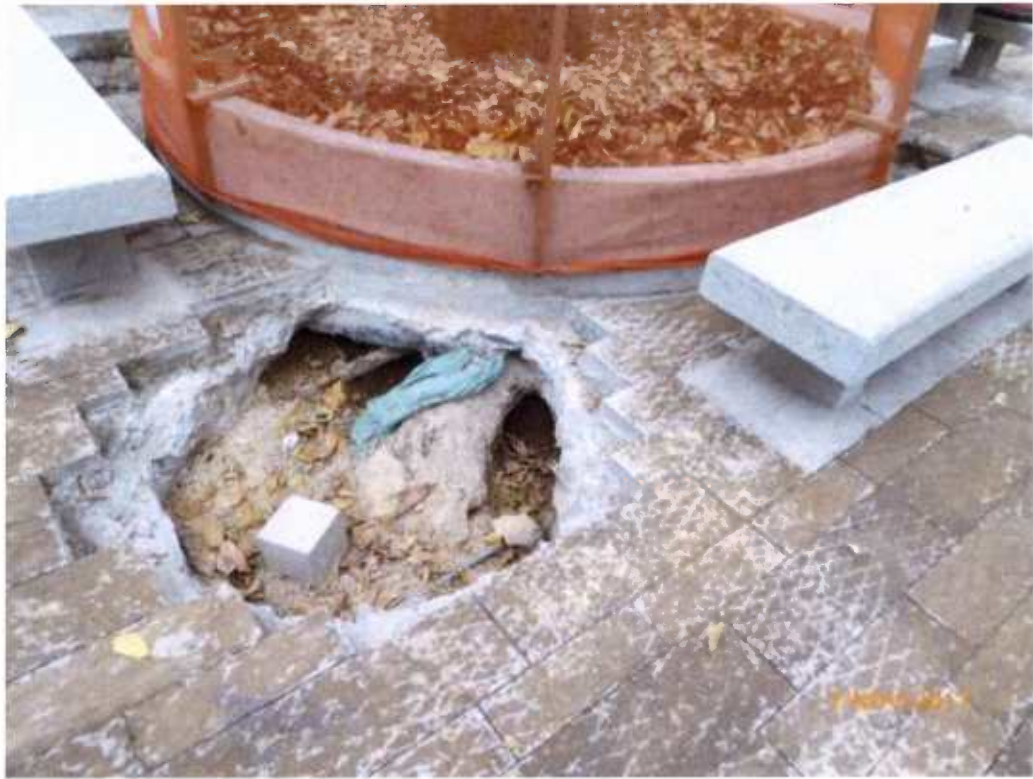
Fig. 10 Four pits were recently excavated close to the planter.

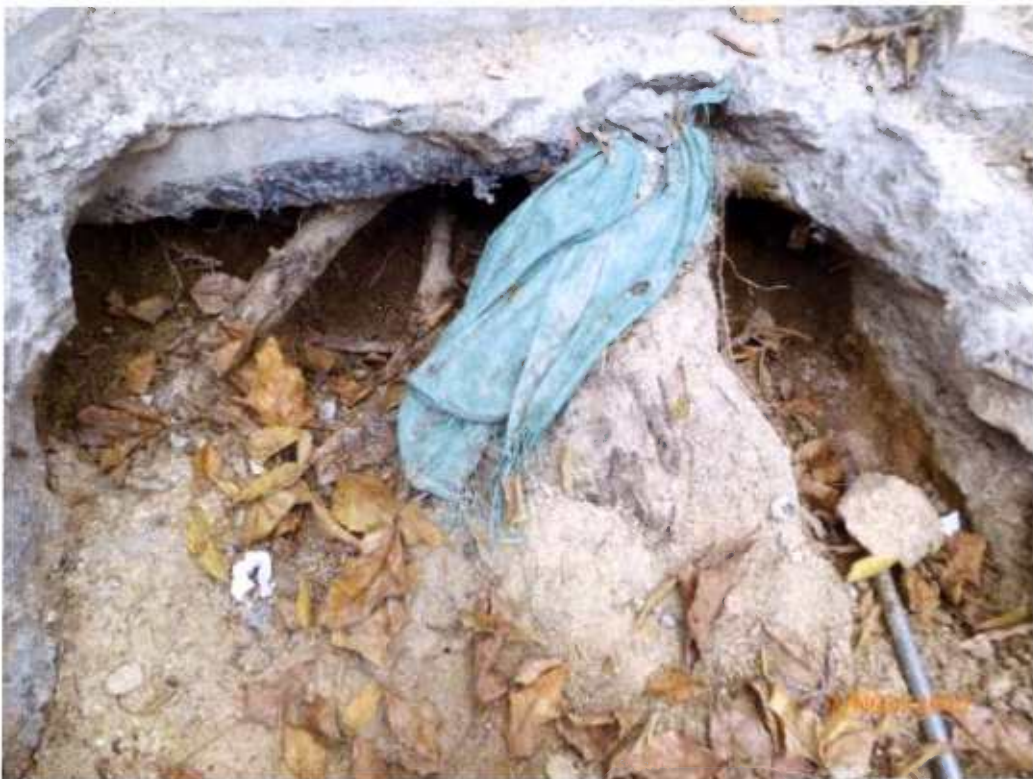
Fig. 11 Many large bare roots have exposed to sun, it will seriously affect the growth of the tree.
