The Jockey Club CPS Limited

Central Police Station Conservation
and Revitalisation Project:
76th Monthly EM&A Report
(1 February to 28 February 2018)

Issue Date: March 2018

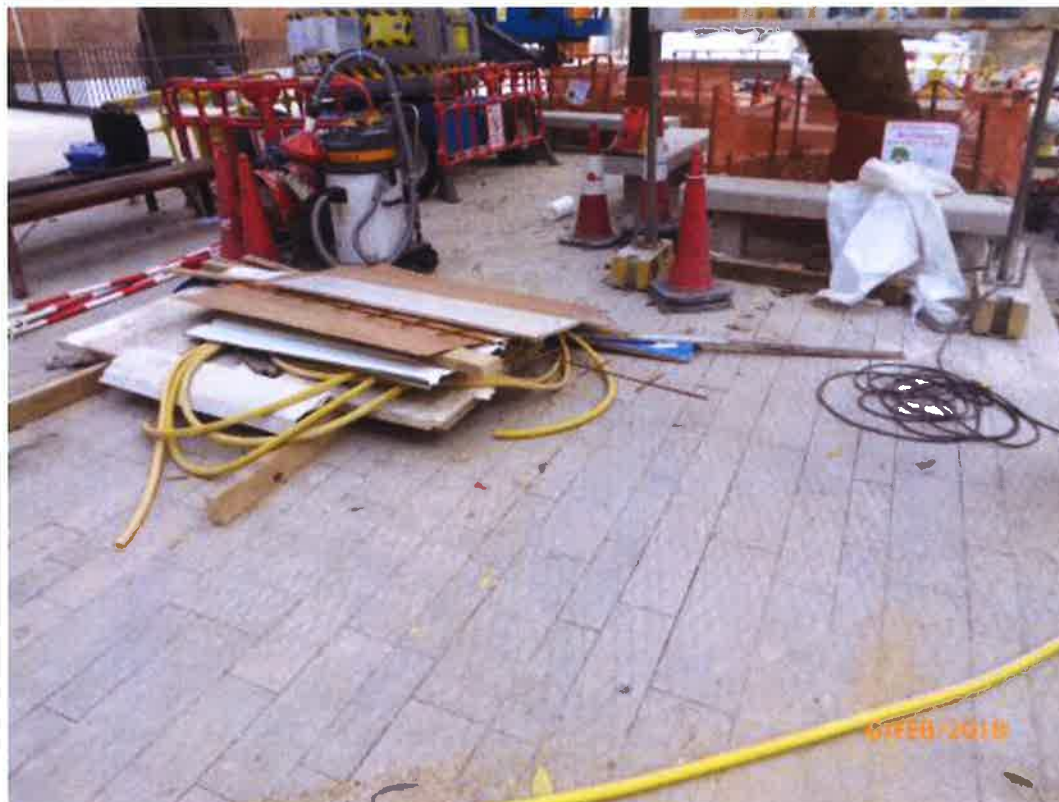
Fig. 11 Many construction materials are placed near the tree.

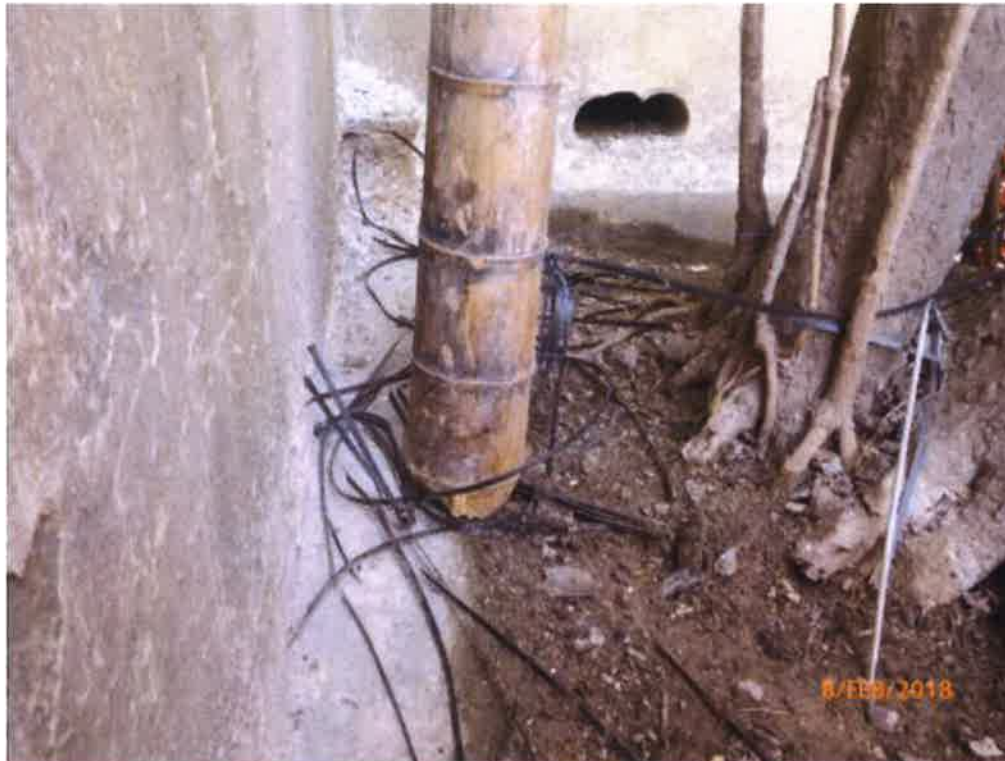
Fig. 3 A few construction debris remained at the planter.

Tree No.	Botanical Name	Overall Health Condition	Arborist's Observations / Recommendations
			<p>monitor the growth of the tree especially when the nearby renovation works are in progress.</p> <ul style="list-style-type: none"> Some construction debris was observed at the planter. The Contractor was reminded to remove the construction debris from the planter.
