The Jockey Club CPS Limited

Central Police Station Conservation  
and Revitalisation Project:  
*79<sup>th</sup> Monthly EM&A Report*  
*(1 May to 25 May 2018)*

Issue Date: June 2018

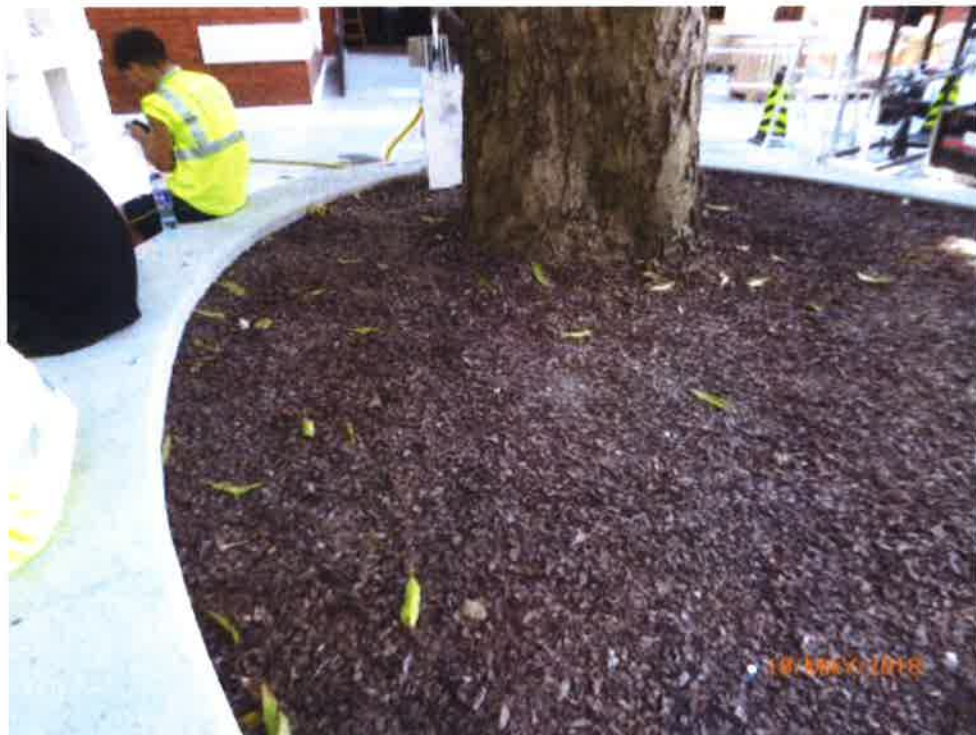
Fig. 4 Health condition of the lower trunk is fair.

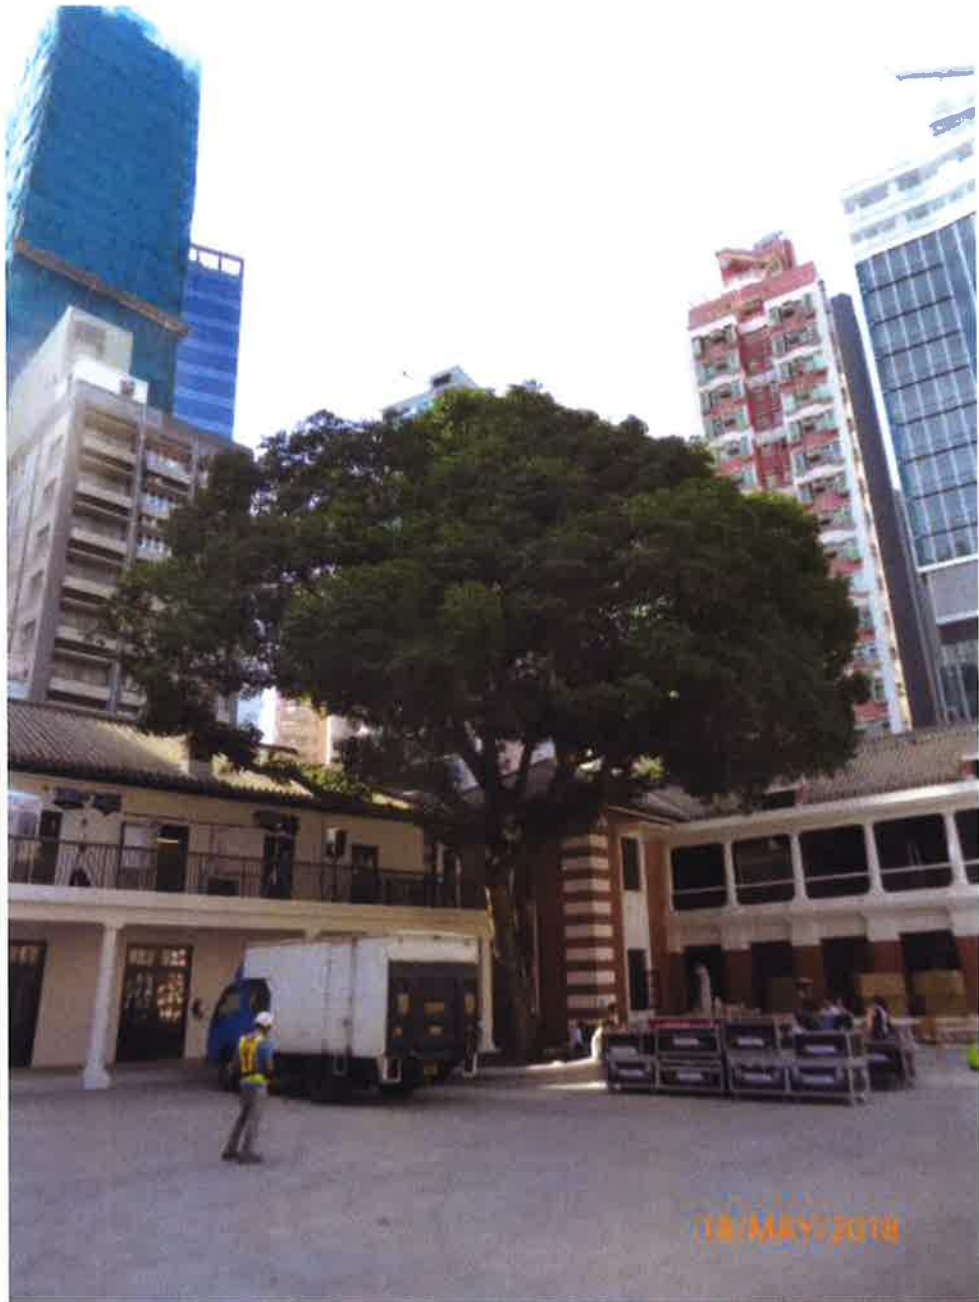
Fig. 12 Overall view of Tree-5 during inspection on 18<sup>th</sup> May 2018.

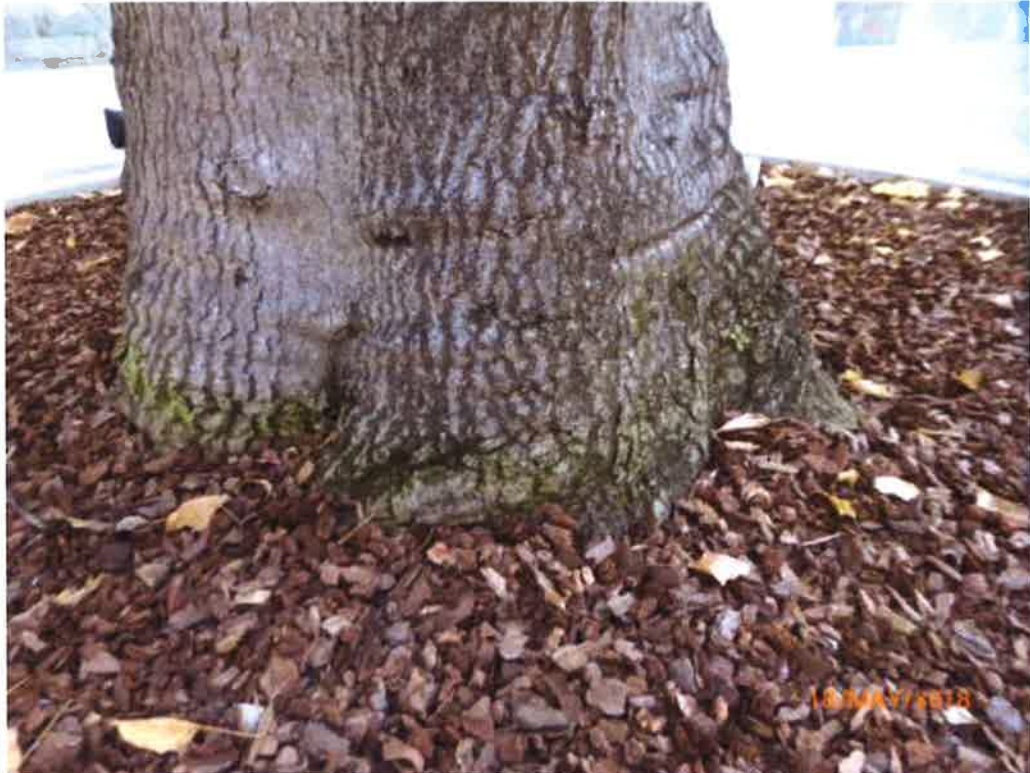
Fig. 3 The planter is covered with small pieces of mulch.

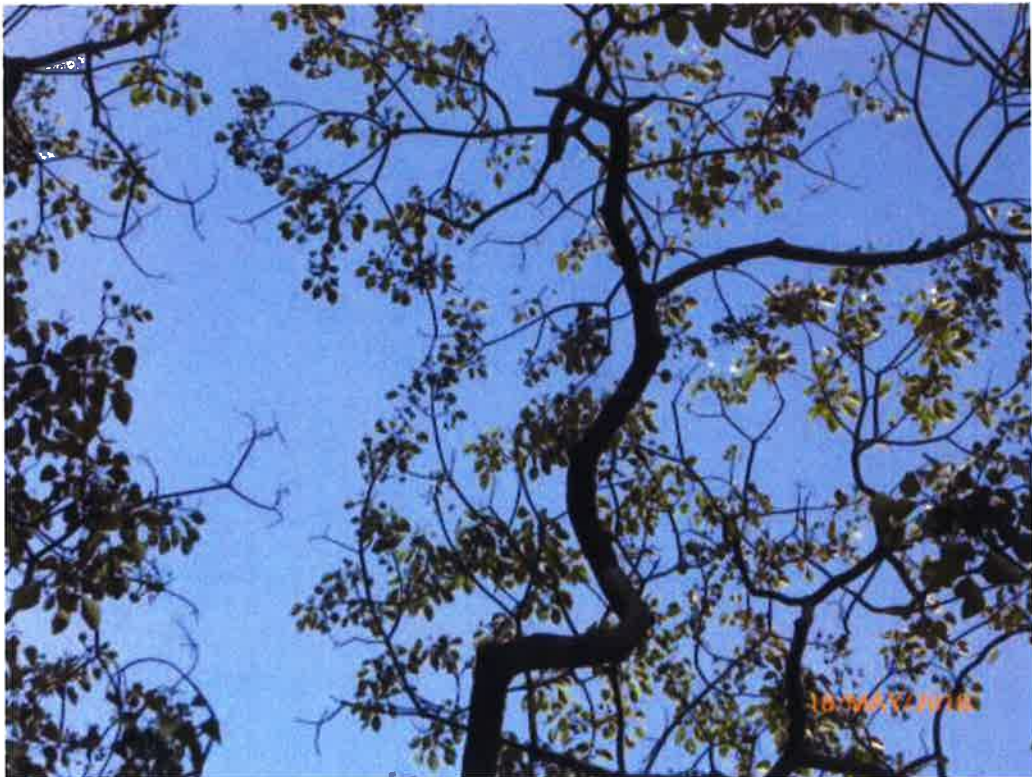
Fig. 8 Many dead twigs still remain on the upper branches.

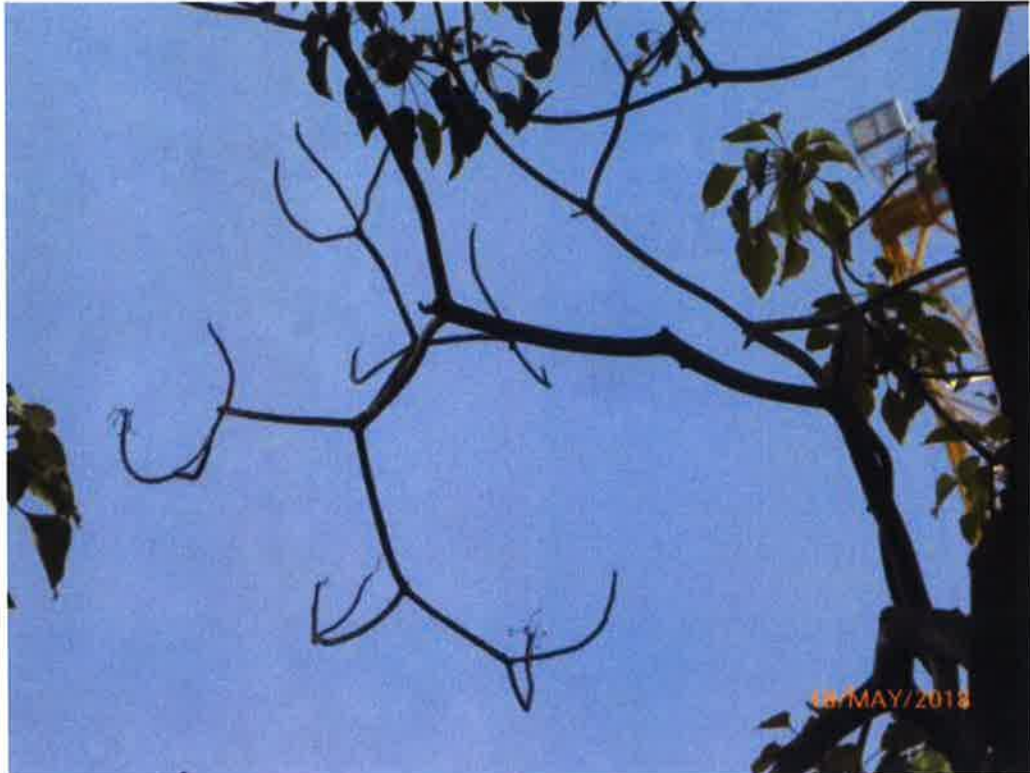
Fig. 9 Leaves on the lower branches are normal.

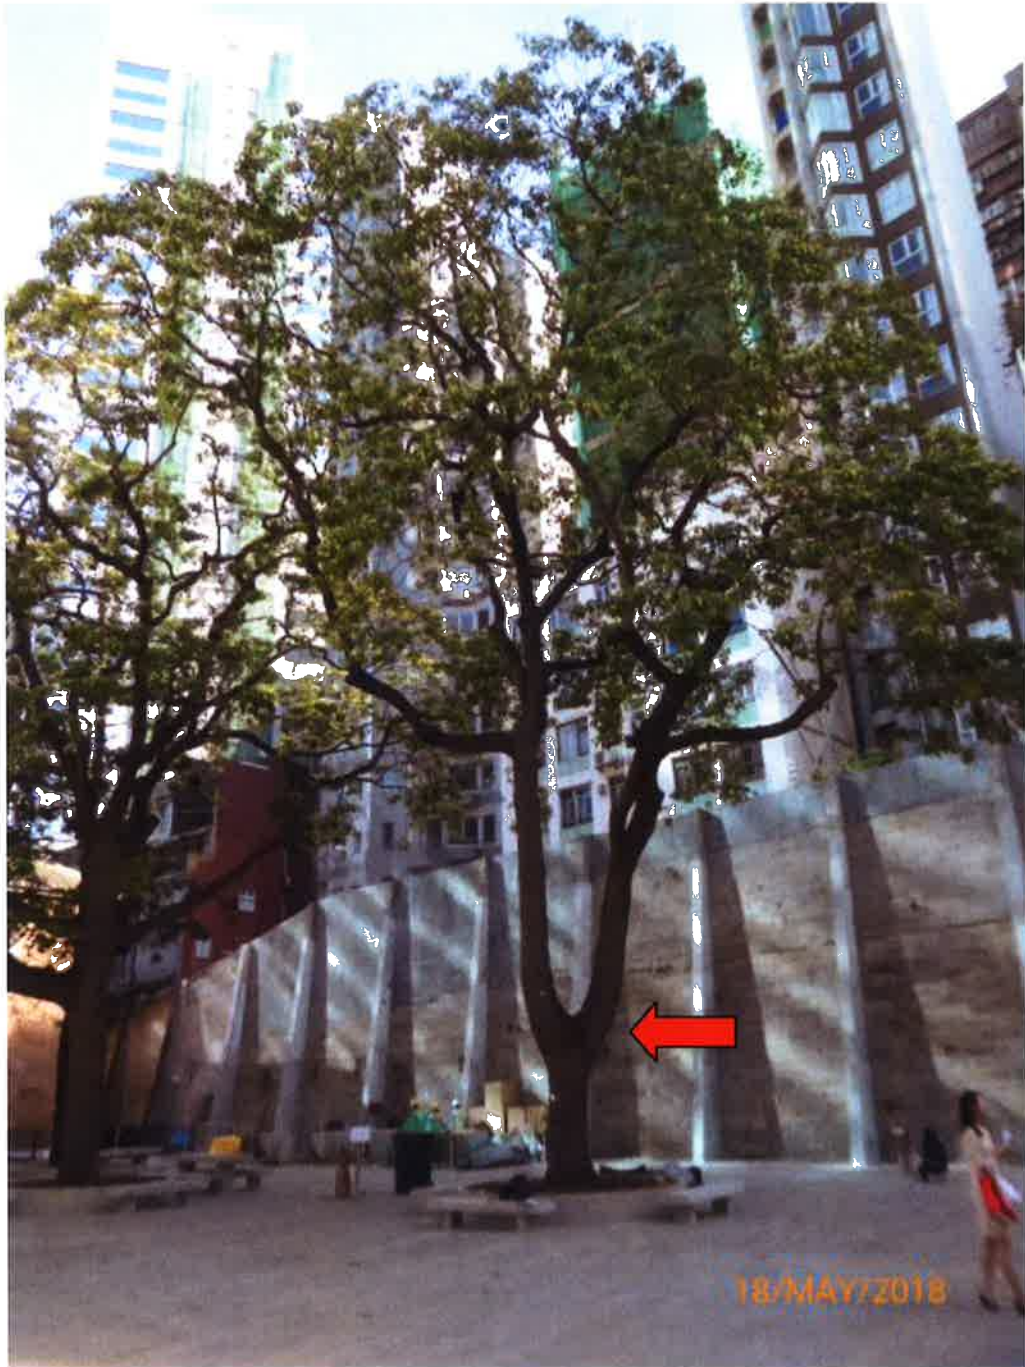
Fig. 12 Overall view of Tree-6 during inspection on 18<sup>th</sup> May 2018.

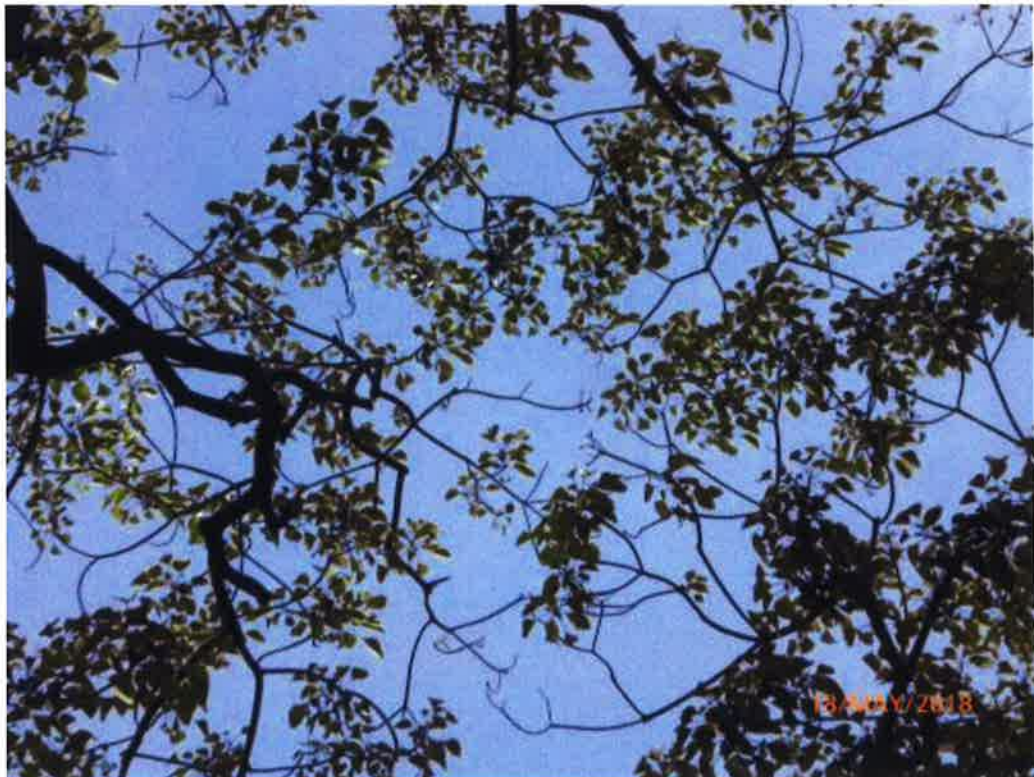
Fig. 8 Many dead twigs still remain on the upper branches.

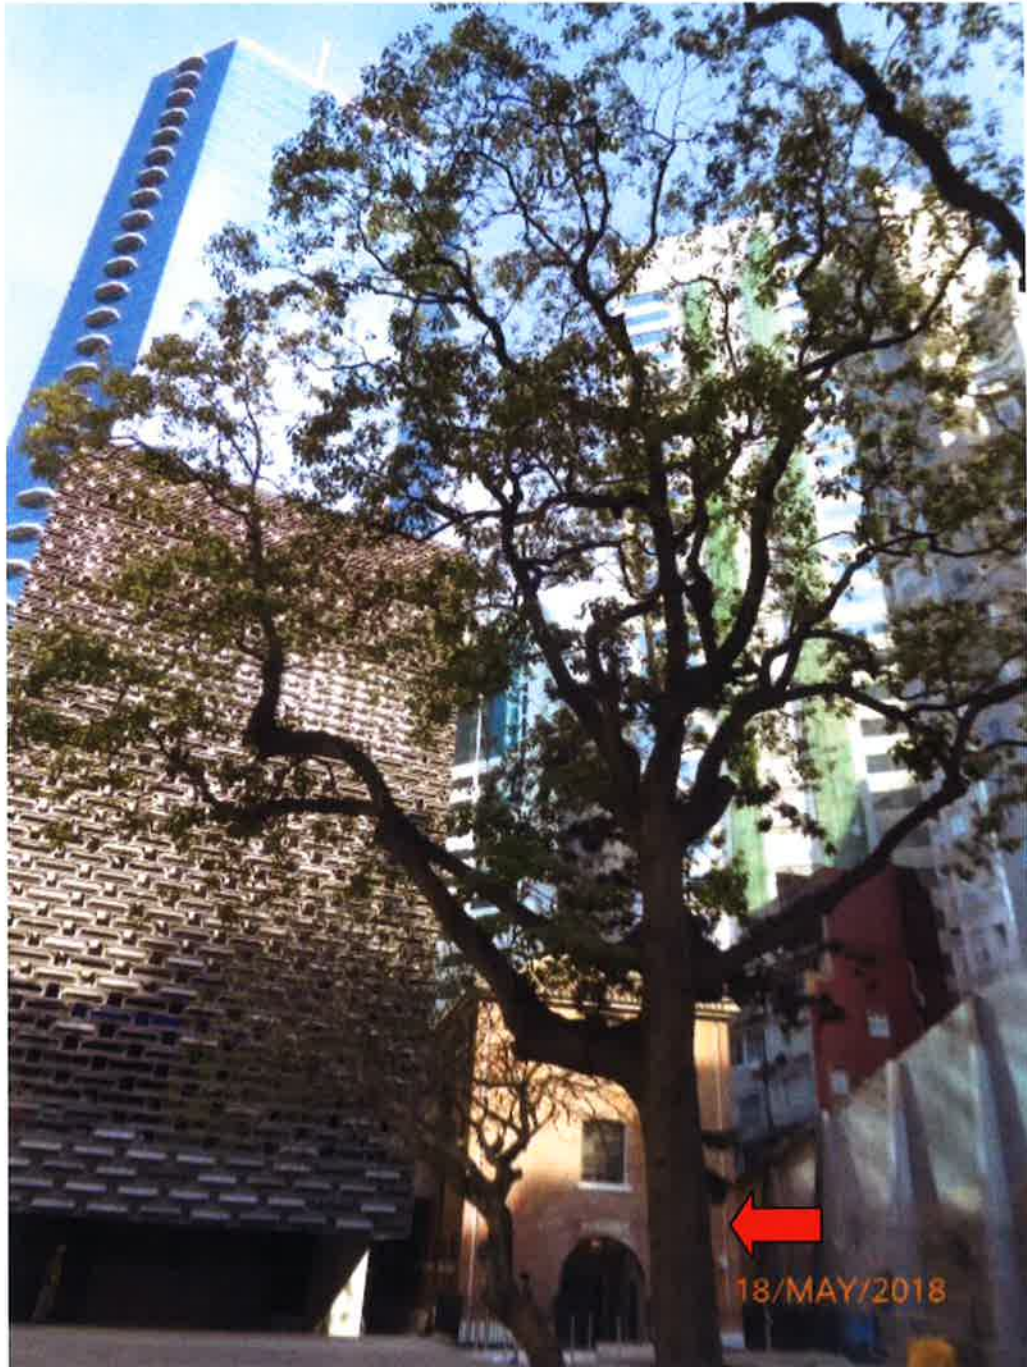
Fig. 12 Overall view of Tree-7 during inspection on 18<sup>th</sup> May 2018.

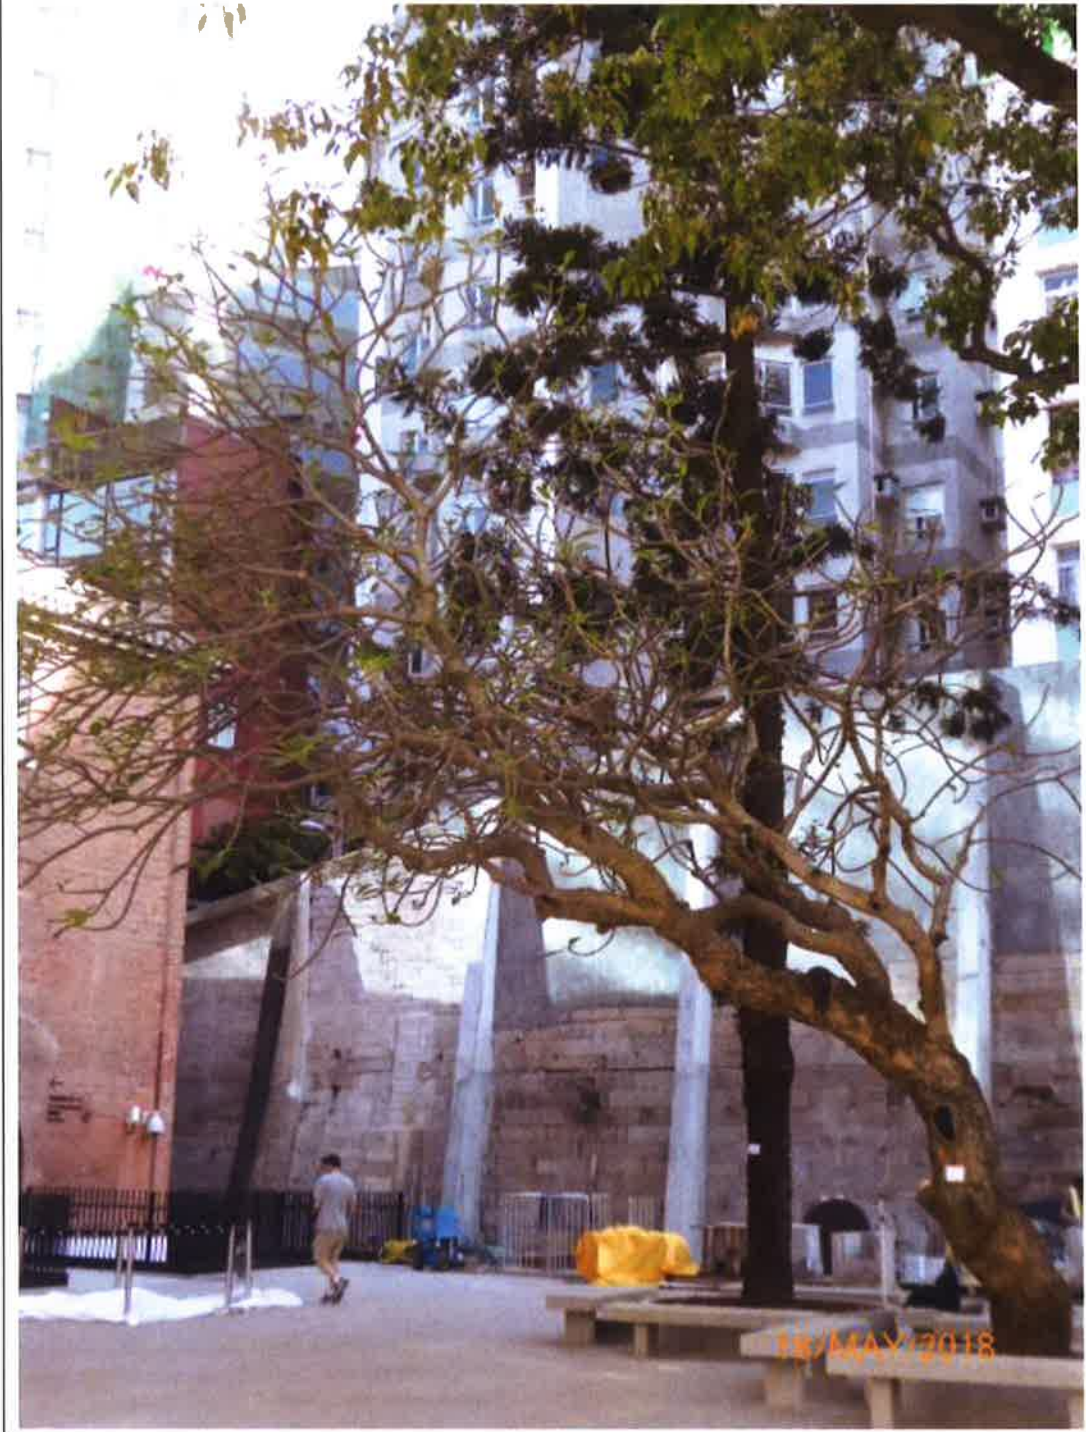
Fig. 12 Overall view of Tree-8 during inspection on 18<sup>th</sup> May 2018.

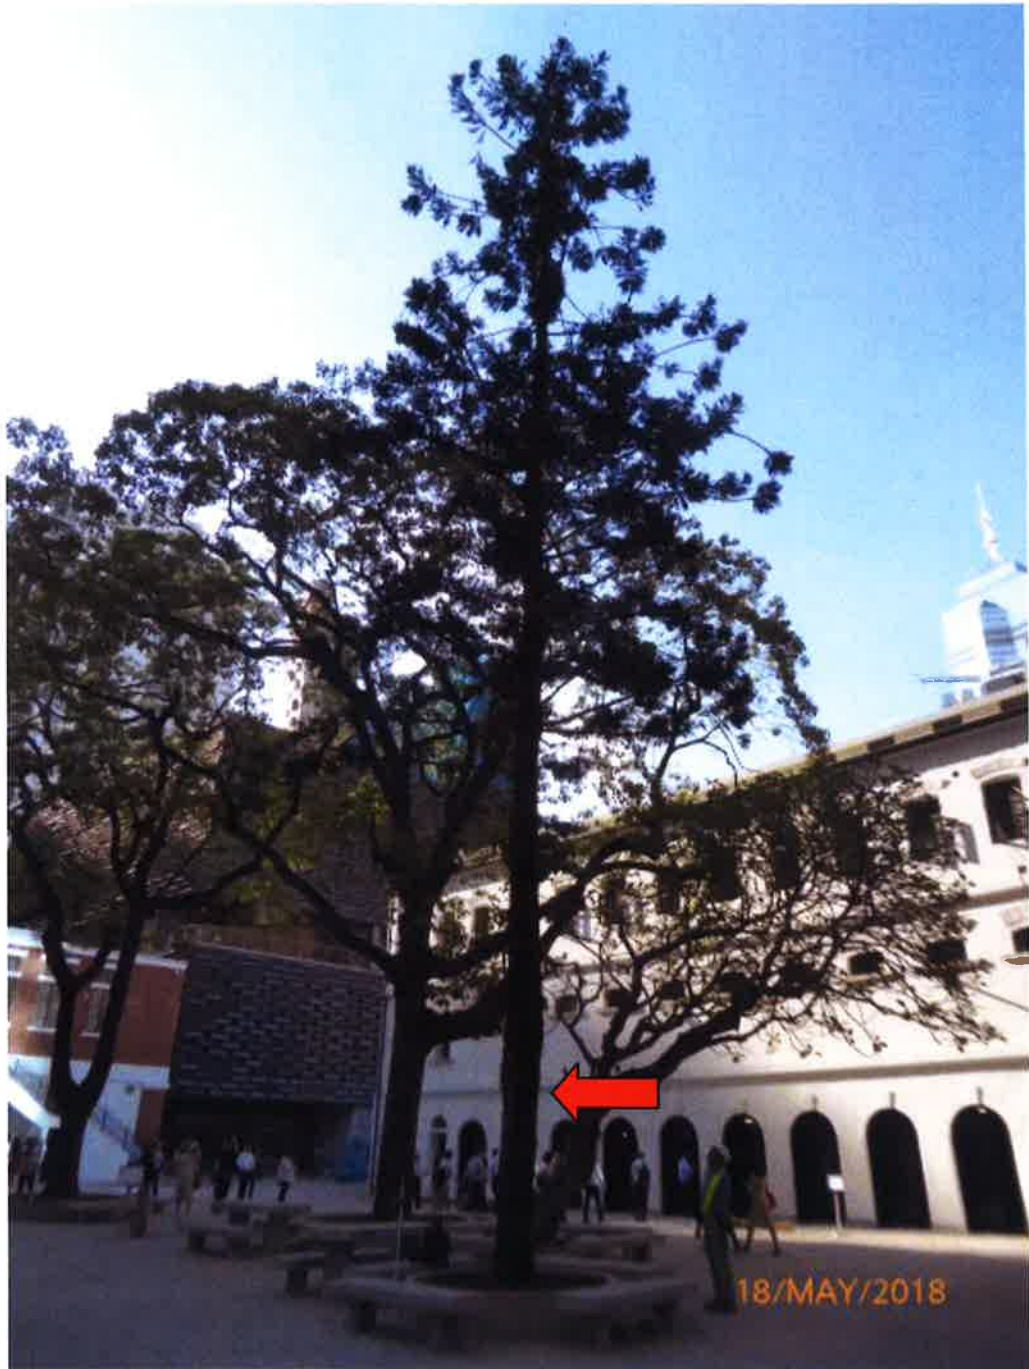
Fig. 12 Overall view of Tree-9 during inspection on 18<sup>th</sup> May 2018.

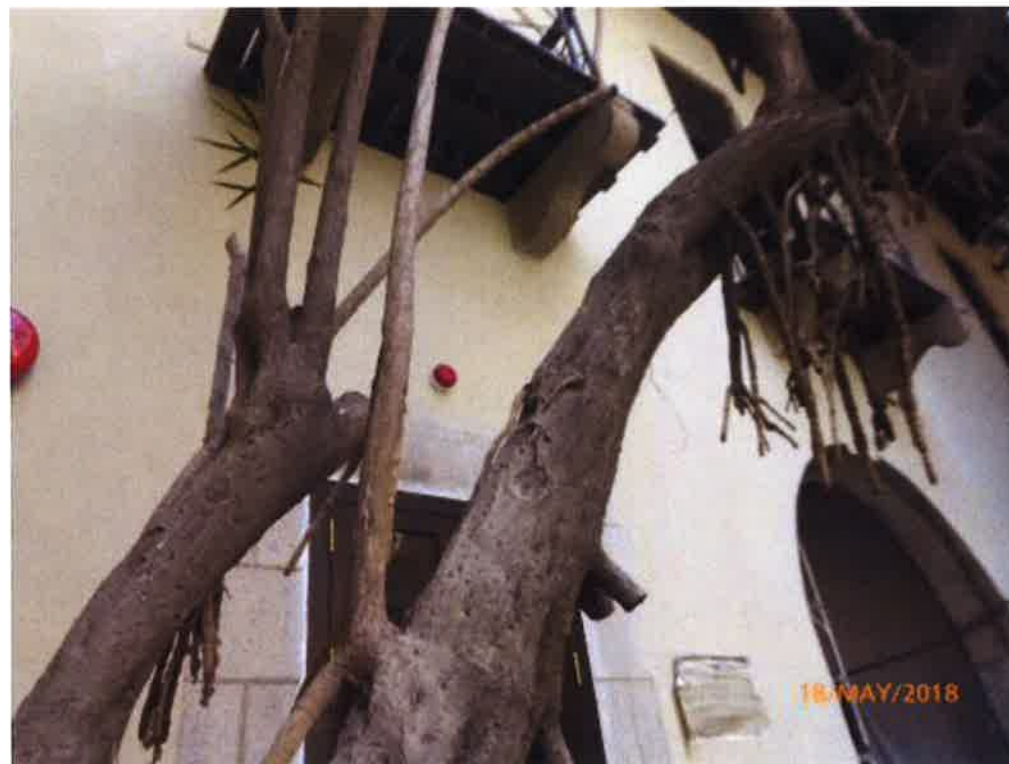
Fig. 6 A few withered leaves still remain on the upper branches.

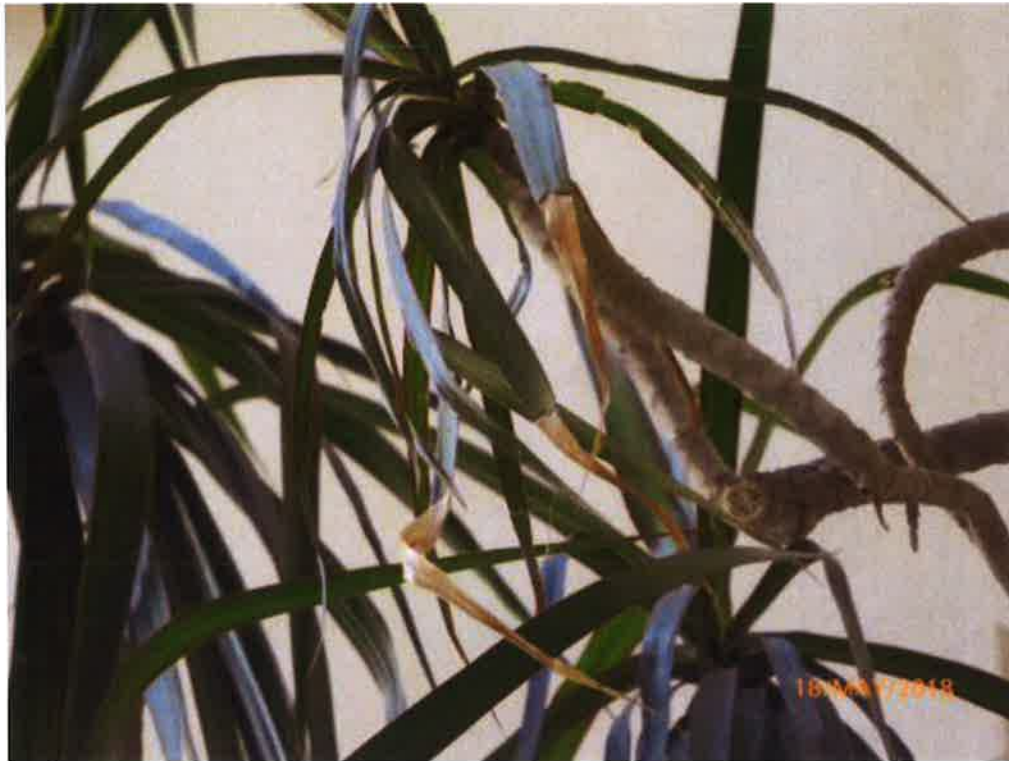
Fig. 7 Two cutting wounds have been covered with Tree Seal during the pruning/trimming work on 28<sup>th</sup> April 2018.

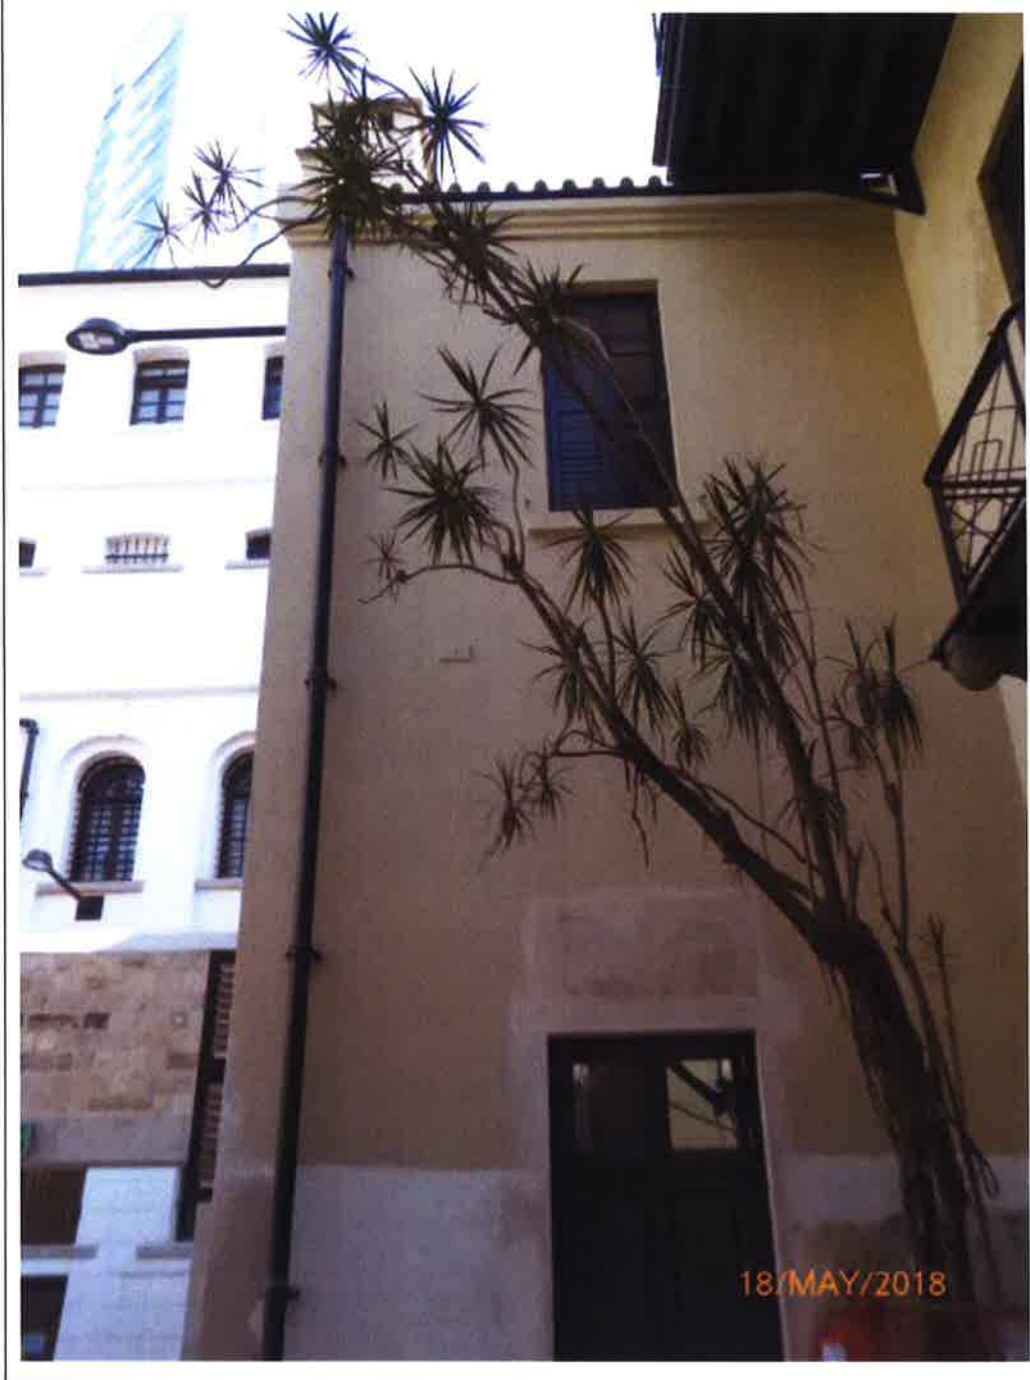
Fig. 12 Overall view of Tree-11 during inspection on 18<sup>th</sup> May 2018.
