The Jockey Club CPS Limited

Central Police Station Conservation and Revitalisation Project: 24<sup>th</sup> Quarterly EM&A Report (1 August 2017 to 31 October 2017)

Issue Date: February 2018

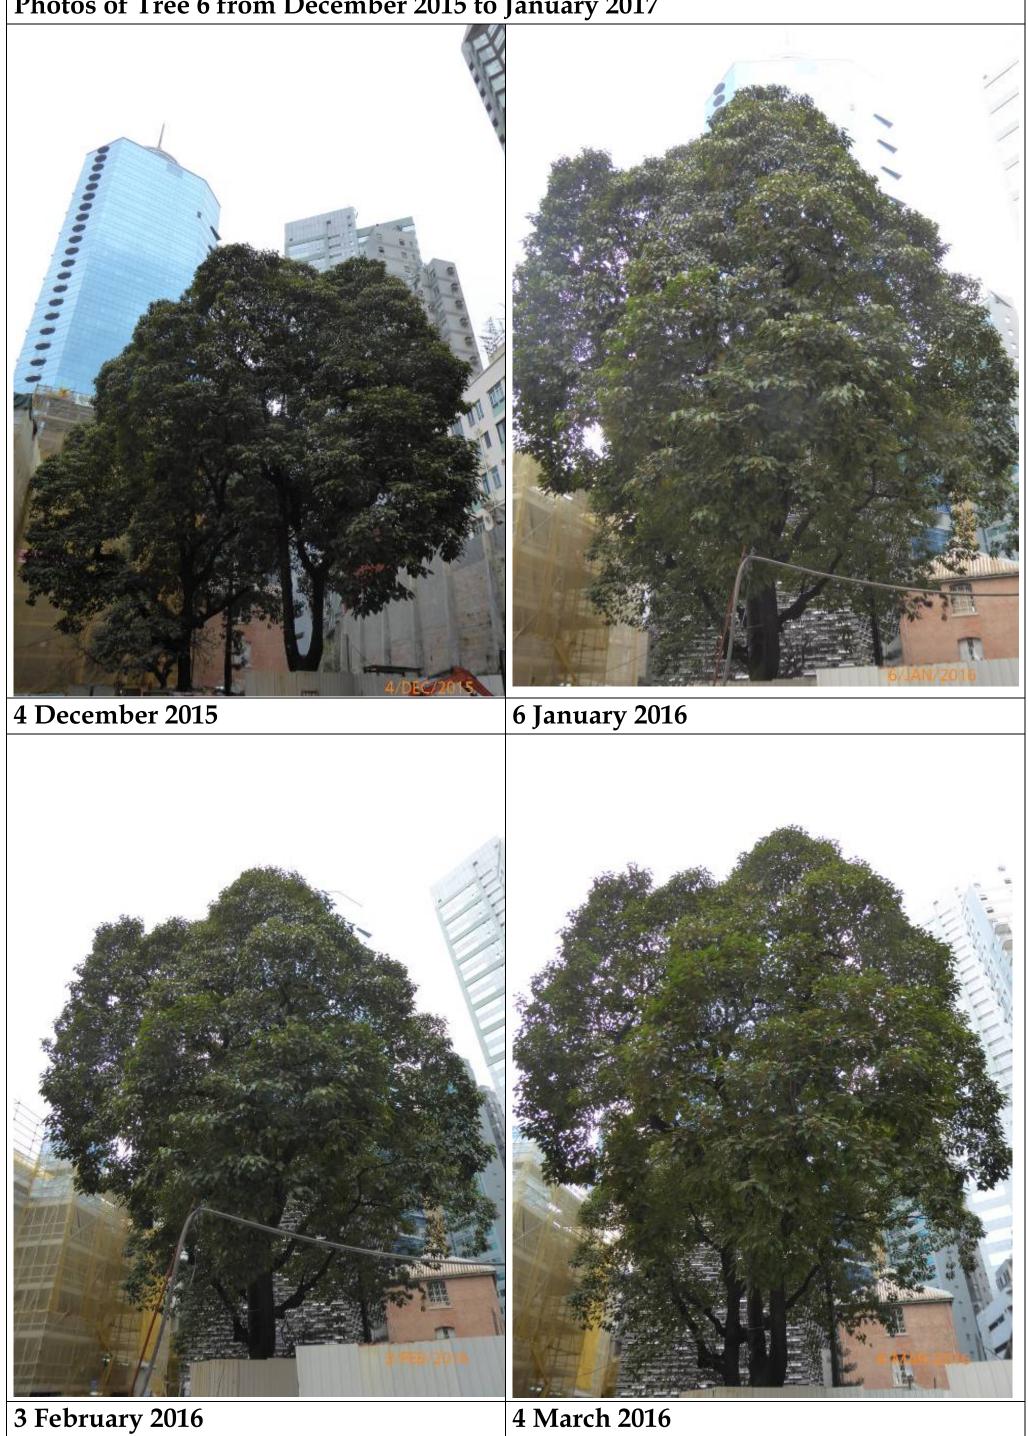
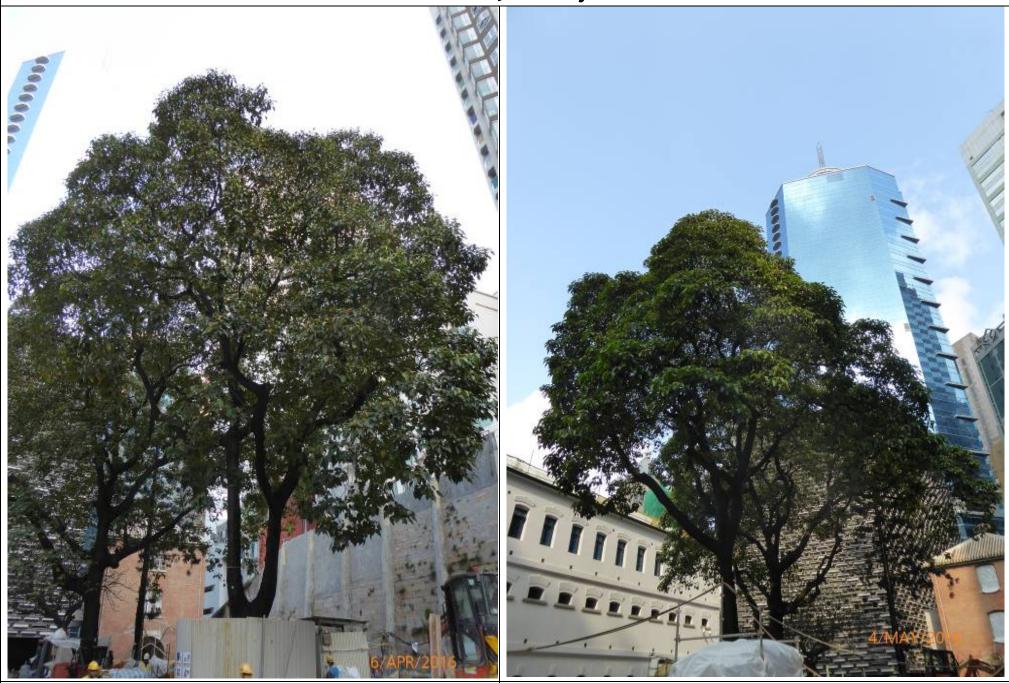
i) Presence of pests – Besides the pests (*Trialeurodes vaporariorum*) which were recently discovered during the tree inspection on 10 July 2017, Tree 6 and Tree 7 have also been infected with the pest Mealy Bugs in April 2016. Pests present on the leaves take up nutrients from the trees, causing loss of leaves and potential deterioration of the health of the trees. Subsequent application of pesticides and pruning of affected leaves and branches were performed on 25 April 2016 and proved effective with signs of pests apparently reduced and hardly found after the application. Although the trees were clear of pests after the pest application on 25 April 2016, gradual loss of leaves at Tree 6 and Tree 7 can be observed since around May 2016.

ii) Age of the trees – Tree 6 and Tree 7 were planted in 1960s and are currently about 50-60 years of age. According to the arborist responsible for the trees on site and other experienced arborists in Hong Kong, Aleurites moluccana (Tree 6 and Tree 7), which is a non-native species, generally has a life expectancy of about 60 to 80 years. The loss of leaves and possible deterioration of health may reflect the natural aging of the tree.

All construction works are carried out strictly following the necessary requirements specified in the EP, EIA, and the EM&A Manual of this Project. Application of pesticides and pruning of decayed log have been conducted on Tree 6 and Tree 7 on 3 and 4 August 2017 after the discovery of the presence of pest (*Trialeurodes vaporariorum*) during the tree inspection on 10 July 2017. As observed by the arborist in the inspection on 12 August 2017, the pests on Tree 6 and Tree 7 appeared to be under control. Further application of pesticides is considered not necessary at the moment but the arborist will continue to closely monitor the effectiveness of the pesticide and the health of the trees and apply further measures if required.
