The Jockey Club CPS Limited

Central Police Station Conservation and Revitalisation Project: 25th Quarterly EM&A Report (1 November 2017 to 31 January 2018)

Issue Date: March 2018

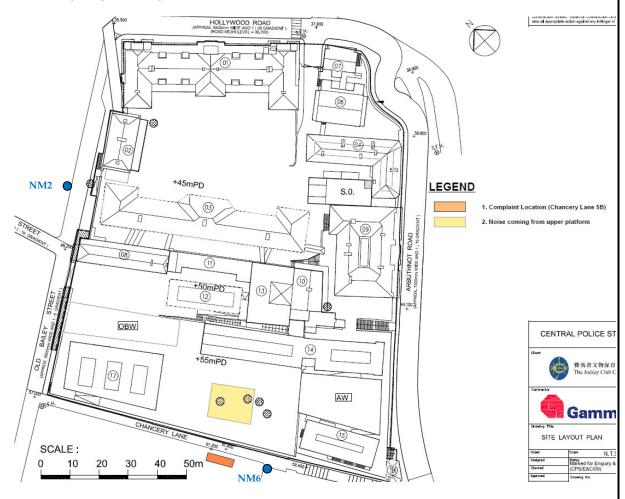
It can be seen that recent noise measurements at NM2 and NM6 comply with the relevant noise criterion. Concrete breaking works were carried out during the noise monitoring period on 20 December 2017 and the measured noise level during that period complied with the noise criterion.

3. After receiving the complaint, the Contractor has provided acoustic blanket to the head of the breaker and such provision shall continue to be implemented when the breaker is used.

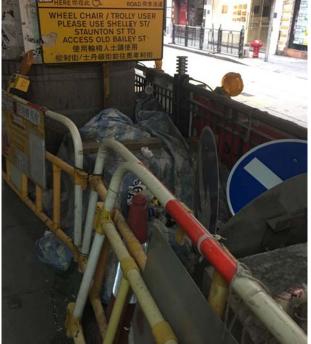
Photo 2: Temporary Storage Area (CPS Site)

- 2. A small area at the junction of Old Bailey Street and Hollywood was barricaded for temporary storage of materials for the ongoing footbridge construction. A photo of the temporary storage area is shown in *Photo* 2 and its location is shown in *Figure* 1. No construction waste is placed in the temporary storage area. The temporary storage area, which is included in the approved works area for the footbridge construction, only occupies part of the sidewalk of Hollywood Road and is considered not causing significant obstruction to the pedestrians. The temporary storage area would be in place until June 2018 which is the expected completion month of the footbridge construction.

All construction works are carried out strictly following the necessary requirements specified in EIA, EM&A Manual, EMP, Method Statements, General and Particular Specifications of this Project. The Contractor has been reminded to maintain tidiness of the construction waste skip and its surroundings. Construction waste should only be stored inside the waste skip and should be cleared on a daily basis to prevent accumulation. With regard to the temporary storage area at the junction of Old Bailey Street and Hollywood Road, the Contractor was also reminded to keep the temporary storage area tidy and clear of litter.

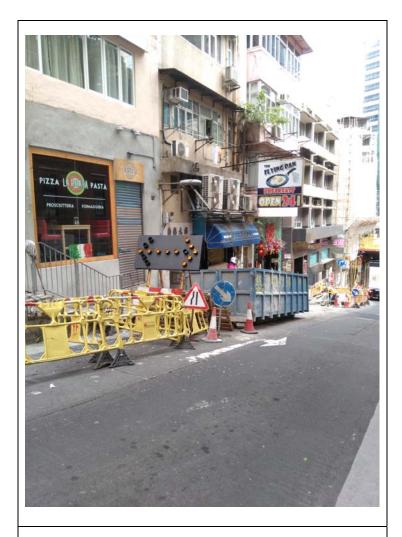
Photo 3: Construction Waste Skip (Other Construction Site)

- 3. A waste skip which belongs to a construction site opposite to the CPS Site is located on the west side of Old Bailey Street near the junction of Old Bailey Street and Hollywood (*Figure 1*). A photo of the waste skip is shown in *Photo 3*. As the complainant mentioned the presence of the waste skip causing obstruction of road at Old Bailey Street, it is suspected that the complainant is referring to this waste skip which is not managed by the CPS Site.
