The Jockey Club CPS Limited

Central Police Station Conservation and Revitalisation Project: 30th Quarterly EM&A Report (1 July 2023 to 30 September 2023)

Issue Date: December 2023

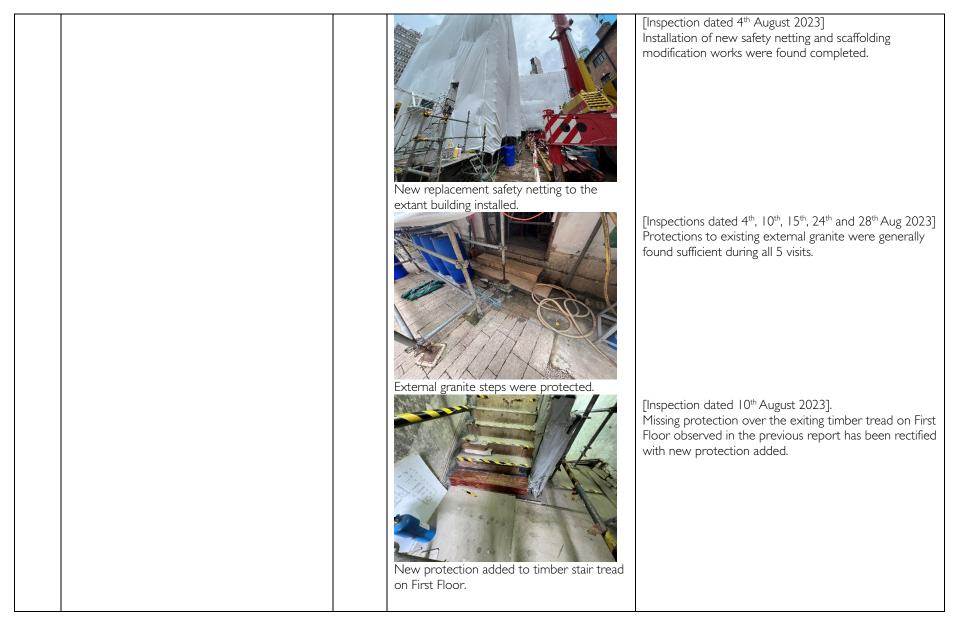
Excessive mortar in the affected areas was removed and cleaned off.	 [Inspection dated 24th August 2023]. Missing protection was observed on exiting walls and skirting in areas adjacent concreting works. The consequence of this was splashes of concrete mortar on the historic fabric. Purcell immediately notified the Contractor. The Contractor was requested to clean and remove the splashes from the affected surfaces and then apply appropriate protection over historic fabric adjacent to active concreting works. [Inspection dated 28th August 2023]. Splashes of concrete on walls and skirting had been removed. Note: Since the concreting works had been completed in this area, there was no protective covering in place during the inspection.

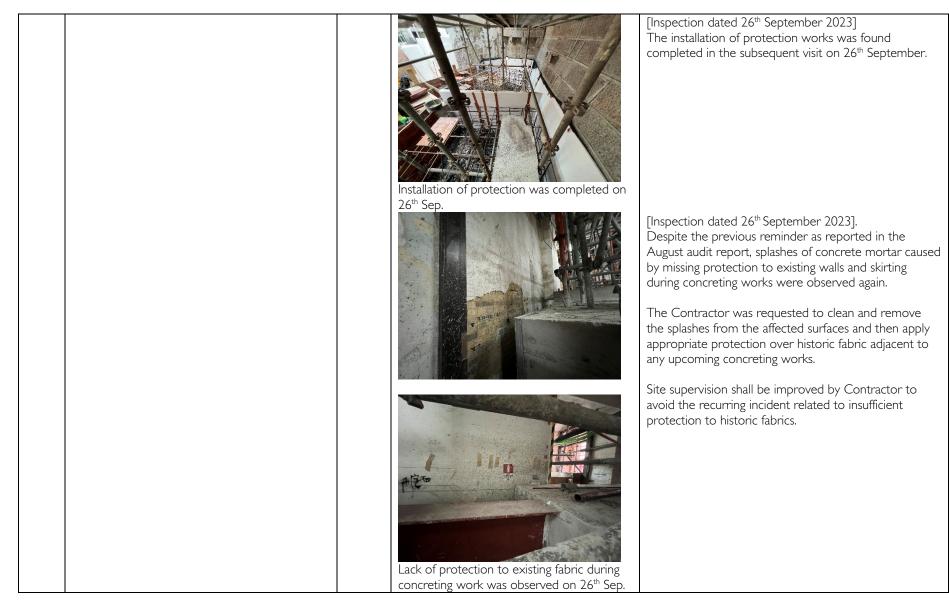
3.5	Is protection of the existing building adequate and effective?	4/10	Protections to existing timber windows.	[Inspections dated 12 th , 14 th , 22 nd and 26 th Sep 2023] Protections to existing timber windows and doors insitu were generally found sufficient during all visits.
			New replacement safety netting to the	[Inspection dated 22 nd September 2023] Previously removed windows casements and shutters were relocated to the outdoor area near the building entrance due to insufficient working space internally. The protection was found to be deteriorating and all windows/shutters were sitting directly on ground without any pallet or spacer provided to prevent water ingress. Contractor was requested to rectify this by improving protection and providing spacer or pallet.
			extant building installed. When the second	[Inspection dated 22 nd September 2023] The reinforcement works for the hoarding construction in Sergeant Yard was progressing. No protection to the granite retaining walls was observed. Purcell immediately notified the Contractor. The Contractor was requested to provide the protection as per the approved method statement. Site supervision shall be improved by Contractor to ensure the compliance with the approved method statement and contract document.
