Our Ref: WMA20002/AECOM/it200826

8/F Grand Central Plaza Tower 2
138 Shatin Rural Committee Road
Shatin, Hong Kong

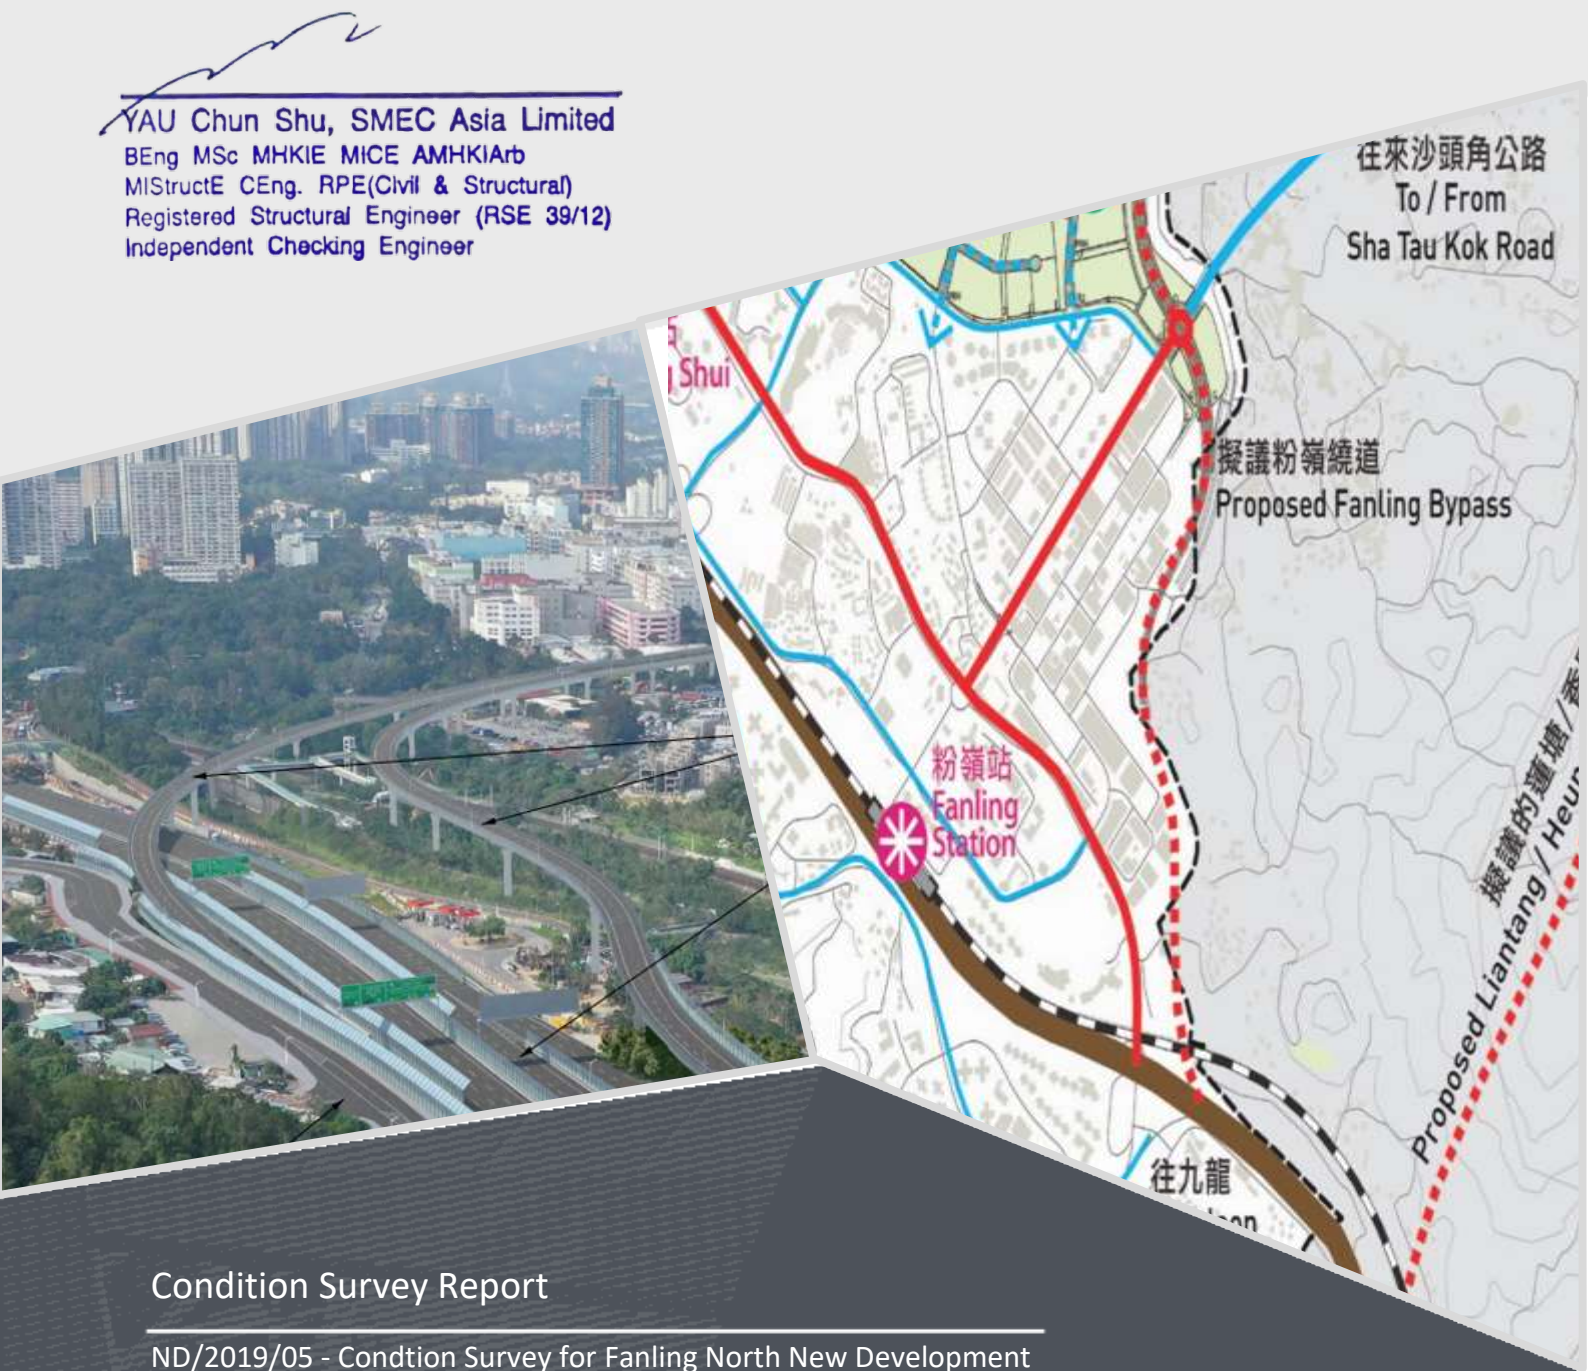
Condition Survey Report

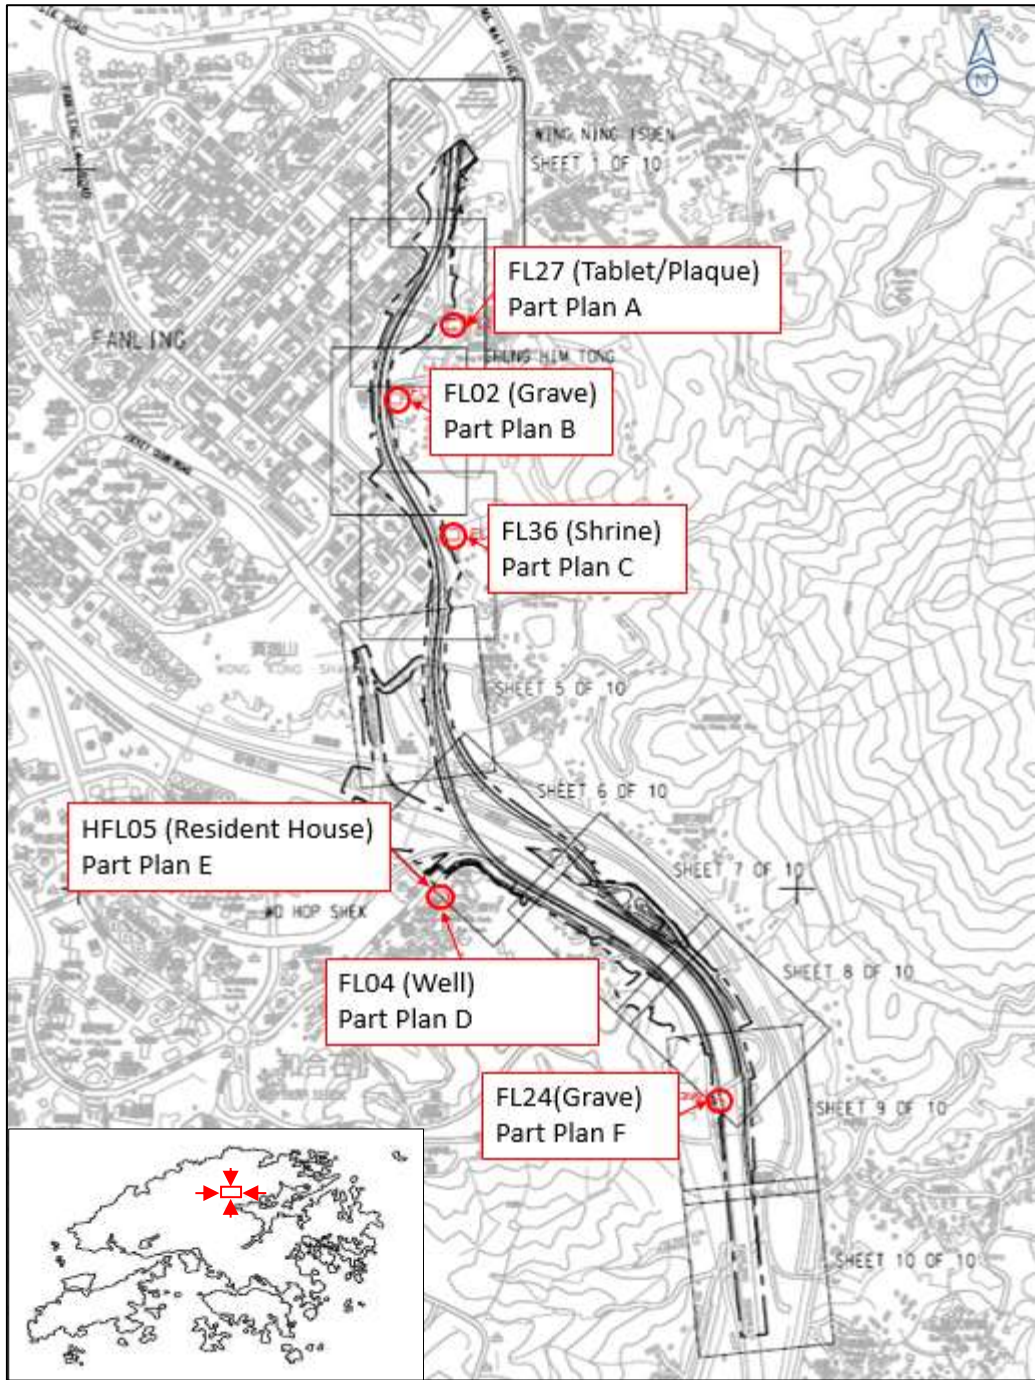
2 CONDITION SURVEY METHODOLOGY

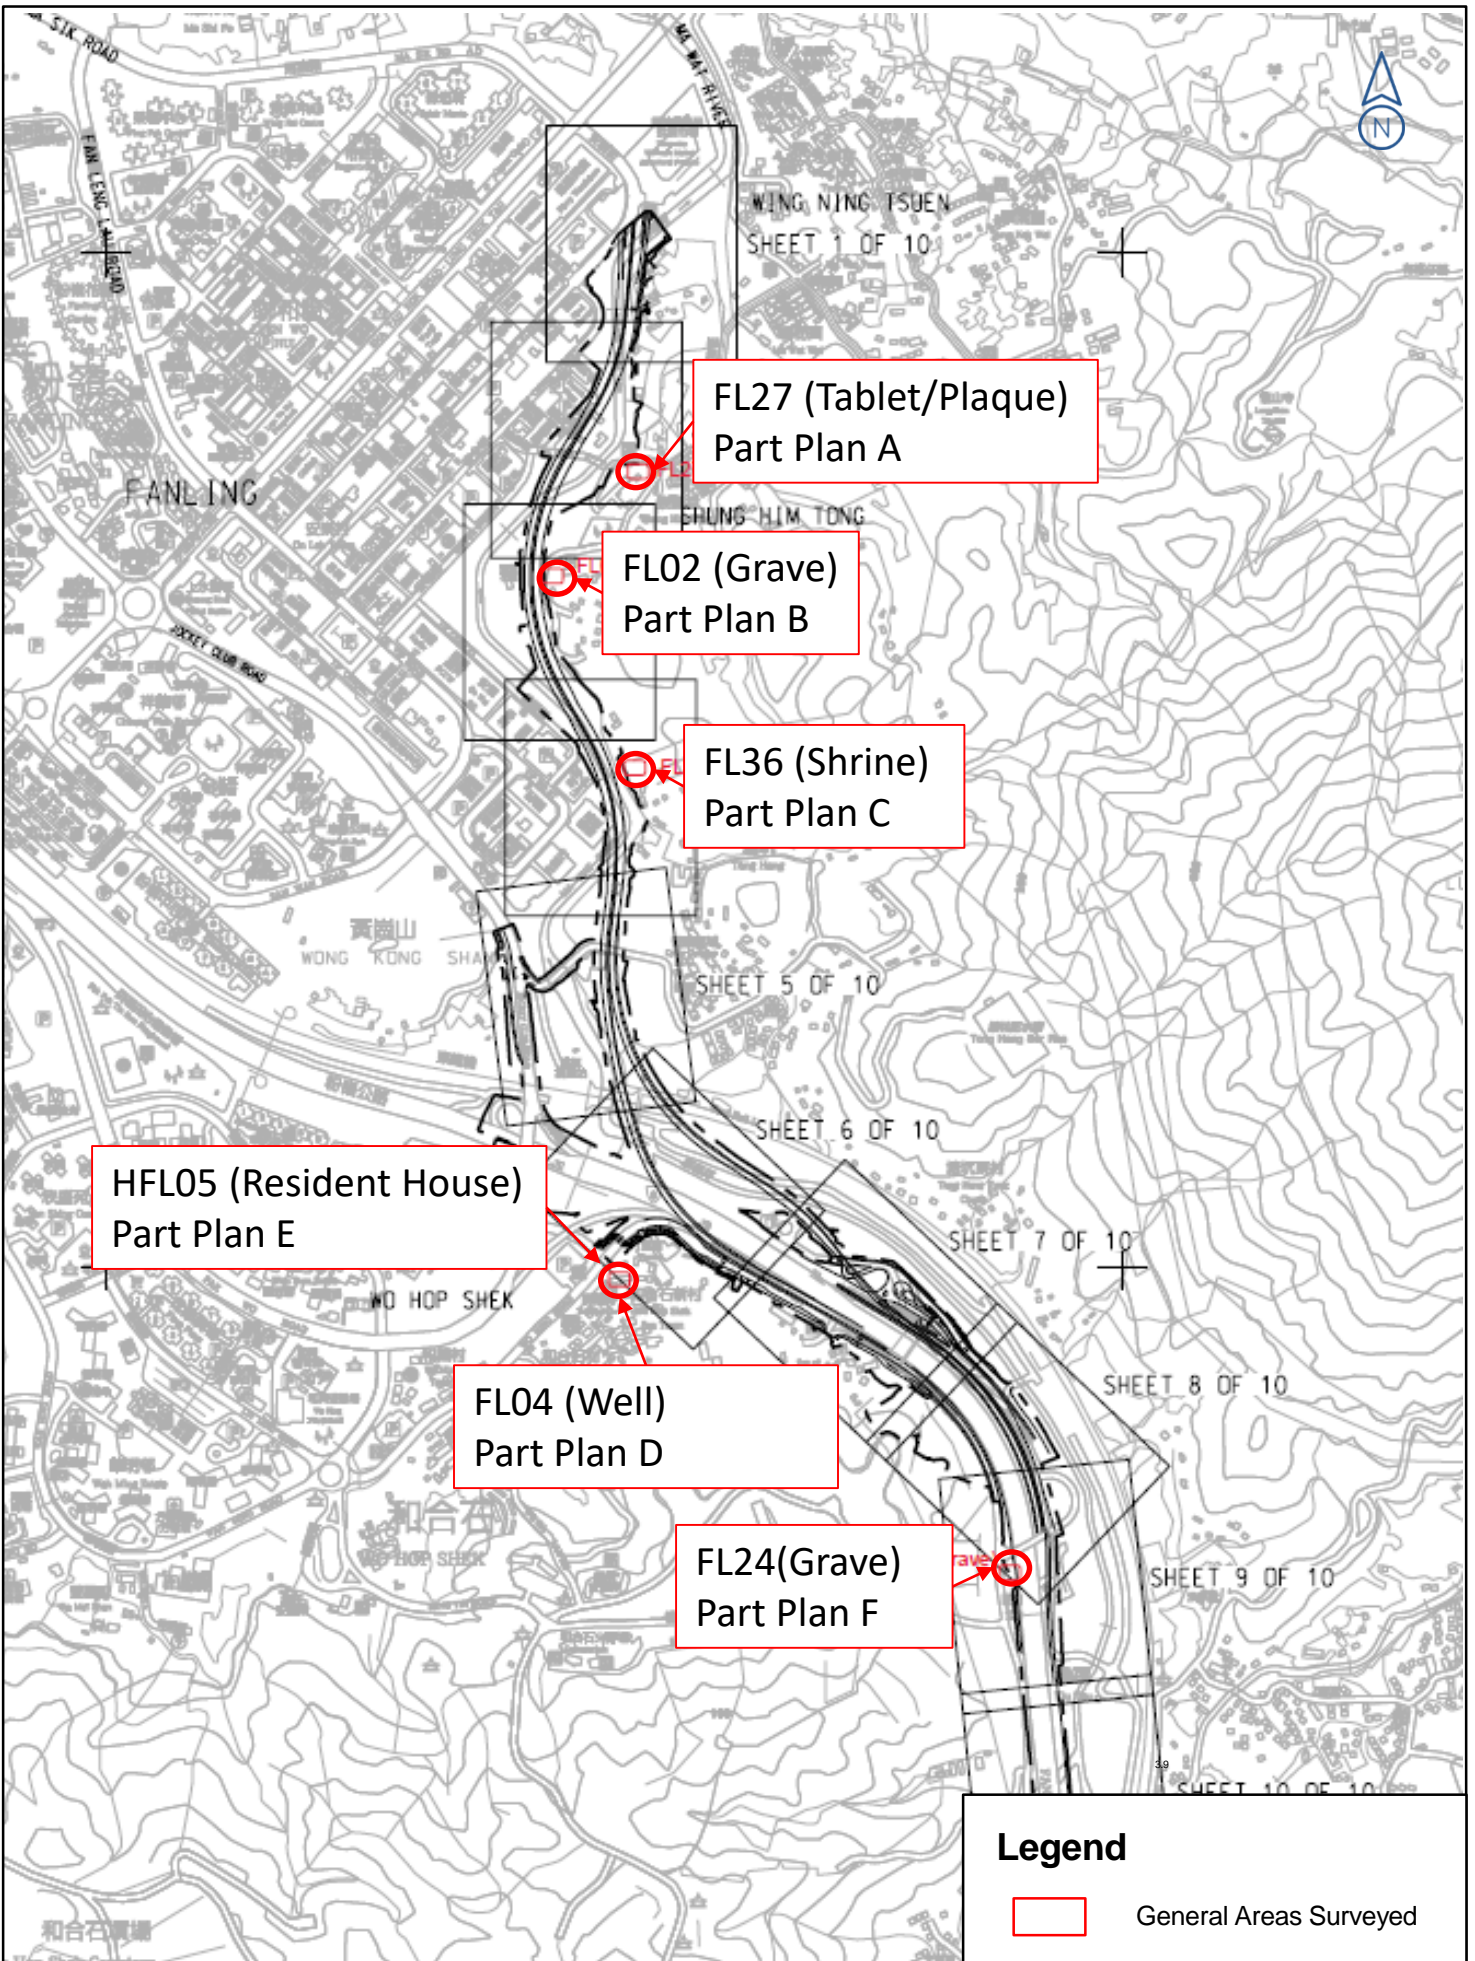
Appendix A LAYOUT PLAN OF CULTURAL HERITAGE

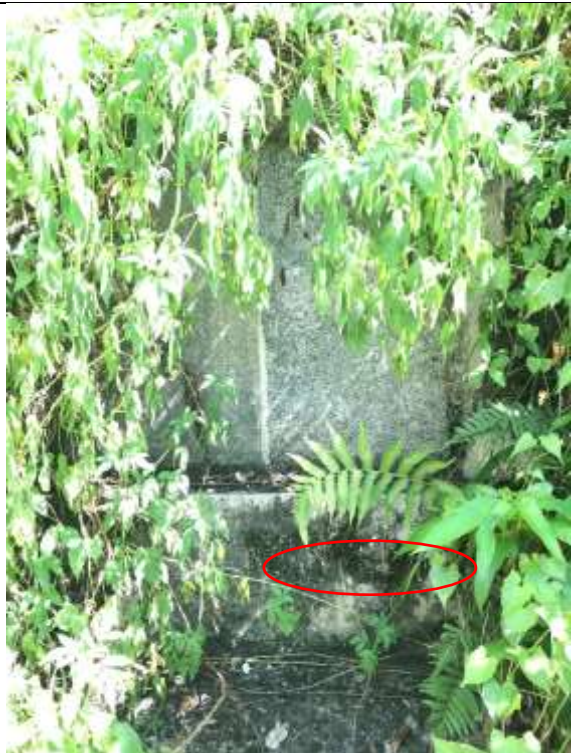
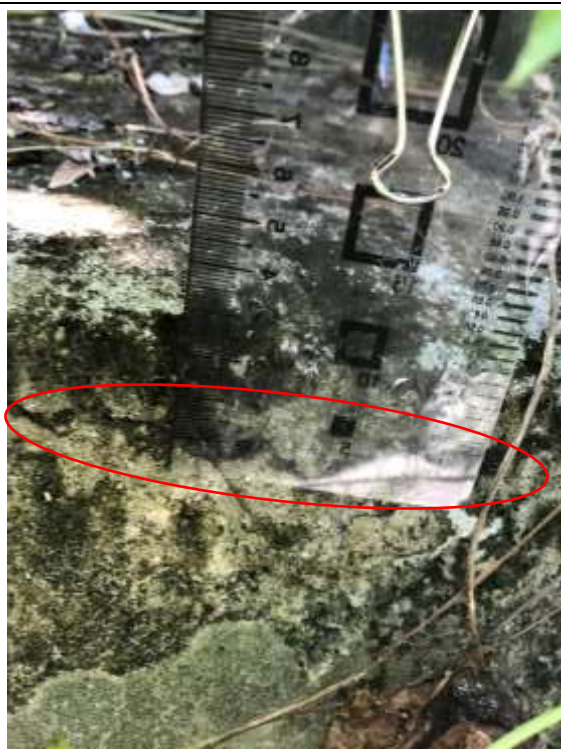
<p>1A-D1(1) - Moderate Crack on Tablet (General View)</p>	<p>1A-D1(2) - Moderate Crack on Tablet (Length:300mm/Width:2mm)</p>

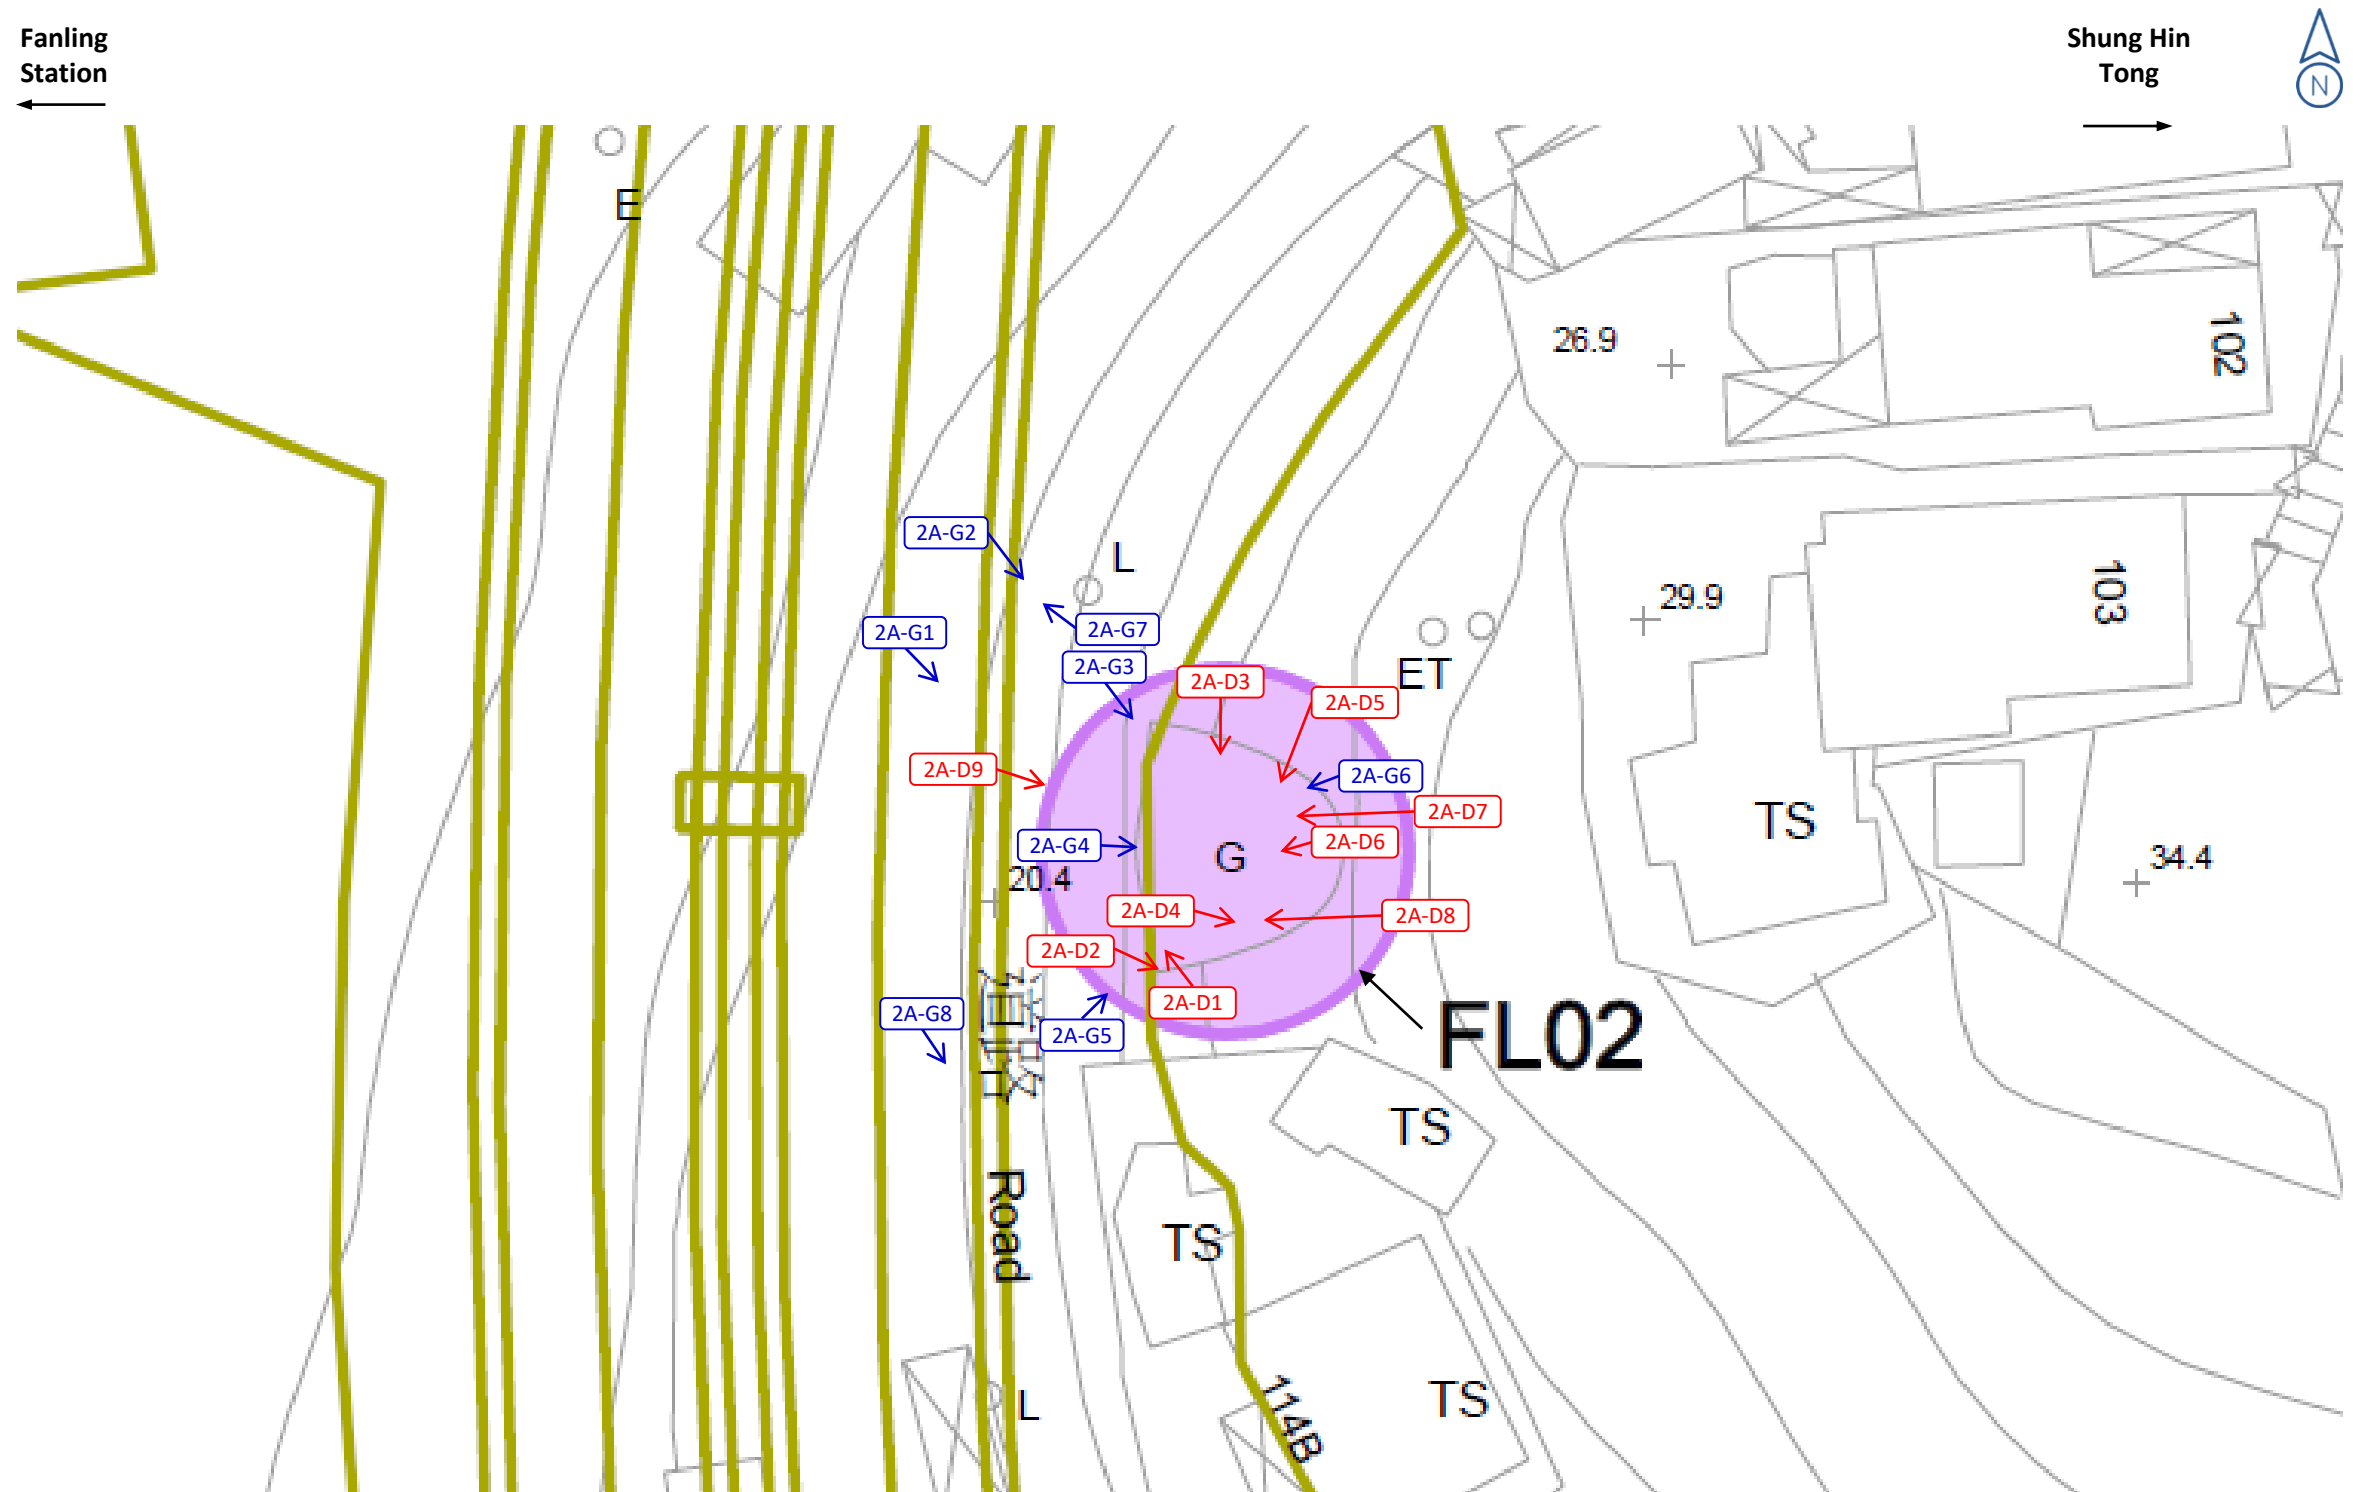
**Part Plan B - Layout Plan of FL02
with Location of General Photos**

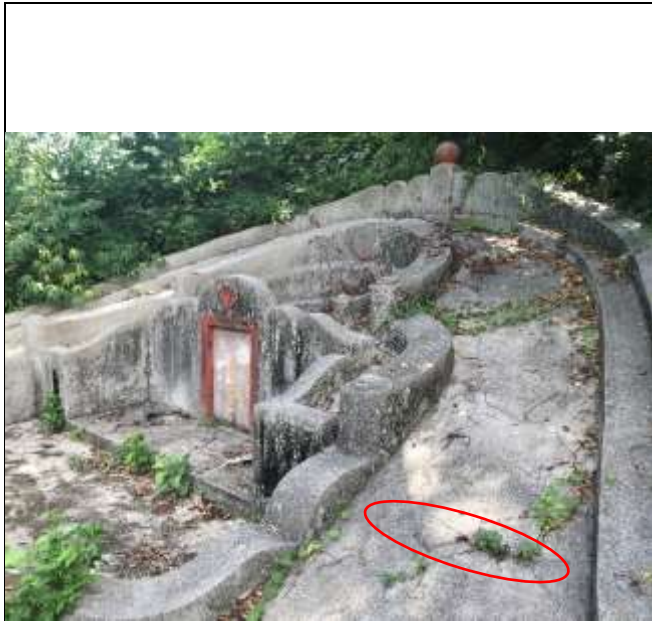
2A-D1(1) - Moderate Crack on Surface
(General View)

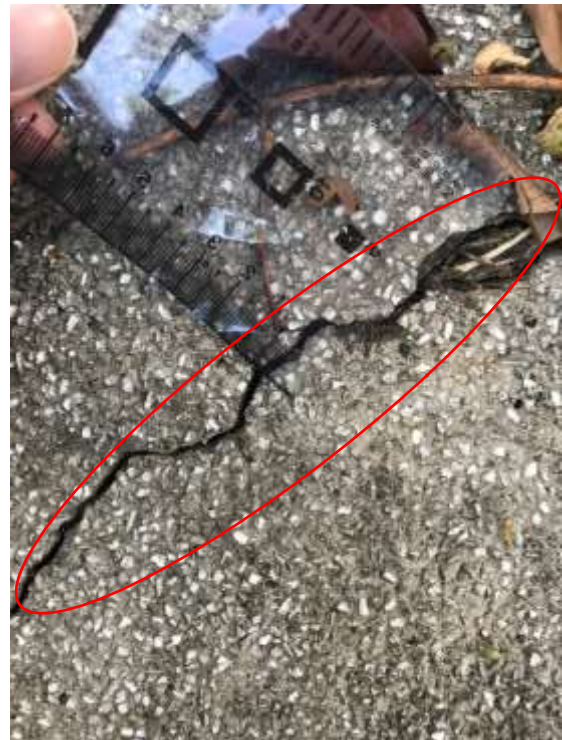
2A-D1(2) - Wide Crack on Surface
(Length:1000mm/Width:2.5mm)

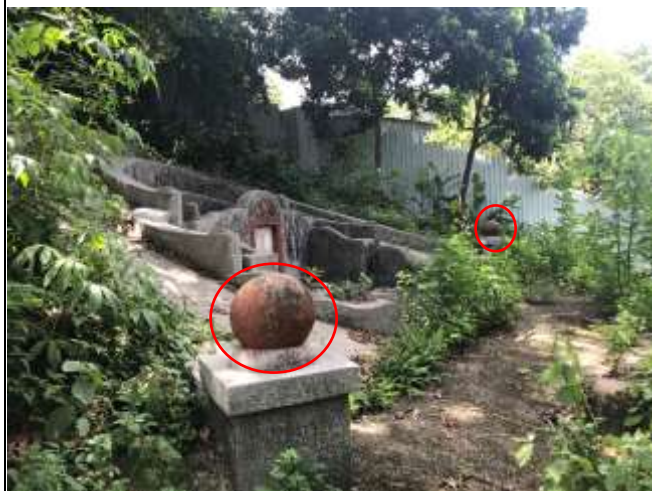
2A-D2(1) - Peeling Paint from Surface
(General View)

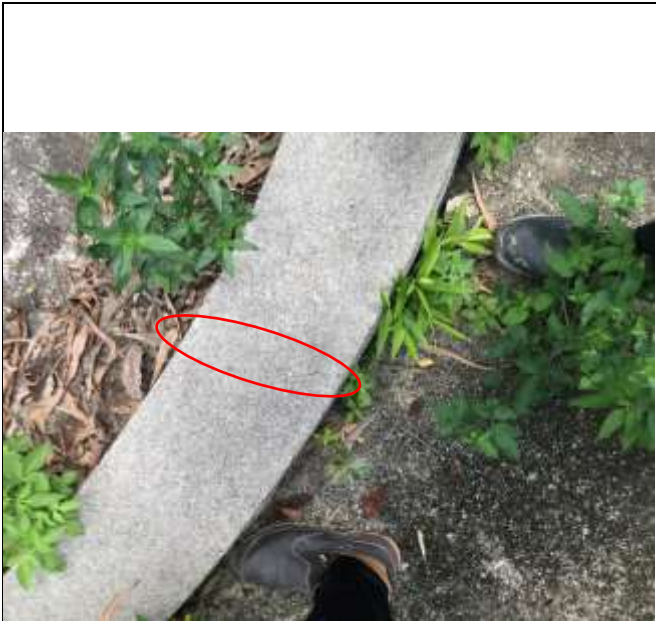
2A-D3(1) - Fine Crack on Surface
(General View)

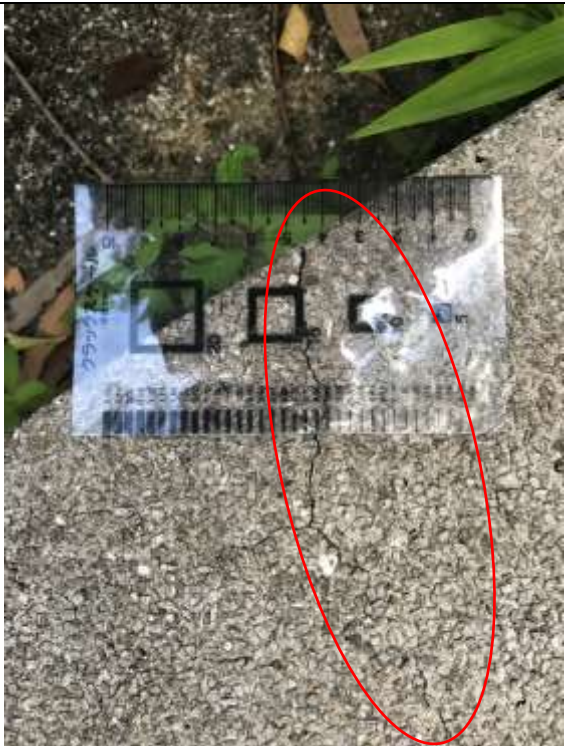
2A-D3(2) - Fine Crack on Surface
(Length:200mm/Width:0.65mm)

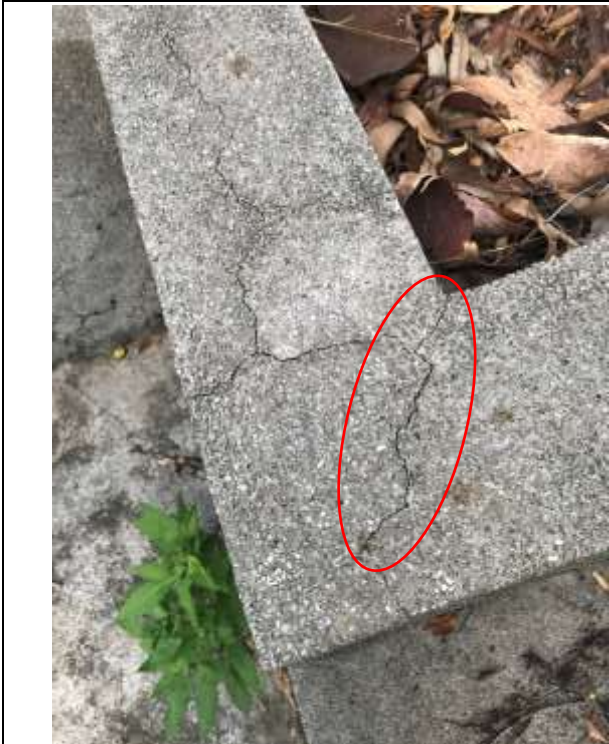
2A-D4(1) - Fine Crack on Surface
(General View)

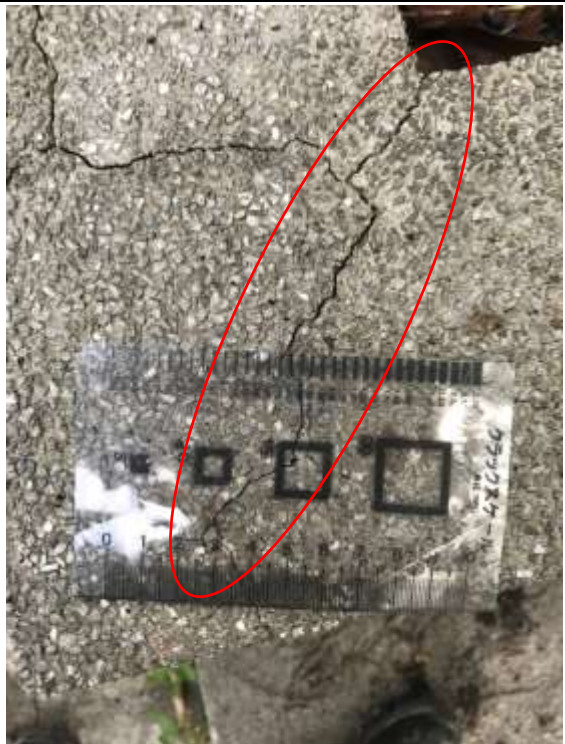
2A-D4(2) - Fine Crack on Surface
(Length:200mm/Width:0.80mm)

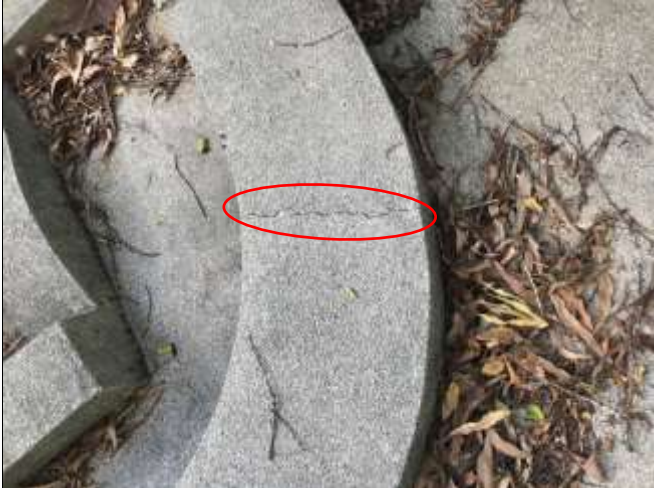
<p>2A-D5(1) - Moderate Crack on Surface (General View)</p>	<p>2A-D5(2) - Moderate Crack on Surface (Length:250mm/Width:1.20mm)</p>

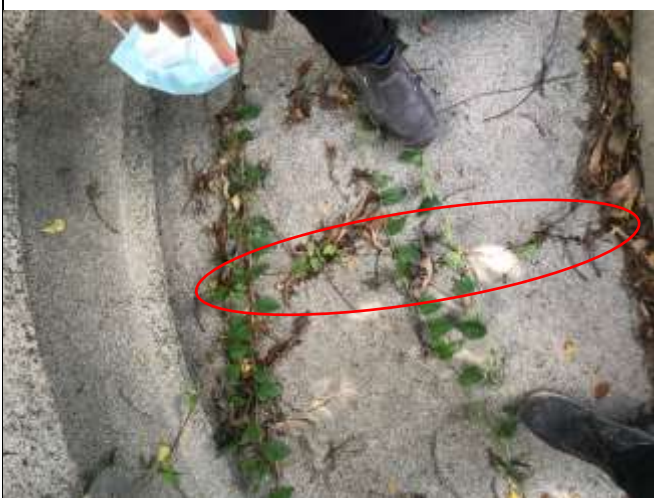
<p>2A-D6(1) - Moderate Crack on Surface (General View)</p>	<p>2A-D6(2) - Moderate Crack on Surface (Length:1200mm/Width:1.50mm)</p>

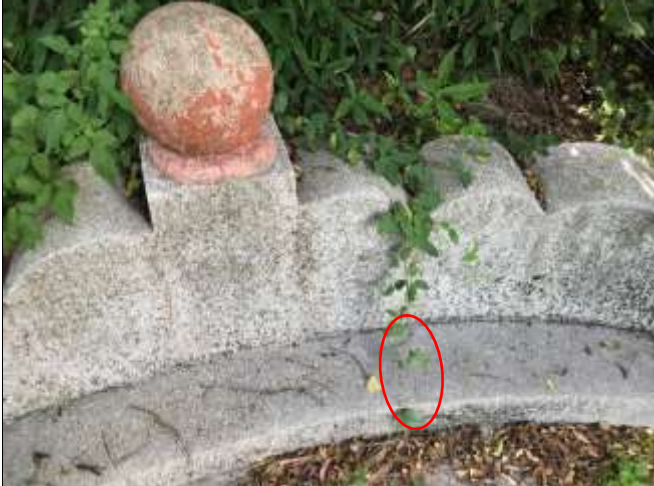
<p>A photograph showing a concrete surface with a fine crack. A red oval highlights the crack. The background shows some green foliage and a stone structure.</p>

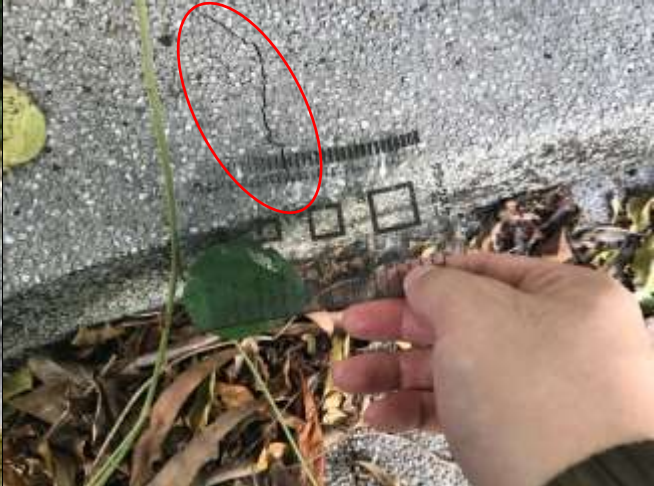
<p>A close-up photograph of a fine crack on a concrete surface. A ruler is placed next to the crack for scale. A red oval highlights the crack.</p>
<p>2A-D7(1) - Fine Crack on Surface (General View)</p>	<p>2A-D7(2) - Fine Crack on Surface (Length:250mm/Width:0.60mm)</p>

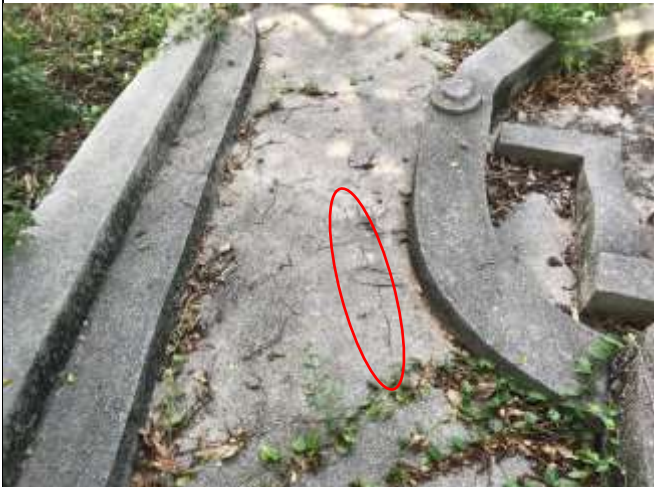
<p>A photograph showing a wide crack on a concrete surface. A red oval highlights the crack. The background shows some green foliage and a stone structure.</p>

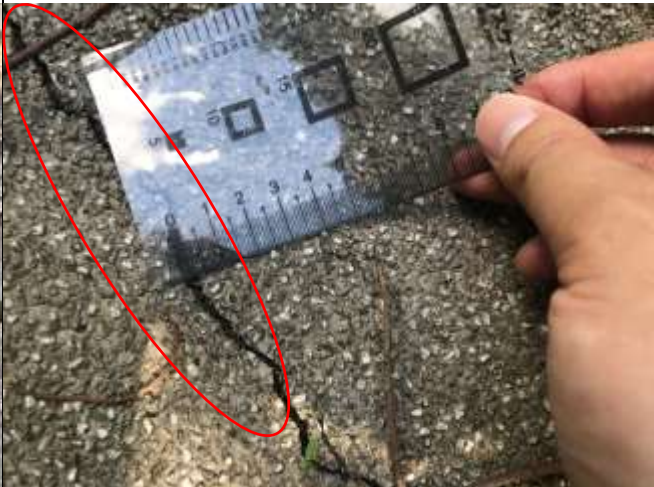
<p>A close-up photograph of a wide crack on a concrete surface. A ruler is placed next to the crack for scale. A red oval highlights the crack.</p>
<p>2A-D8(1) - Wide Crack on Surface (General View)</p>	<p>2A-D8(2) - Wide Crack on Surface (Length:1200mm/Width:3.00mm)</p>

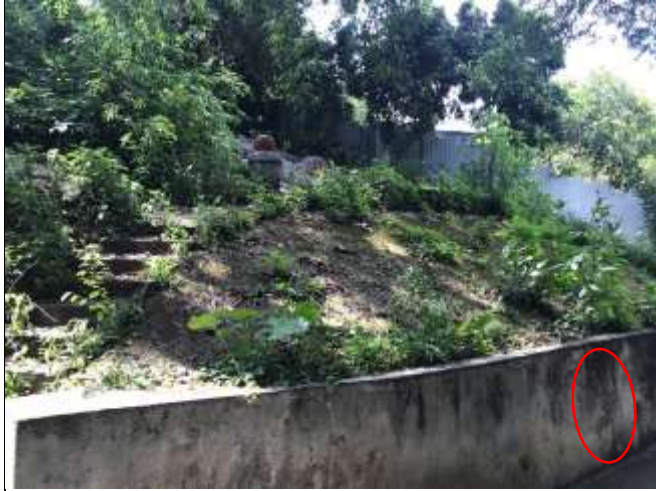
<p>2A-D9(1) - Wide Crack on Surface (General View)</p>	<p>2A-D9(2) - Wide Crack on Surface (Length:1000mm/Width:3.00mm)</p>

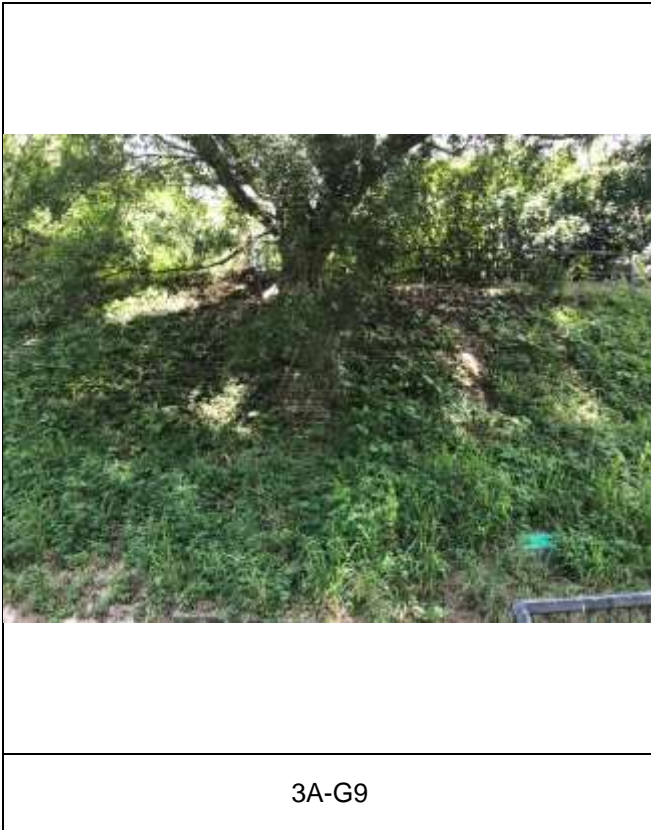
Appendix B – Detailed Inspection Report of General Areas
Part Plan C – FL36 (Shrine)
Date of Photo Taken: 13rd July 2020

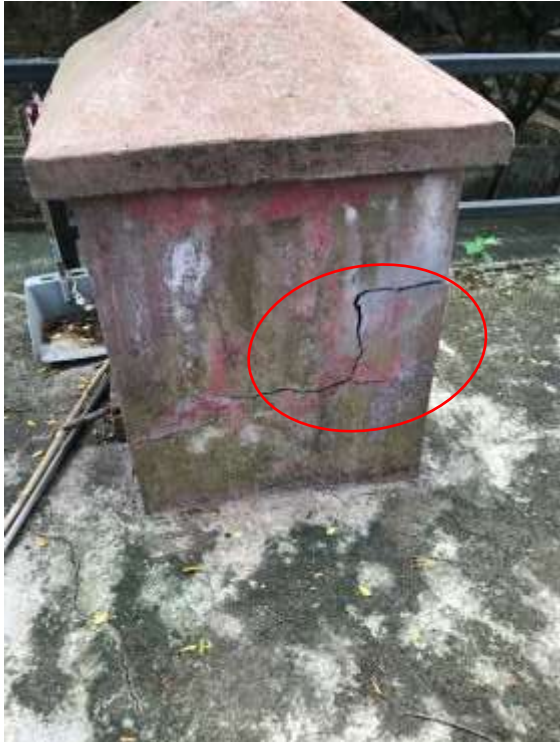
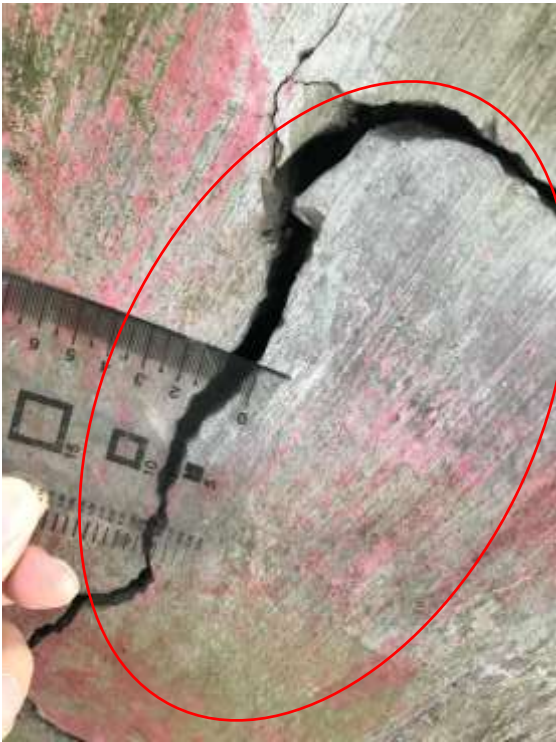
<p>3A-D1(1) - Moderate Crack on Surface (General View)</p>	<p>3A-D1(2) - Wide Crack on Surface (Length:1000mm/Width:2.00mm)</p>

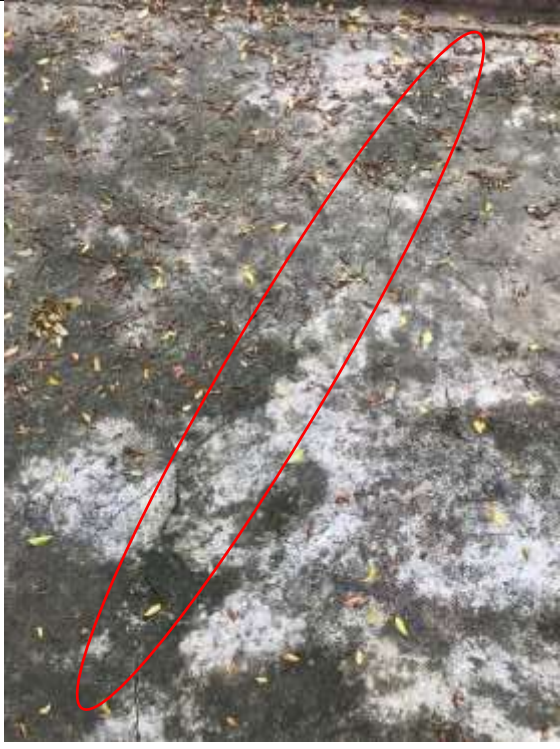
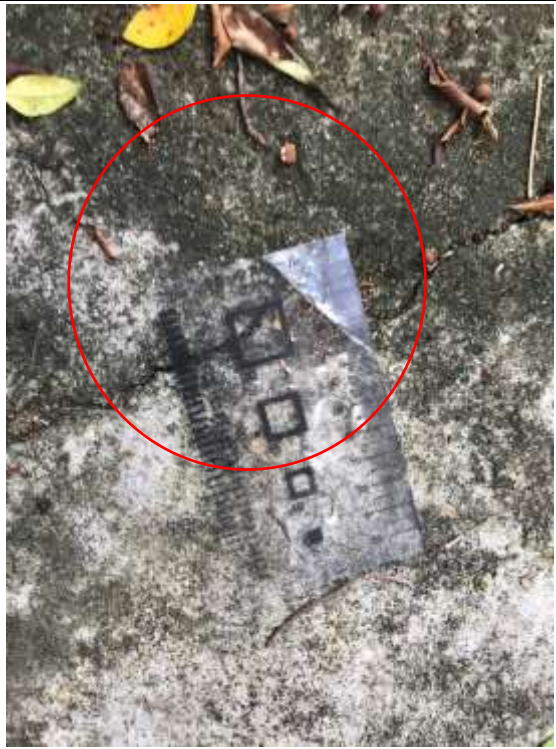
<p>3A-D2(1) - Moderate Crack on Floor (General View)</p>	<p>3A-D2(2) – Moderate Crack on Floor (Length:3000mm/Width:1.10mm)</p>

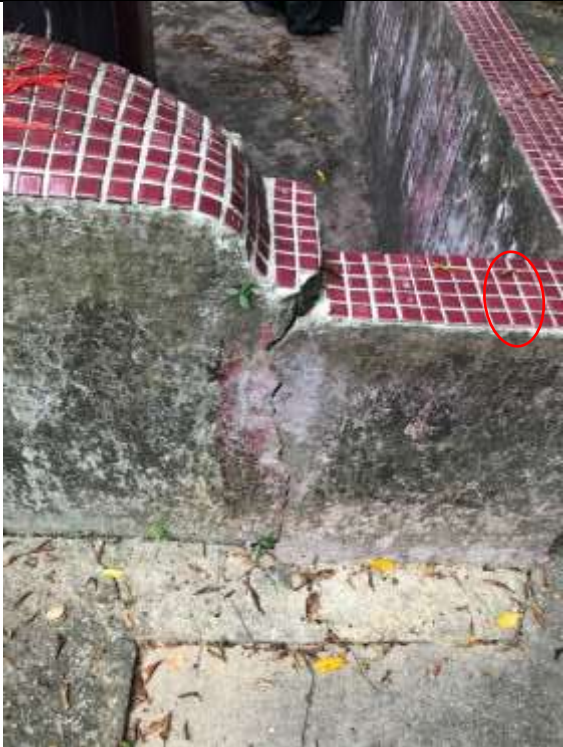
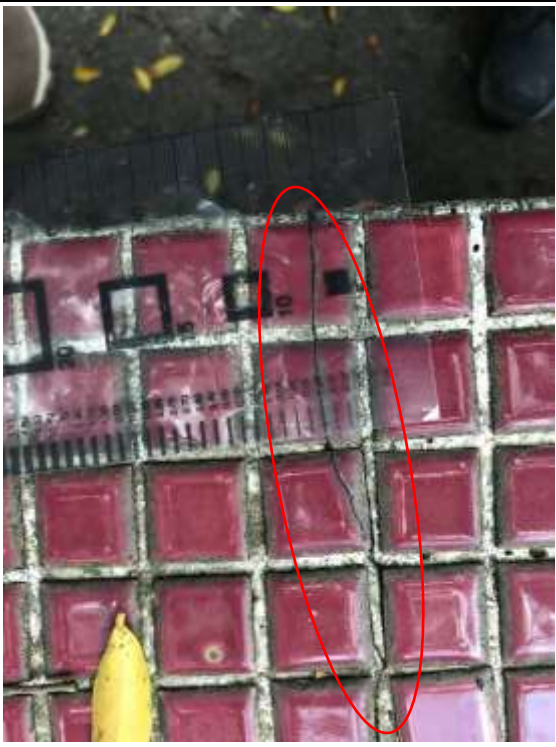
<p>3A-D9(1) - Fine Crack on Surface (General View)</p>	<p>3A-D9(2) - Fine Crack on Surface (Length:100mm/Width:0.20mm)</p>

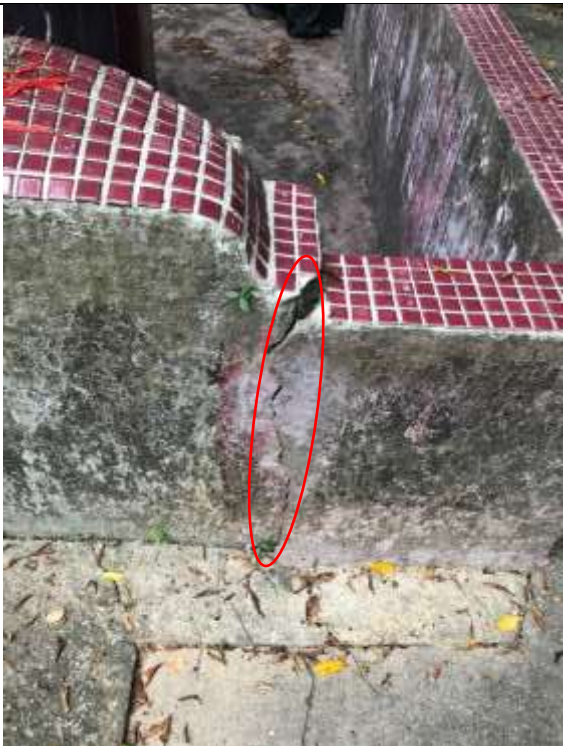
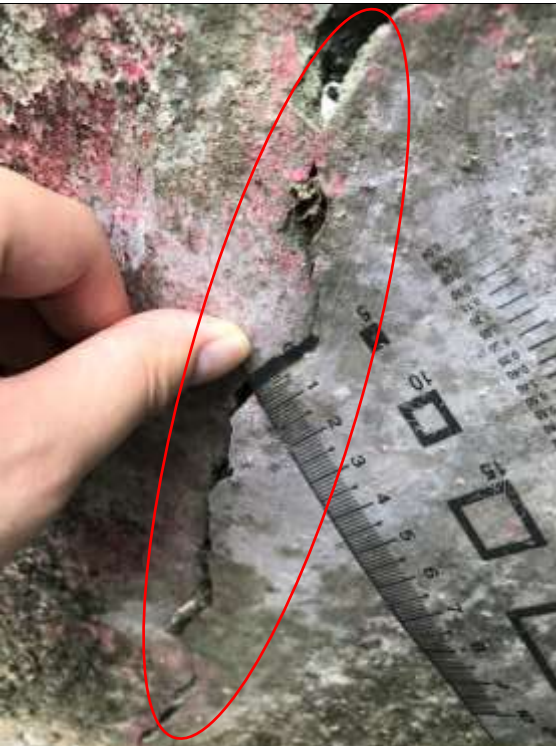
<p>3A-D10(1) - Wide Crack on Surface (General View)</p>	<p>3A-D10(2) - Wide Crack on Surface (Length:800mm/Width:3.40mm)</p>

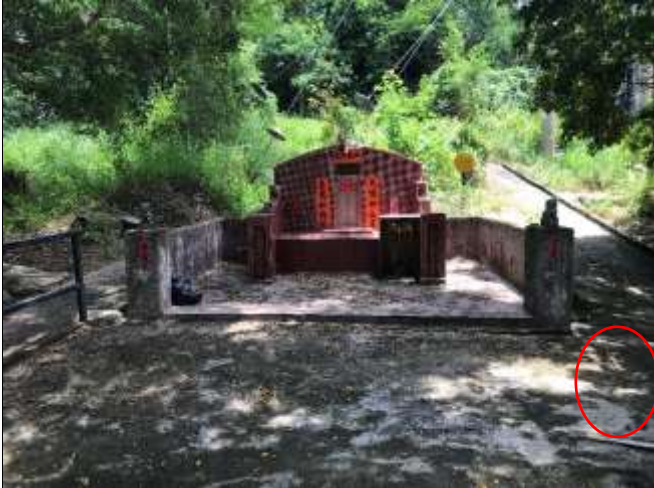
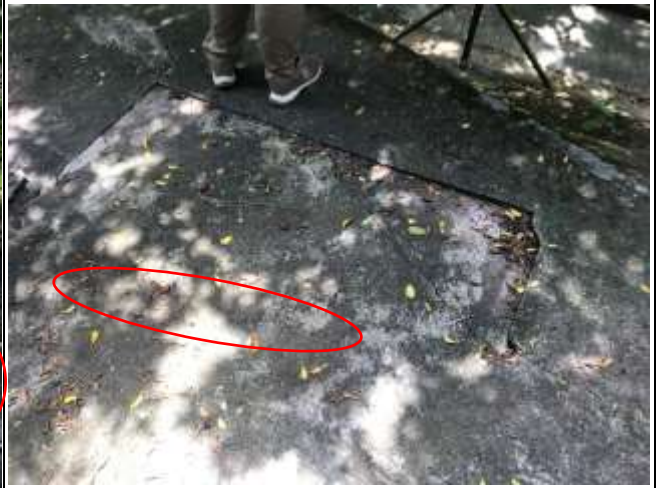
<p>3A-D13(1) - Ravelling on Floor Surface (General View)</p>	<p>3A-D13(1) - Ravelling on Floor Surface</p>

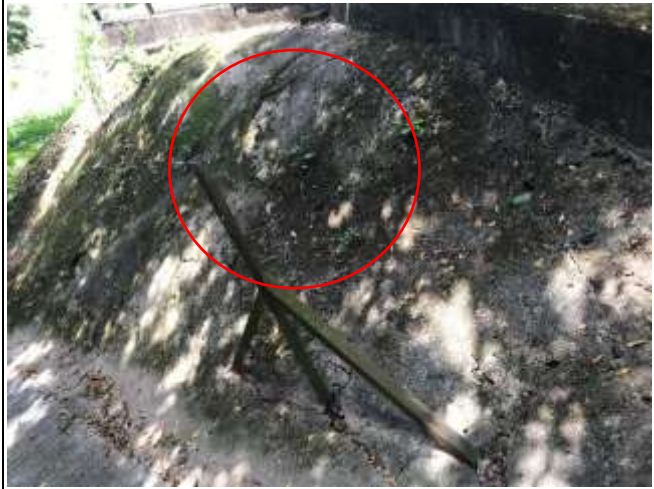
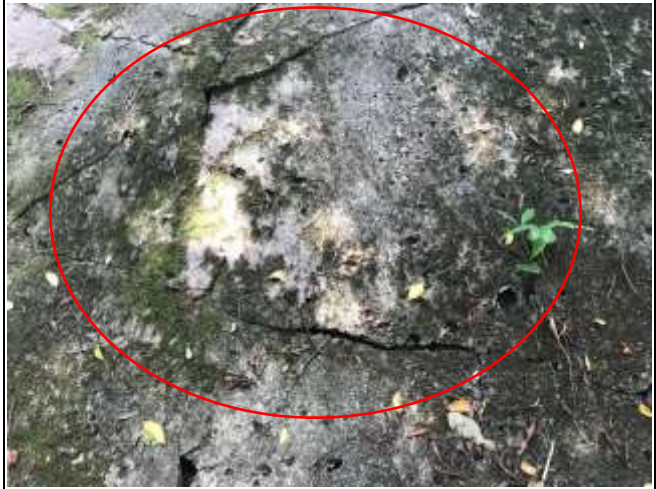
<p>3A-D14(1) - Wide Crack on Slope (General View)</p>	<p>3A-D14(2) - Wide Crack on Slope (Width:8.00mm)</p>

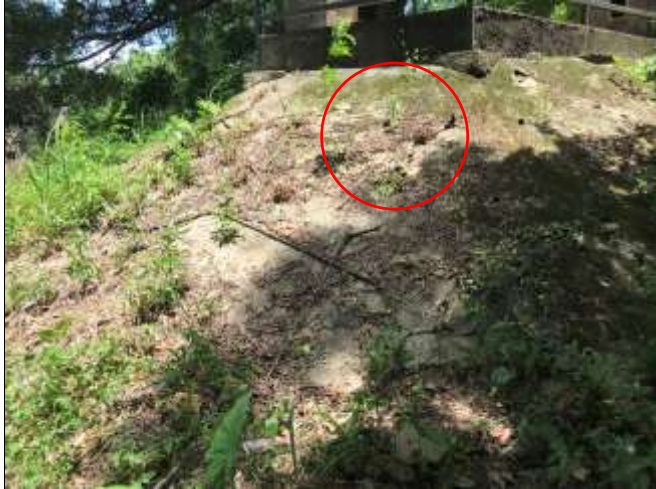
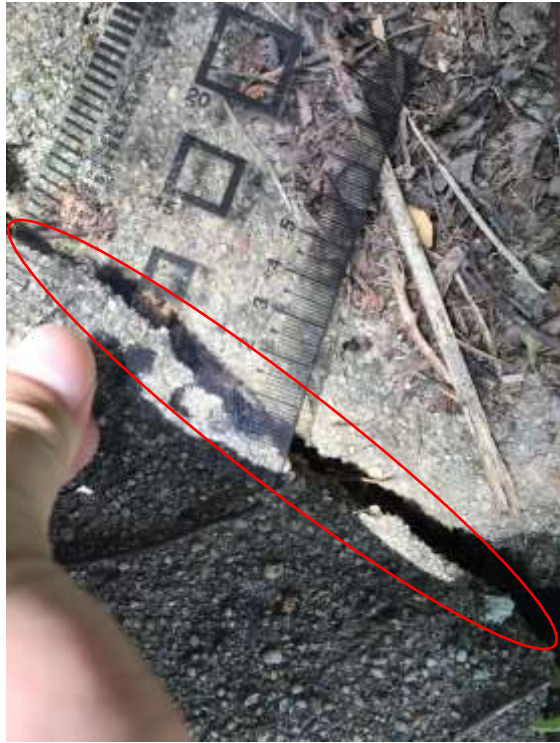
<p>3A-D15(1) - Wide Crack on Slope (General View)</p>	<p>3A-D15(1) – Wide Crack on Slope (Length:600mm/Width:5.00mm)</p>
