Our Ref: WMA20002/AECOM/it200826

8/F Grand Central Plaza Tower 2
138 Shatin Rural Committee Road
Shatin, Hong Kong

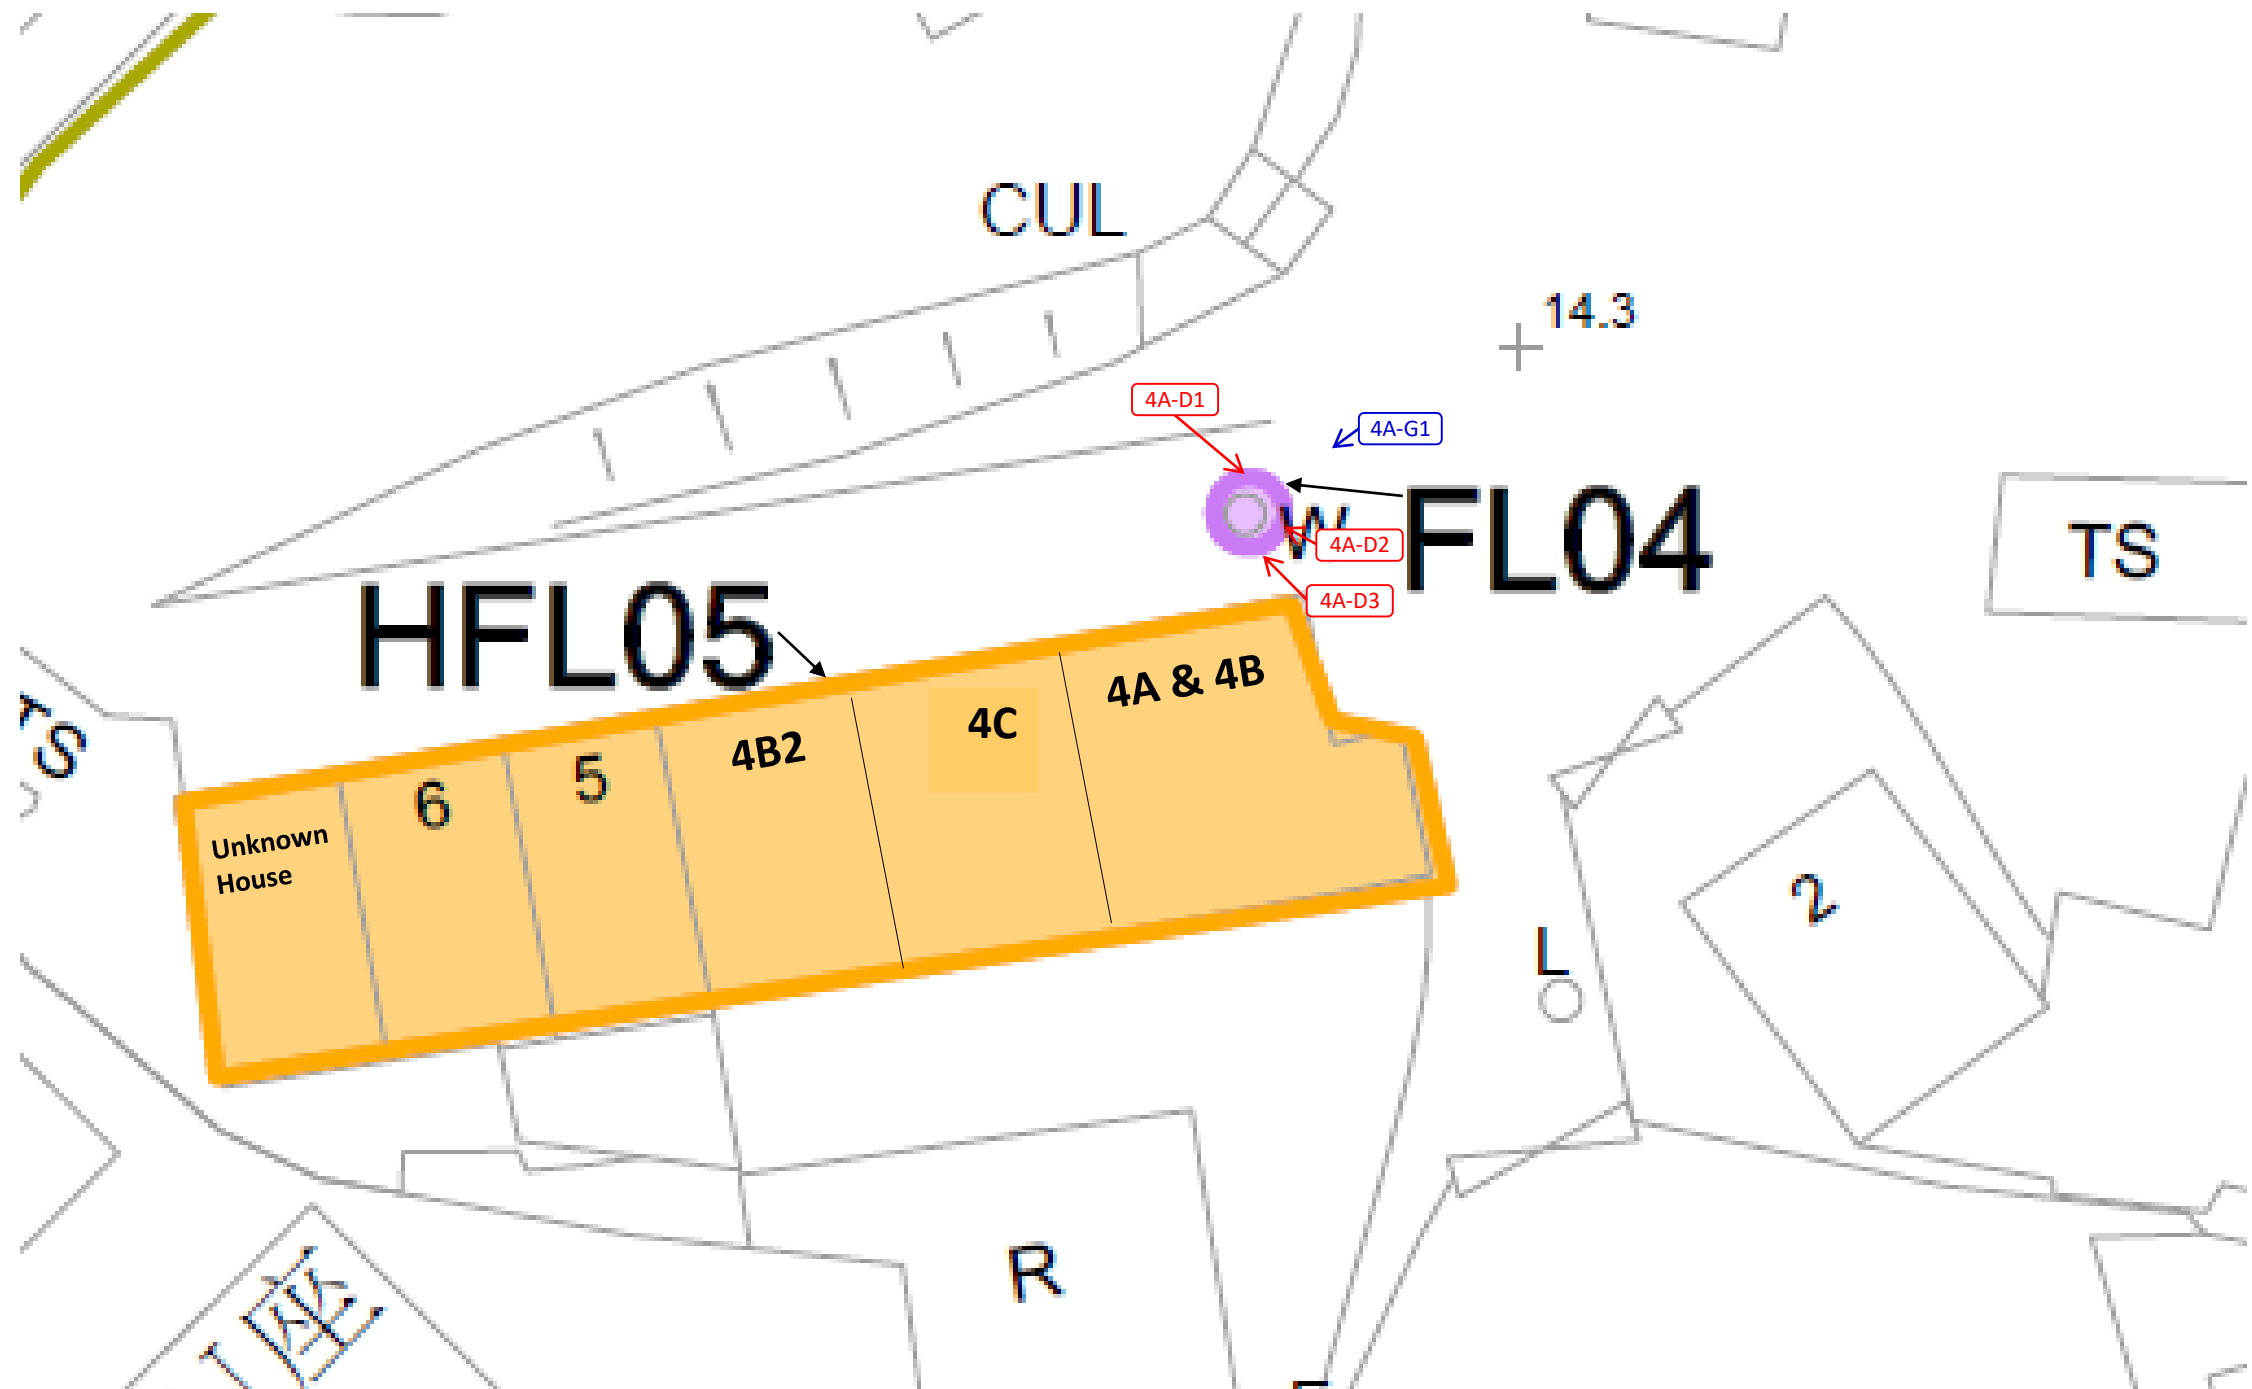
**Part Plan D - Layout Plan of FL04
with Location of General Photos**

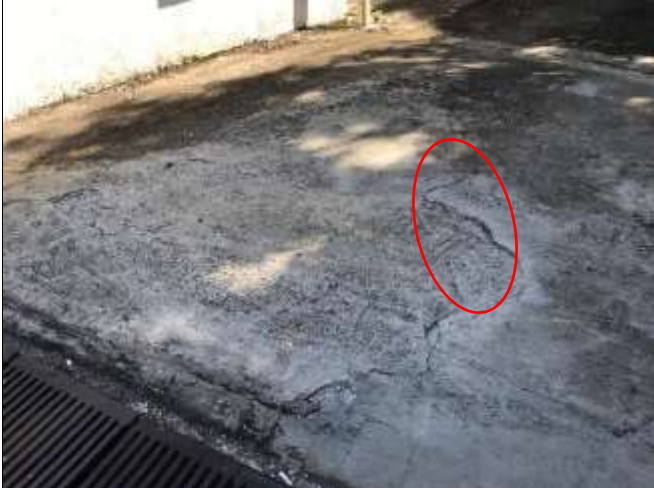
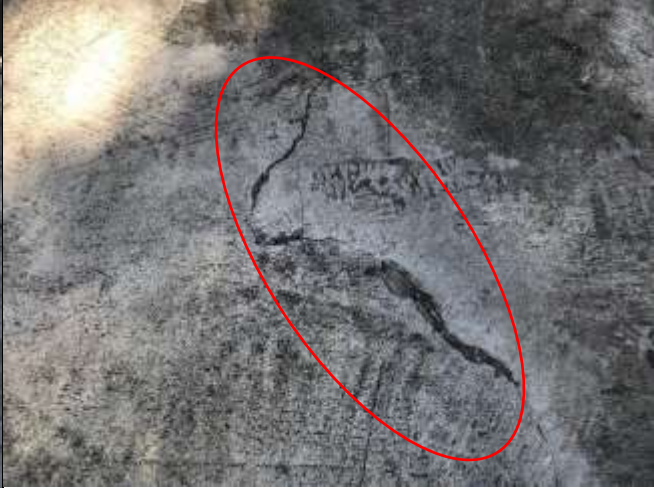
<p>4A-D1(1) - Wide Crack on Floor (General View)</p>	<p>4A-D1(2) - Wide Crack on Floor (Length:150mm/Width:5.00mm)</p>

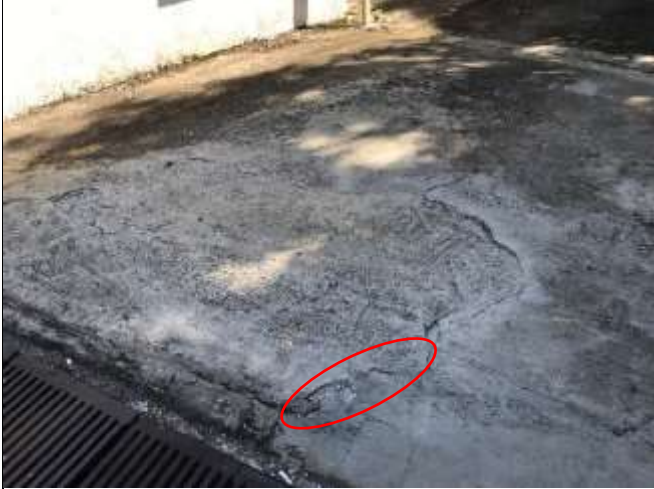
<p>4A-D2- Moderate Crack on Floor (Length:200mm/Width:2.50mm)</p>	<p>4A-D3(1) – Spalling on Floor Surface</p>

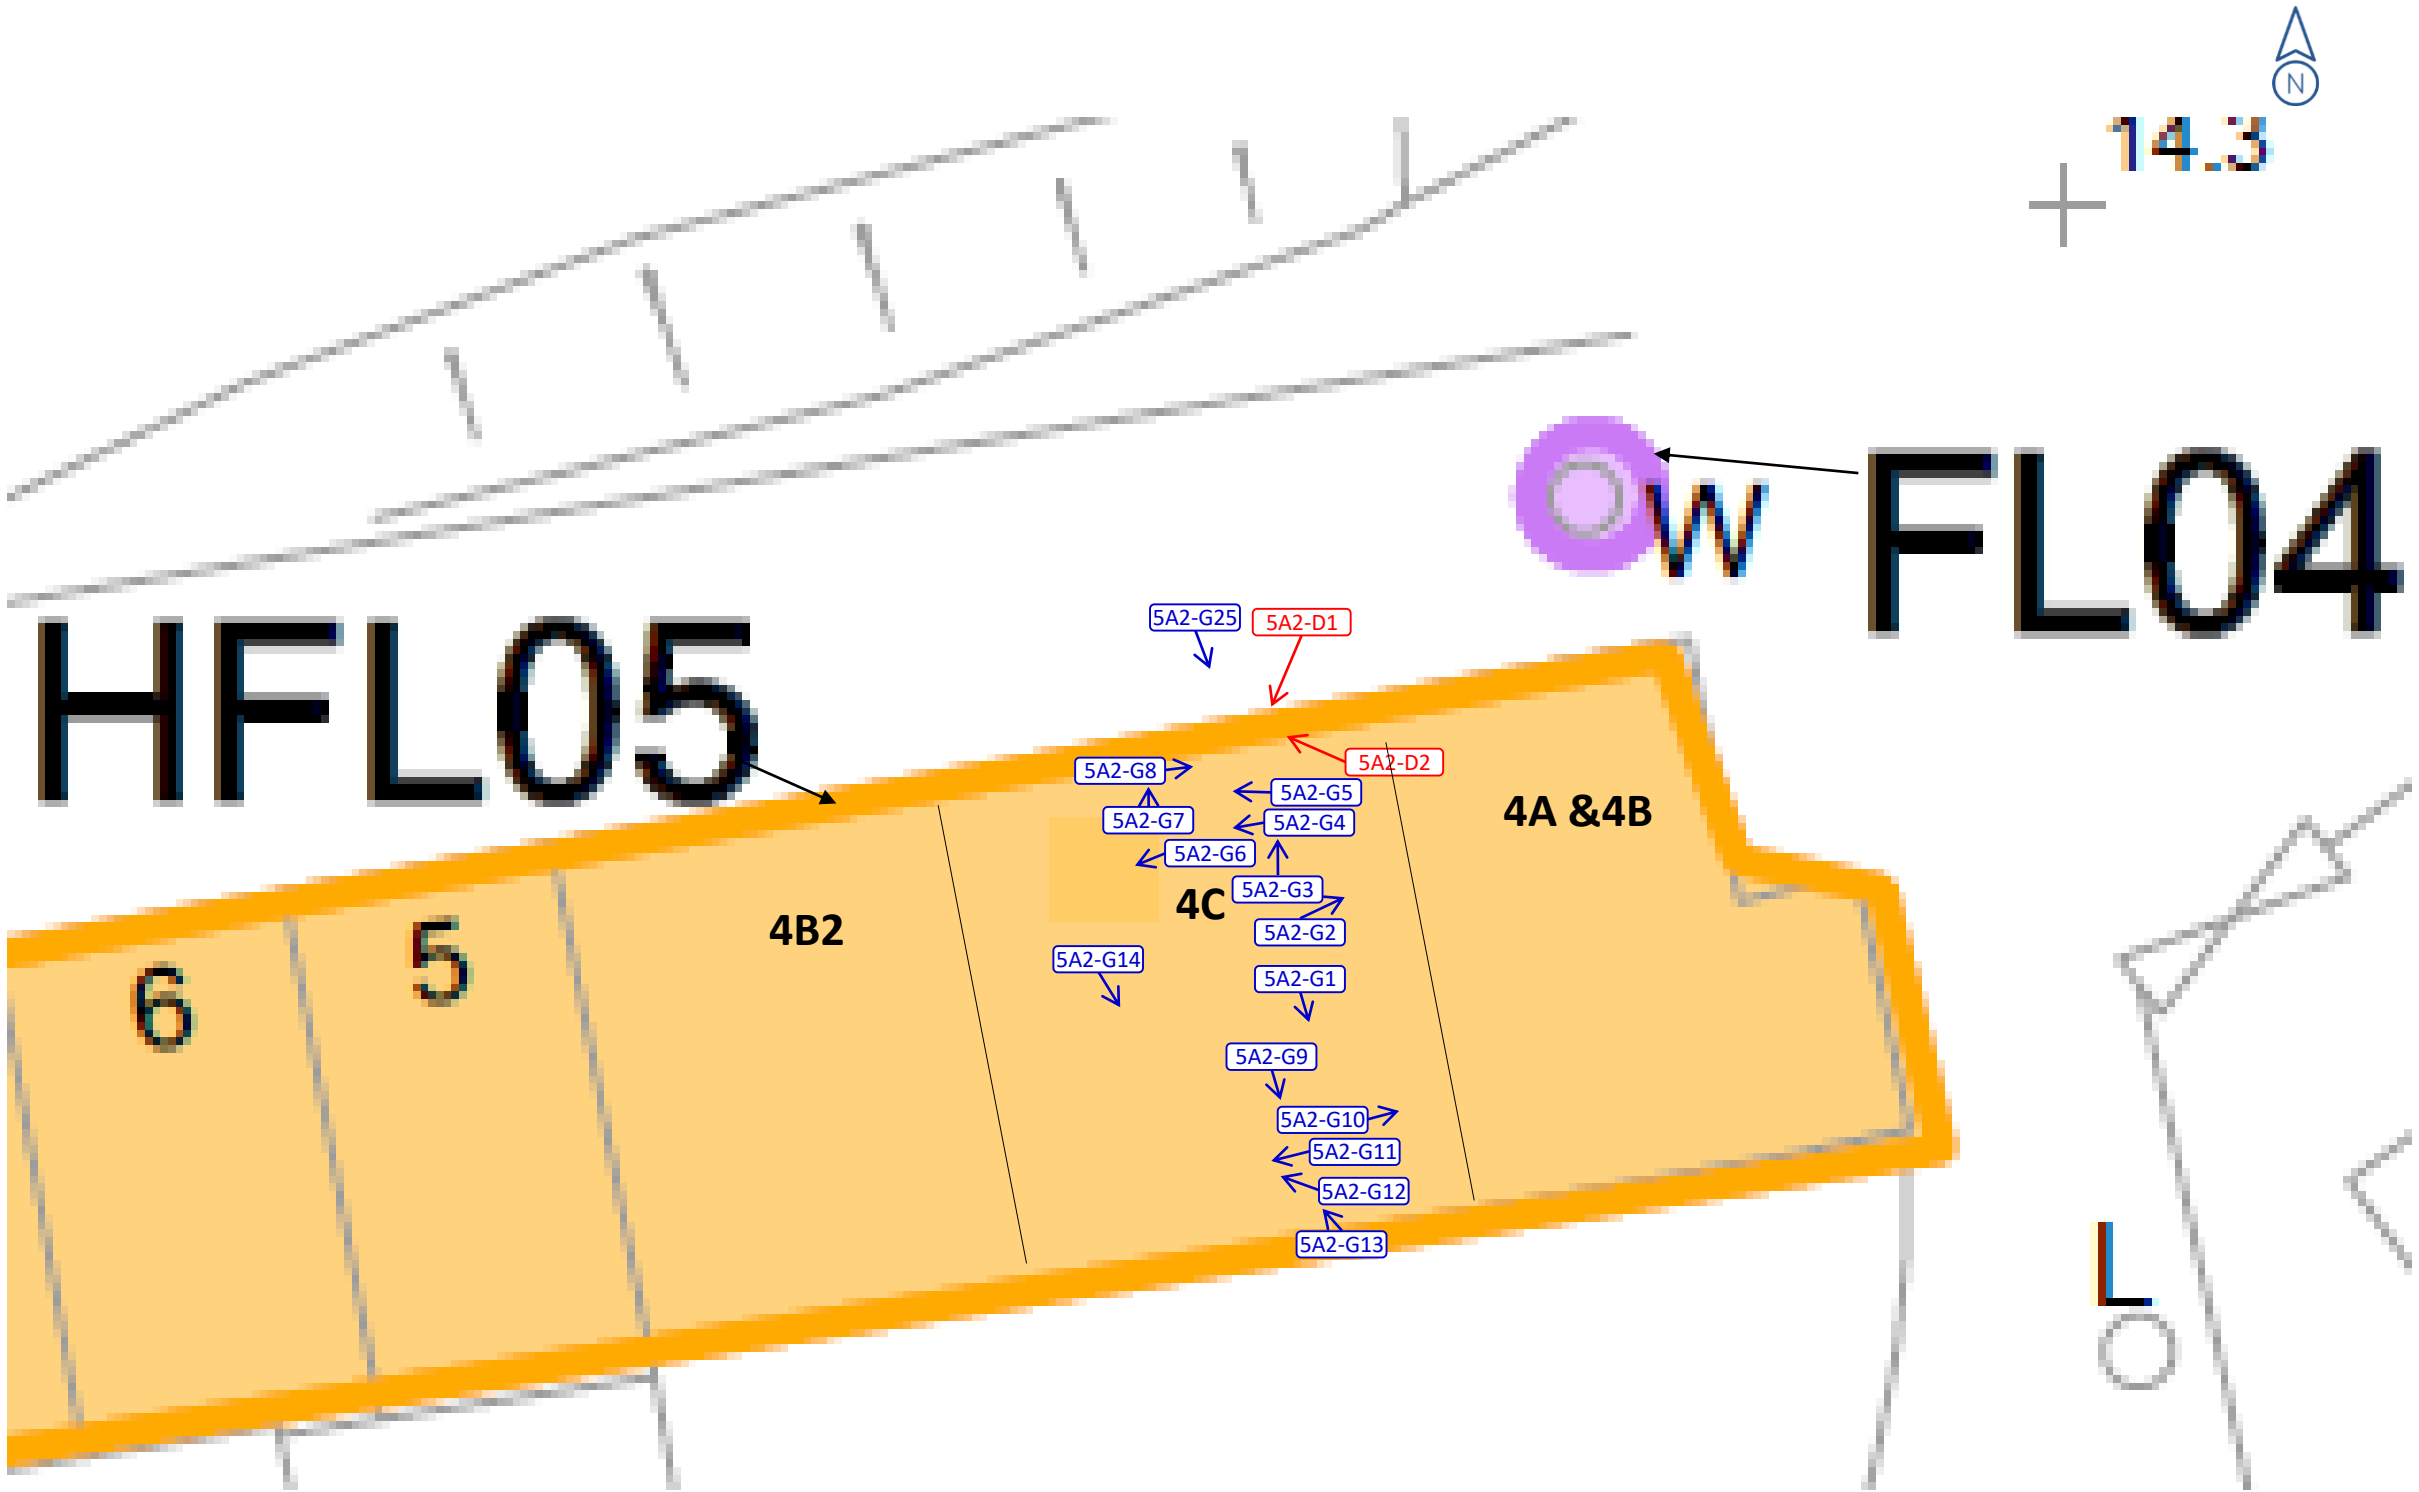
**Part Plan E(2) - Layout Plan of HFL05 (House 4C – 1st Floor)
with Location of General Photos**

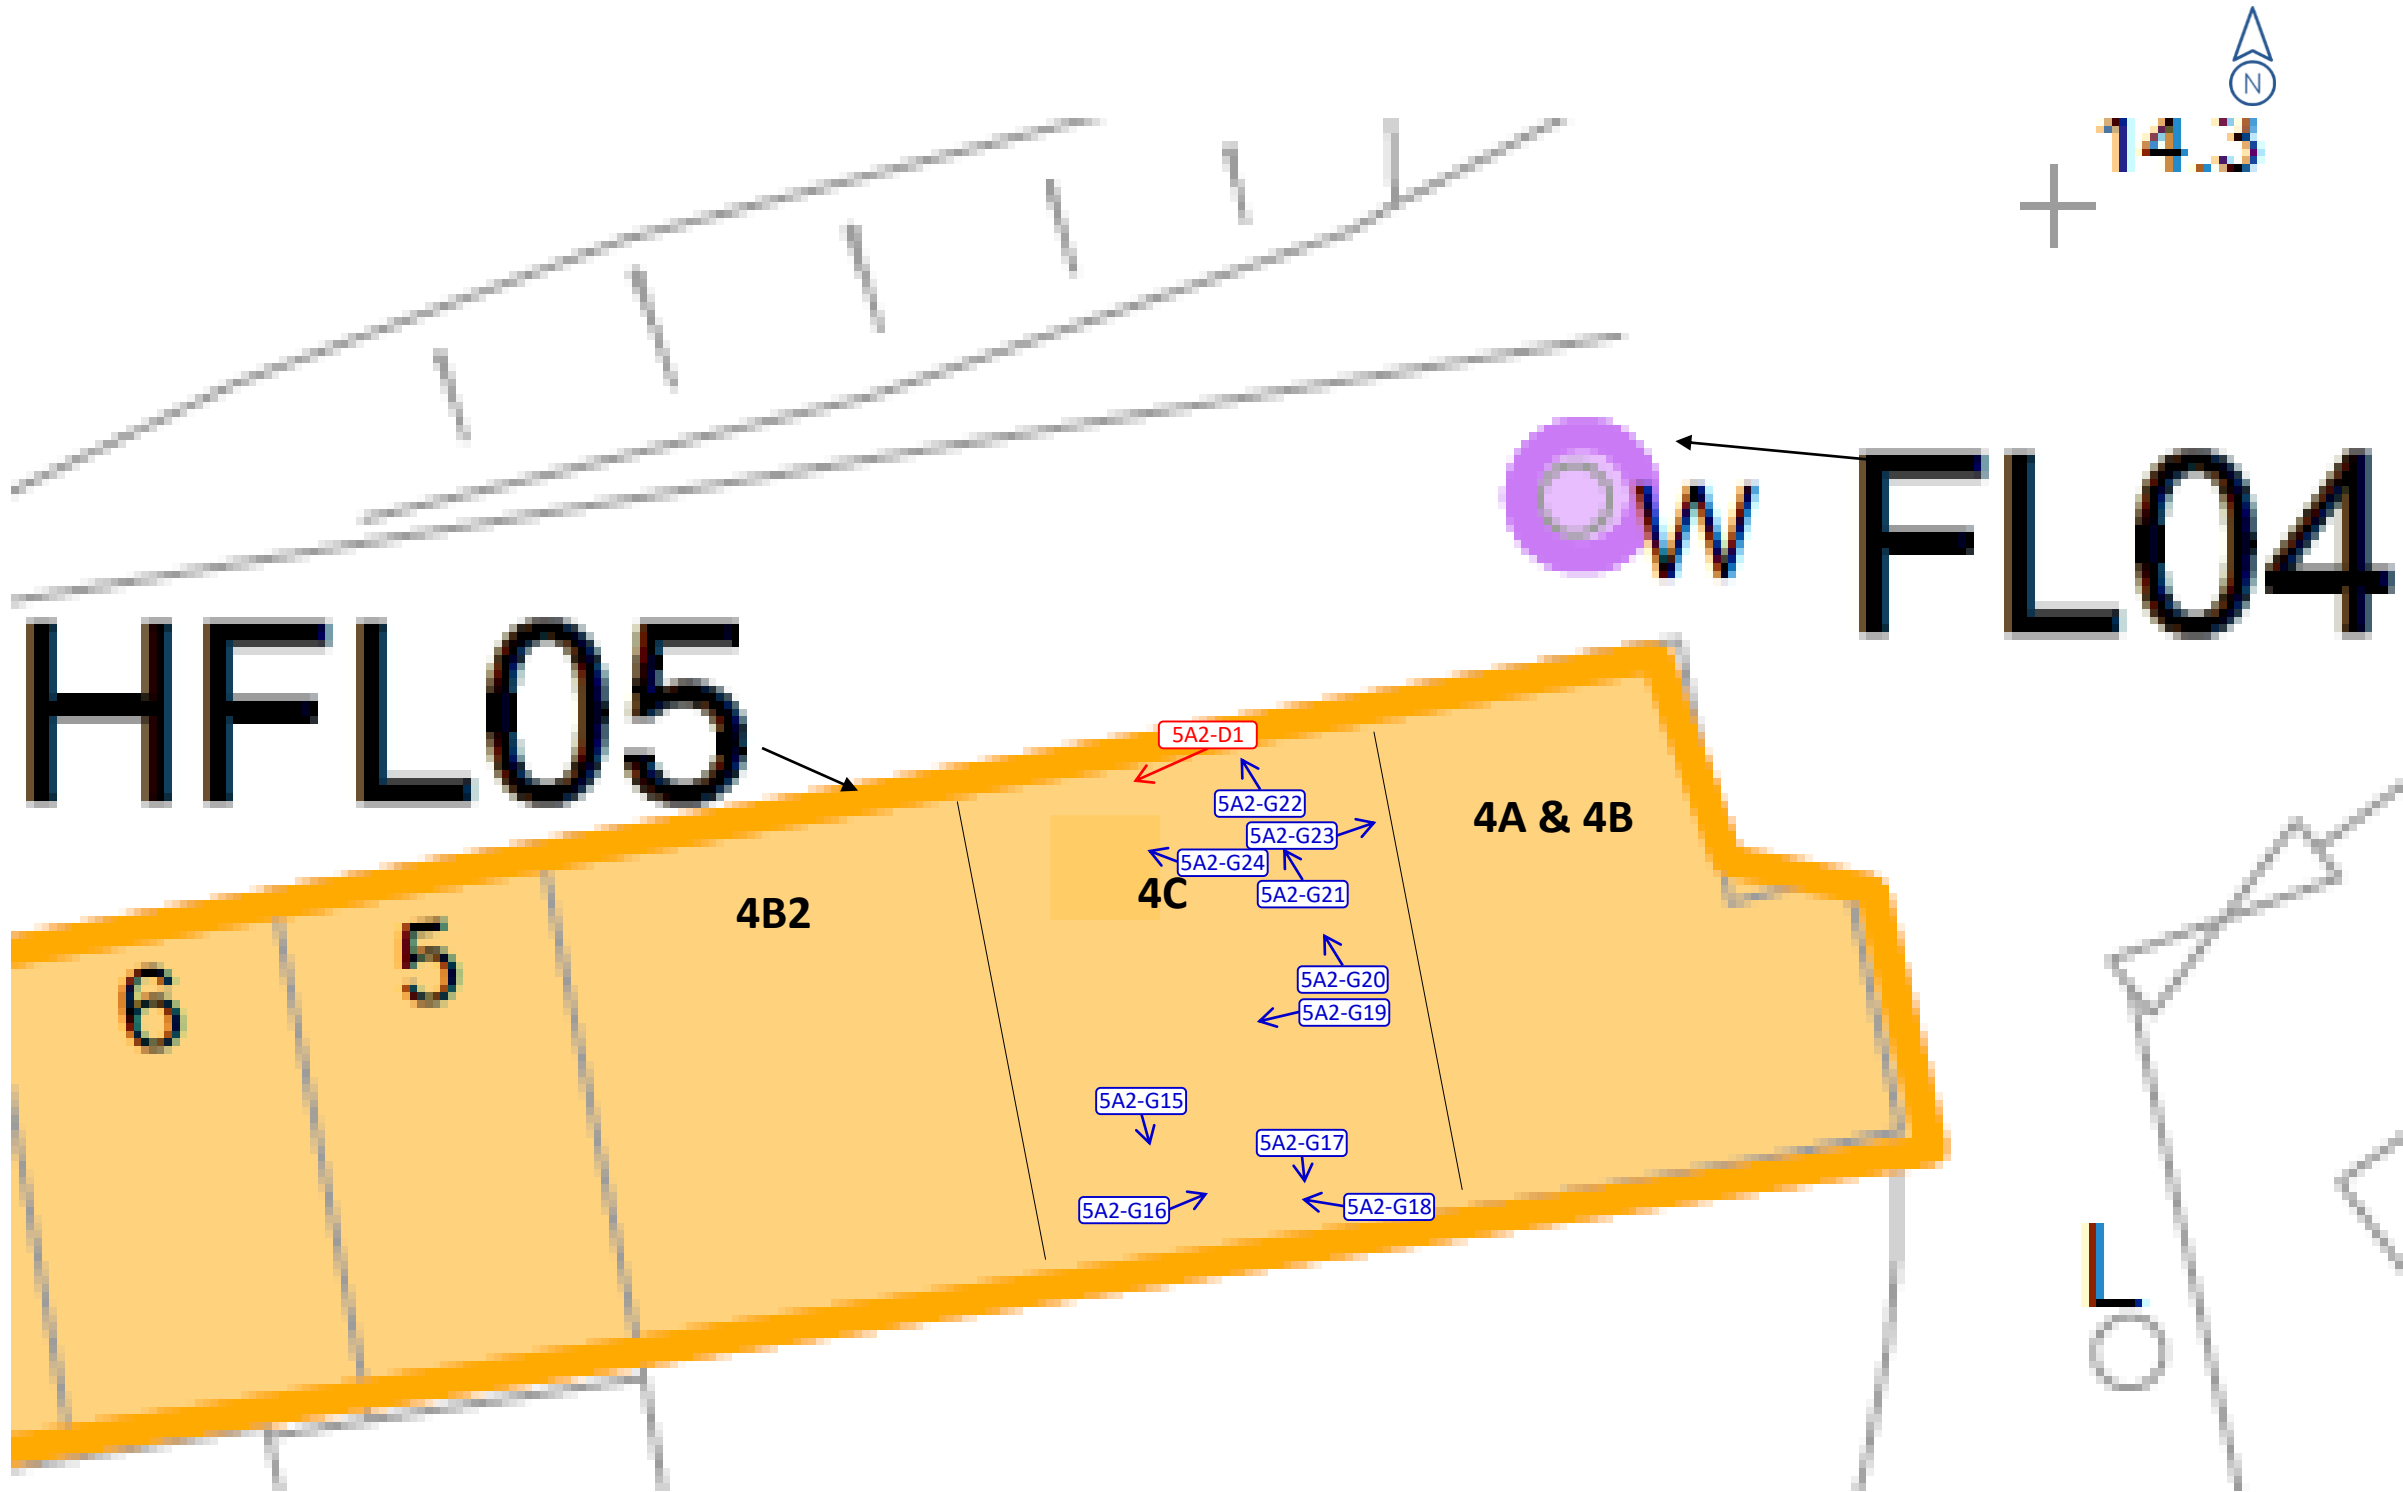
**Part Plan E(2) - Layout Plan of HFL05 (House 4C – 2nd Floor)
with Location of General Photos**

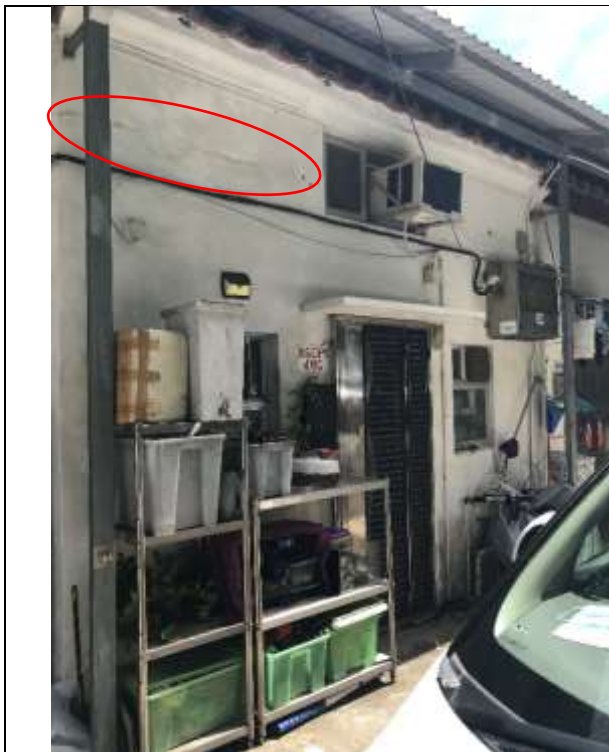
5A2-D1(1) - Crack on Surface

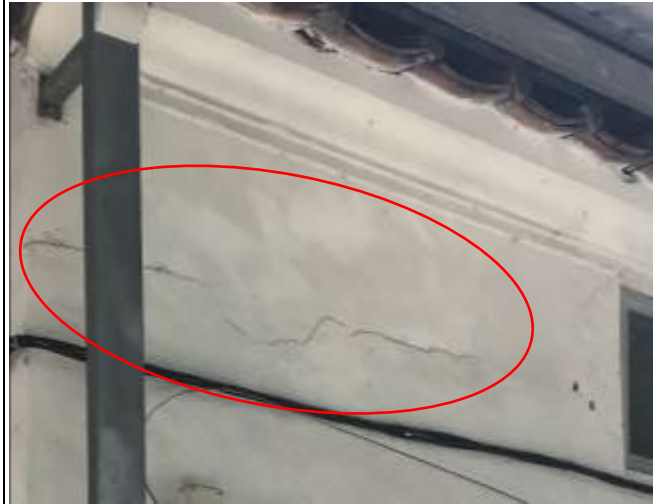
5A2-D1(2) - Crack on Surface

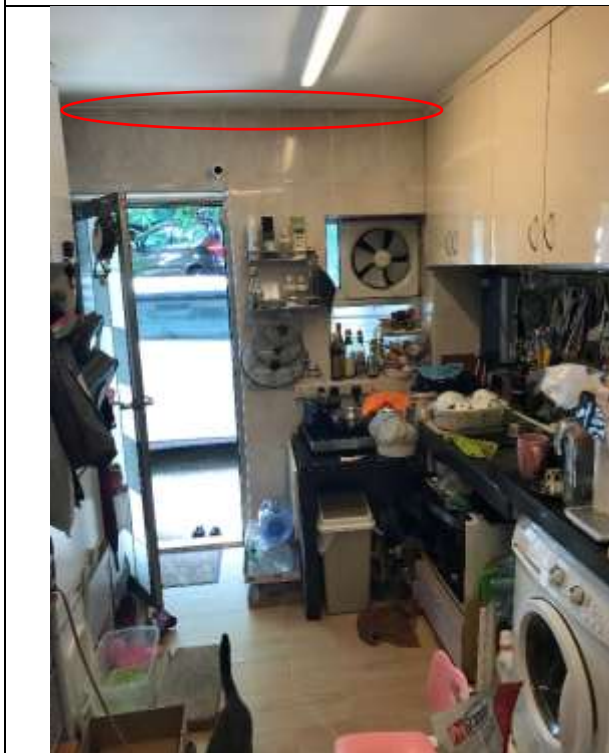
5A2-D2(1) – Spalling between Wall & Ceiling

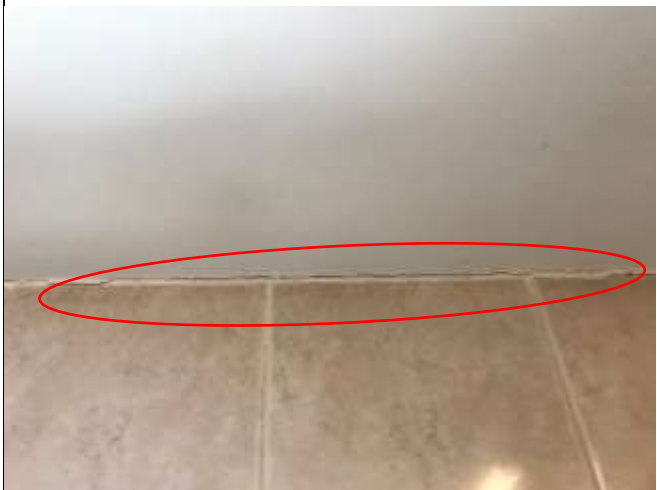
5A2-D2(2) – Spalling between Wall & Ceiling

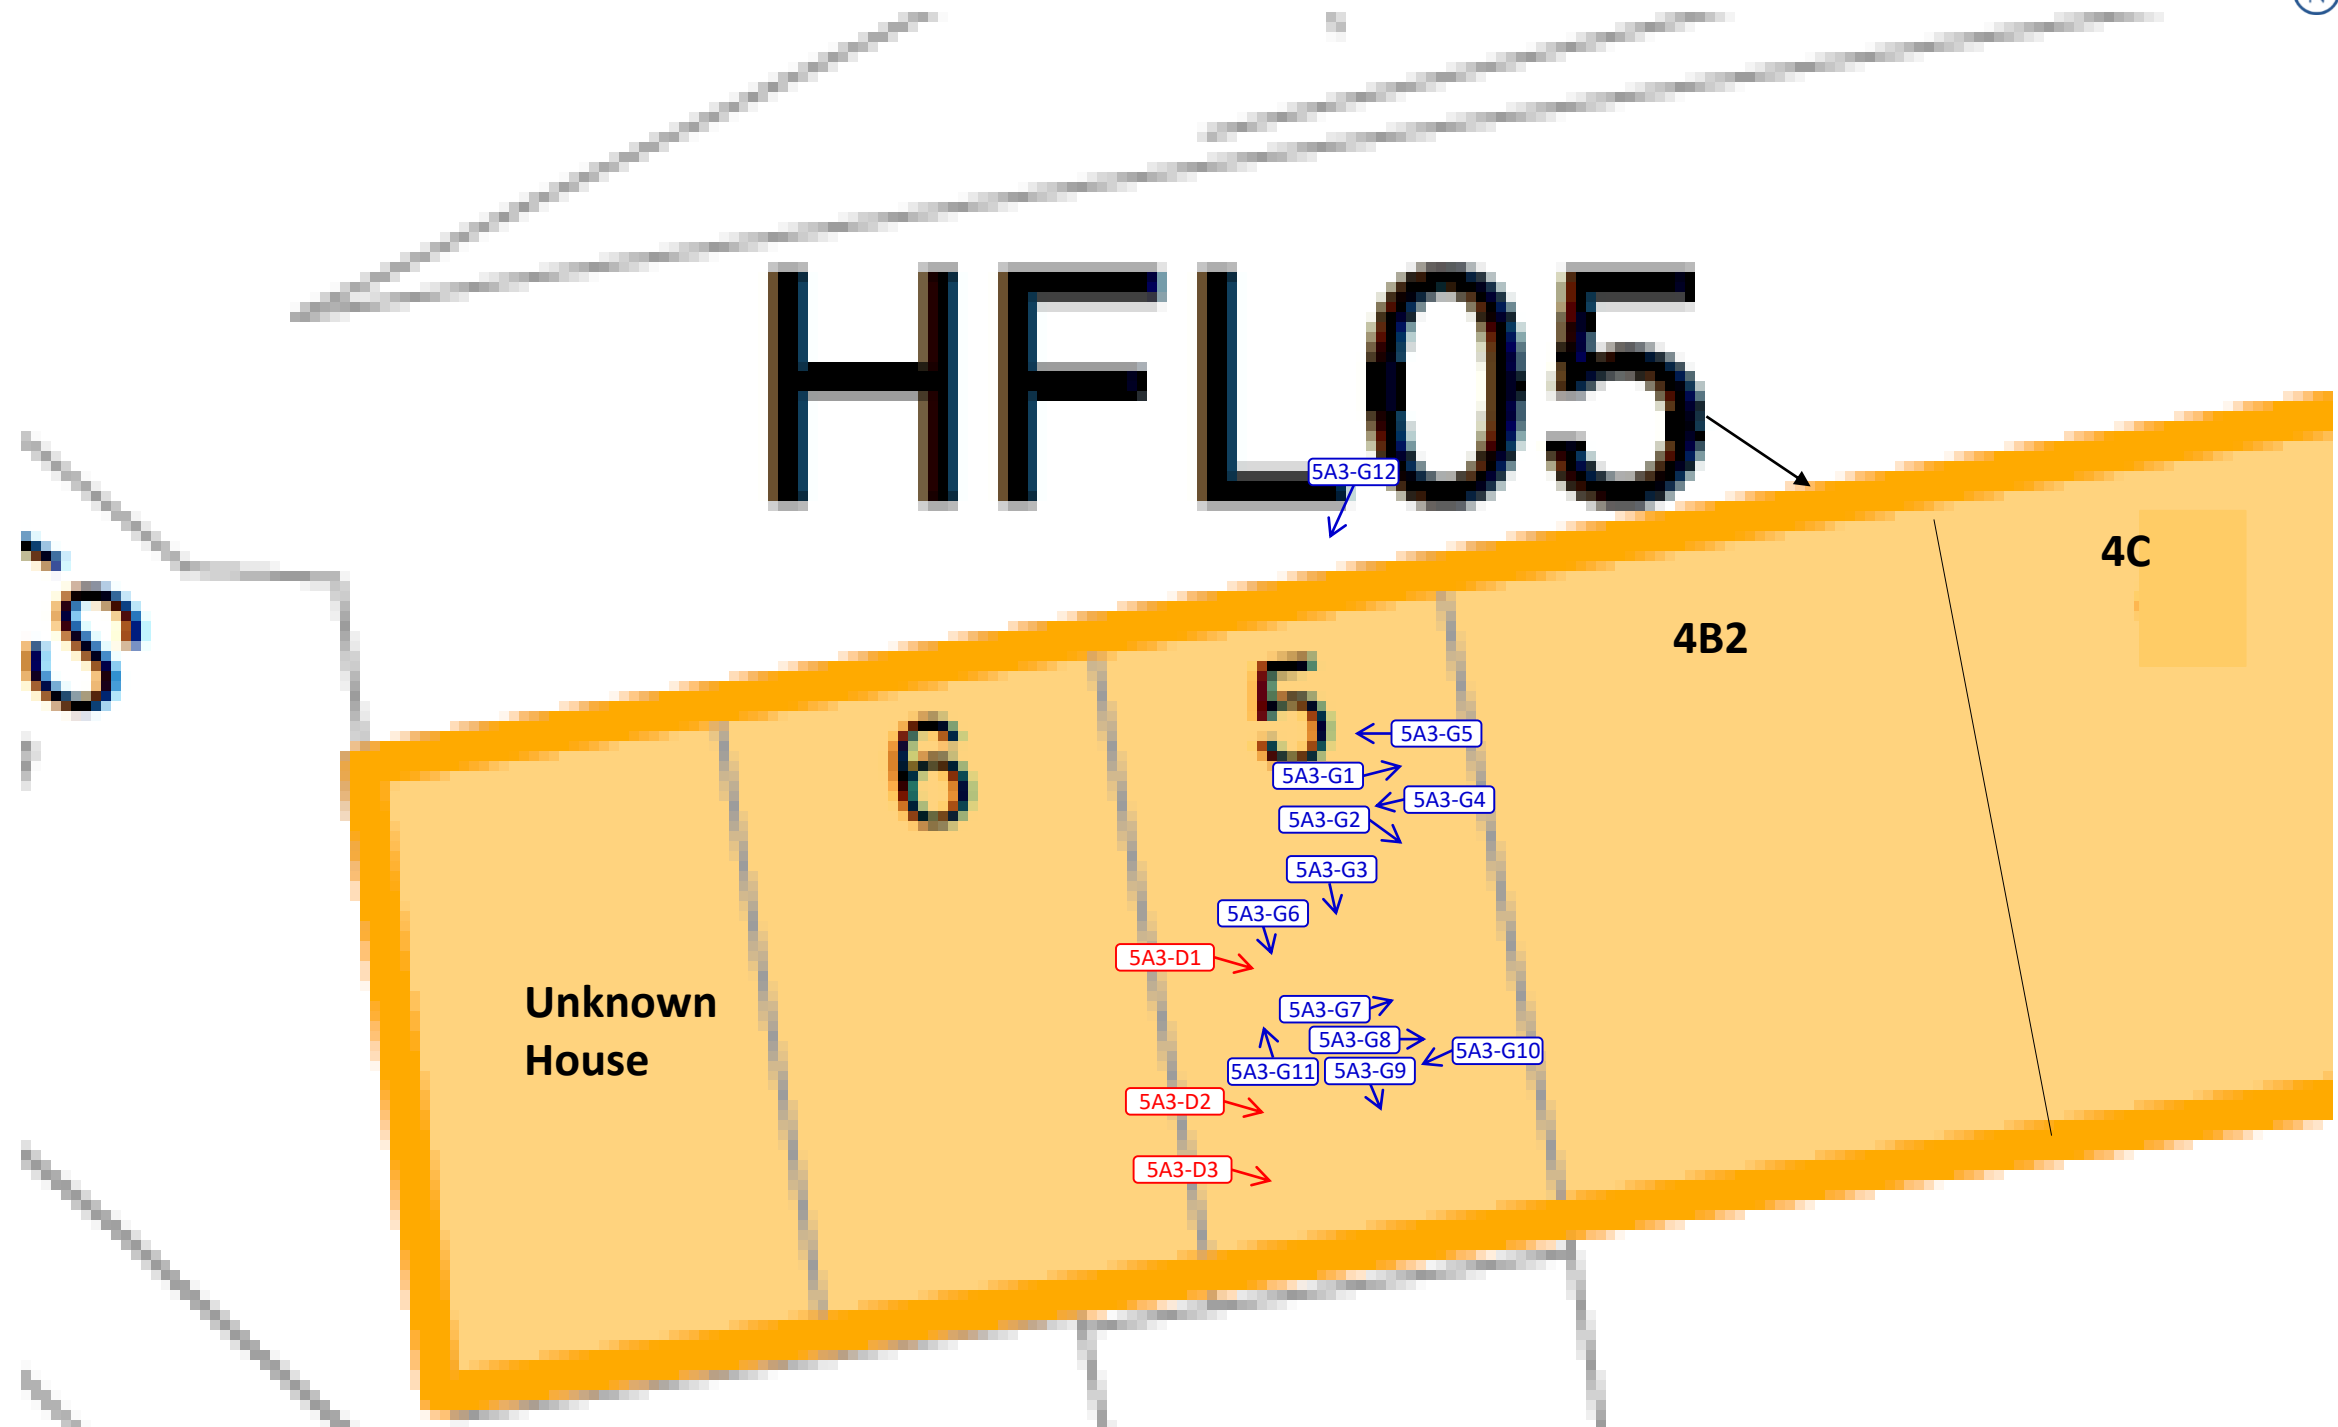
**Part Plan E(3) - Layout Plan of HFL05 (House 5)
with Location of General Photos**

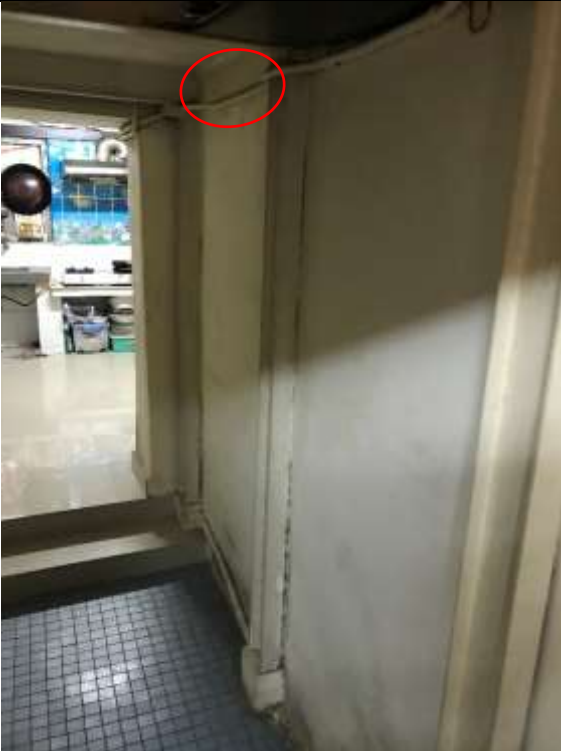
<p>5A3-D1(1) - Water Stain on Surface (General View)</p>	<p>5A3-D1(2) – Water Stain on Surface</p>

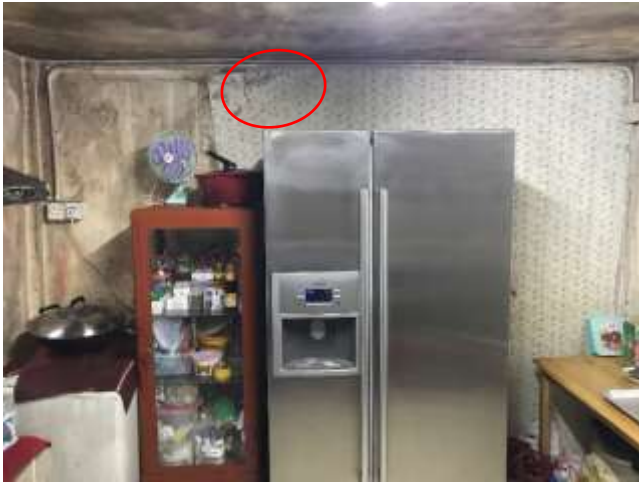
<p>5A3-D3(2) – Wide Crack on Wall (General View)</p>	<p>5A3-D3(2) – Wide Crack on Wall (Length:600mm/Width:3.00mm)</p>

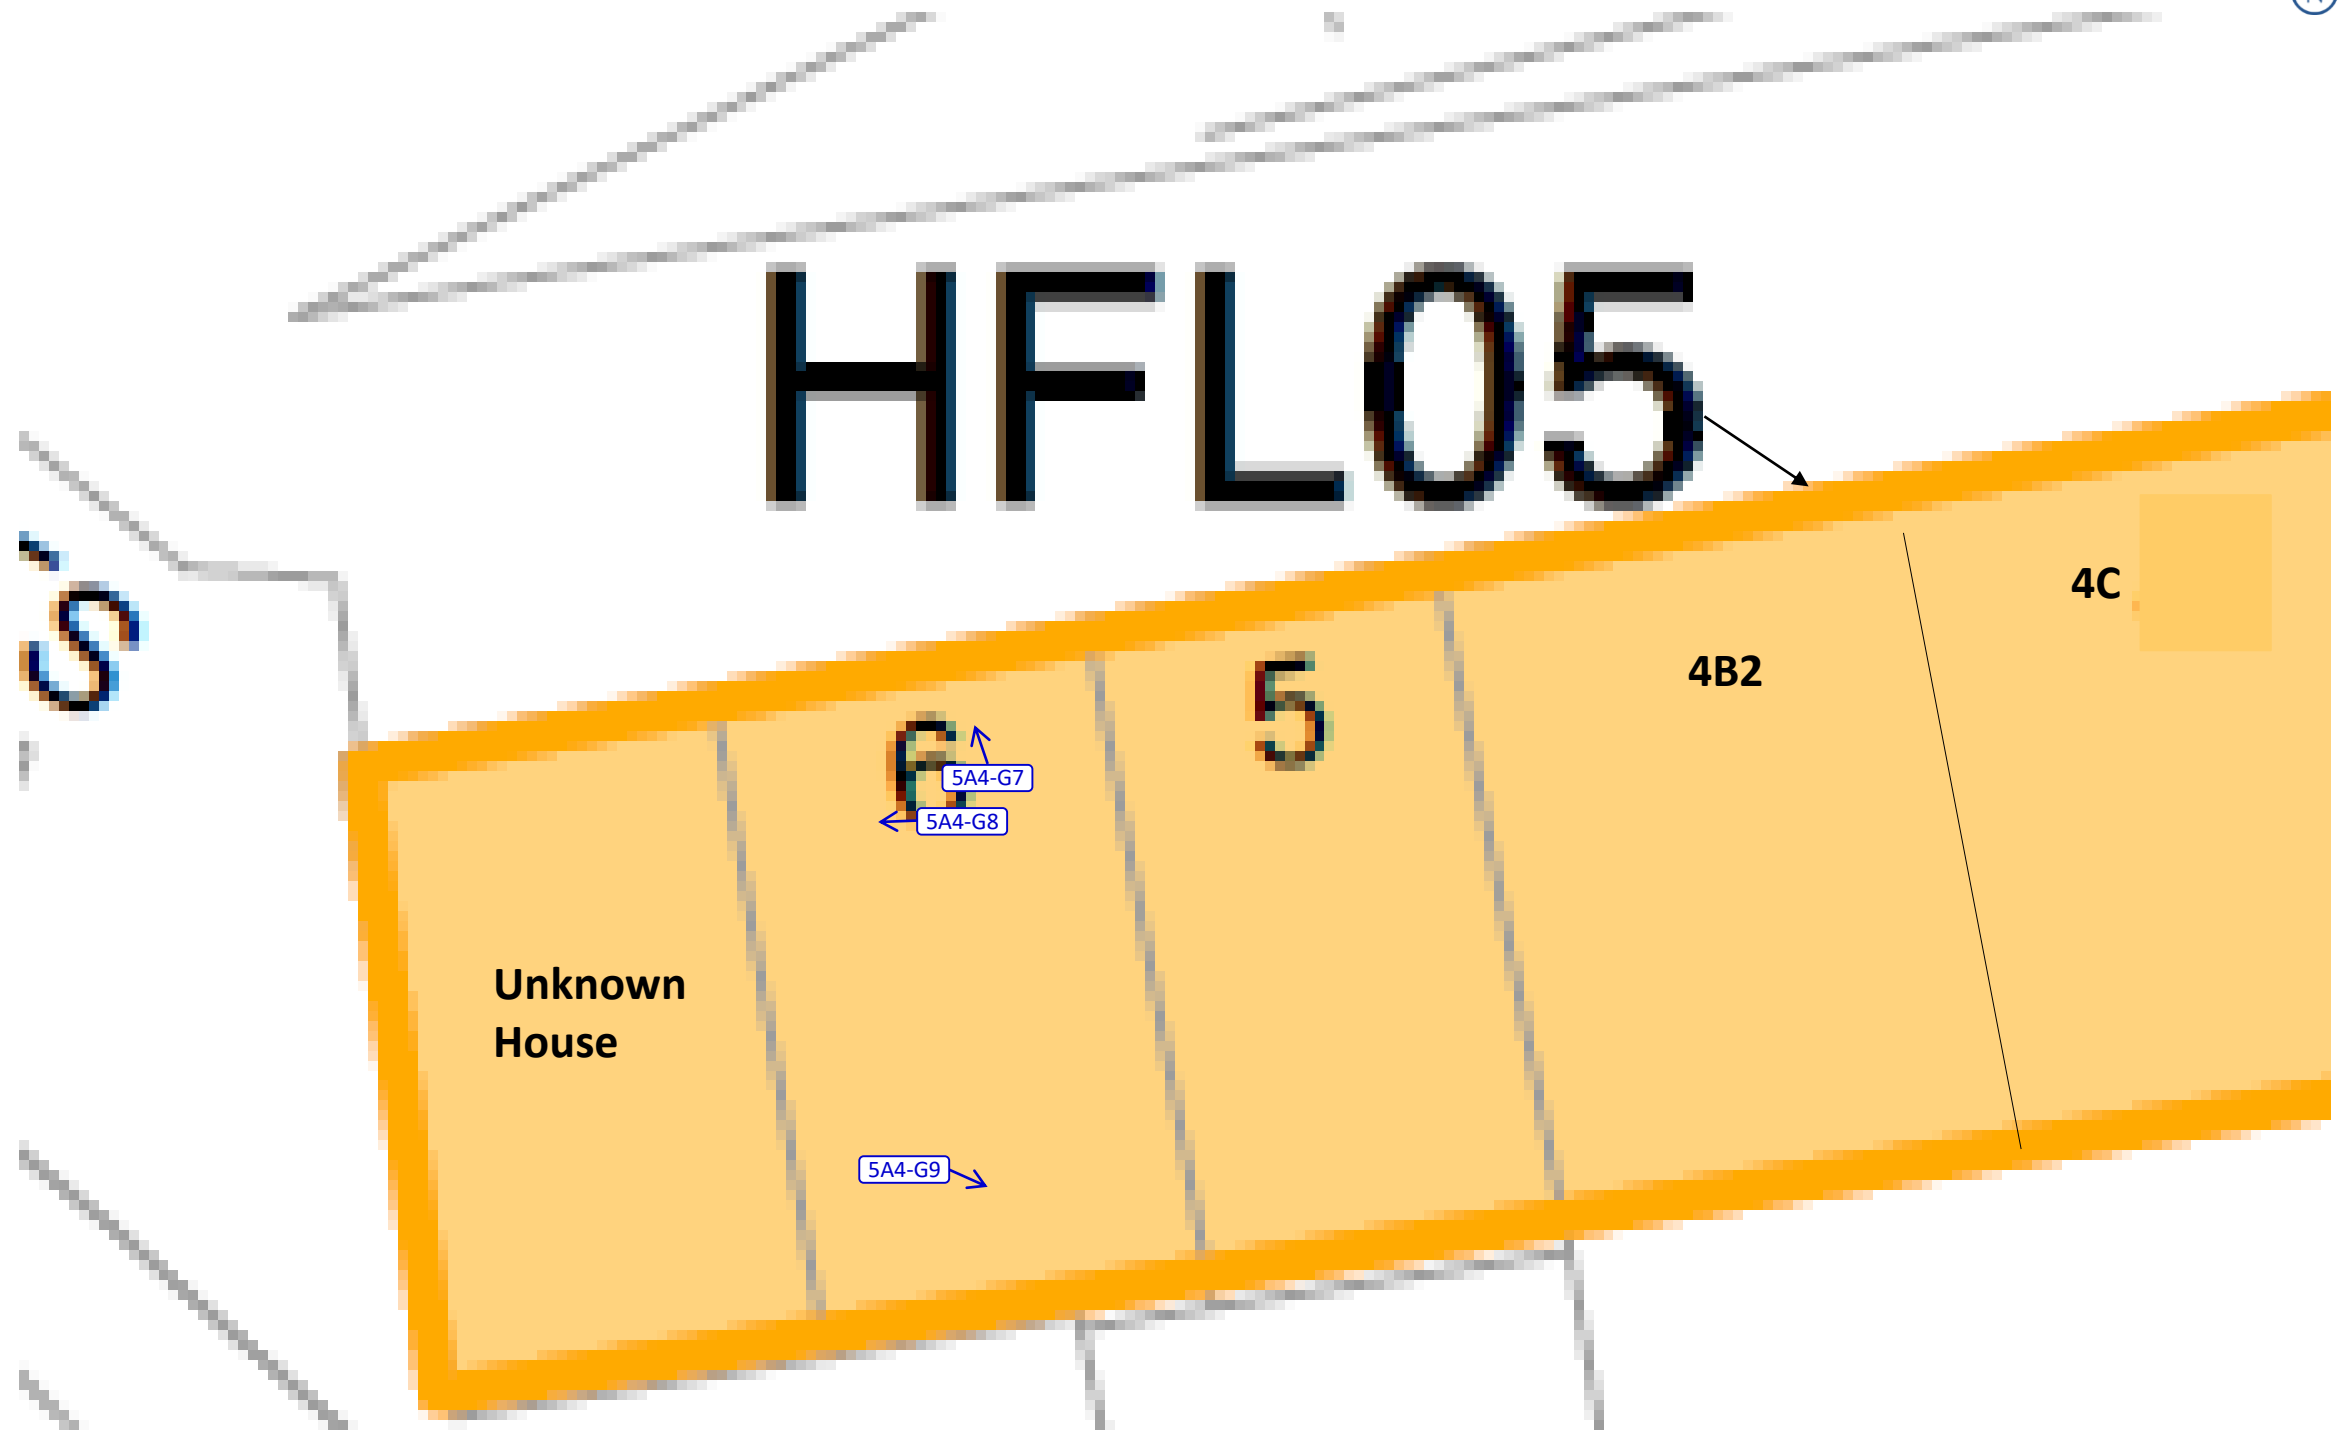
Part Plan E(4) - Layout Plan of HFL05 (House 6 – 2nd Floor)
with Location of General Photos

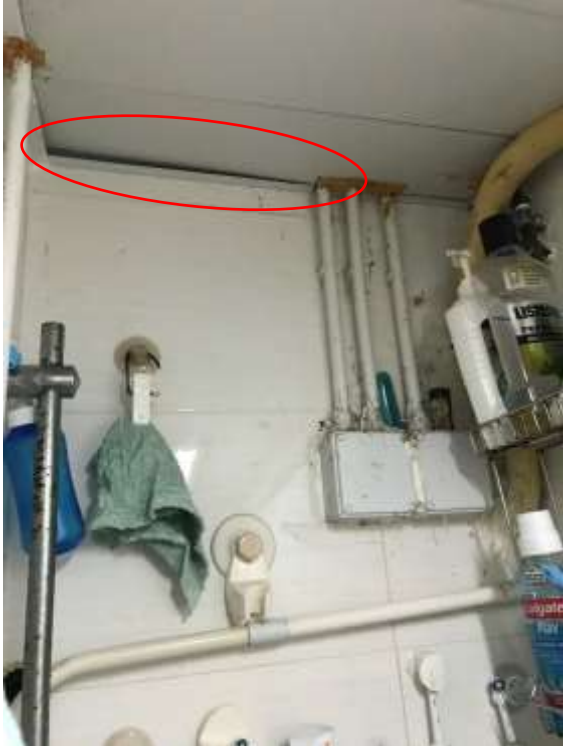
A photograph showing a bathroom interior. A white false ceiling panel is partially detached from the wall, with a red oval highlighting the gap between the panel and the wall. The room contains a shower, a sink, and various toiletries.

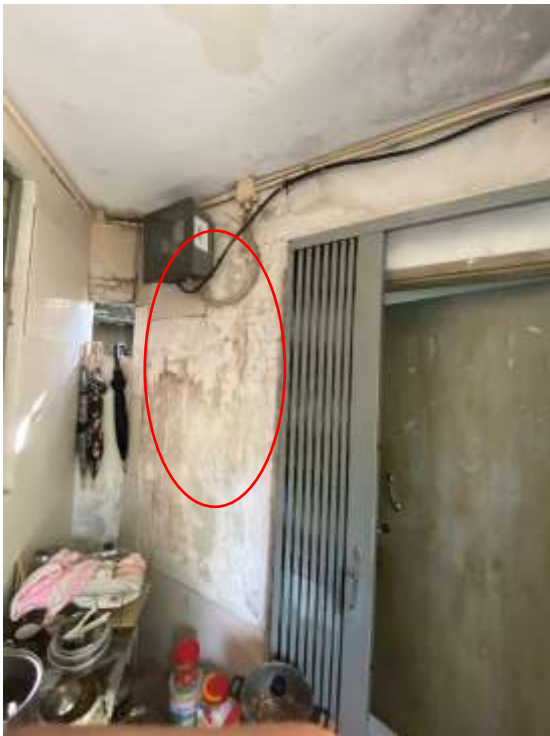
5A5-D6 – Water Stain and Crazing

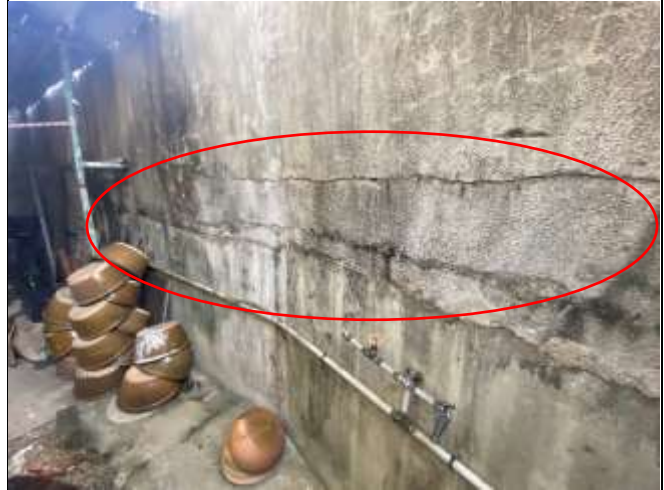
5A5-D7(1) – Wide Crack on Wall Surface
(General View)

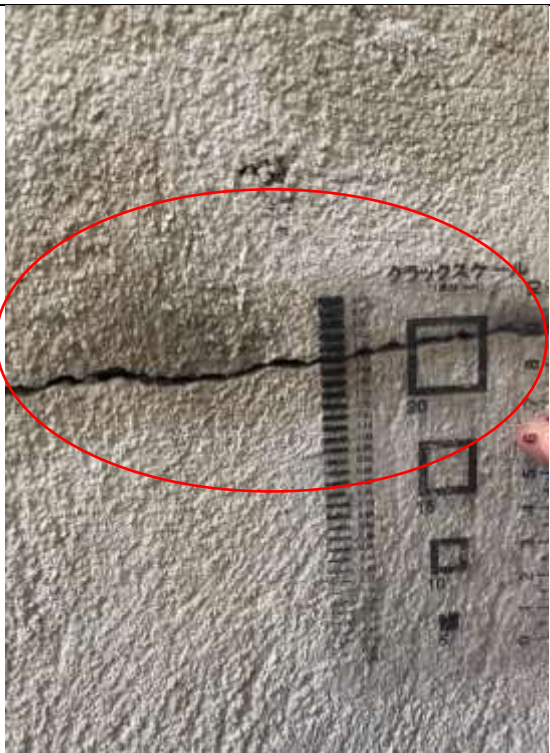
5A5-D7(2) –Moderate Crack on Wall Surface
(Length:2000mm/Width:1.75mm)

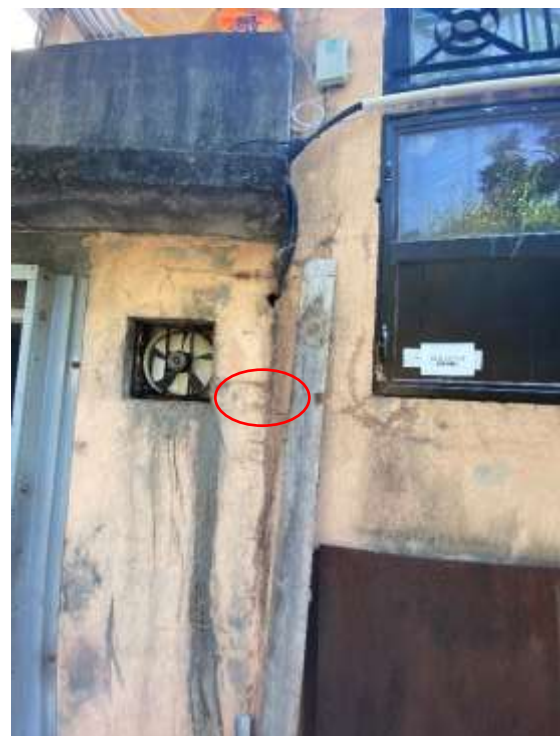
5A5-D8(1) – Moderate Crack on Wall Surface
(General View)

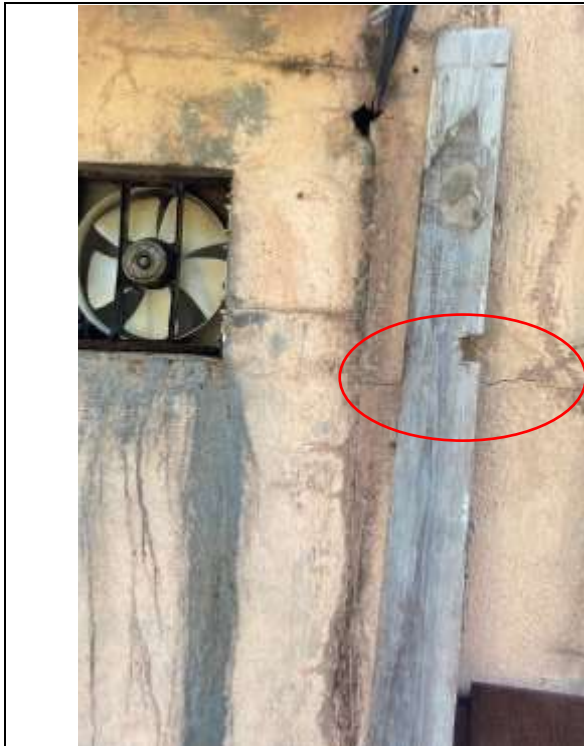
5A5-D8(2) – Moderate Crack on Wall Surface
(Length:400mm/Width:1.80mm)
