Our Ref: WMA20002/AECOM/it200826

8/F Grand Central Plaza Tower 2
138 Shatin Rural Committee Road
Shatin, Hong Kong

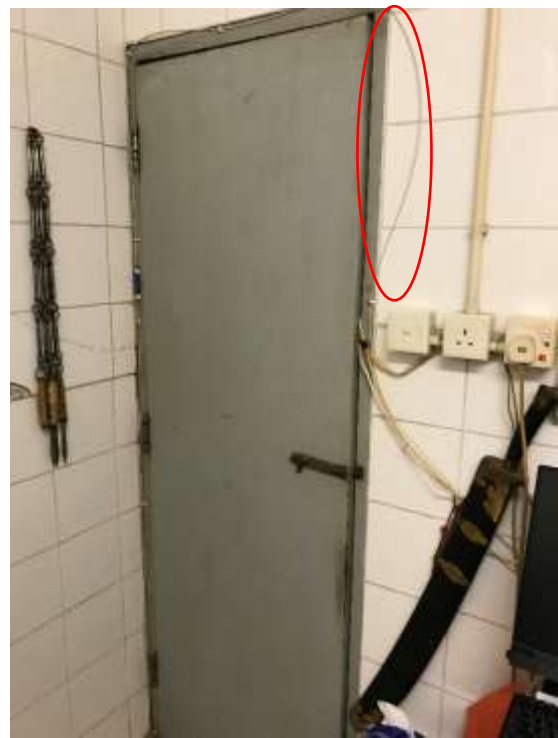
5A5-D9(1) – Moderate Crack on Wall Surface
(General View)

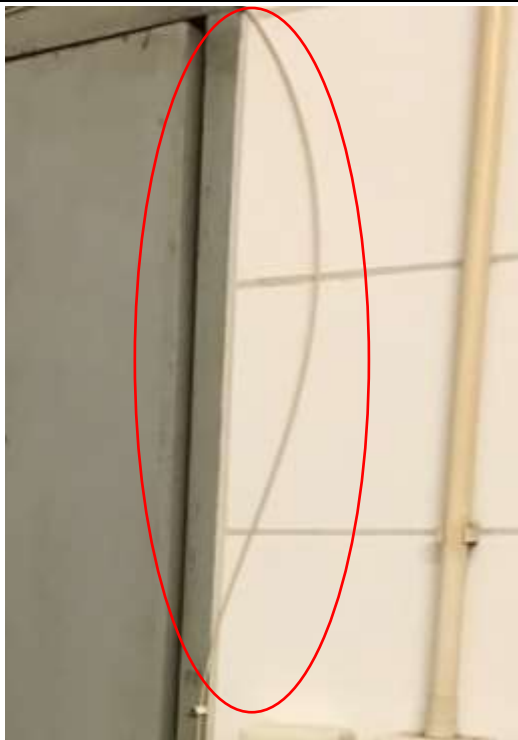
5A5-D9(2) – Moderate Crack on Wall Surface
(Length:300mm/Width:1.80mm)

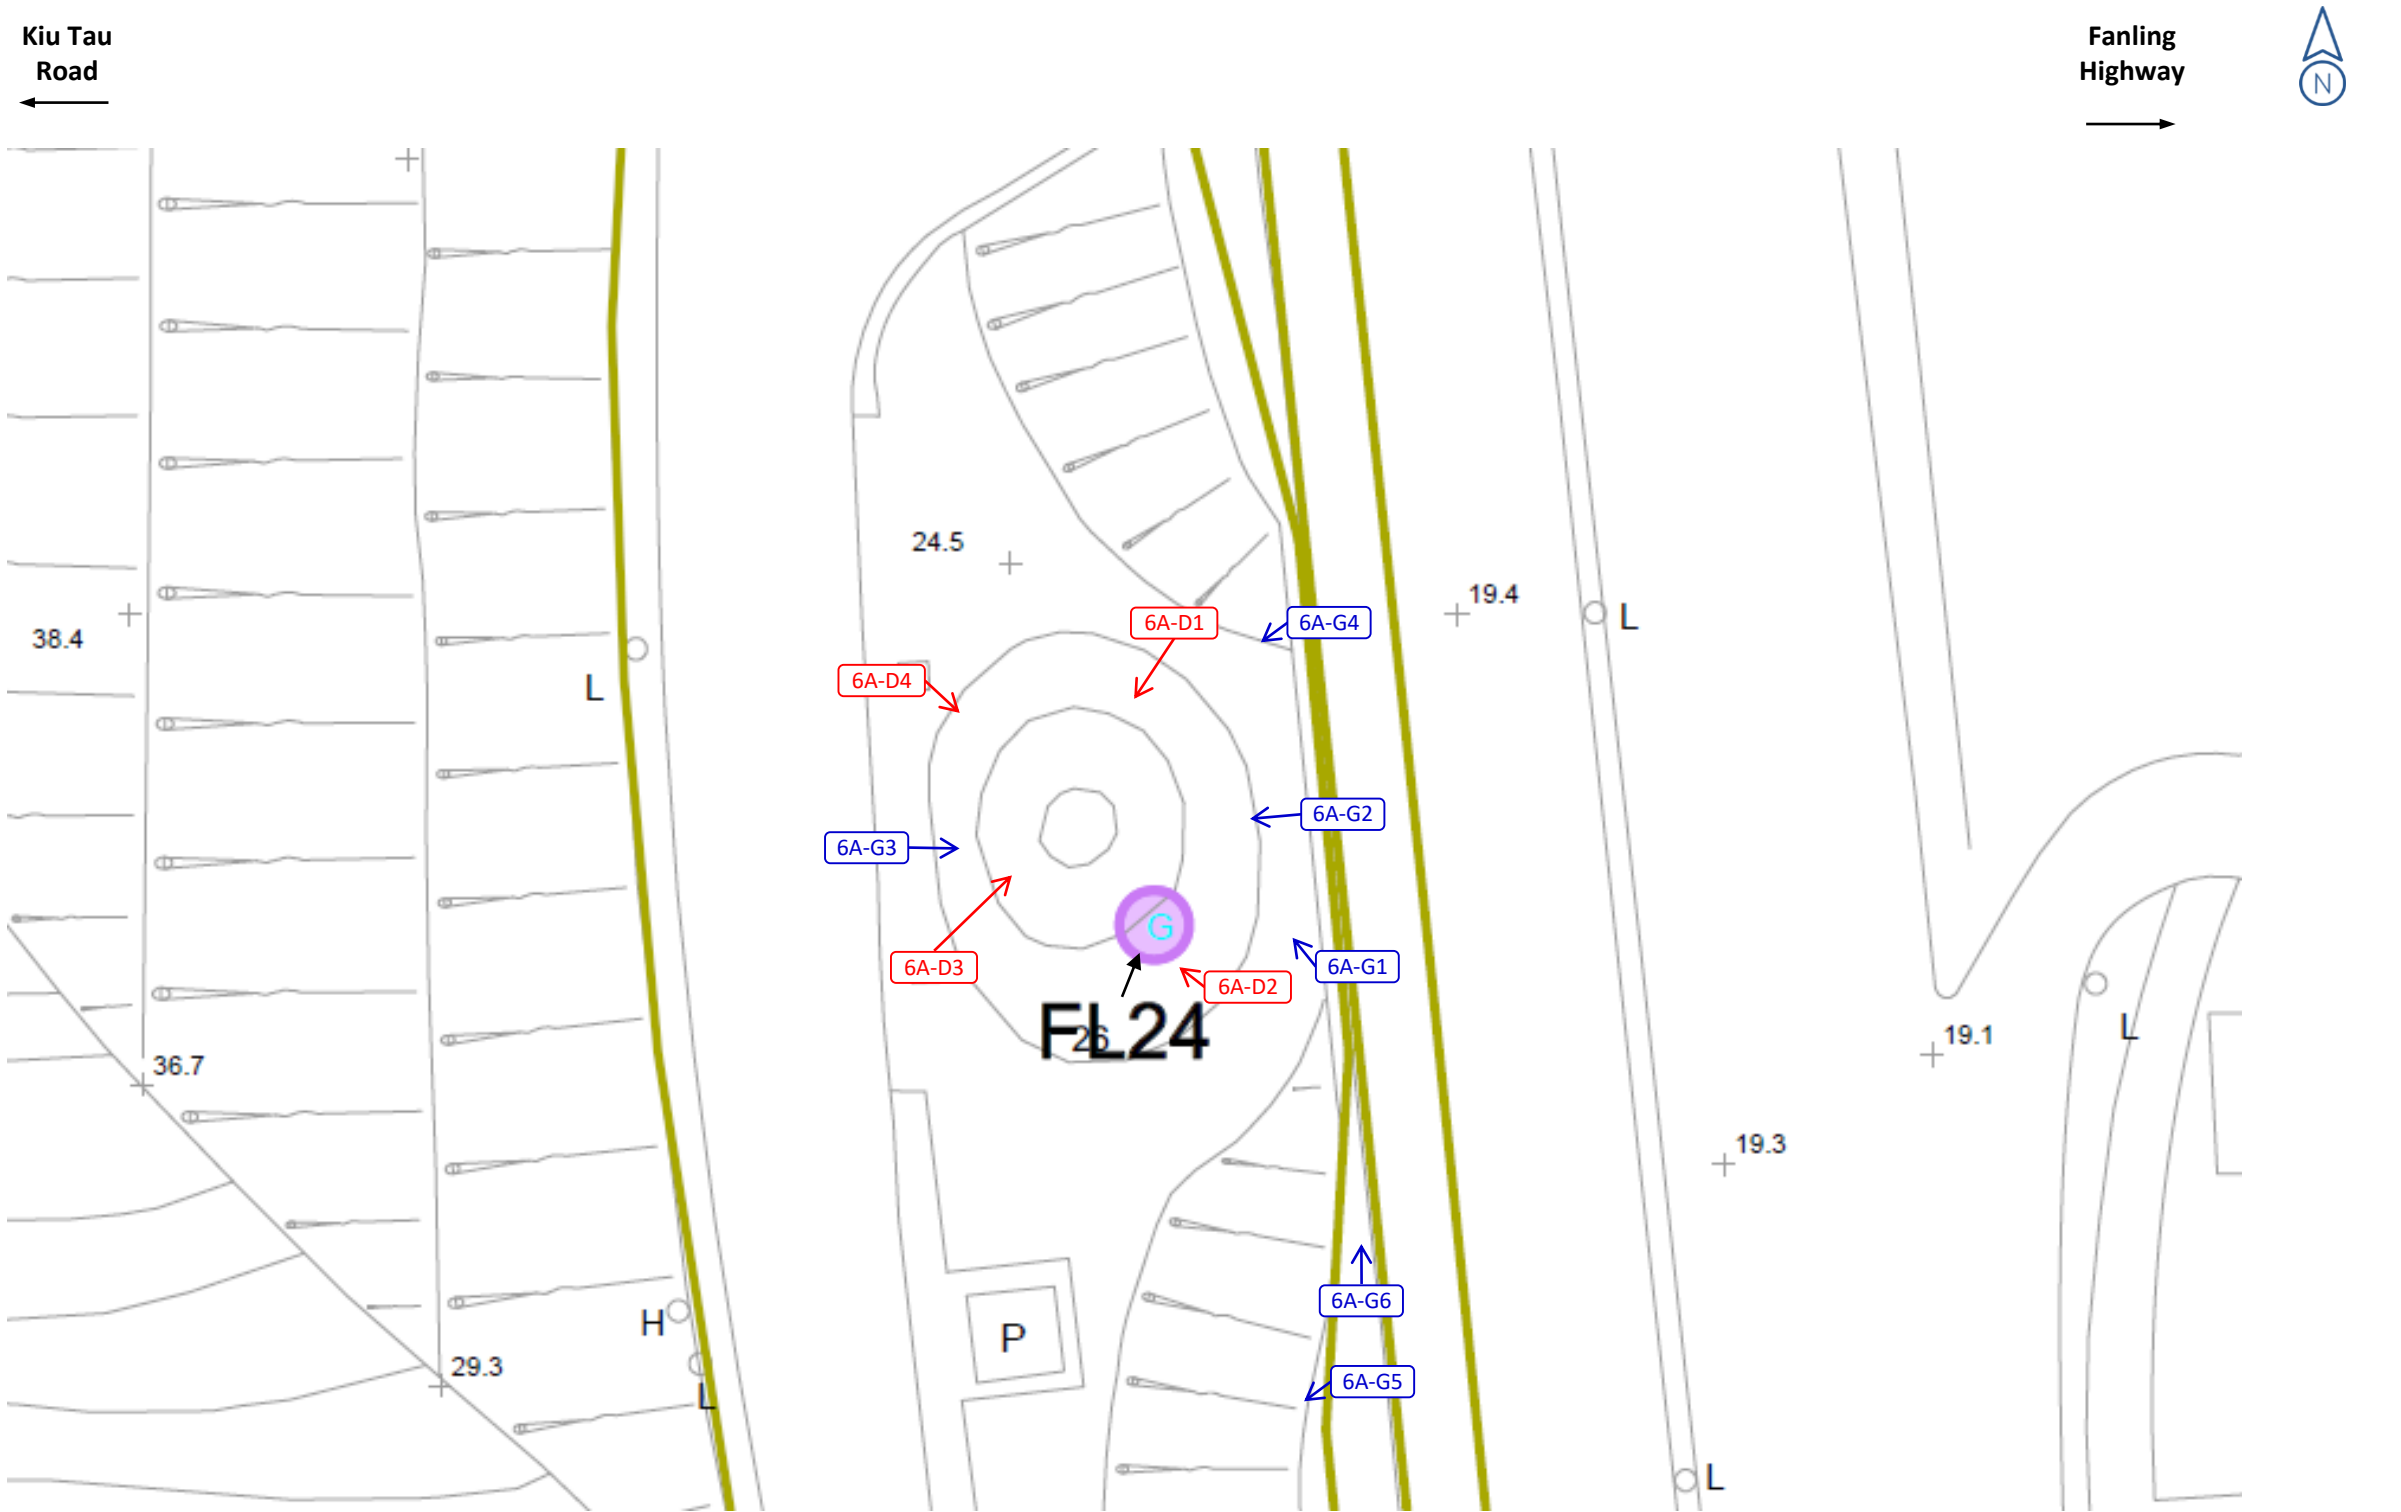
**Part Plan F - Layout Plan of FL24
with Location of General Photos**

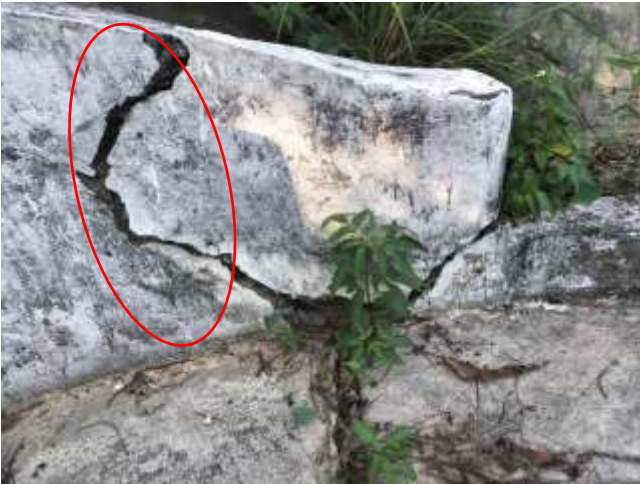
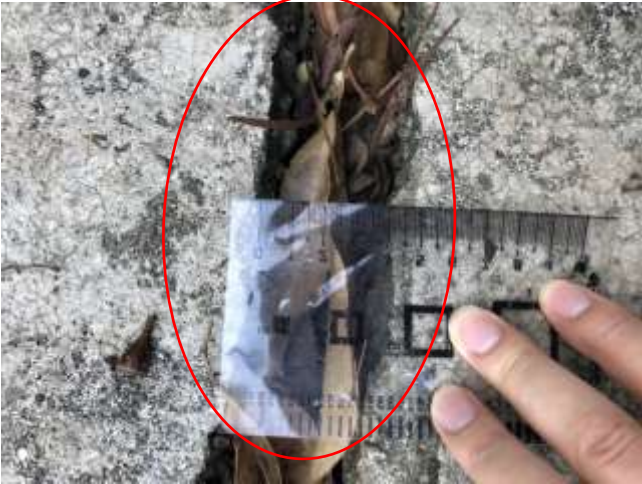
<p>6A-D1(1) - Wide Crack on Grave (General View)</p>	<p>6A-D1(2) - Wide Crack on Grave (Length:500mm/Width:45.00mm)</p>

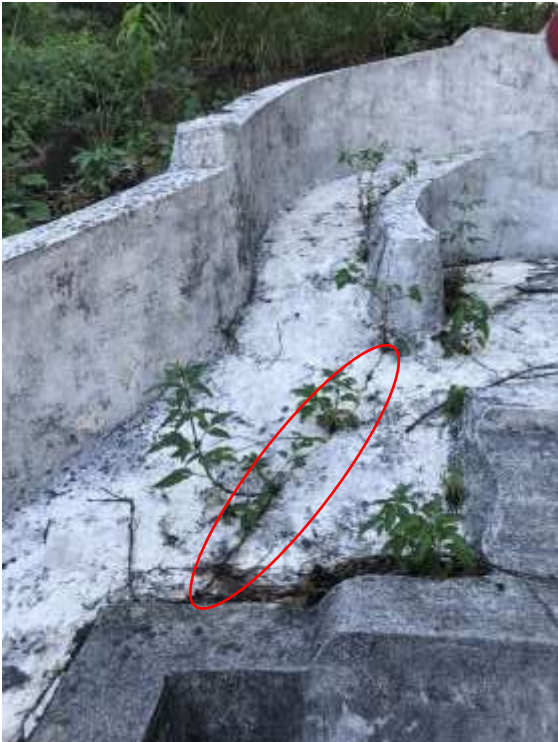
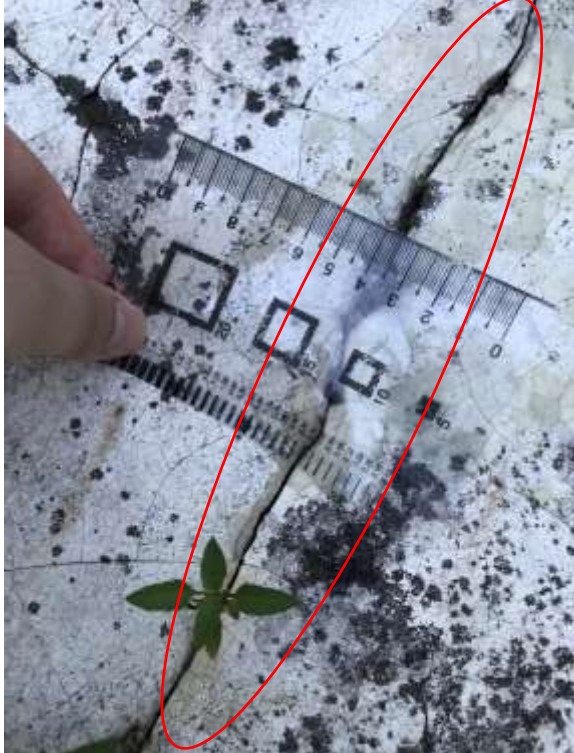
<p>6A-D2(1) - Fine Crack on Grave (General View)</p>	<p>6A-D2(2) – Fine Crack on Grave (Length:900mm/Width:0.50mm)</p>

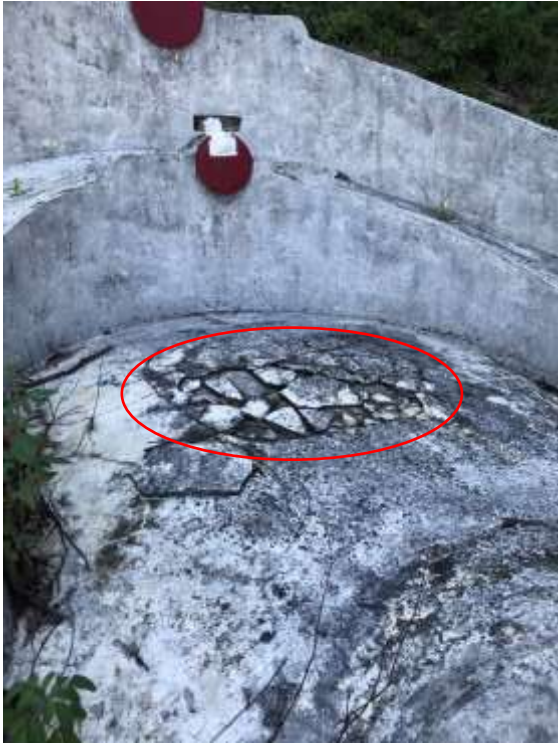
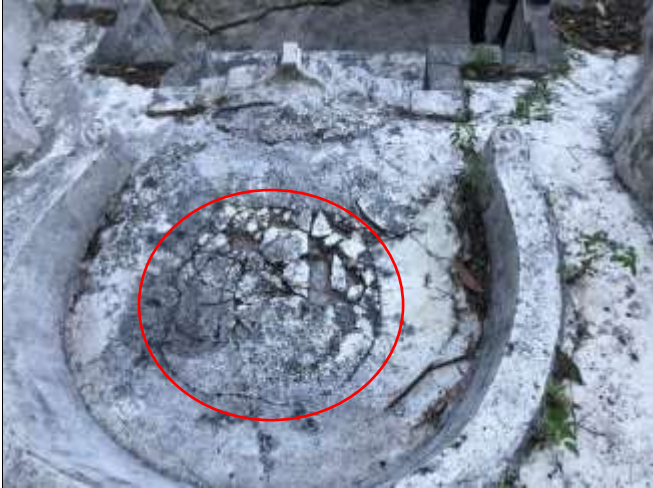
<p>6A-D3(1) - Broken Surface</p>	<p>6A-D3(2) - Broken Surface</p>

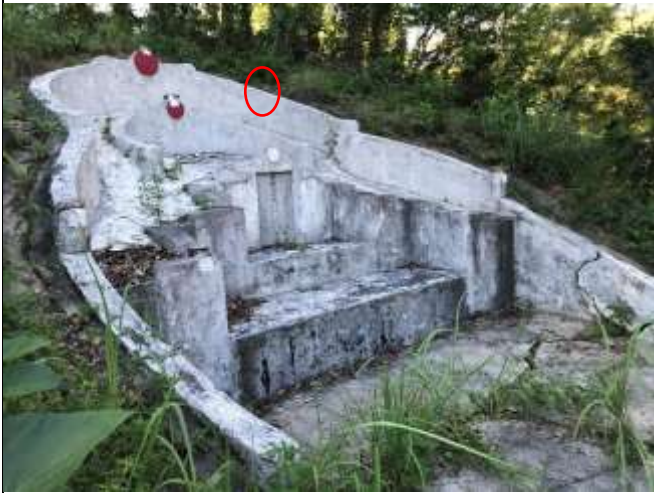
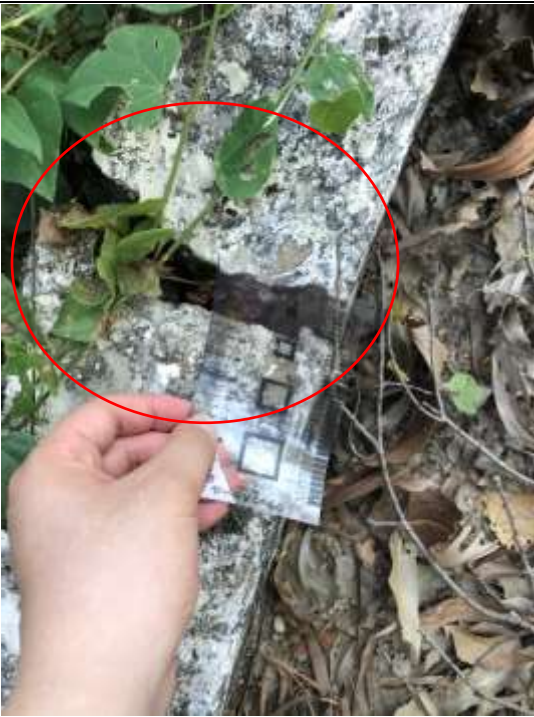
<p>6A-D4(1) - Wide Crack on Grave (General View)</p>	<p>6A-D4(2) - Wide Crack on Grave (Length:200mm/Width:20.00mm)</p>
