**- Contract No.: ND/2019/04**

**Baseline Condition Survey and Baseline Vibration Impact Assessment Report (Condition 2.10 and 3.3)**

**Baseline Condition Survey**  
**for the**  
**Built Heritages**  
**for**  
**Fanling North New Development Area,**  
**Phase1:**  
**Fanling Bypass Eastern Section**  
**(Shek Wu San Tsuen North**  
**to**  
**Lung Yeuk Tau)**  
**Under Contract No. ND/2019/04**

**Condition Survey Report**

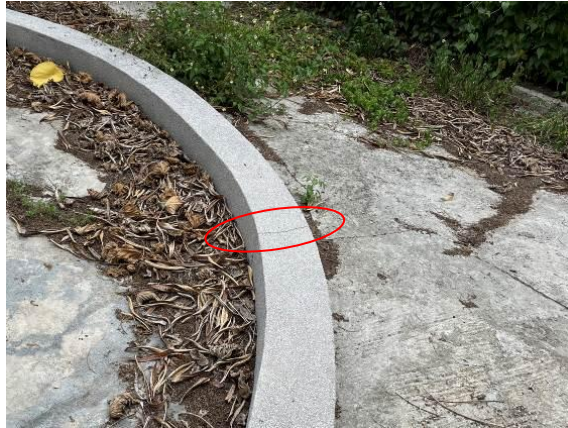
<p>Defect No.: FL11-EW-01 Location / Structure: Kerb Defect Category: Crack Size: 300 mm x 1 mm (w) Influenced Area: 0.0003 m<sup>2</sup></p>

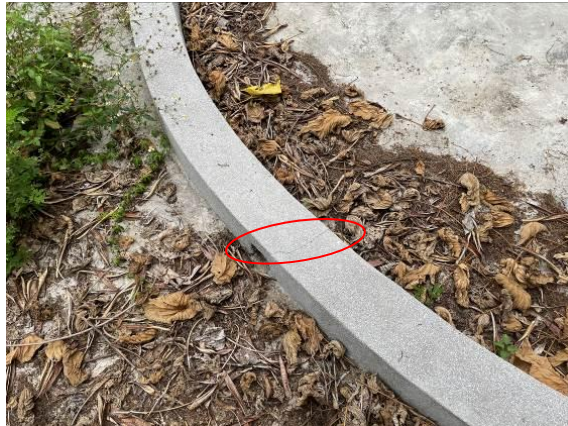
<p>Defect No.: FL11-EW-02 Location / Structure: Kerb Defect Category: Crack Size: 300 mm x 1 mm (w) Influenced Area: 0.0003 m<sup>2</sup></p>

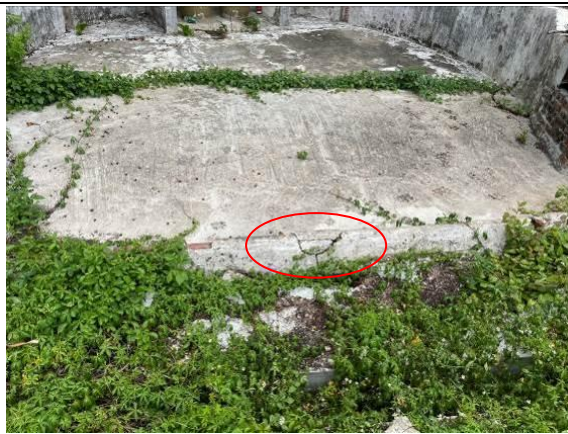
<p>Defect No.: FL10-EW-01 Location / Structure: Kerb Defect Category: Cracking Concrete Size: 300 mm x 200 mm Influenced Area: 0.06 m<sup>2</sup></p>

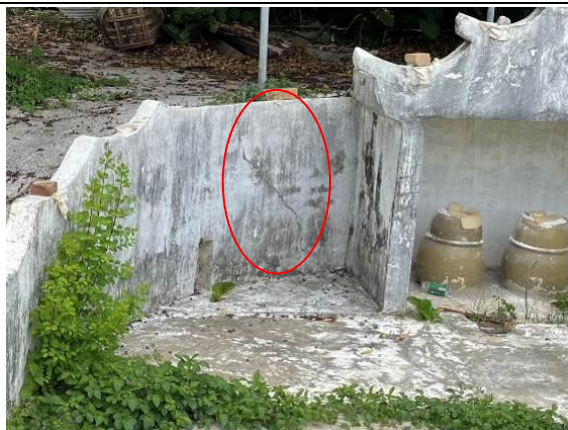
<p>Defect No.: FL10-EW-02 Location / Structure: External Envelope Defect Category: Crack Size: 1200 mm x 1 mm (w) Influenced Area: 0.0012 m<sup>2</sup></p>

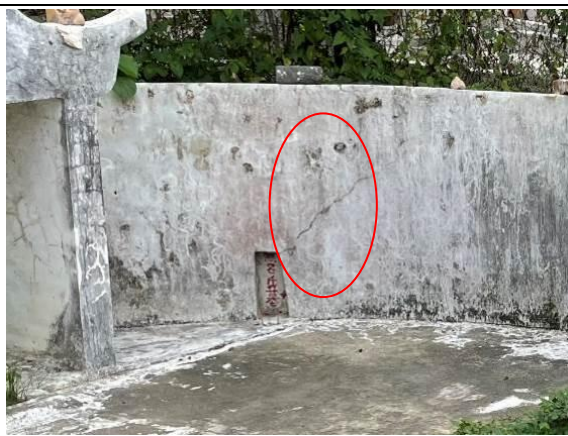
<p>FL10 Kam Tap (Con't) Defect No.: FL10-EW-03 Location / Structure: External Envelope Defect Category: Crack Size: 1000 mm x 1 mm (w) Influenced Area: 0.001 m<sup>2</sup></p>

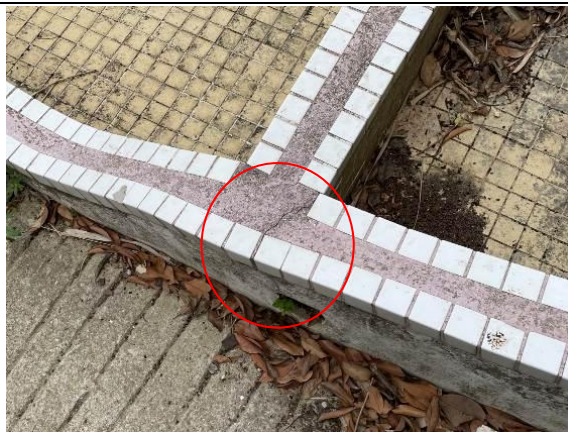
<p>Defect No.: FL07-EW-01 Location / Structure: External Envelope Defect Category: Crack Size: 300 mm x 1 mm (w) Influenced Area: 0.0003 m<sup>2</sup></p>

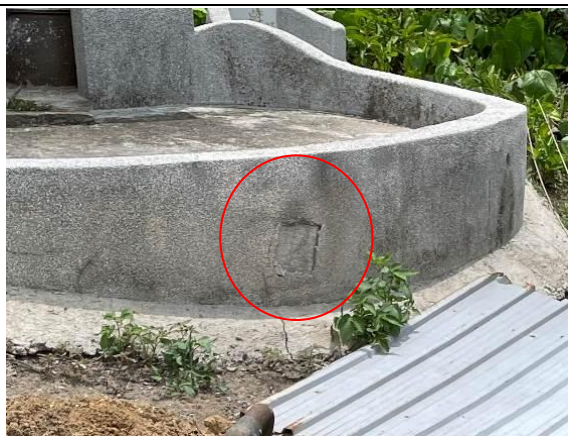
<p><u>FL08 Wen Grave (Con't)</u> Defect No.: FL08-EW-01 Location / Structure: External Envelope Defect Category: Delamination of Cover Size: 200 mm x 200 mm Influenced Area: 0.04 m<sup>2</sup></p>

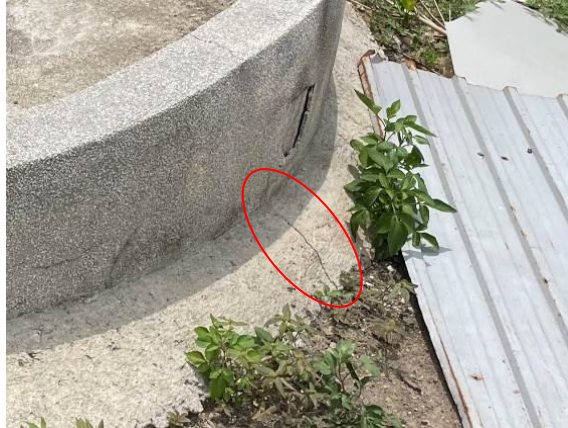
<p>Defect No.: FL08-EW-02 Location / Structure: External Envelope Defect Category: Crack Size: 400 mm x 1 mm (w) Influenced Area: 0.0004 m<sup>2</sup></p>

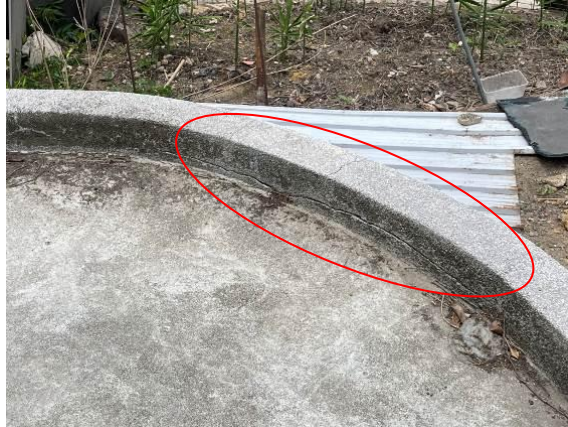
<p>Defect No.: FL08-EW-03 Location / Structure: Kerb Defect Category: Multiple Cracks Size: 1800 mm x 1 mm (w) in total Influenced Area: 0.0018 m<sup>2</sup></p>

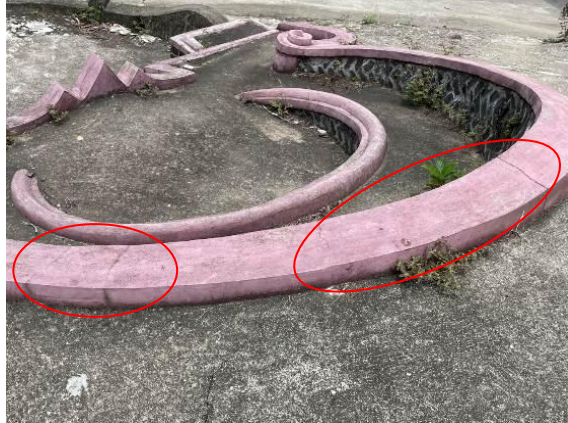
<p>Defect No.: FL17-EW-01 Location / Structure: External Envelope Defect Category: Multiple Cracks Size: 1600 mm x 1 mm (w) in total Influenced Area: 0.0016 m<sup>2</sup></p>

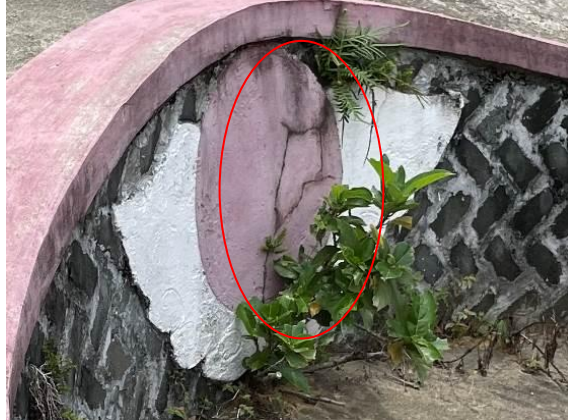
<p>Defect No.: FL17-EW-02 Location / Structure: External Envelope Defect Category: Multiple Cracks Size: 800 mm x 1 mm (w) in total Influenced Area: 0.0008 m<sup>2</sup></p>

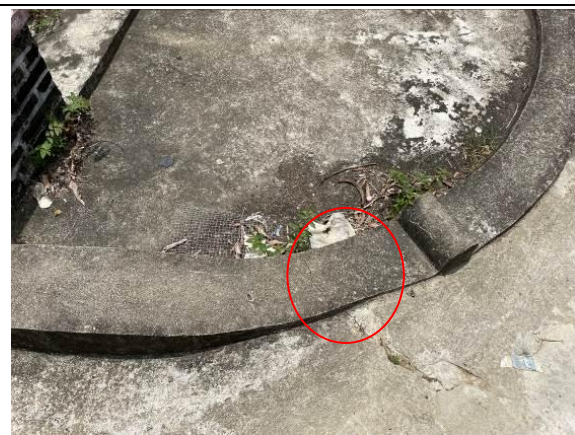
Defect No.: FL17-EW-03

Defect Category: Crack

Size: 300 mm x 1 mm (w)

Influenced Area: 0.0003 m<sup>2</sup>

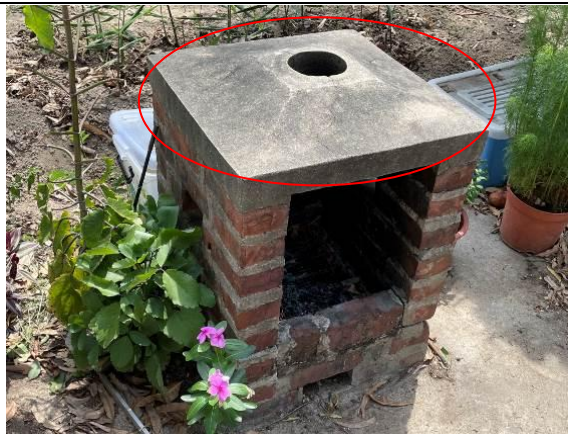
<p>Defect No.: FL05-EW-01 Location / Structure: External Envelope Defect Category: Multiple Cracks Size: 900 mm x 1 mm (w) in total Influenced Area: 0.0009 m<sup>2</sup></p>

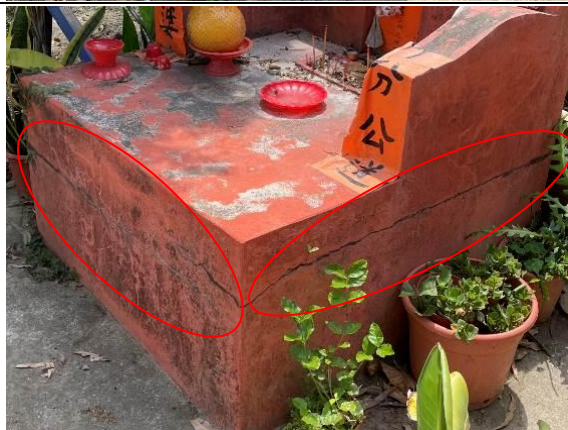
<p>Defect No.: FL05-EW-02 Location / Structure: External Envelope Defect Category: Multiple Cracks Size: 2200 mm x 1 mm (w) in total Influenced Area: 0.0022 m<sup>2</sup></p>

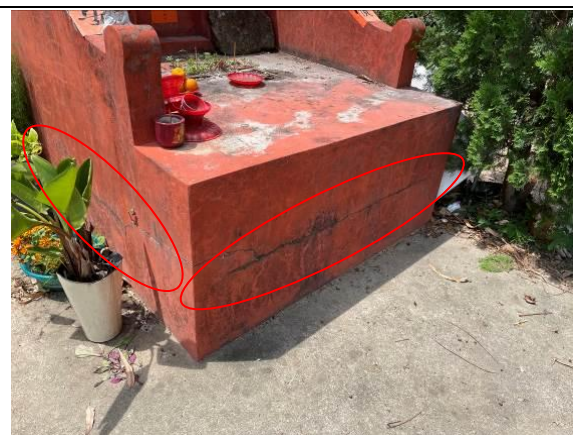
Defect No.: FL05-EW-03

Defect Category: Multiple Cracks

Size: 2200 mm x 1 mm (w) in total

Influenced Area: 0.0022 m<sup>2</sup>

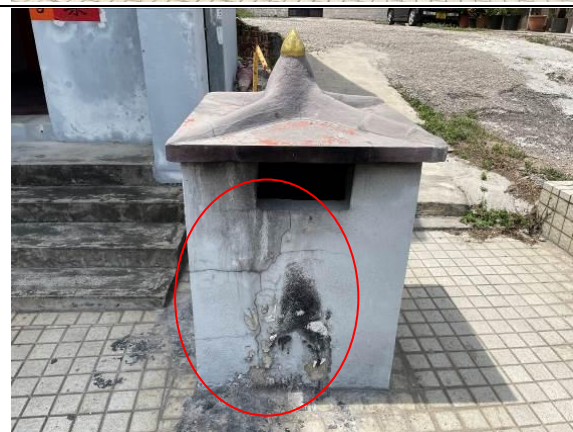
Defect No.: HFL08-EW-01

Location / Structure: External Envelope

Defect Category: Multiple Cracks

Size: 1200 mm x 1 mm (w) in total

Influenced Area: 0.0012 m<sup>2</sup>

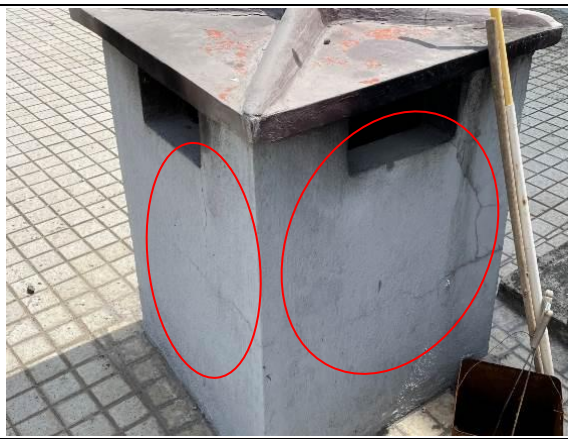
<p>HFL08 Nos. 2 to 4 Siu Hang Tsuen (Con't) Defect No.: HFL08-EW-02 Location / Structure: External Envelope Defect Category: Multiple Cracks Size: 1400 mm x 1 mm (w) in total Influenced Area: 0.0014 m<sup>2</sup></p>

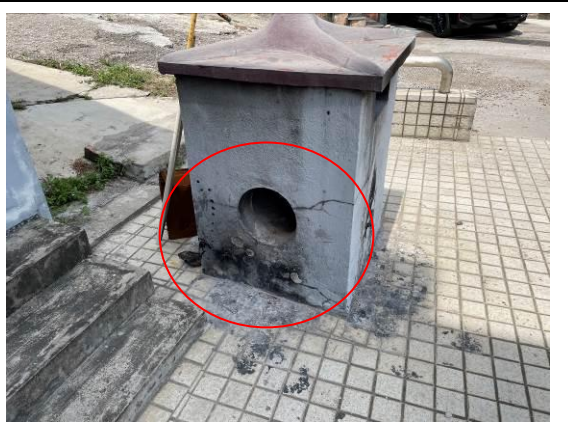
<p>Defect No.: HFL08-EW-03 Location / Structure: External Envelope Defect Category: Multiple Cracks Size: 1000 mm x 1 mm (w) in total Influenced Area: 0.001 m<sup>2</sup></p>

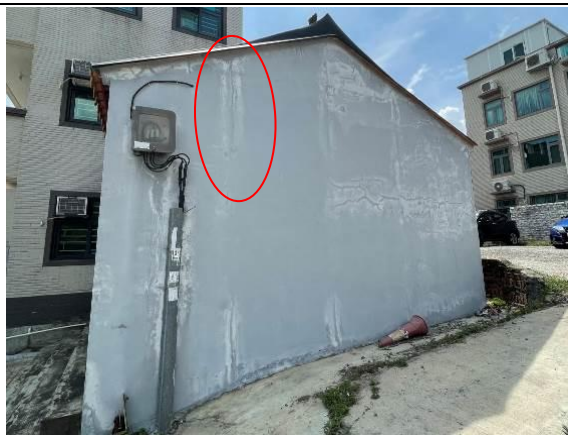
<p>Defect No.: HFL08-EW-04 Location / Structure: External Envelope Defect Category: Crack Size: 1200 mm x 1 mm (w) Influenced Area: 0.0012 m<sup>2</sup></p>

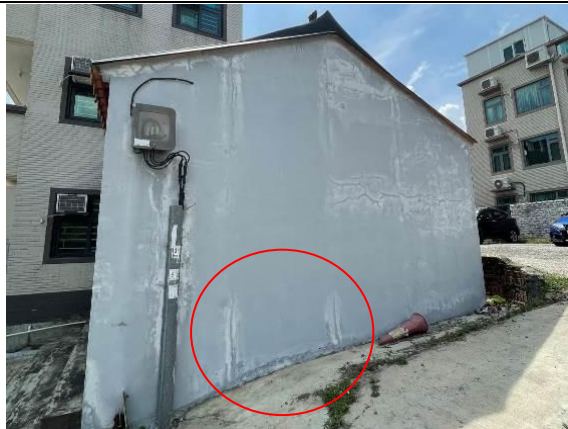
<p>Defect No.: HFL08-EW-05 Location / Structure: External Envelope Defect Category: Multiple Cracks Size: 1400 mm x 1 mm (w) in total Influenced Area: 0.0014 m<sup>2</sup></p>

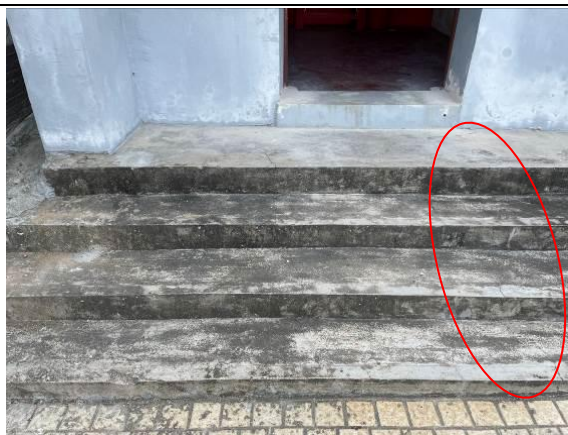
<p>HFL08 Nos. 2 to 4 Siu Hang Tsuen (Con't) Defect No.: HFL08-EW-10 Location / Structure: External Steps Defect Category: Crack Size: 1800 mm x 1 mm (w) Influenced Area: 0.0018 m<sup>2</sup></p>

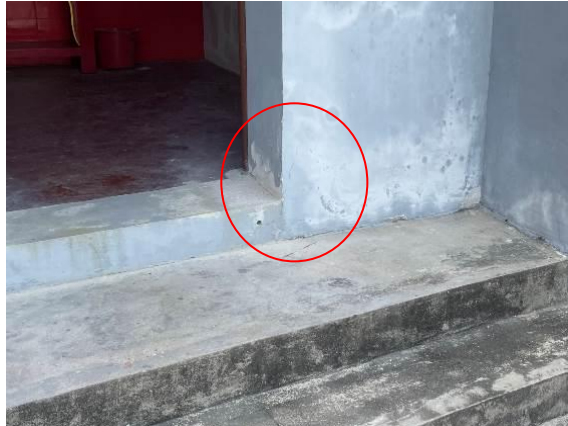
<p>Defect No.: HFL08-EW-11 Location / Structure: External Wall and Kerb Defect Category: Crack Size: 800 mm x 1 mm (w) Influenced Area: 0.0008 m<sup>2</sup></p>

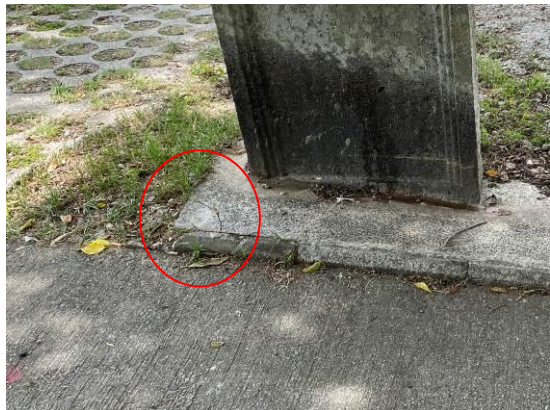
<p>Defect No.: FL19-EW-01                  Location / Structure: Kerb                  Defect Category: Crack                  Size: 300 mm x 1 mm (w)                  Influenced Area: 0.0003 m<sup>2</sup></p>
