Ocean Park Tai Shue Wan Water World Project

Operation Phase Monthly EM&A Report
March 2022

April 2022

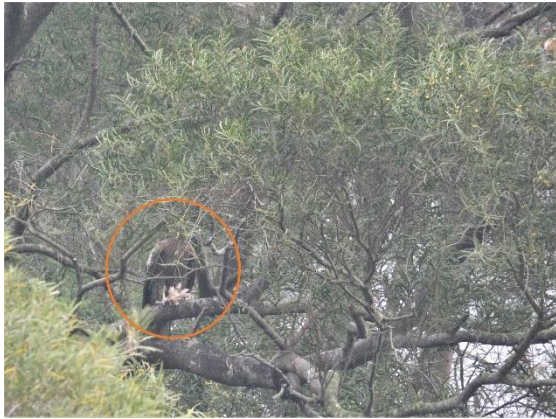
Figure 2.1 Black Kite feeding on prey

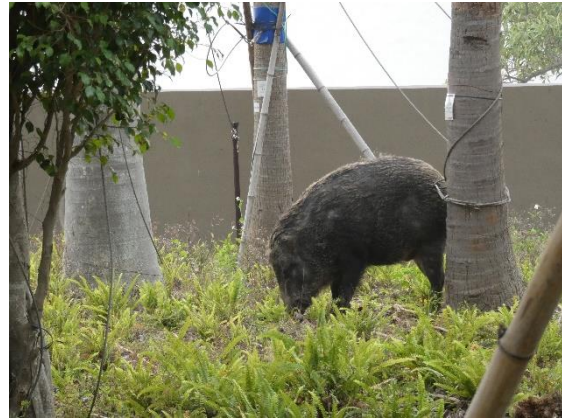
Figure 2.2 Wild boar foraging in EEA

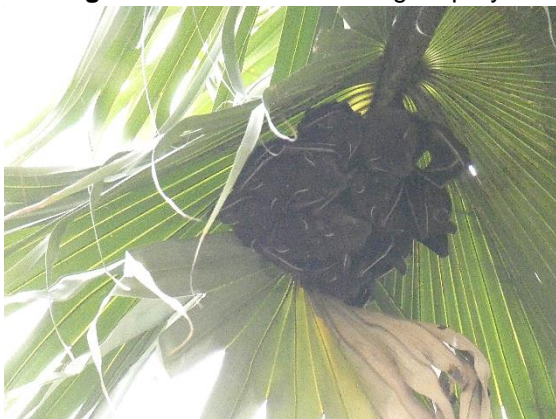
Figure 2.3 Short-nosed Fruit Bat roosting on frond of Chinese Fan-palm

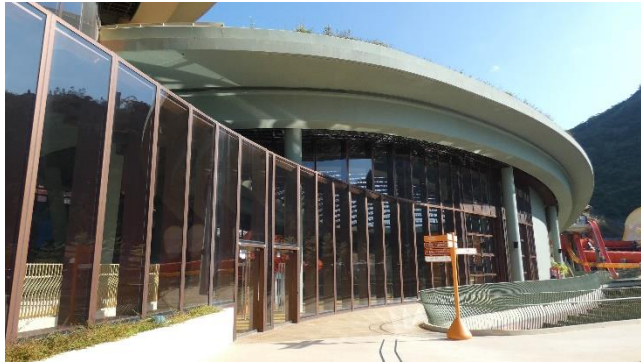
OP01 Sensitive Design and Disposition – Color palette of the design was mostly in subdued tones. Floor and walls were painted with non-reflective finishing.

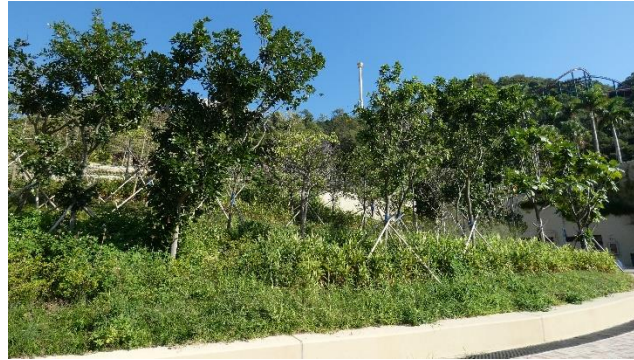
OP02 Compensatory Tree Planting – General view of whip trees newly planted.

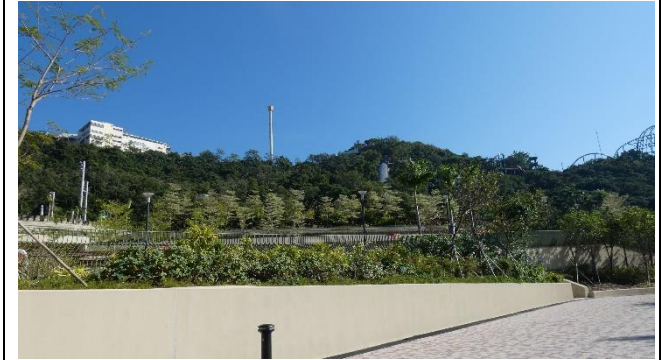
OP03 Enhancement Planting – Additional trees and shrubs were planted along the pedestrian walkway.

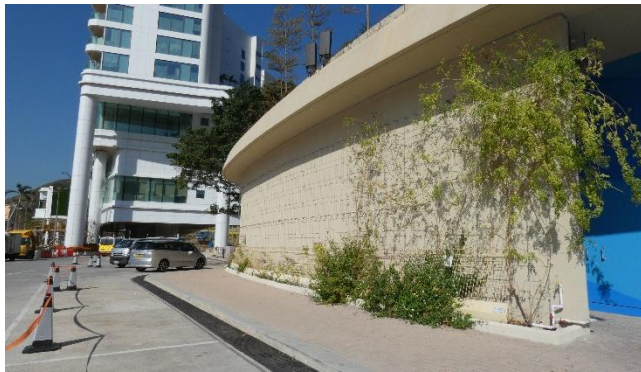
OP04 Green Roofs and Vertical Greening – General view of green roof and vertical green in establishment.

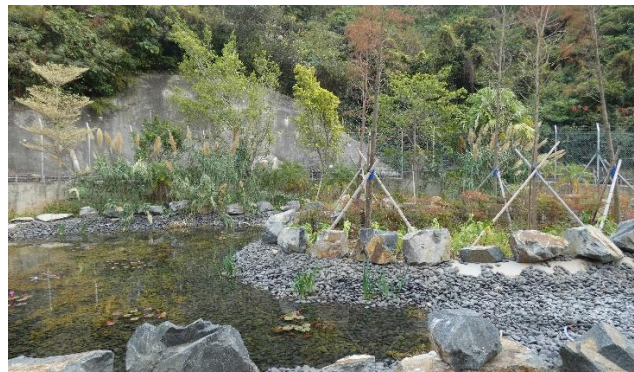
OP05 Re-provision of Flamingo Pond – General view

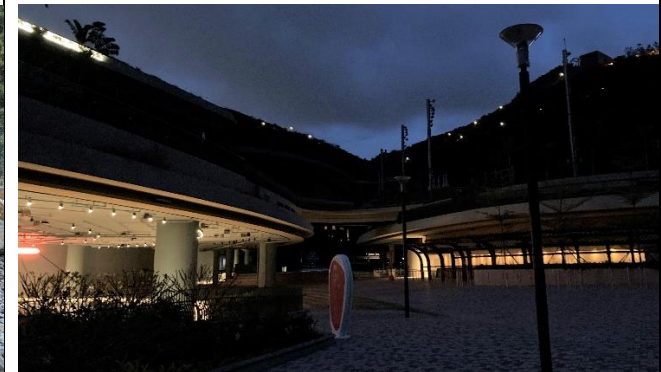
OP06 Responsive Lighting Design – General view of lighting design with appropriate level of lighting to reduce potential impact
