Ocean Park Tai Shue Wan Water World Project

Operation Phase Monthly EM&A Report
July 2022

August 2022

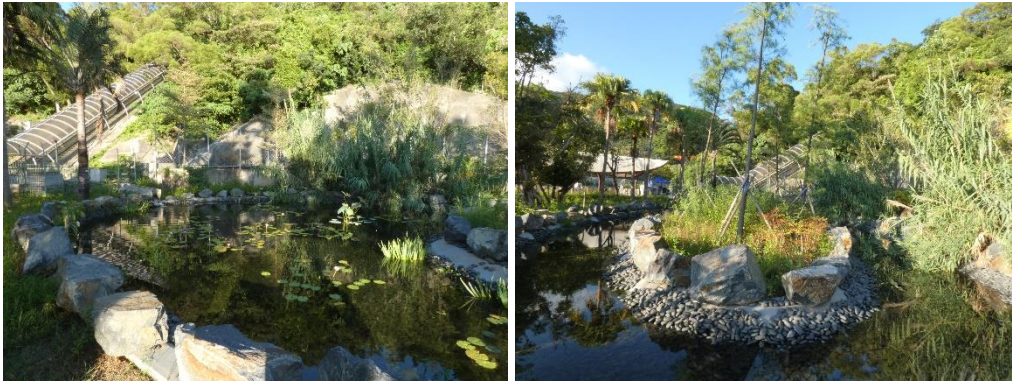
Monitoring of the EEA was undertaken on 21 July 2022. The condition of vegetation in the EEA was generally well-maintained, while the pond was also maintained with suitable water level and continuous water inflow (see **Figure 2.1**). The EEA was inspected, but no ardeids or day roost of Black-crowned Night Heron were found in the EEA. Individuals of Black Kite (*Milvus migrans*) were observed soaring over the area. Greater Coucal (*Centropus sinensis*), which is rated as “Vulnerable” in Chinese Red Data Book (Zheng & Wang, 1998)¹ and is a Class II protected species II under the state protection of China (2021)², was heard from the woodland at the edge of EEA. Other bird species observed in the EEA include Black-collared Starling (*Gracupica nigricollis*), Chinese Bulbul (*Pycnonotus sinensis*), Eurasian Tree Sparrow (*Passer montanus*), and Red-whiskered Bulbul (*Pycnonotus jocosus*). A butterfly species Dark Brand Bush Brown (*Mycalesis mineus*) was recorded within the EEA. Odonate species Common Blue Skimmer (*Orthetrum glaucum*) (see **Figure 2.2**) and Red-faced Skimmer (*Orthetrum chrysis*) were also observed at the pond of EEA. Apart from that, two groups of Short-nosed Fruit Bat (*Cynopterus sphinx*), which is a species listed as “Near Threatened” in Red List of China's Vertebrates (Jiang *et al.*, 2016)³, were observed roosting under Chinese Fan-palms within the EEA (see **Figure 2.3**), which echoes the findings of the Short-nosed Fruit Bat Inspection Report submitted prior the construction phase.

Figure 2.1 General view of the freshwater pond and vegetation in the EEA

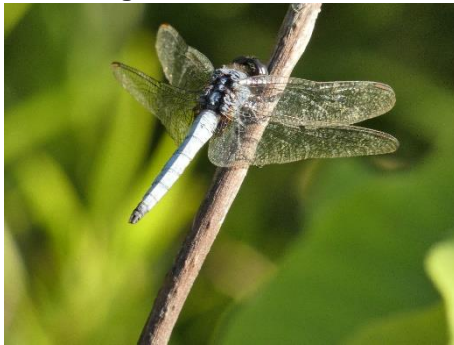
Figure 2.2 Odonate species Common Blue Skimmer (*Orthetrum glaucum*)

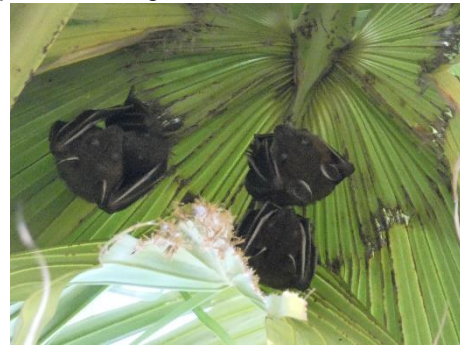
Figure 2.3 Short-nosed Fruit Bat roosting on frond of Chinese Fan-palm

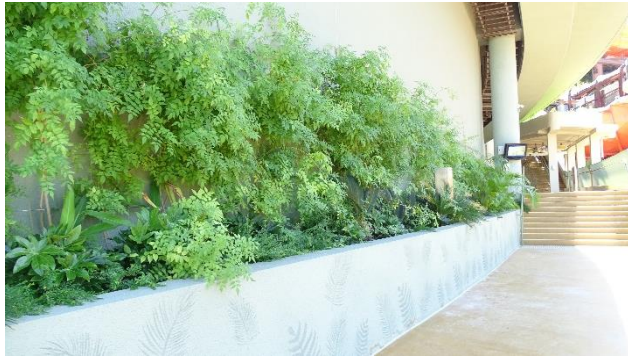
OP01 Sensitive Design and Disposition – Color palette of the design was mostly in subdued tones. Floor and walls were painted with non-reflective finishing.

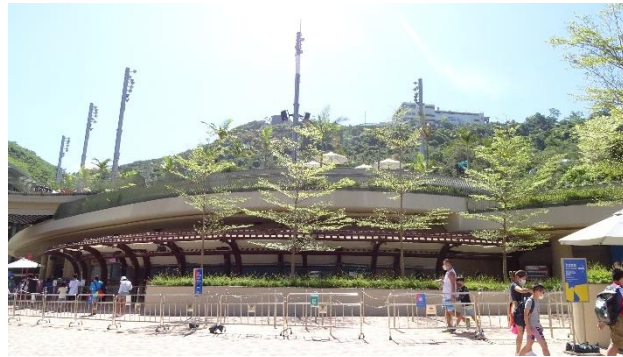
OP02 Compensatory Tree Planting – General view of whip trees newly planted.

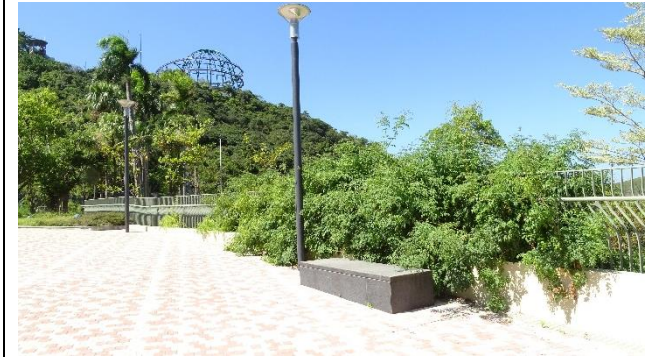
OP03 Enhancement Planting – Additional trees and shrubs were planted along the pedestrian walkway.

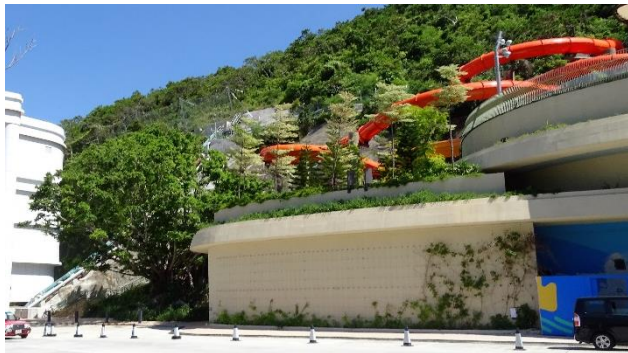
OP04 Green Roofs and Vertical Greening – General view of green roof and vertical green in establishment.

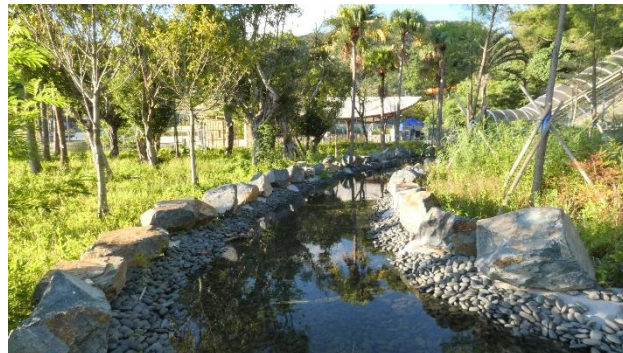
OP05 Reprovision of Flamingo Pond – General view

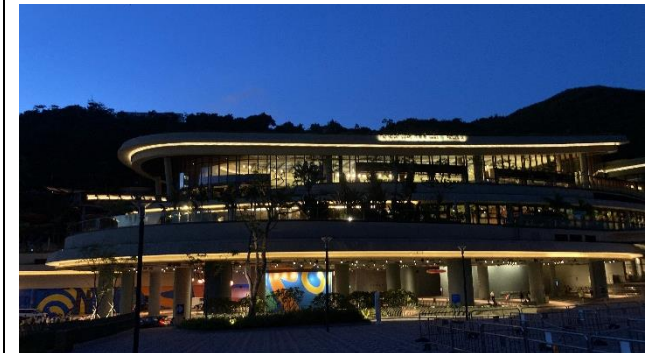
OP06 Responsive Lighting Design – General view of lighting design with appropriate level of lighting to reduce potential impact
