Ocean Park Tai Shue Wan Water World Project

Operation Phase Monthly EM&A Report
September 2022

October 2022

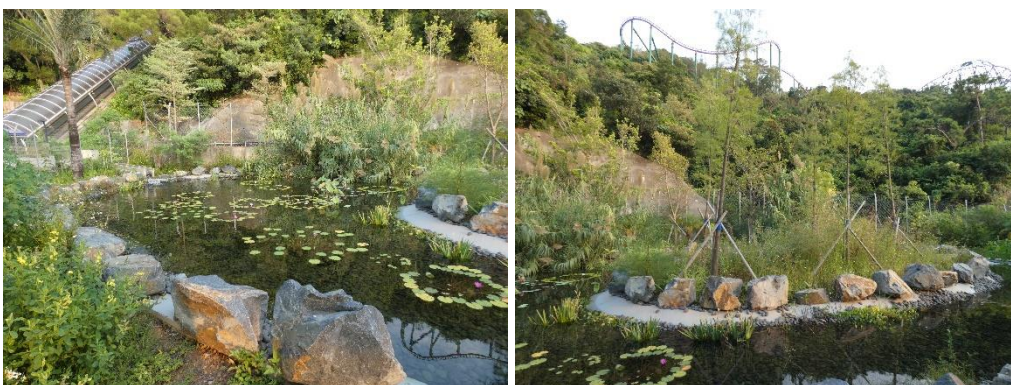
Monitoring of the EEA was undertaken on 23 September 2022. The condition of vegetation in the EEA was generally well-maintained, while the pond was also maintained with suitable water level and continuous water inflow (see **Figure 2.1**). The EEA was inspected, but no ardeids or day roost of Black-crowned Night Heron were found in the EEA. Individuals of Black Kite (*Milvus migrans*) were observed soaring over the area. Other bird species observed in the EEA include Chinese Bulbul (*Pycnonotus sinensis*), Crested Myna (*Acridotheres cristatellus*), Red Collared Dove (*Streptopelia tranquebarica*) and Swinhoe's White-eye (*Zosterops simplex*). Butterfly species Common Tiger (*Danaus genutia*) and odonate species Blue Percher (*Diplacodes trivialis*) (see **Figure 2.2**) were also recorded within the EEA. Apart from that, two small groups of Short-nosed Fruit Bat (*Cynopterus sphinx*), which is a species listed as “Near Threatened” in Red List of China's Vertebrates (Jiang *et al.*, 2016)¹, were observed roosting under Chinese Fan-palms within the EEA (see **Figure 2.3**), which echoes the findings of the Short-nosed Fruit Bat Inspection Report submitted prior the construction phase.

Figure 2.1 General view of the freshwater pond and vegetation in the EEA

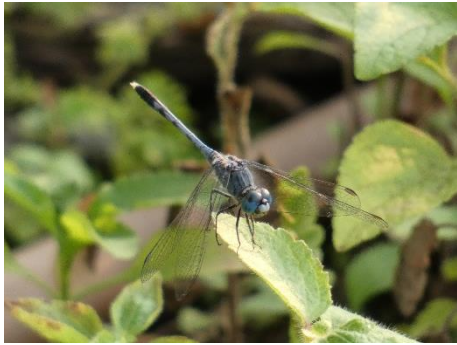
Figure 2.2 Odonate species Blue Percher
(*Diplacodes trivialis*)

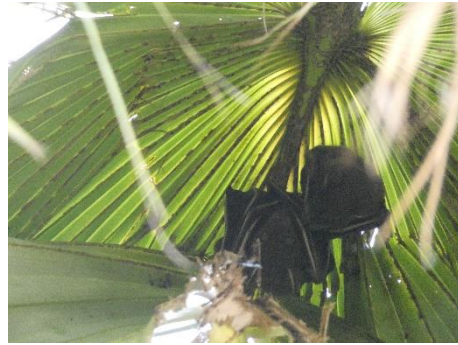
Figure 2.3 Short-nosed Fruit Bat roosting on
frond of Chinese Fan-palm

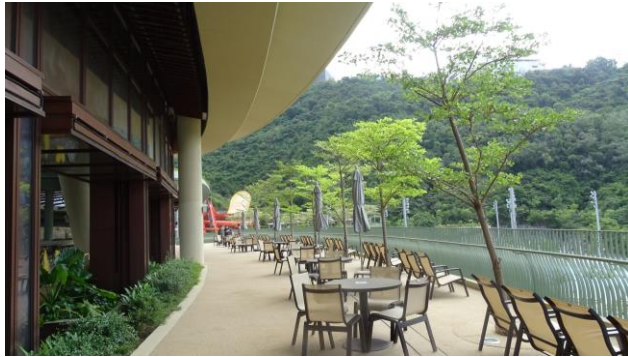
OP01 Sensitive Design and Disposition – Color palette of the design was mostly in subdued tones. Floor and walls were painted with non-reflective finishing.

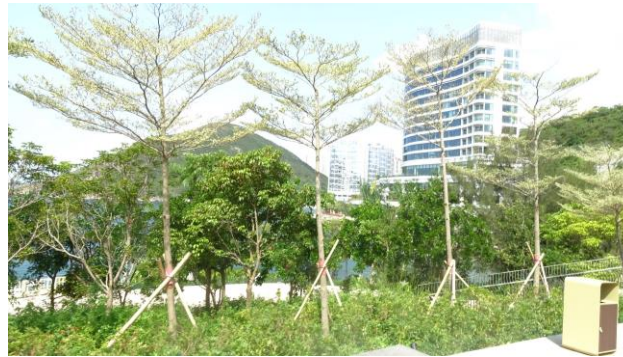
OP02 Compensatory Tree Planting – General view of whip trees newly planted.

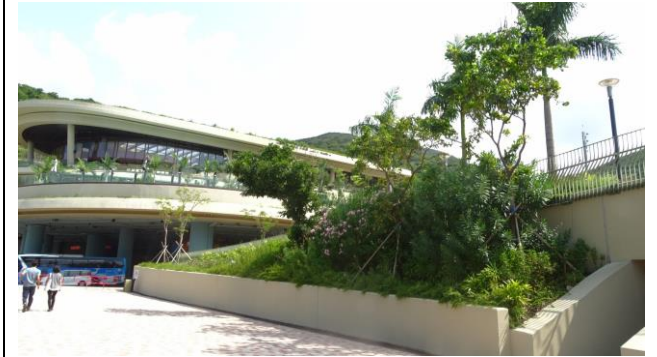
OP03 Enhancement Planting – Additional trees and shrubs were planted along the pedestrian walkway.

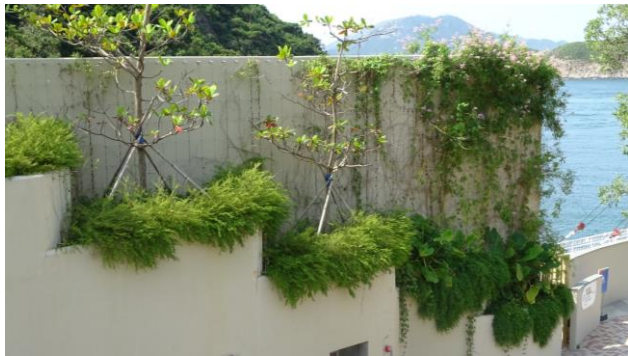
OP04 Green Roofs and Vertical Greening – General view of green roof and vertical green in establishment.

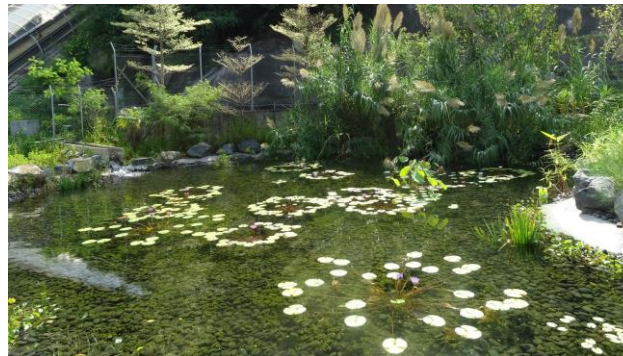
OP05 Re-provision of Flamingo Pond – General view

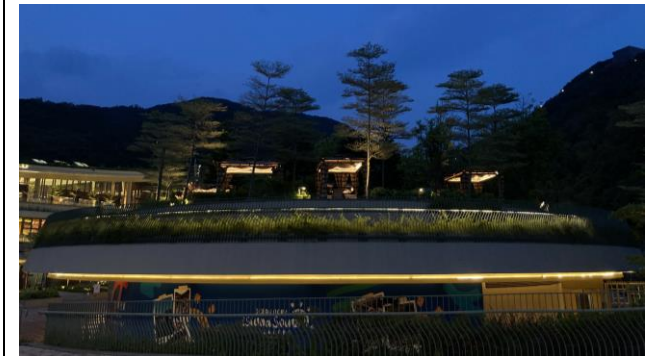
OP06 Responsive Lighting Design – General view of lighting design with appropriate level of lighting to reduce potential impact
