JOB No.: TCS01264/22

**CEDD Contract No. SD/2022/01 –
Site Formation and Infrastructure Works for Public
Housing Development at Ex-Mount Davis Cottage Area
in Kennedy Town**

*Further Review Report for Land Contamination
Assessment on Working Area under the Contract within
New World First Bus Former Depot Area*

Date	Reference No.	Prepared By	Certified By
13 April 2023	TCS01264/22/600/R0015v6

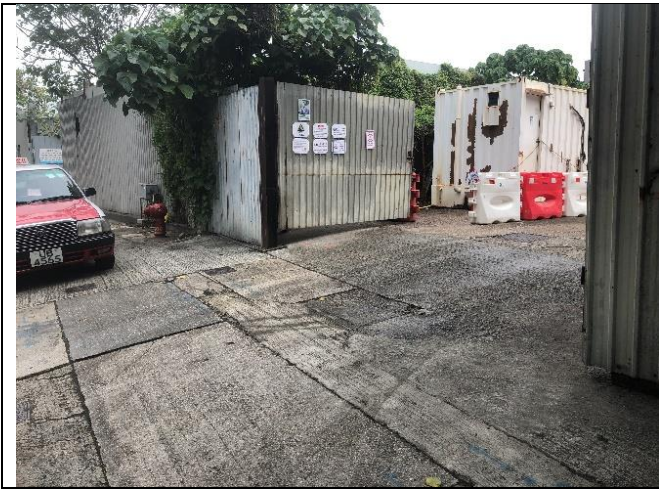
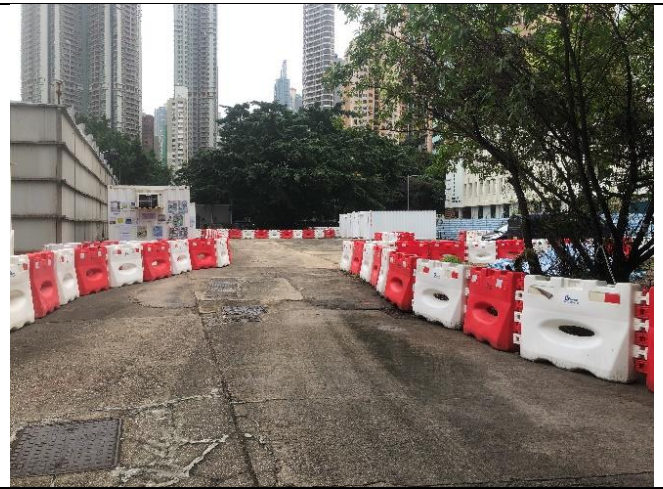
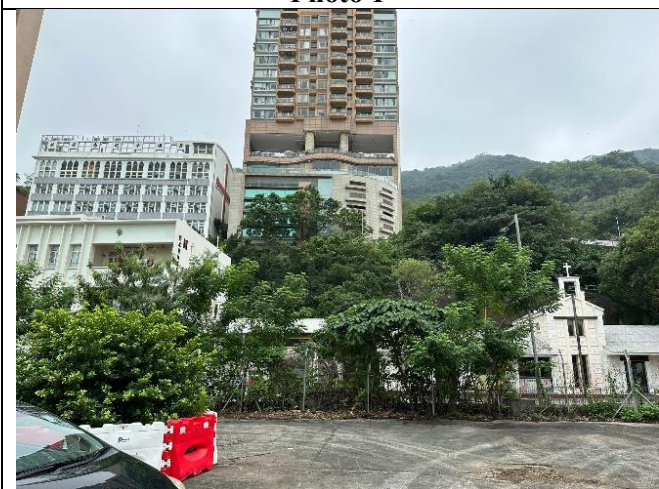
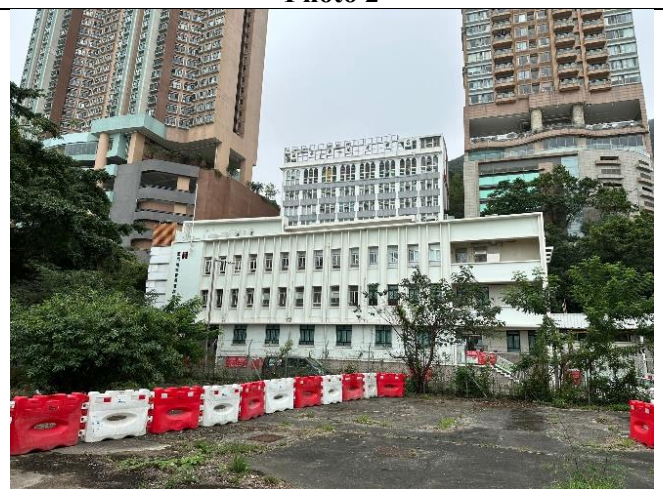
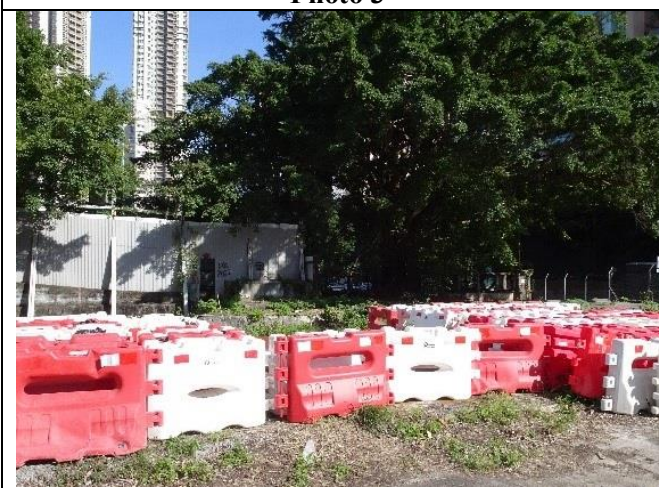
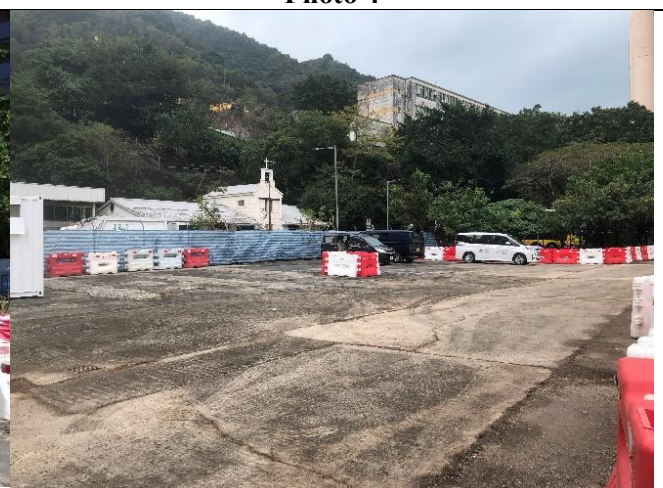
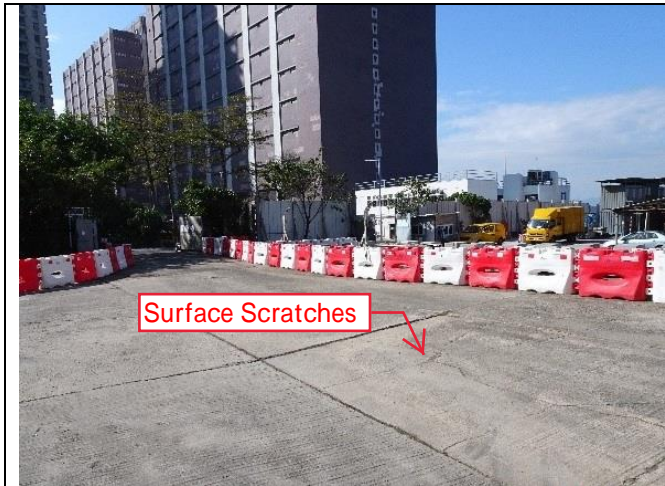
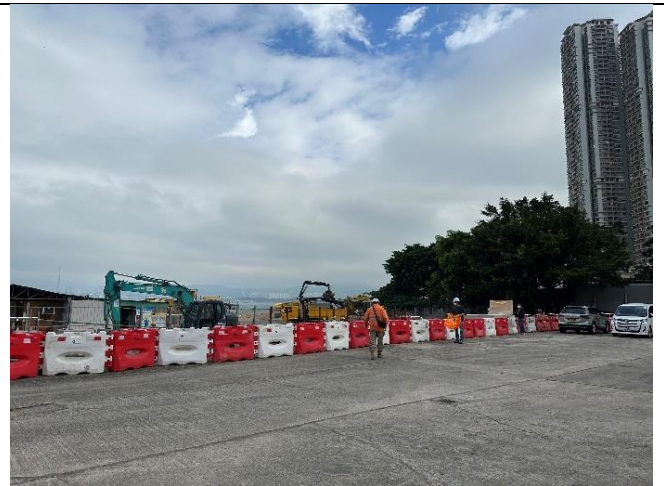
3.3.1 Site visit was conducted in November 2022 by AUES. The site was an idling government site and the floor of the site was paved with concrete with minor surface scratches. No potential source of contamination was spotted during the site visit. The site photos and the walkover checklist are provided in **Appendix D**.

It is an idle government site with paved ground and no site activity was observed.
