Proposed Golf Course Development at Tai Po Lot No. 246 Shuen Wan

Tai Po Golf Club Limited

Land Contamination Review

Reference: 289499-REP-001-02

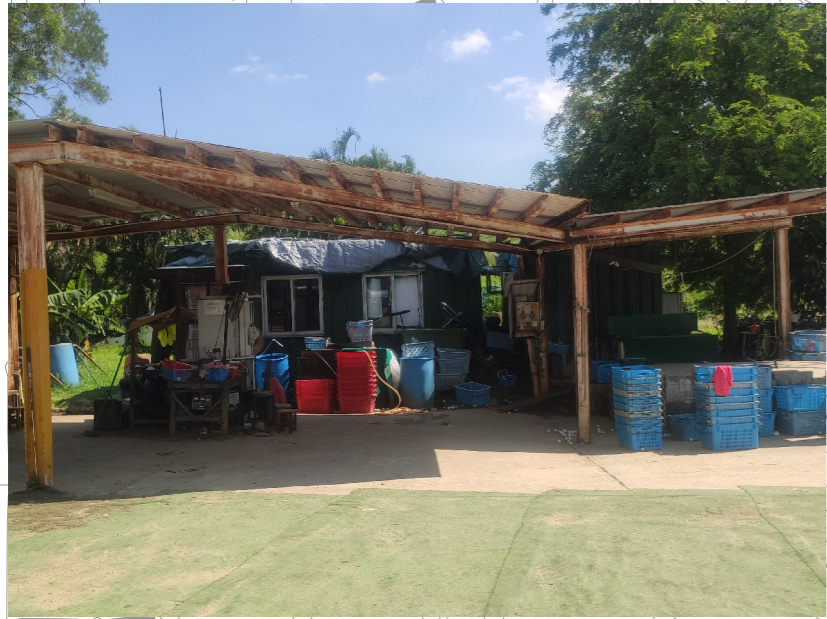
PHOTO 2

- 2.4.2.3 The temporary shelter at the north eastern side of the storage/ workshop area was comprised of staff rest room and an area for storing and washing golf ball in baskets (photo 2). Besides, cleaning solvent was not observed. As advised by the workers of the closed Golf Driving Range (“the workers”), golf balls were washed with water. The baskets storing golf balls were placed on concrete-paved ground with no observable cracks. Therefore, the land contamination potential due to the storage of staff rest room and golf balls and staff room is unlikely.

Photo No.	Description	Contamination Potential
1	Storage/ workshop area	Unlikely
2	Storage for golf ball/ Staff room	Unlikely
3	Storage/ workshop area	Unlikely
4	Containers for storage	Unlikely

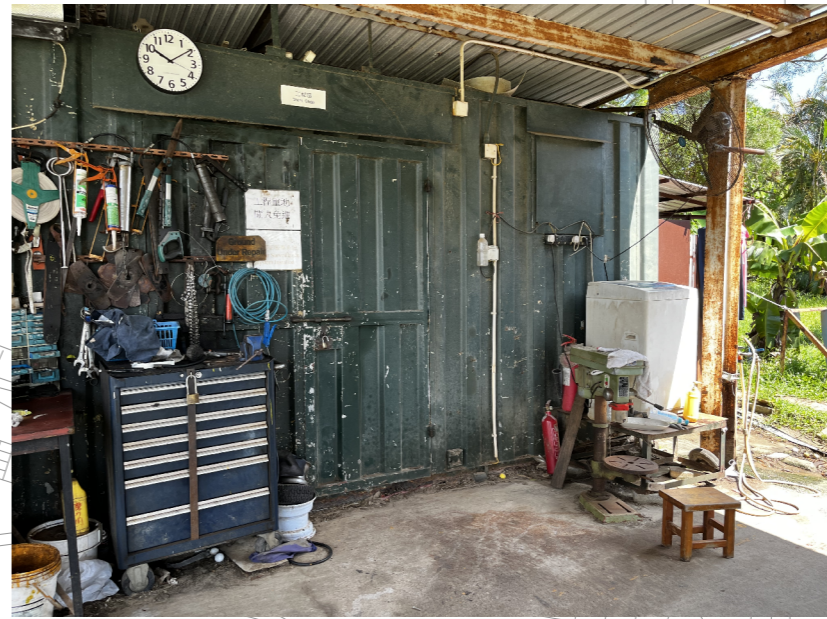
PHOTO 3

- 2.4.2.5 An approximate 41m² workshop area was observed under the temporary shelter at the western side of the storage/ workshop area (photo 3). As advised by the workers, only electric golf carts were being used at the closed Golf Driving Range, and no gasoline or fuel were required for refuelling the golf carts. Thus, the usage of electric golf carts eliminated the chance of release of fuels during the repairing activities from contaminating the land as observed, which aligned with the findings in the approved EIA report (AEIAR-221/2019).

- 2.4.2.6 In addition, as advised by the workers, only minor lubricating activities on small movable joints or parts of equipment, e.g. bearing, were carried out at this workshop area if necessary. No waste oil drums were observed in the workshop area, and no oil stain was observed on the ground of the workshop area (photo 3). Besides, no evidence of major vehicle repairing activities was observed during the supplementary site walk, which aligned with the findings in the approved EIA report (AEIAR-221/2019). Considering the area did not appear to be occupied by land contamination activities and the ground was well paved with concrete slab, the land contamination potential due to the workshop area

is unlikely, which aligned with the findings in the approved EIA report (AEIAR-221/2019).

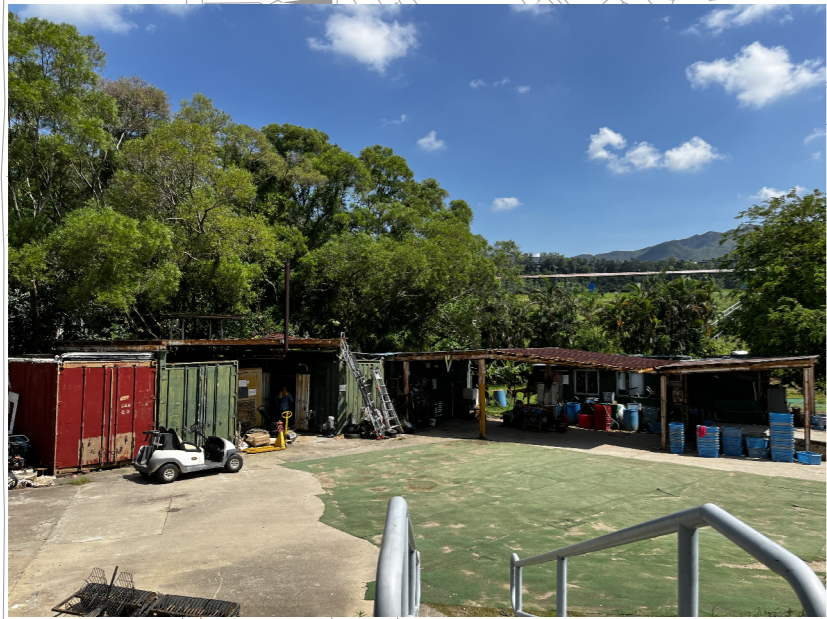
PHOTO 1

- 2.4.2.2 Photos records of the site survey are given in **Figure 2.1**. The site walkover checklist is given in **Appendix 2.2**. In general, the findings in the supplementary site survey were mostly identical with those in the approved EIA Report. The storage/ workshop area (photo 1) was mainly vacant with electric golf carts parked and covered with grass and trees along the perimeter of the boundary. Temporary shelters were mainly located at the central area of the storage/ workshop area.

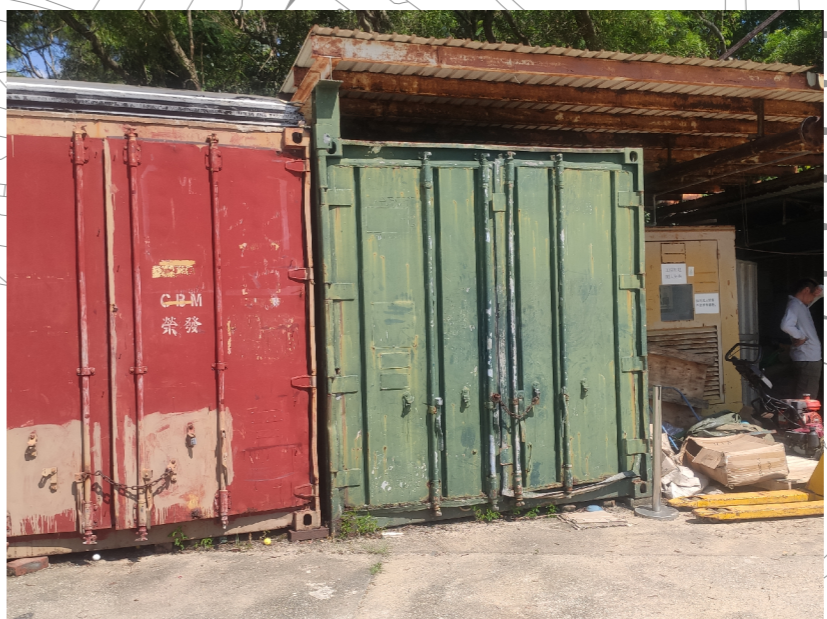
PHOTO 4

- 2.4.2.4 The containers at the western side of the storage/ workshop area were used for the storage of golfing equipment (e.g. golf balls, baskets, trolleys, etc.) and staff room (photo 4). Generator was observed next to the containers. As advised by the workers, the generator would only be used during emergency situation, and it had not been used since its installation. In addition, the generator was placed on concrete-paved ground with no observable cracks or oil stains. Therefore, the land contamination potential due to the emergency generator is unlikely, which aligned with the findings in the approved EIA Report (AEIAR-221/2019).
