## **APPENDIX – 12-1**

### **Built Heritage Survey Catalogue**

## **APPENDIX – 12-2**

### Preliminary Built Heritage Condition Survey Catalogue

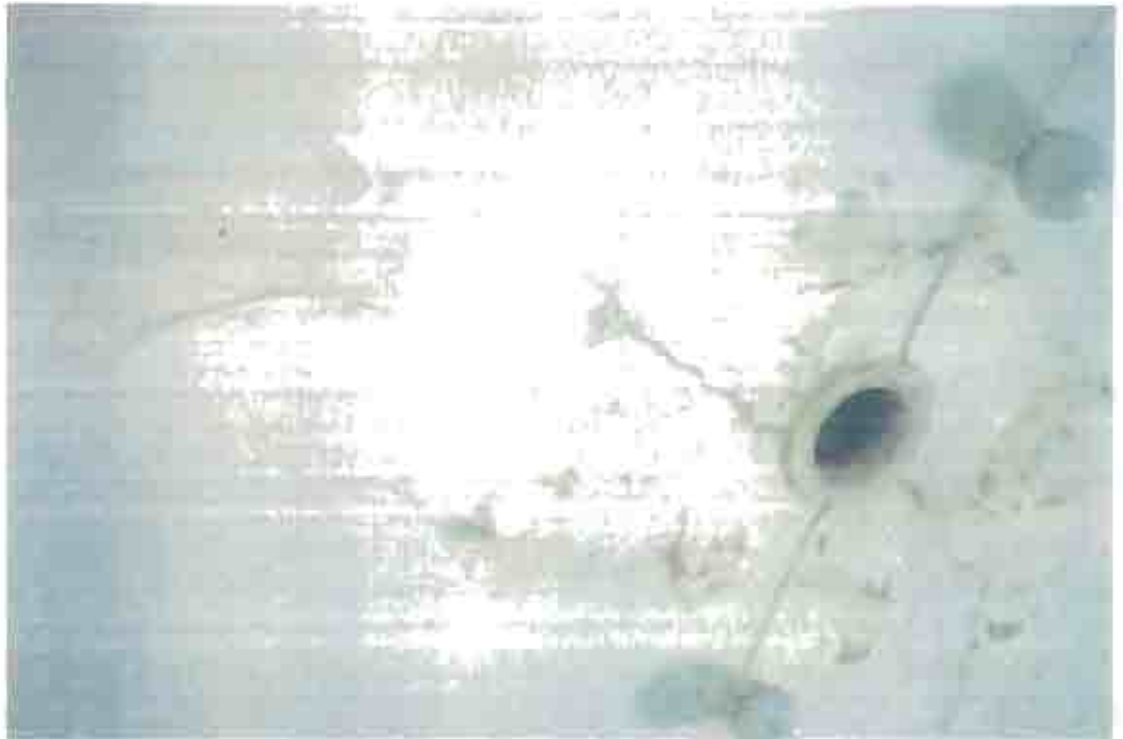
The structure is in fair condition. The exterior shows no obvious signs of cracks. The interior walls have mould growth on the upper floor and the ceiling on the upper floor has minor cracks.
---

- (A) Ceiling: Moisture damage and cracks
- (B) Interior wall at south of building on 1<sup>st</sup> floor: Moisture damage and mould growth

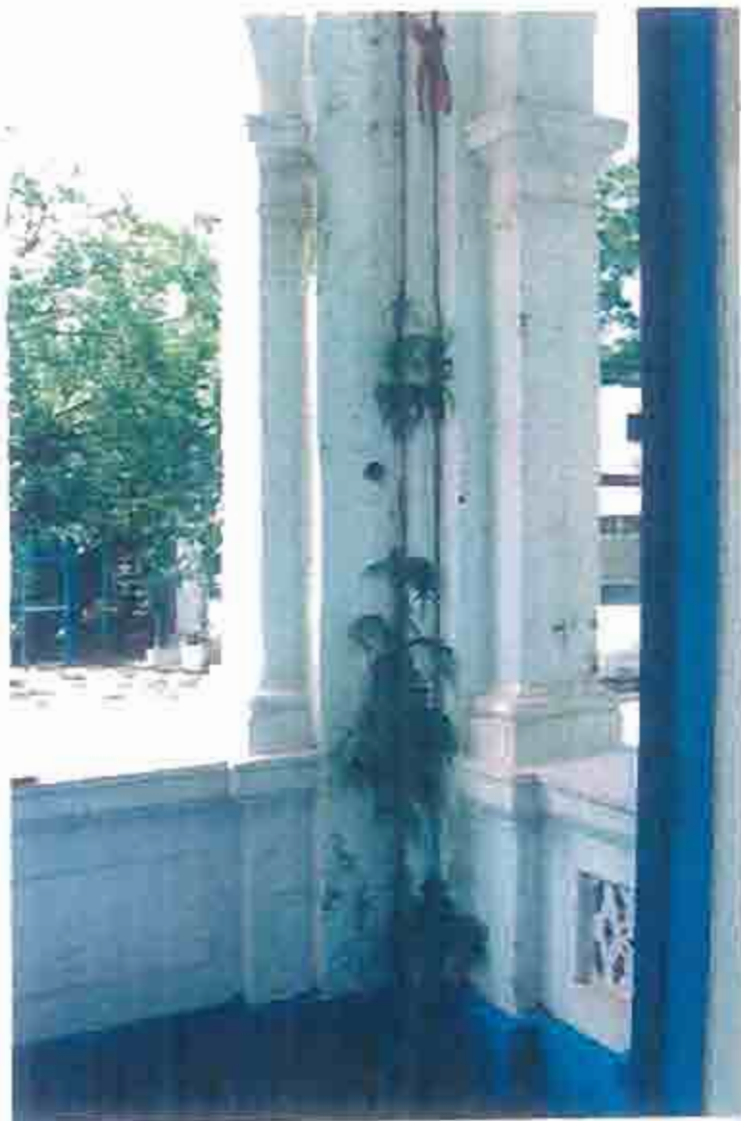
(A) Vegetation growth and water damage

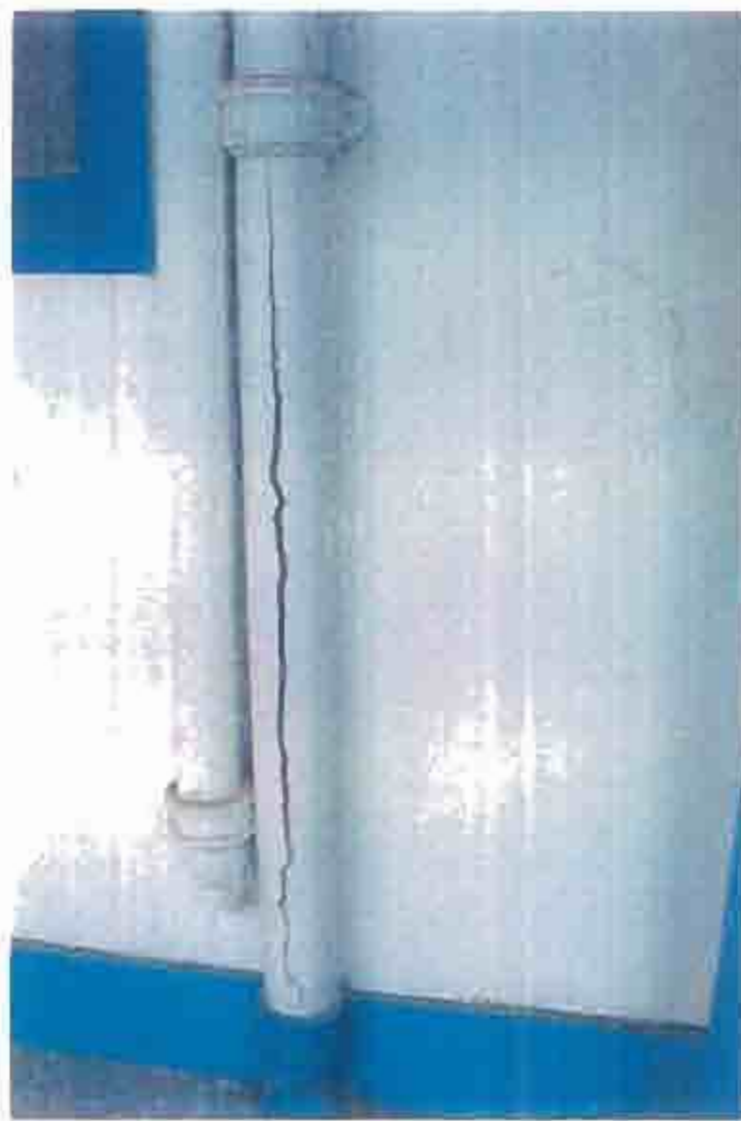
(B) Cracking in pipe

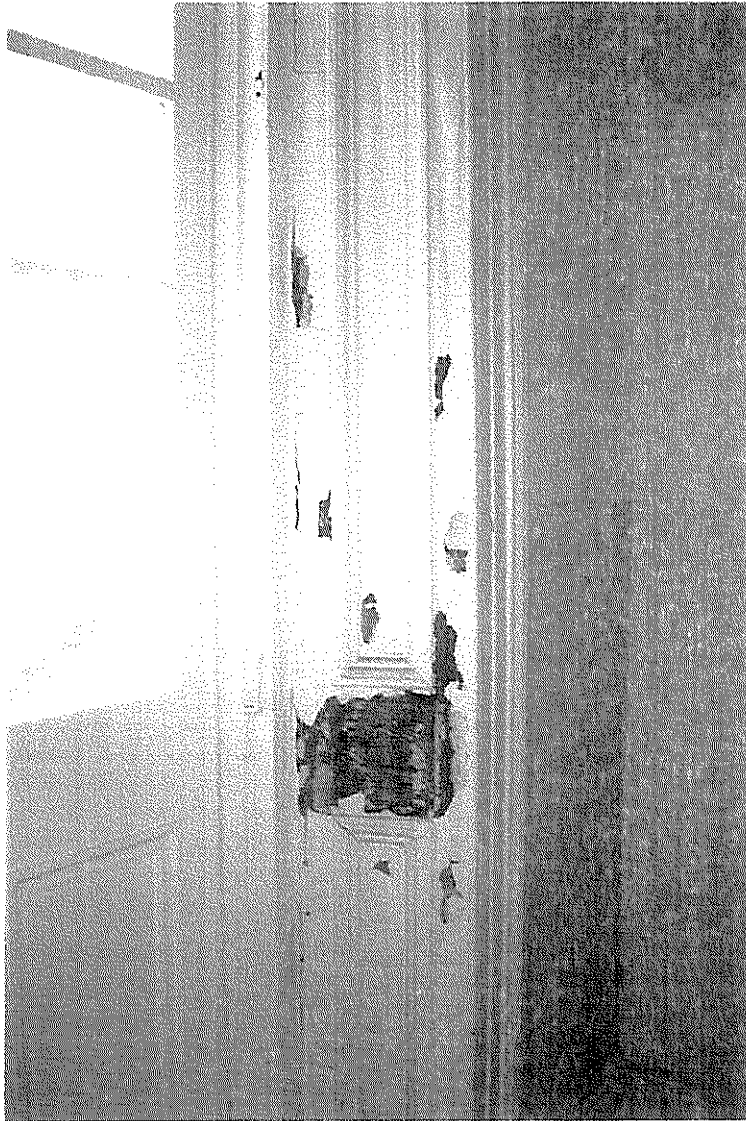
(C) Rotting Wood

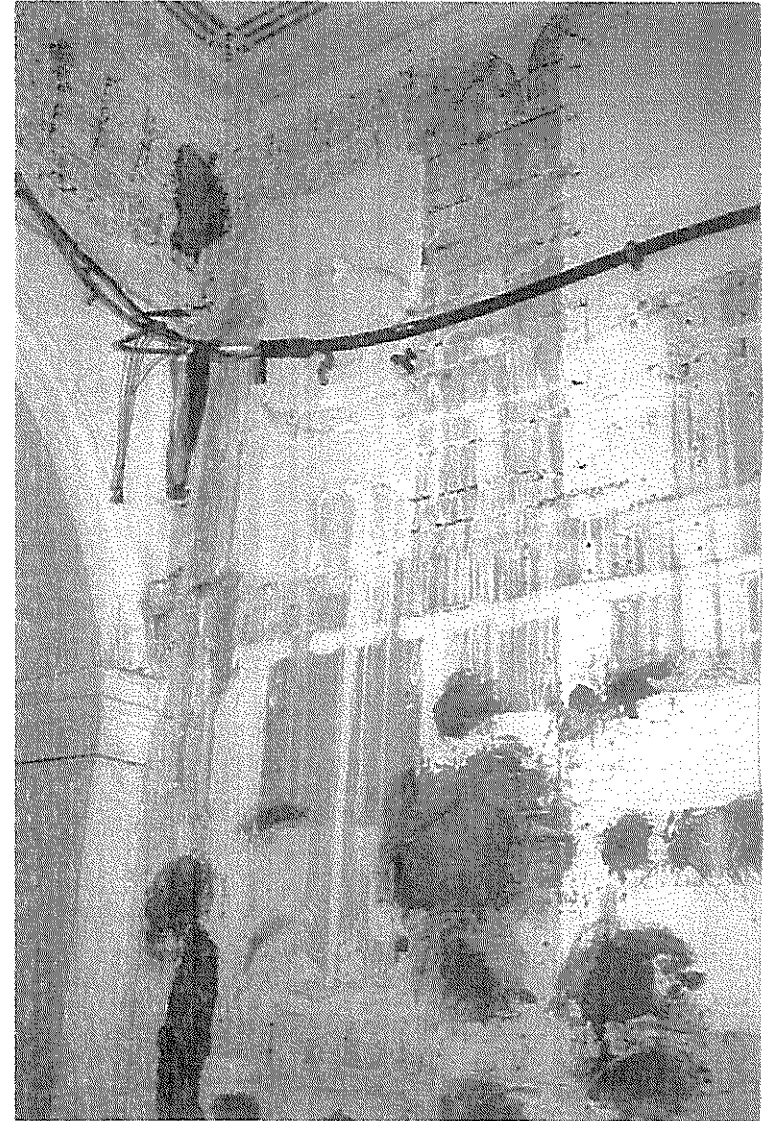
(D) Concrete patch repair

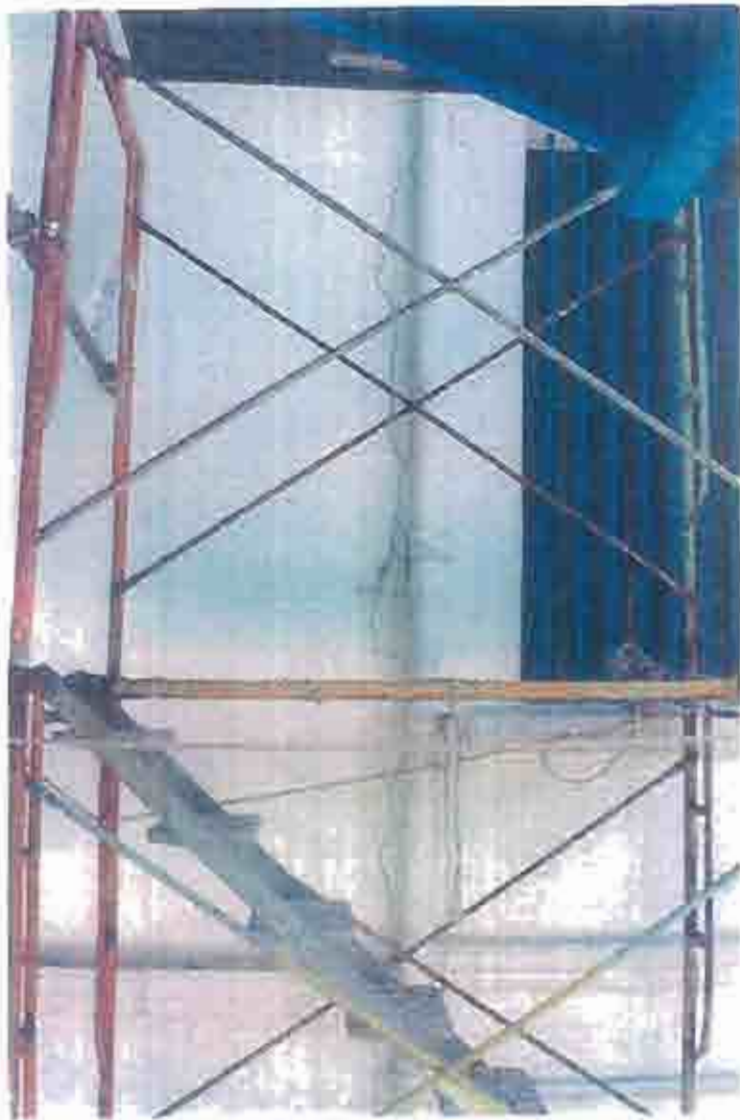
(E) Crack in exterior wall

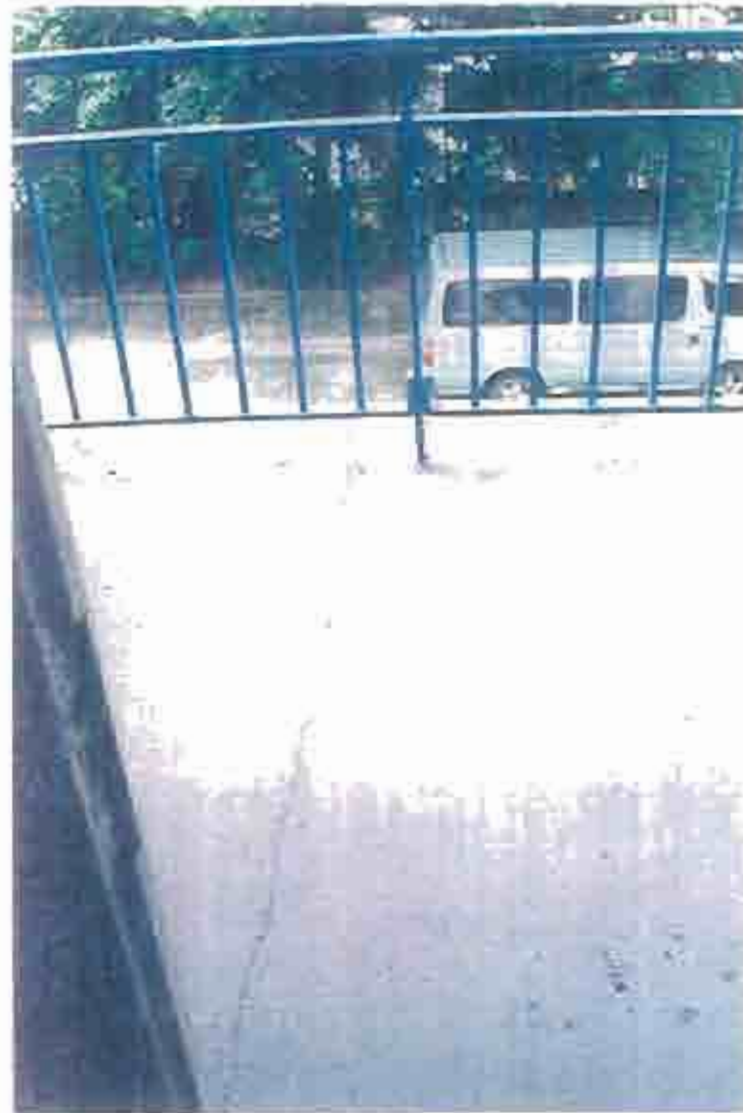
(F) Crack in concrete walkway

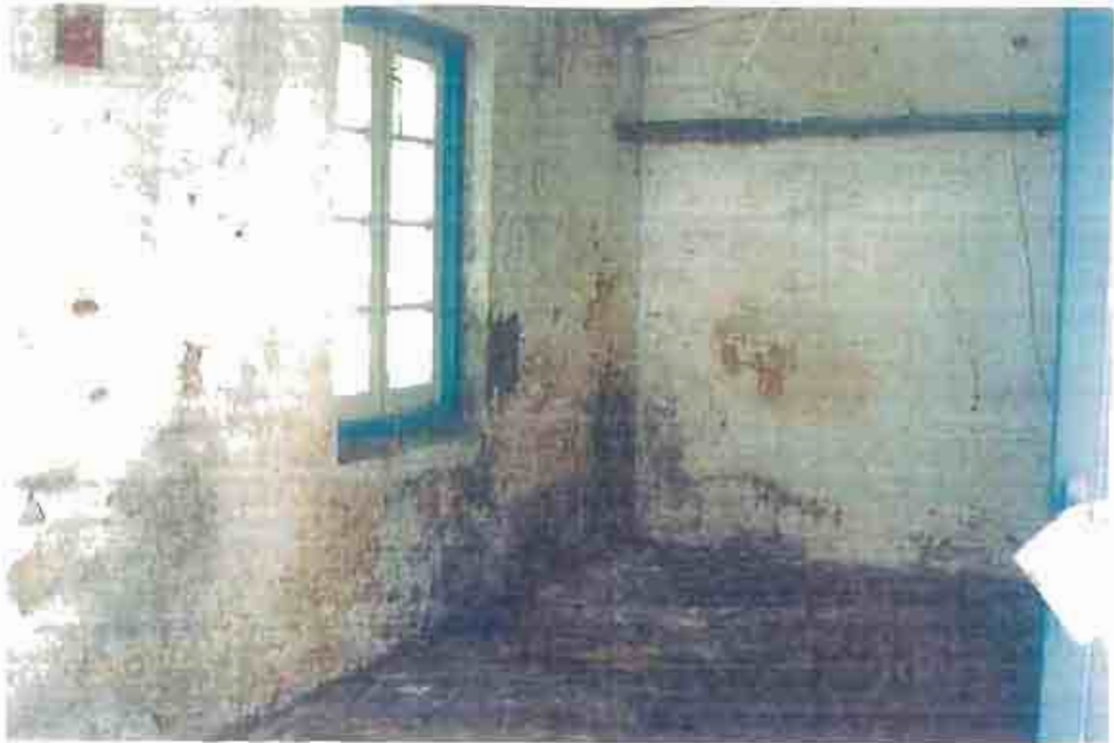
(A)

The structure is generally in poor condition, continued exposure to damp will promote the decay of the wooden elements. The overall structure is at risk from the decay noted in the bricks.

**(A) Moisture damage and crack in wall**

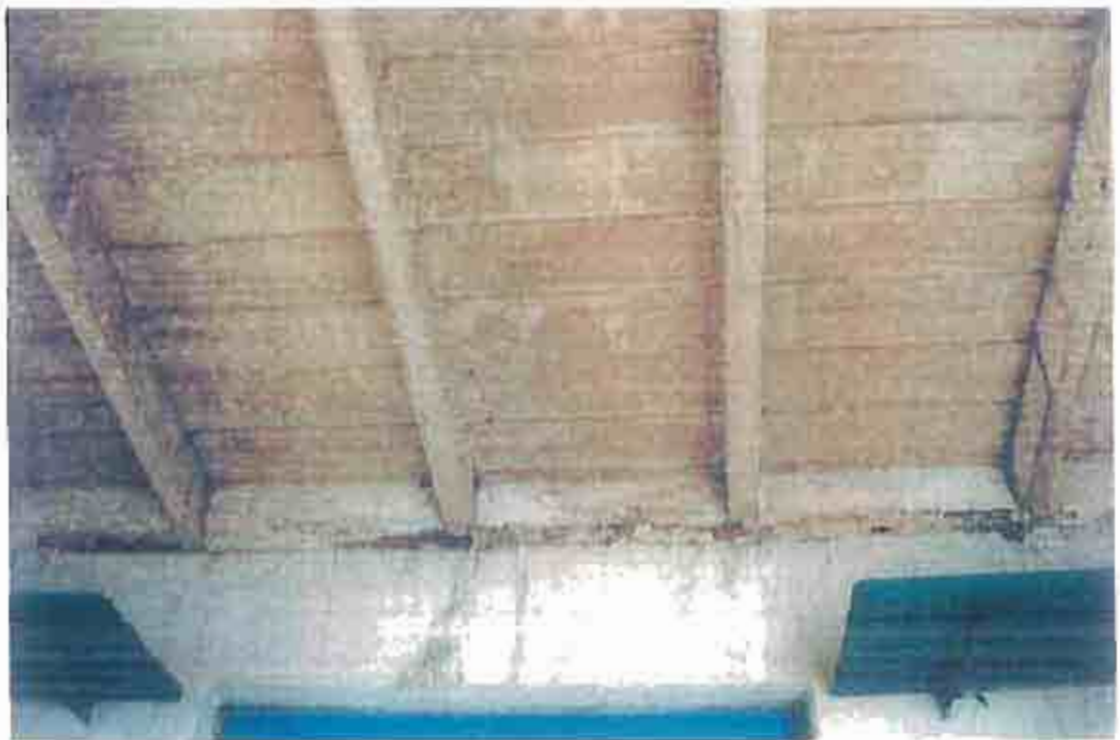
(B)

**(B) Rotting wood at ceiling**

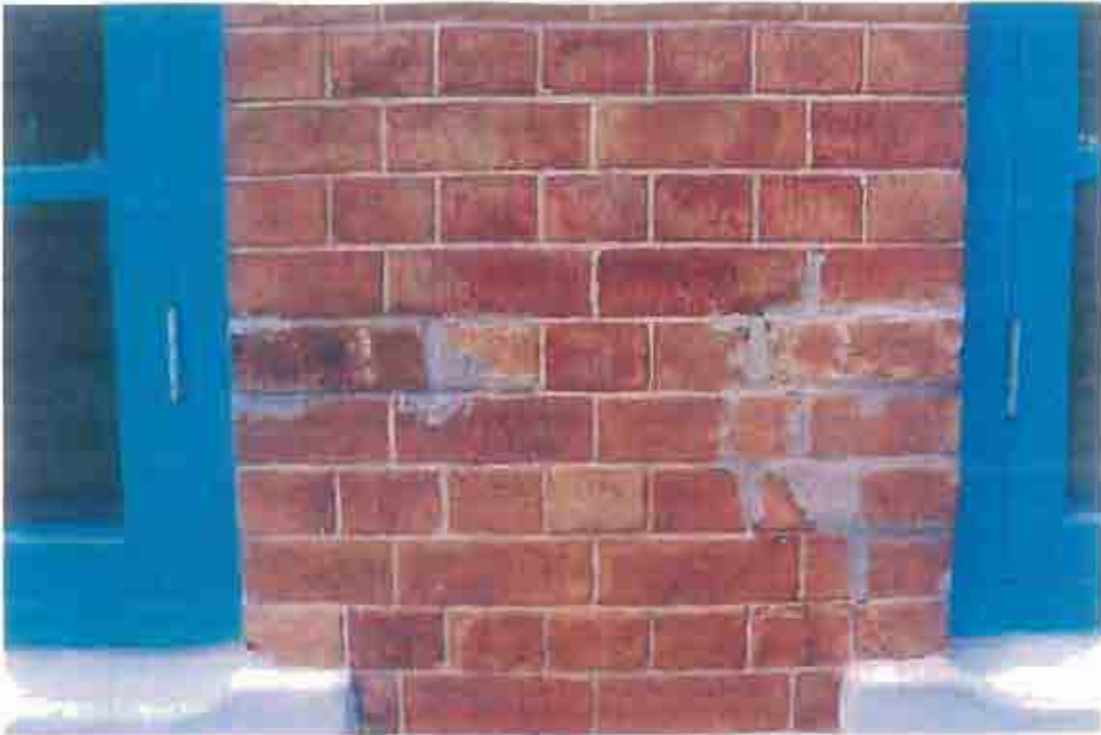
(A) Former Fire Station (KSL-02-10).  
Degrading bricks and concrete patching

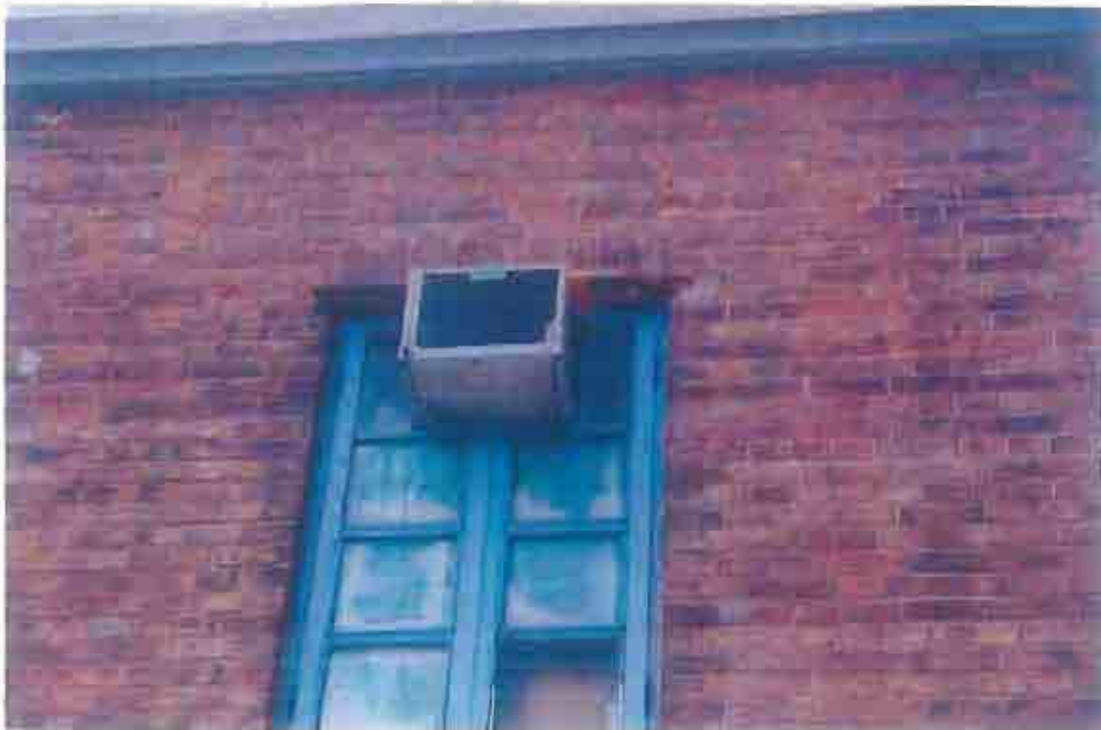
(B) Former Accommodation Block (KSL-02-11).  
Degrading bricks, broken window canopy and crack in wall
