Ref: SHW-01 Construction Date: Unknown

Location: Pui O Lo Wai village

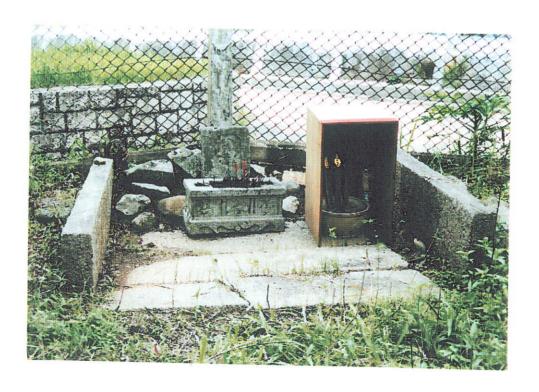
Recorded on: 18.09.03 | Condition: Good

Description: The platform of the shrine consists of three cut granite slabs with two cut granite slabs placed lengthwise on either side; cut stone incense holder and inscribed stone slab are placed at the rear of the platform and are surrounded by loose stones and a single uninscribed shaped stone.

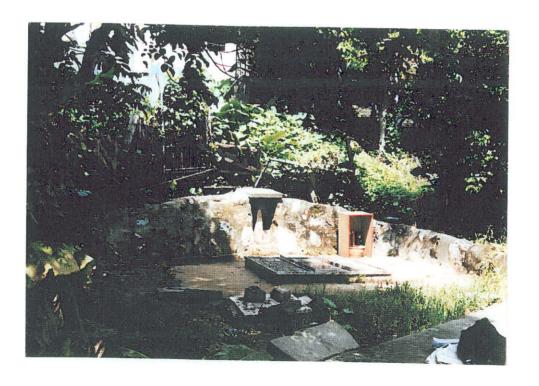
Ref: SHW-02 Construction Date: Unknown

Recorded on: 18.09.03 | Condition: Fair

Description: Uncut stone and cement wall enclosure with shrine niche located southwest wall; niche constructed with concrete lintel slab, a stone is situated within the niche and a stone slab is positioned in front of it; well opening is surrounded by concrete sides and covered with a metal grill.

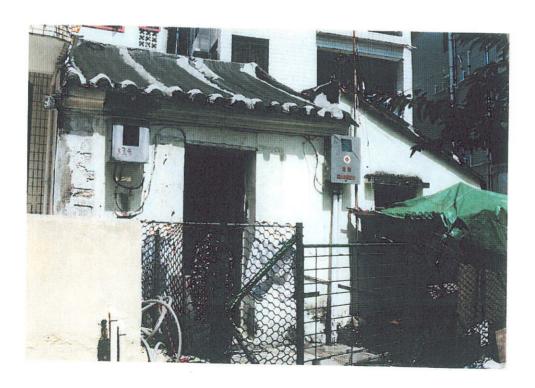
Ref: SHW-03 Construction Date: c. 80 years

Recorded on: 18.09.03 | Condition: Poor

Description: Pitched roofs over front section and rear section. Roof is covered with 'tar paper' chunam stops are visible, most have concrete patching over them. Walls have render covering, southwest corner has cut stone slab with whitewash; double panel entrance door painted dark red; cut granite threshold stone; two windows are located in the east wall; foundation also covered with render. There is an annex room on the east side of the building, it has a slanting roof also covered in 'tar paper'. There is a window in the south wall.

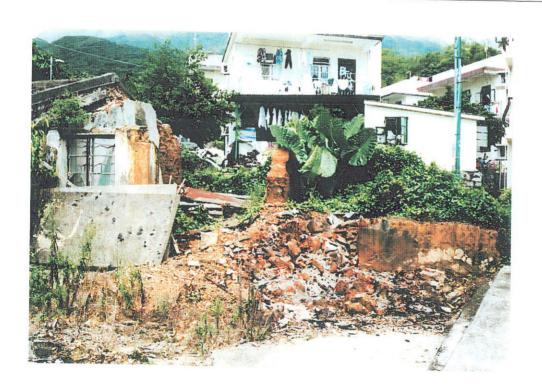
Ref: SHW - 04 Construction Date: Unknown

Recorded on: 18.09.03 Condition: Ruin

Description: Two units, only remaining features are portions of pounded earth walls and some render remains, roofs have completely collapsed.

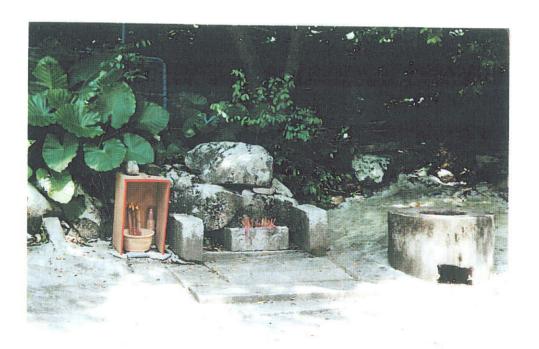
Ref: SHW-05 Construction Date: Unknown

Recorded on: 18.09.03 Condition: Fair

Description: Boulders make up the rear of the enclosure with two cut stone blocks forming the sides of the shrine; base consists of four cut granite slabs, bordered by granite slabs as well. Stone incense holder sitting on stone slabs; red brick, cement covered circular burner, located at right front. Dang Fu shrine at left side.

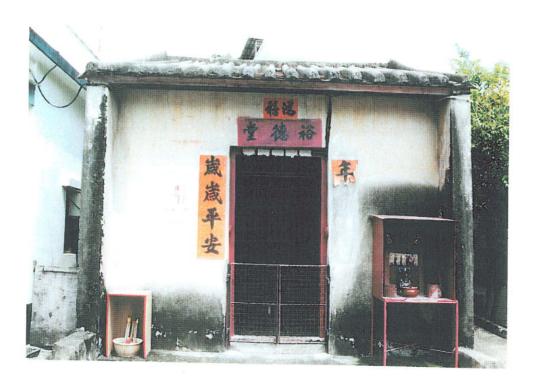
Ref: SHW-06 Construction Date:

Description: Single pitched roof; chunam roll tiles and pan tiles over timber; two wooden panels under projecting eaves of façade; façade wall with piers at each end; render covered façade wall; side and rear walls are cut stone covered by render with irregular oval openings showing the stones. Entranceway has wooden jambs and lintel, concrete threshold; red painted double panel door; drains at rear and side

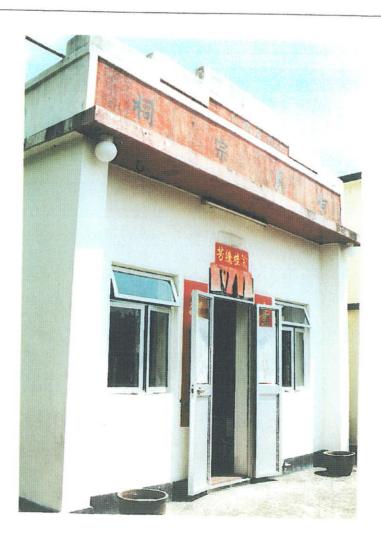
Ref: SHW-07 Construction Date: 1969

Description: Rectangular concrete building with metal framed windows and metal entrance door. Façade wall has piers on either end. Walls are painted white.

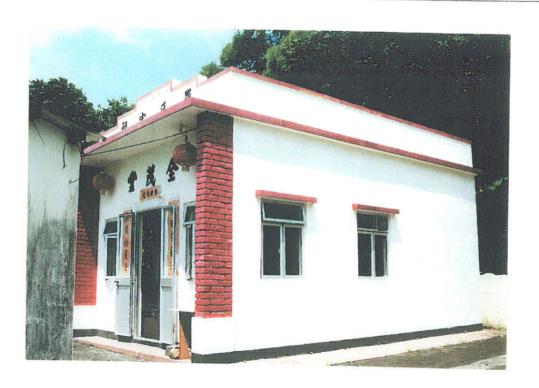
Ref: SHW-08

Description: Rectangular concrete building. There are two brick piers with concrete bases on the façade, (the bricks are painted red). Metal framed windows and metal doors.

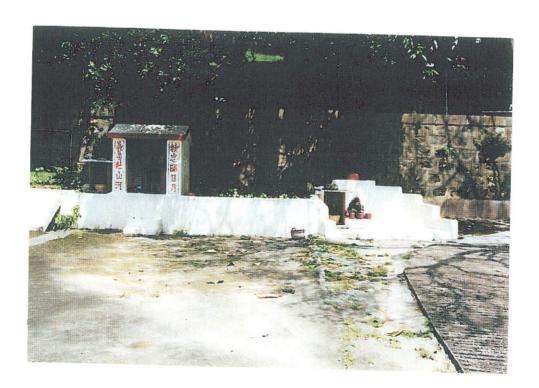
Ref: SHW-09 Construction Date: Modern

Description: Two shrines. (A) consists of concrete rectangular enclosure with pitched roof.; painted white with red characters along sides on the front; simple altar inside with wooden plaque.

(B) consists of horse-shoe shaped enclosure without top; stepped sides and curved at the rear part, painted white; triangular shaped stone set against rear wall. Modern incense holder. Dang fu shrine set along western side.

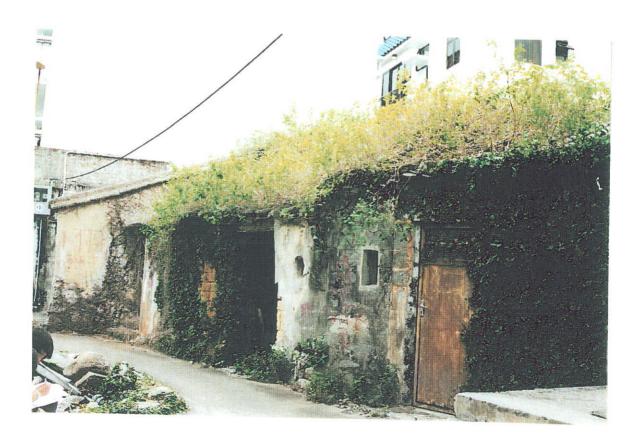
Ref: SHW-10

Condition: Unit a: good Units b, c and d: ruin

Description: The unit that is attached to # 49 has a pitched roof with roll tiles and shaped chunam stops. The rear section of the roof is covered in concrete. This unit has pounded earth walls with render cover. The tile roofs of these three units are partially collapsed and overgrown. The other three units also have pounded earth walls facades and rear walls. The northeastern side wall is cut stone and there is one window in this wall. There is also a small, uncovered opening on the left side of the door on the unit attached to #49. The rear wall has four windows. The doors of the units are either modern or missing.

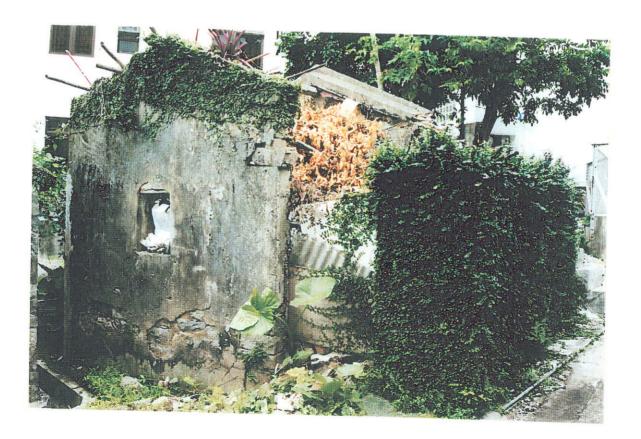
Ref: SHW -11 Construction Date: c. 100 years

Recorded on: 15.10.03 | Condition: Ruin

Description: Roof has collapsed. Remaining walls consist of pounded earth with patches of render. The walls are heavily overgrown with vegetation. Doors have been removed. The interior has been filled with debris.

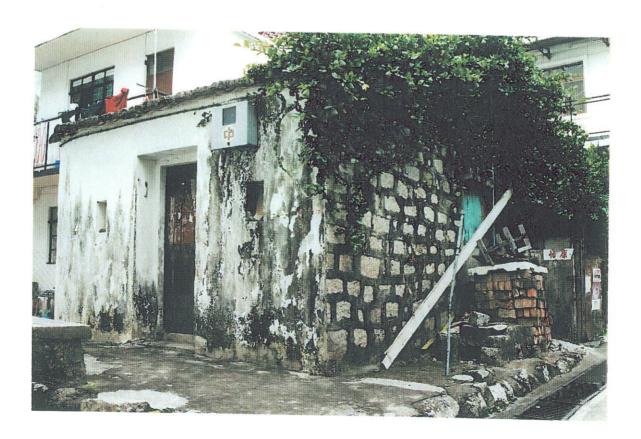
Ref: SHW - 12 Construction Date: C. 80 years Present Use: Abandoned

Recorded on: 15.10.03 | Condition: Poor

Description: Pitched tile roof with chunam stops. Heavily overgrown with vegetation. Cut stone walls covered by render in places. Wooden entrance door, modern concrete frame, threshold and steps. East wall has one window with wooden shutter, west wall has 2 small windows. Two windows on the façade.

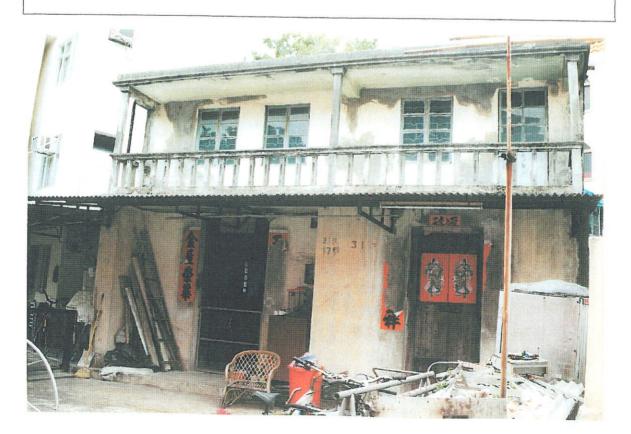
Ref: AAHB - 13 Construction Date: C. 80 years

Recorded on: 15.10.03 Condition: Fair

Description: Two storey rectangular structure. Pitched roof with roll tiles, concrete over the tiles. Plain roof ridge with finials. The façade and side walls are completely covered in render. The rear wall has cut granite blocks, which are partially covered by render. There are double panel wooden doors on both units. There is a concrete balcony on the first floor across the length of the façade. The southern most unit has an entrance door to the balcony intact, the other unit has a window which has been converted from a door, overlooking the balcony. The side walls have one ground floor and two first floor windows each. The rear wall has a small annex built out from it with a window in its southwest wall. There is also a window on the first floor of the main building.

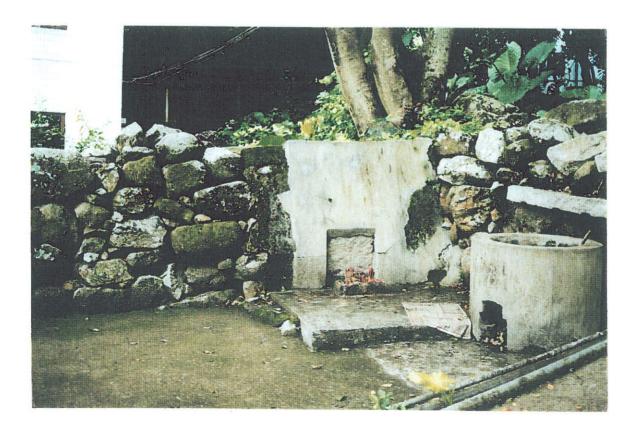
Ref: SHW - 14 Construction Date: Unknown

Recorded on: 15.10.03 | Condition: Good

Description: Rectangular stone set into rear wall of concrete. Concrete platform in front of stone. There is a cut stone incense holder in front of the stone. There is a round sided concrete burner at the front of the platform.

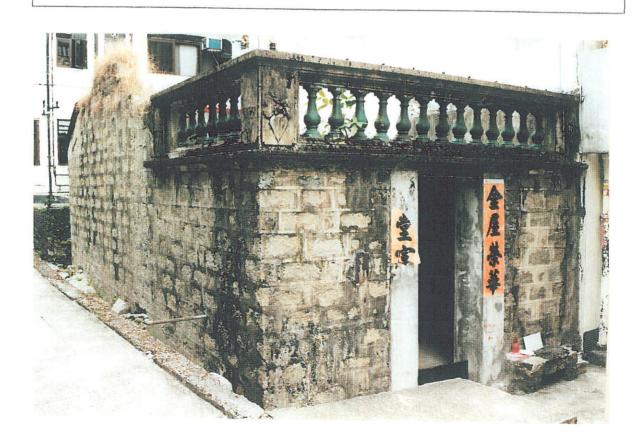
Ref: SHW-15 Construction Date: c. 100 years

Recorded on: 15.10.03 | Condition: Fair

Description: Rectangular shaped structure. Rear section of the house has a pitched roof (now collapsed) front part of the house has a flat roof with concrete balustrade with green urn style balusters. Walls are cut stone. Entrance door has been removed.

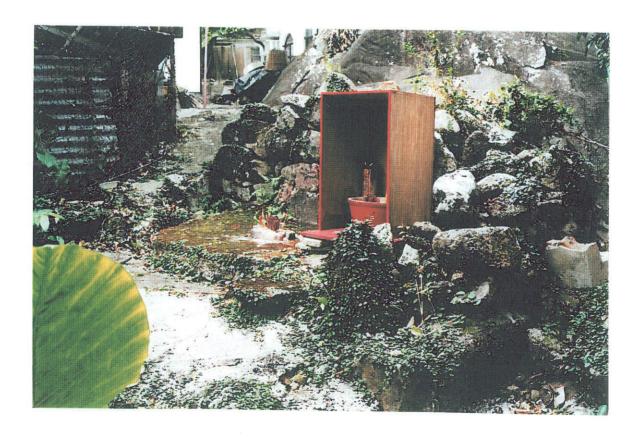
Ref: SHW - 16 Construction Date: Just prior to

Condition: Fair

Description: Three pieces of red sandstone set into concrete in a rectangular shape form the rear wall of the shrine. There is a concrete incense holder in front of the stones set into a concrete platform.

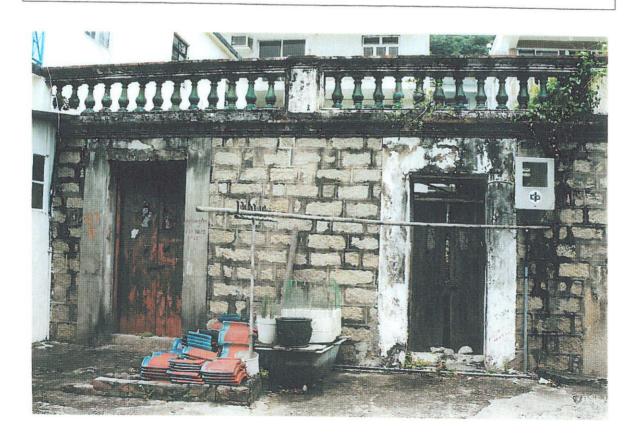
Ref: SHW - 17 Construction Date: c. 70 years

Recorded on: 15.10.03 Condition: Ruin

Description: Two rectangular units with only the front sections remaining. There is part of a flat roof remaining. The façade wall is made of cut granite blocks. The interior dividing wall is pounded earth with render. There is a balustrade running along the top of the façade wall. It has a concrete railing and supports with. Both units have concrete coating around the entrance ways and double panel wooden doors. Unit #87 has a cut granite threshold stone. The entire back section of the building has been demolished.

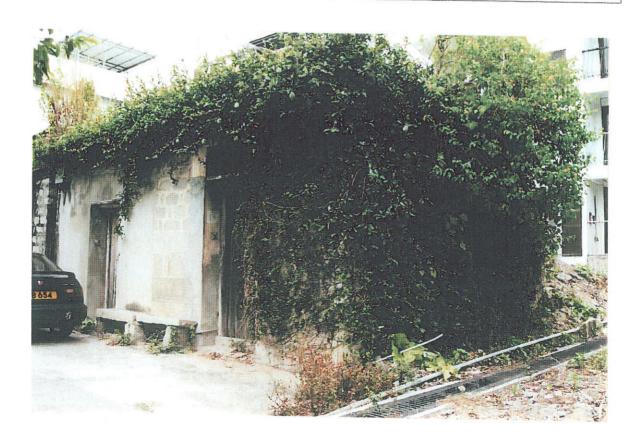
Ref: SHW - 18 Construction Date: c. 70 years

Recorded on: 15.10.03 | Condition: Ruin

Description: Two rectangular units with only the front sections remaining. There is a partial flat roof remaining over this section. It is very overgrown with vegetation. The façade wall of #89 has been covered in concrete. The facade wall of #90 consists of four cut granite courses with smaller cut granite blocks above. The interior dividing wall consists of pounded earth covered in render (it is in very poor condition with the pounded earth fabric deteriorating and the plaster falling off in chunks. There are double panel wooden doors on both units and both have cut granite threshold stones. Unit #90 has a large granite lintel above an open space with iron bars, above the entrance door. The entire rear section of the building has been demolished.

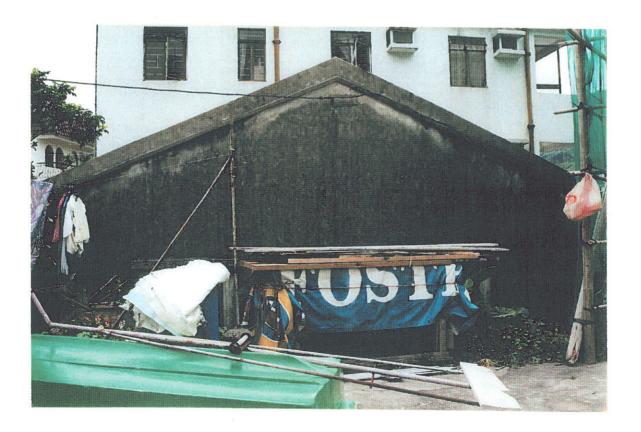
Ref: SHW - 19 Construction Date: Unknown

Recorded on: 15.10.03 | Condition: Fair

Description: Single two storey abandoned unit with plain ridges tiled roof with chunam stops. Walls are covered in render. Modern entrance way with window above. Concrete eaves and concrete column added on the east. West front wall attached to stone wall covered in render and a window of a former building.

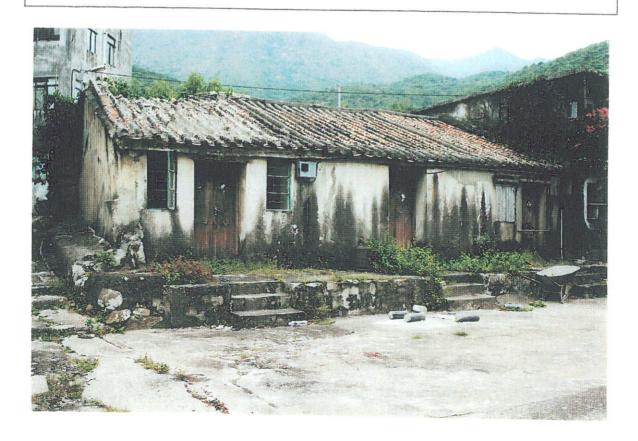
Ref: SHW - 20

Condition: Poor

Description: Three single story terraced units with plain roof ridge and roll tiles with shaped chunam stops. Ridge is collapsing as is the roof covering the most eastern unit. Pounded earth walls with render covering. Large cracks in the render have been patched with concrete. Double panel wooden door in all units with modern handles and locks. Window on either side of the door in the eastern unit and single wooden shuttered window to the east of the door of the western unit. The buildings are set on uncut stone platform, which has been covered in concrete. Concrete steps were added in front of each door from platform to ground level.

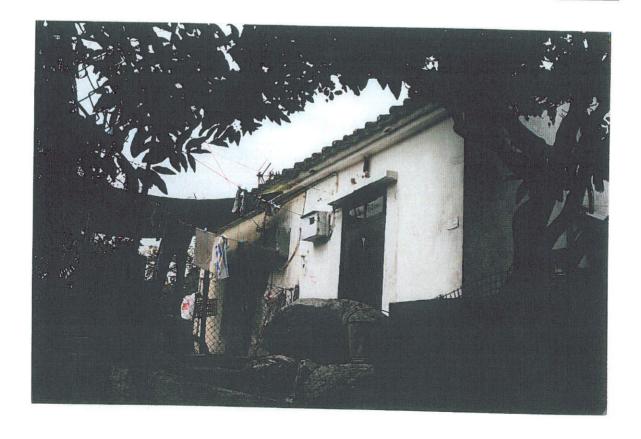
Ref: SHW -21

Condition: Fair

Description: Semi-detached single story two units with roll tiled roof and shaped chunam stops. Plain roof ridge with finials. The walls consist of pounded earth with render. The entrance ways consist of modern metal doors. Single window with air conditioner in rear wall of western unit and single window in the side wall of the western unit.

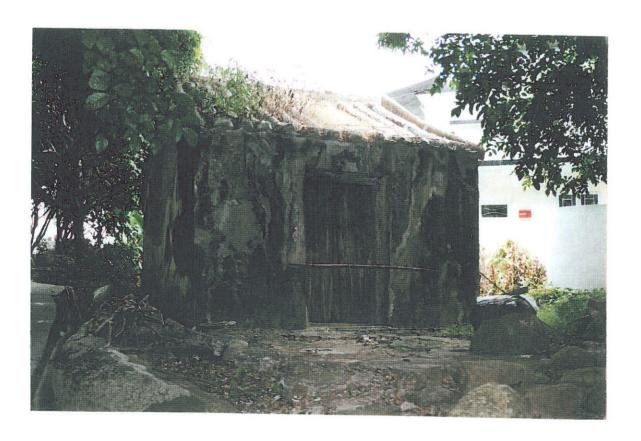
Ref: SHW -22

Condition: Fair

Description: Single storey freestanding unit, plain ridged roof with finials, roll tiles with shaped chunam stops. Walls covered with render. Large cracks in the render have been patched with concrete. Double panel wooden door. Small window on each side wall

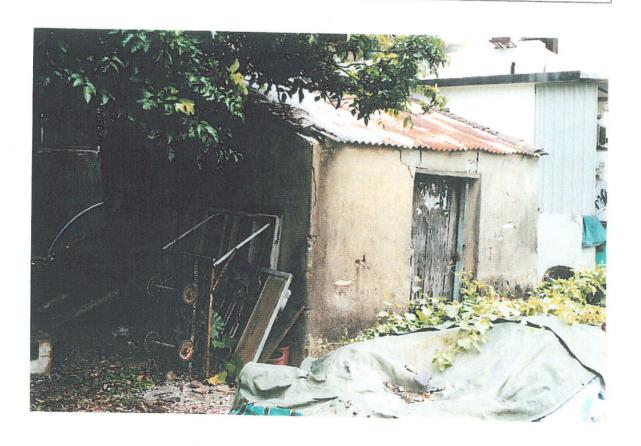
Ref: SHW -23 Construction Date: Unknown

Recorded on: 15.10.03 | Condition: Poor

Description: Single storey freestanding shed with metal corrugated roof and some tiles remaining at the edges of the roof. The walls consist of mud brick with render covering. No windows. Wooden entrance door.

Additional Notes: Render is cracking and falling off in palces and mud bricks are decaying where exposed.

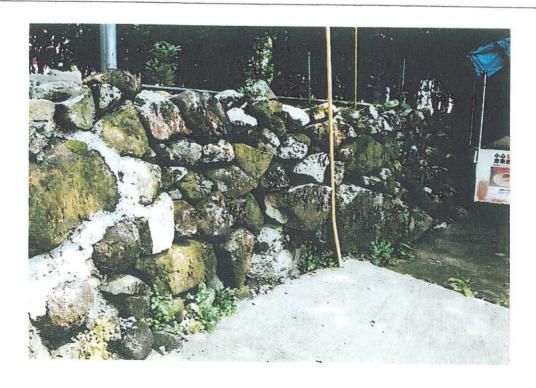
Ref: SHW -24 Construction Date: c. 1940

Recorded on: 15.10.03 | Condition: Good

Description: Dry stone wall of uncut stones. Approximately 1.5 metres in height.
