# Provision of Cremators at Wo Hop Shek Crematorium

Tree Survey Report

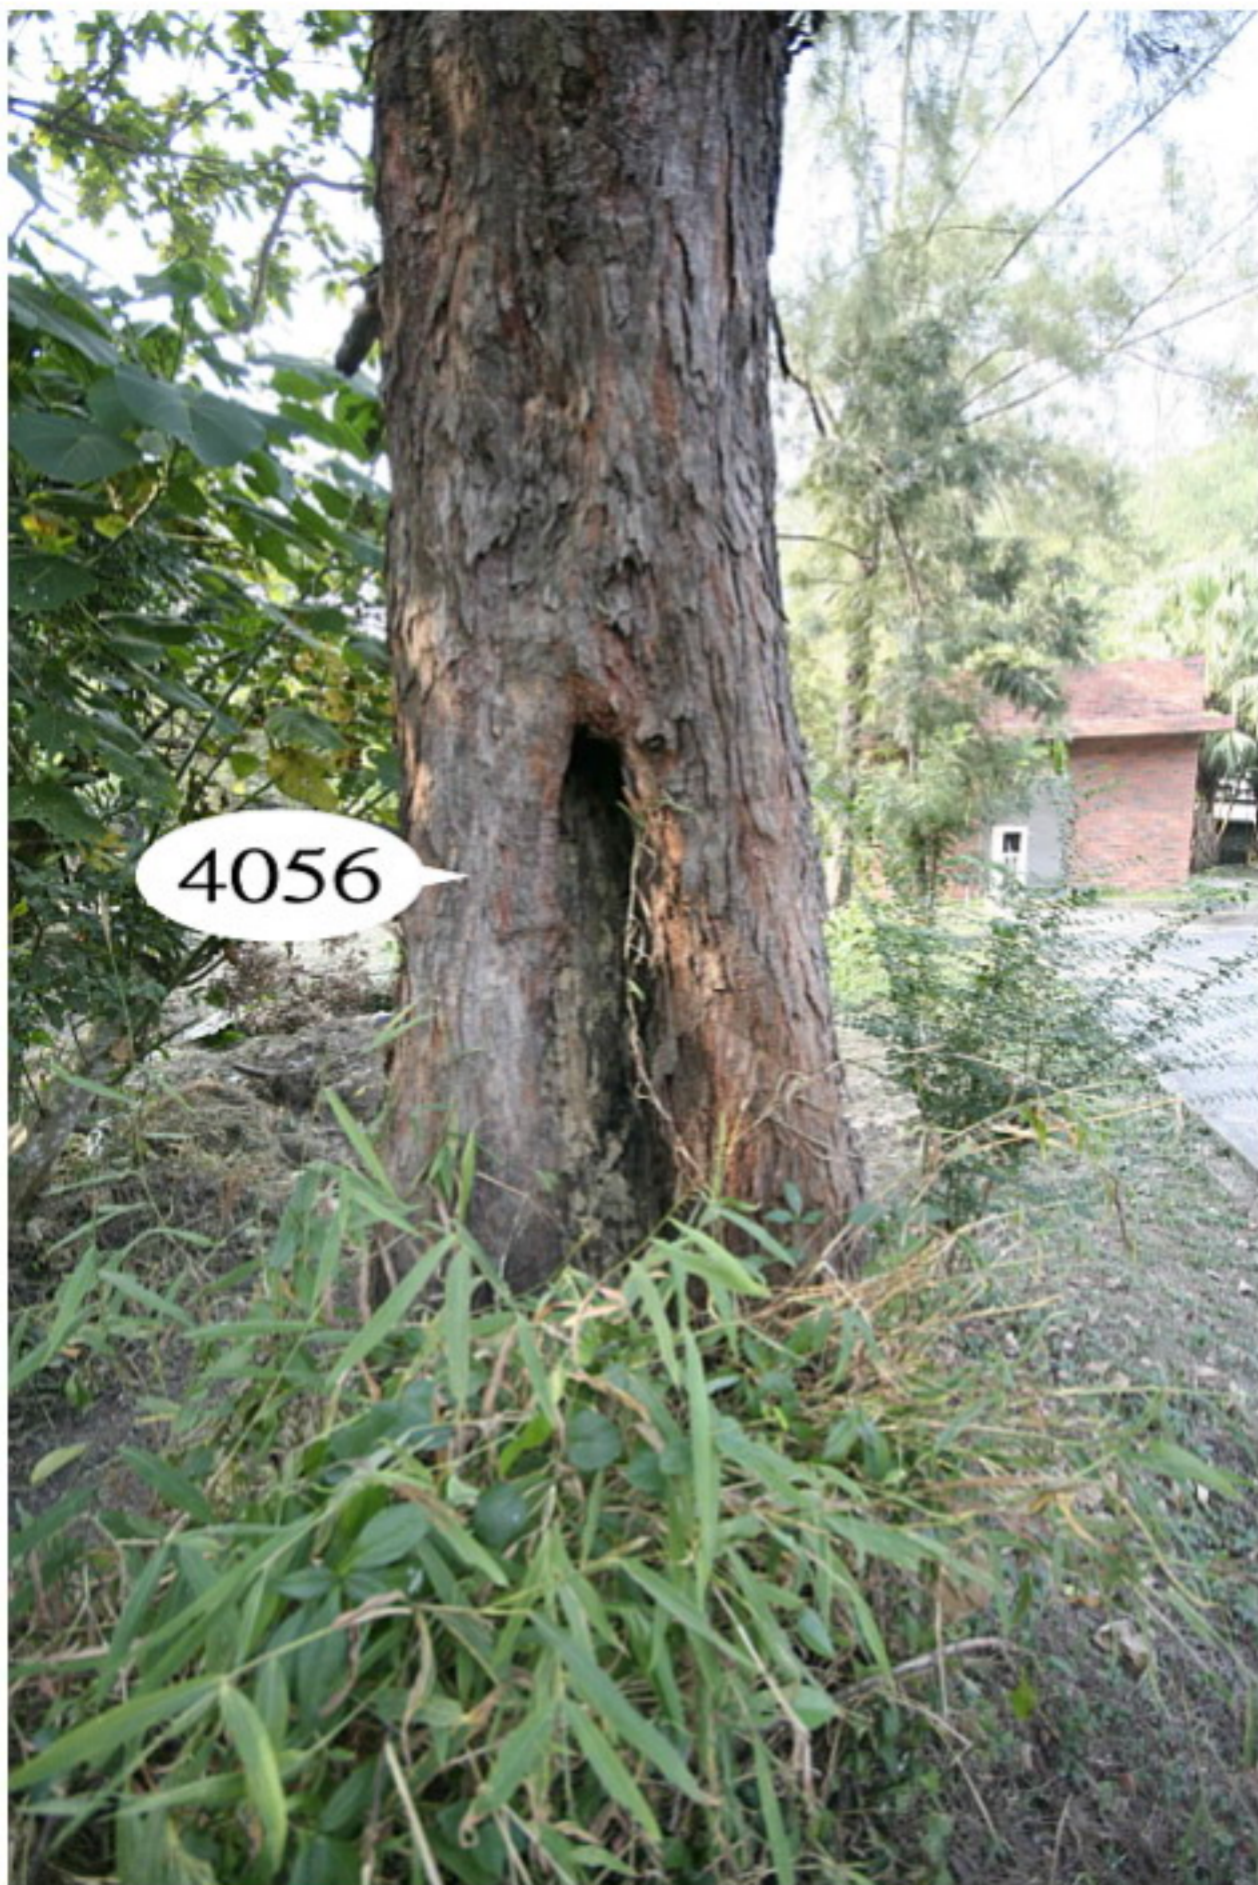
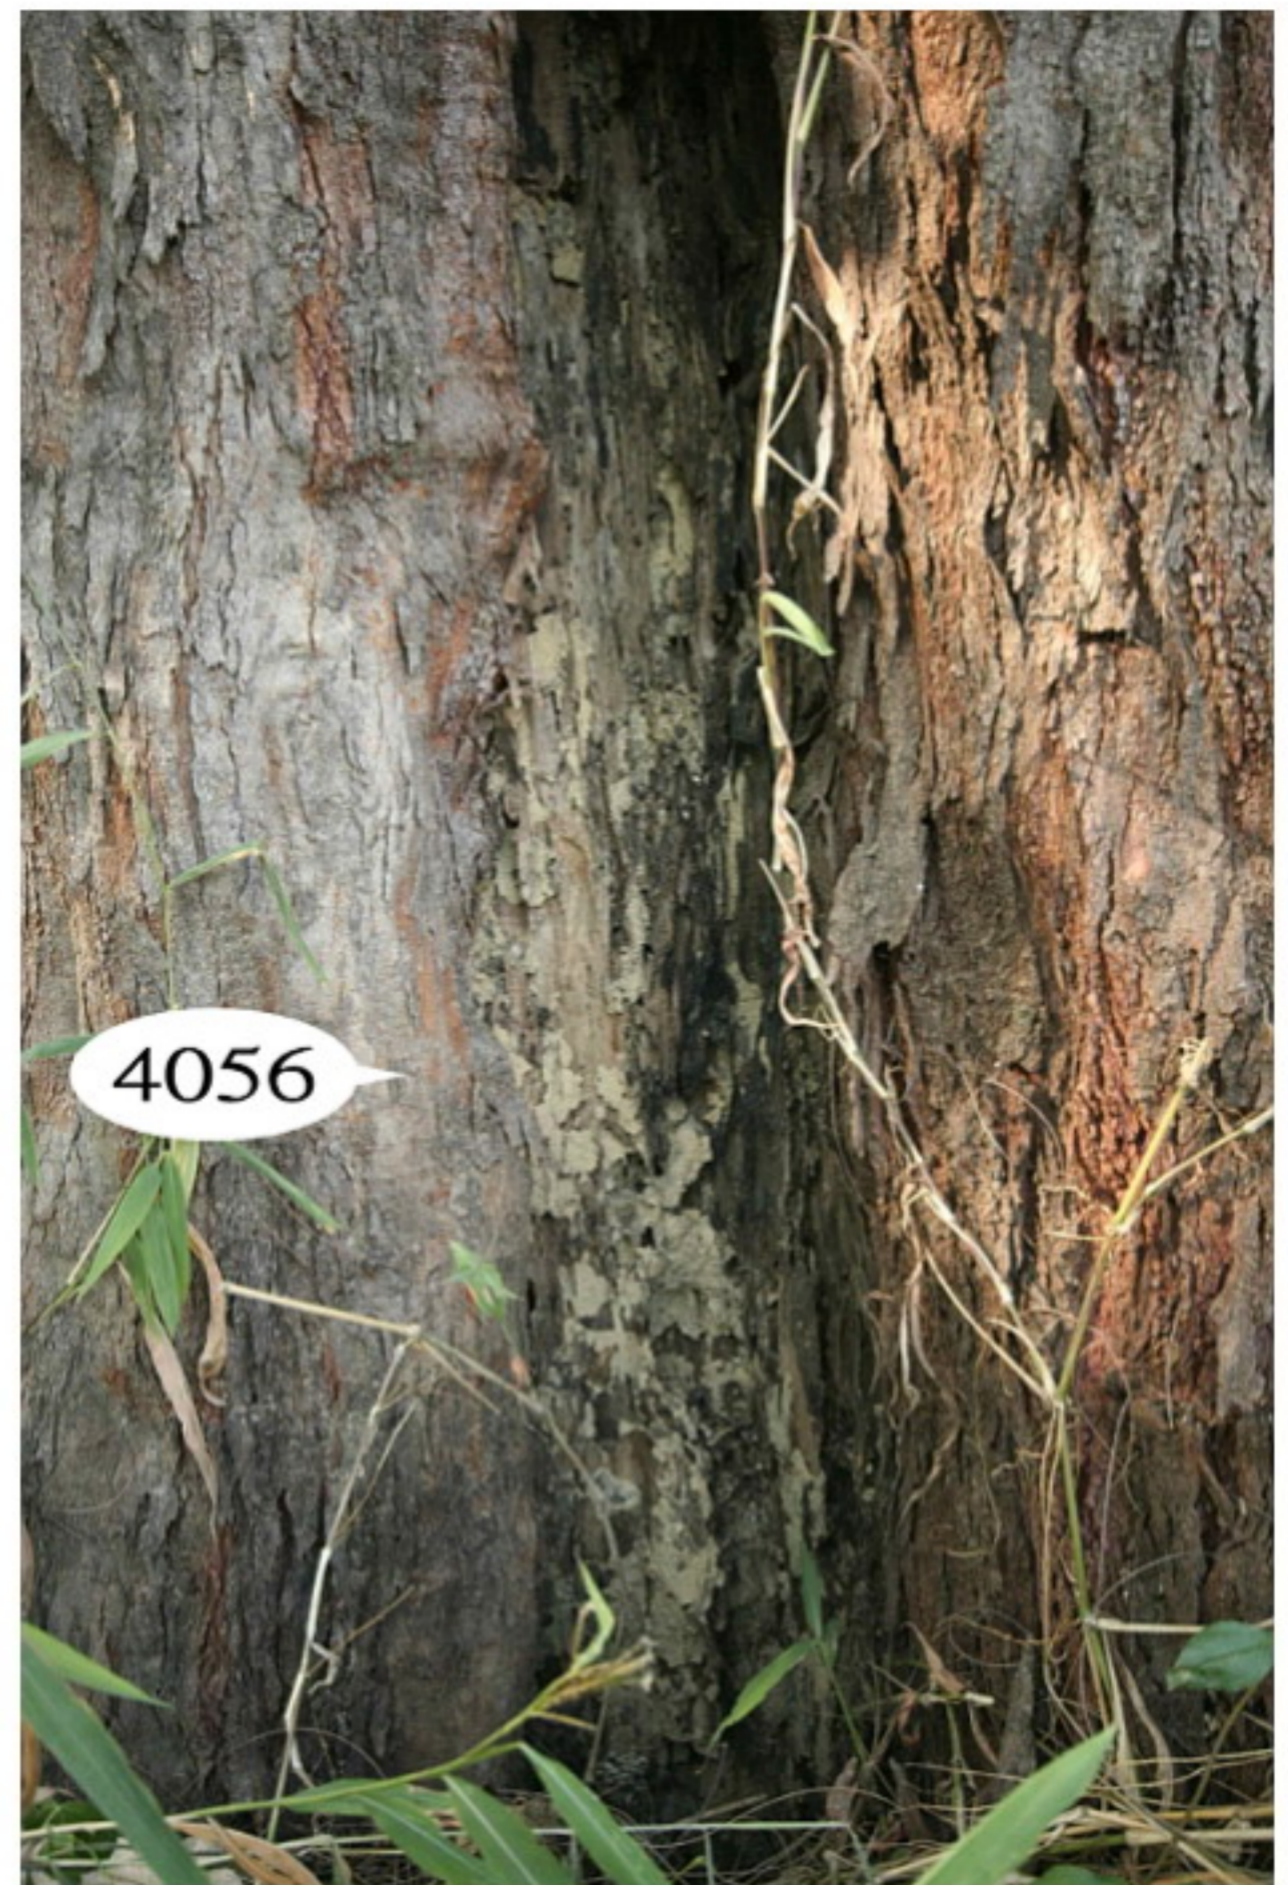
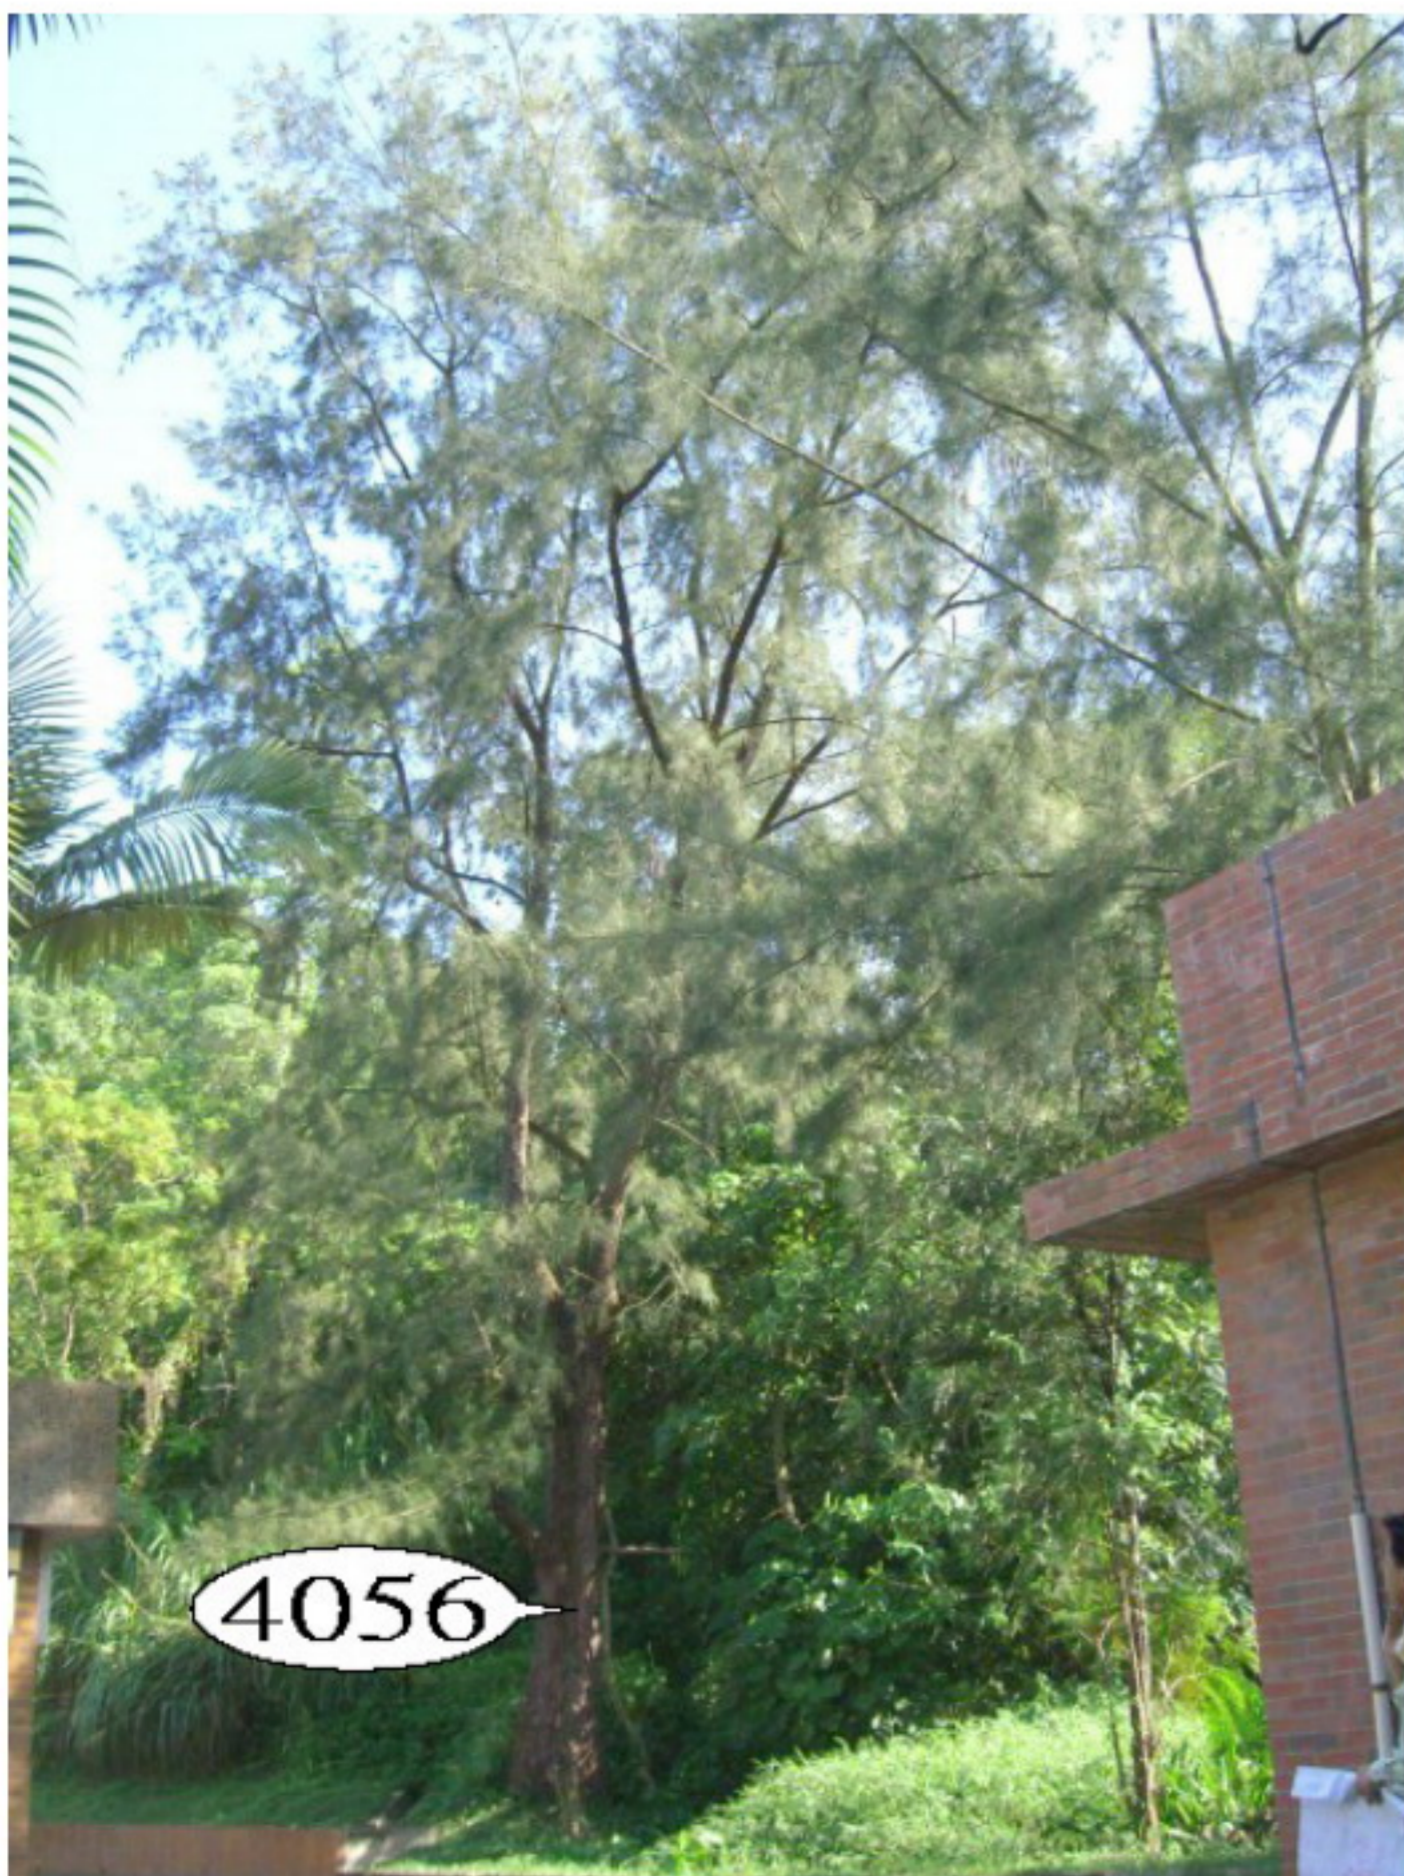
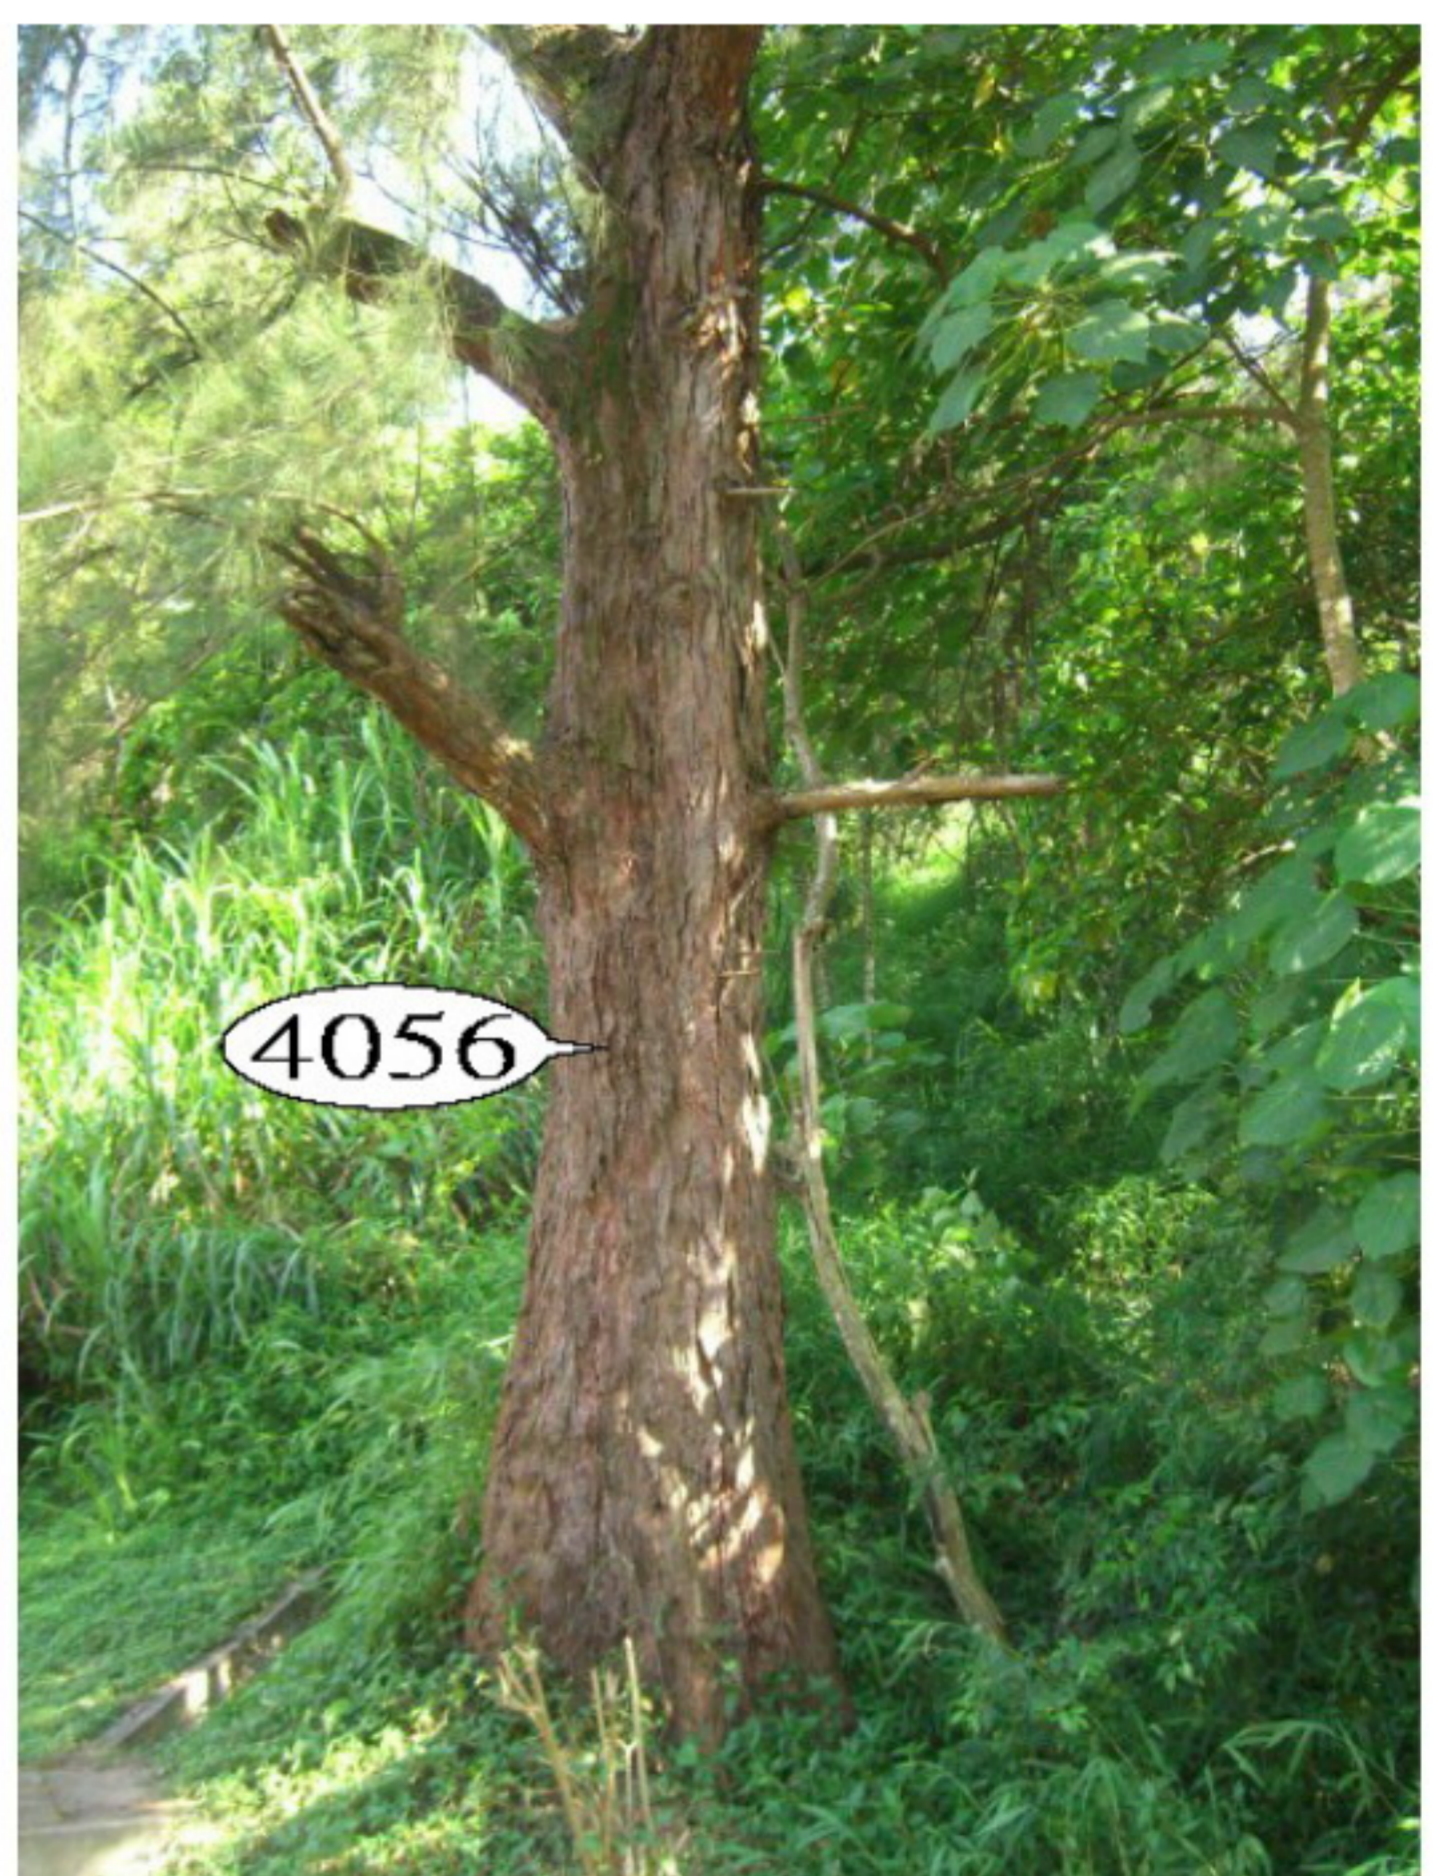
Tree 4056  
Poor health lead to low transplantation survival rate. Cavity was found on tree trunk.

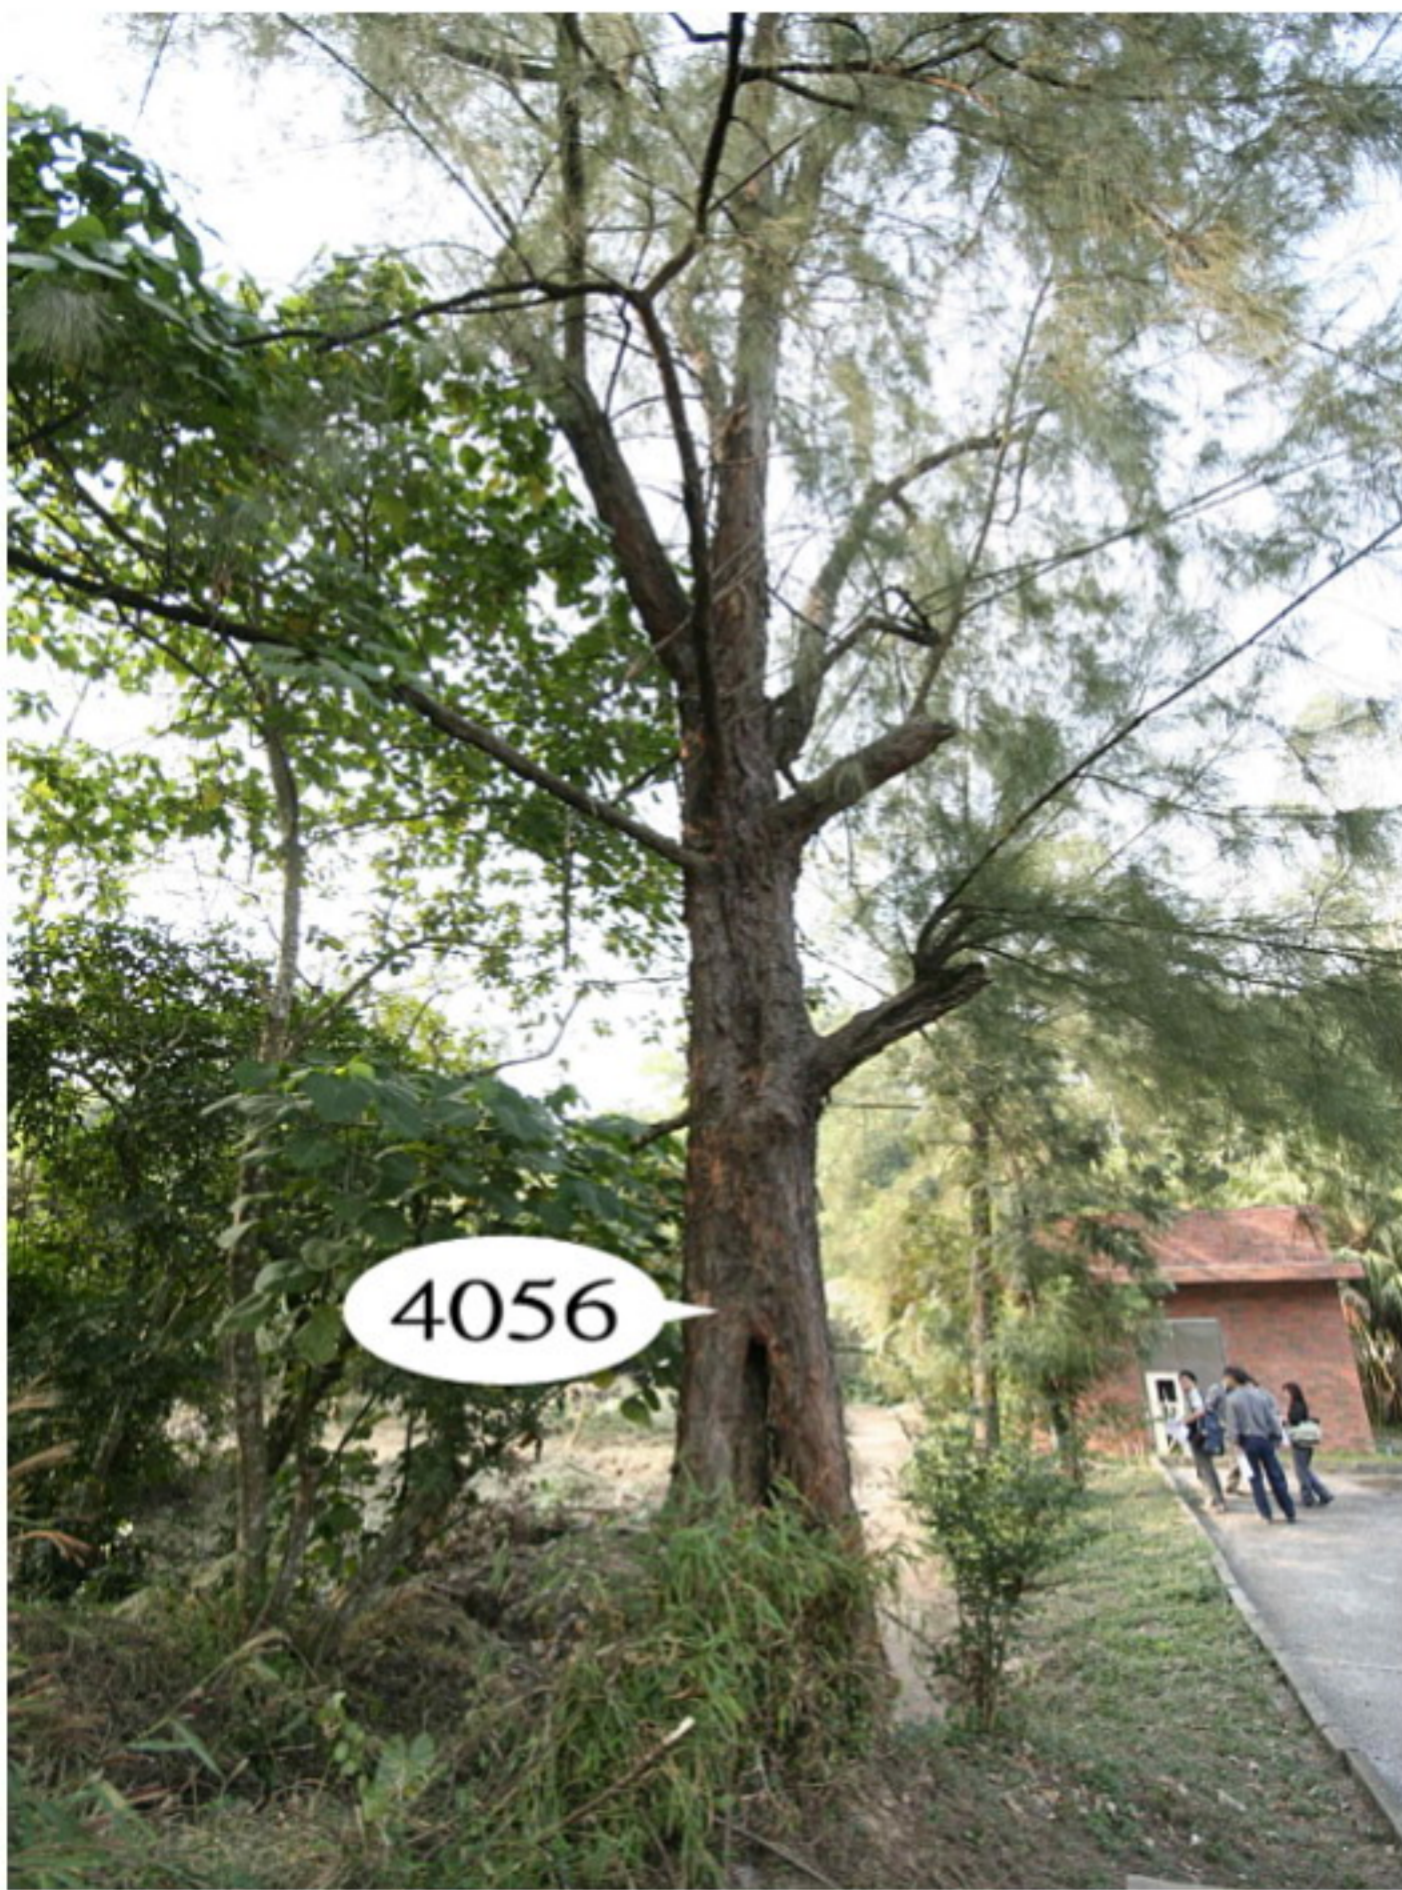
Tree 4056

Poor health lead to low transplantation survival rate. Cavity was found on tree trunk.

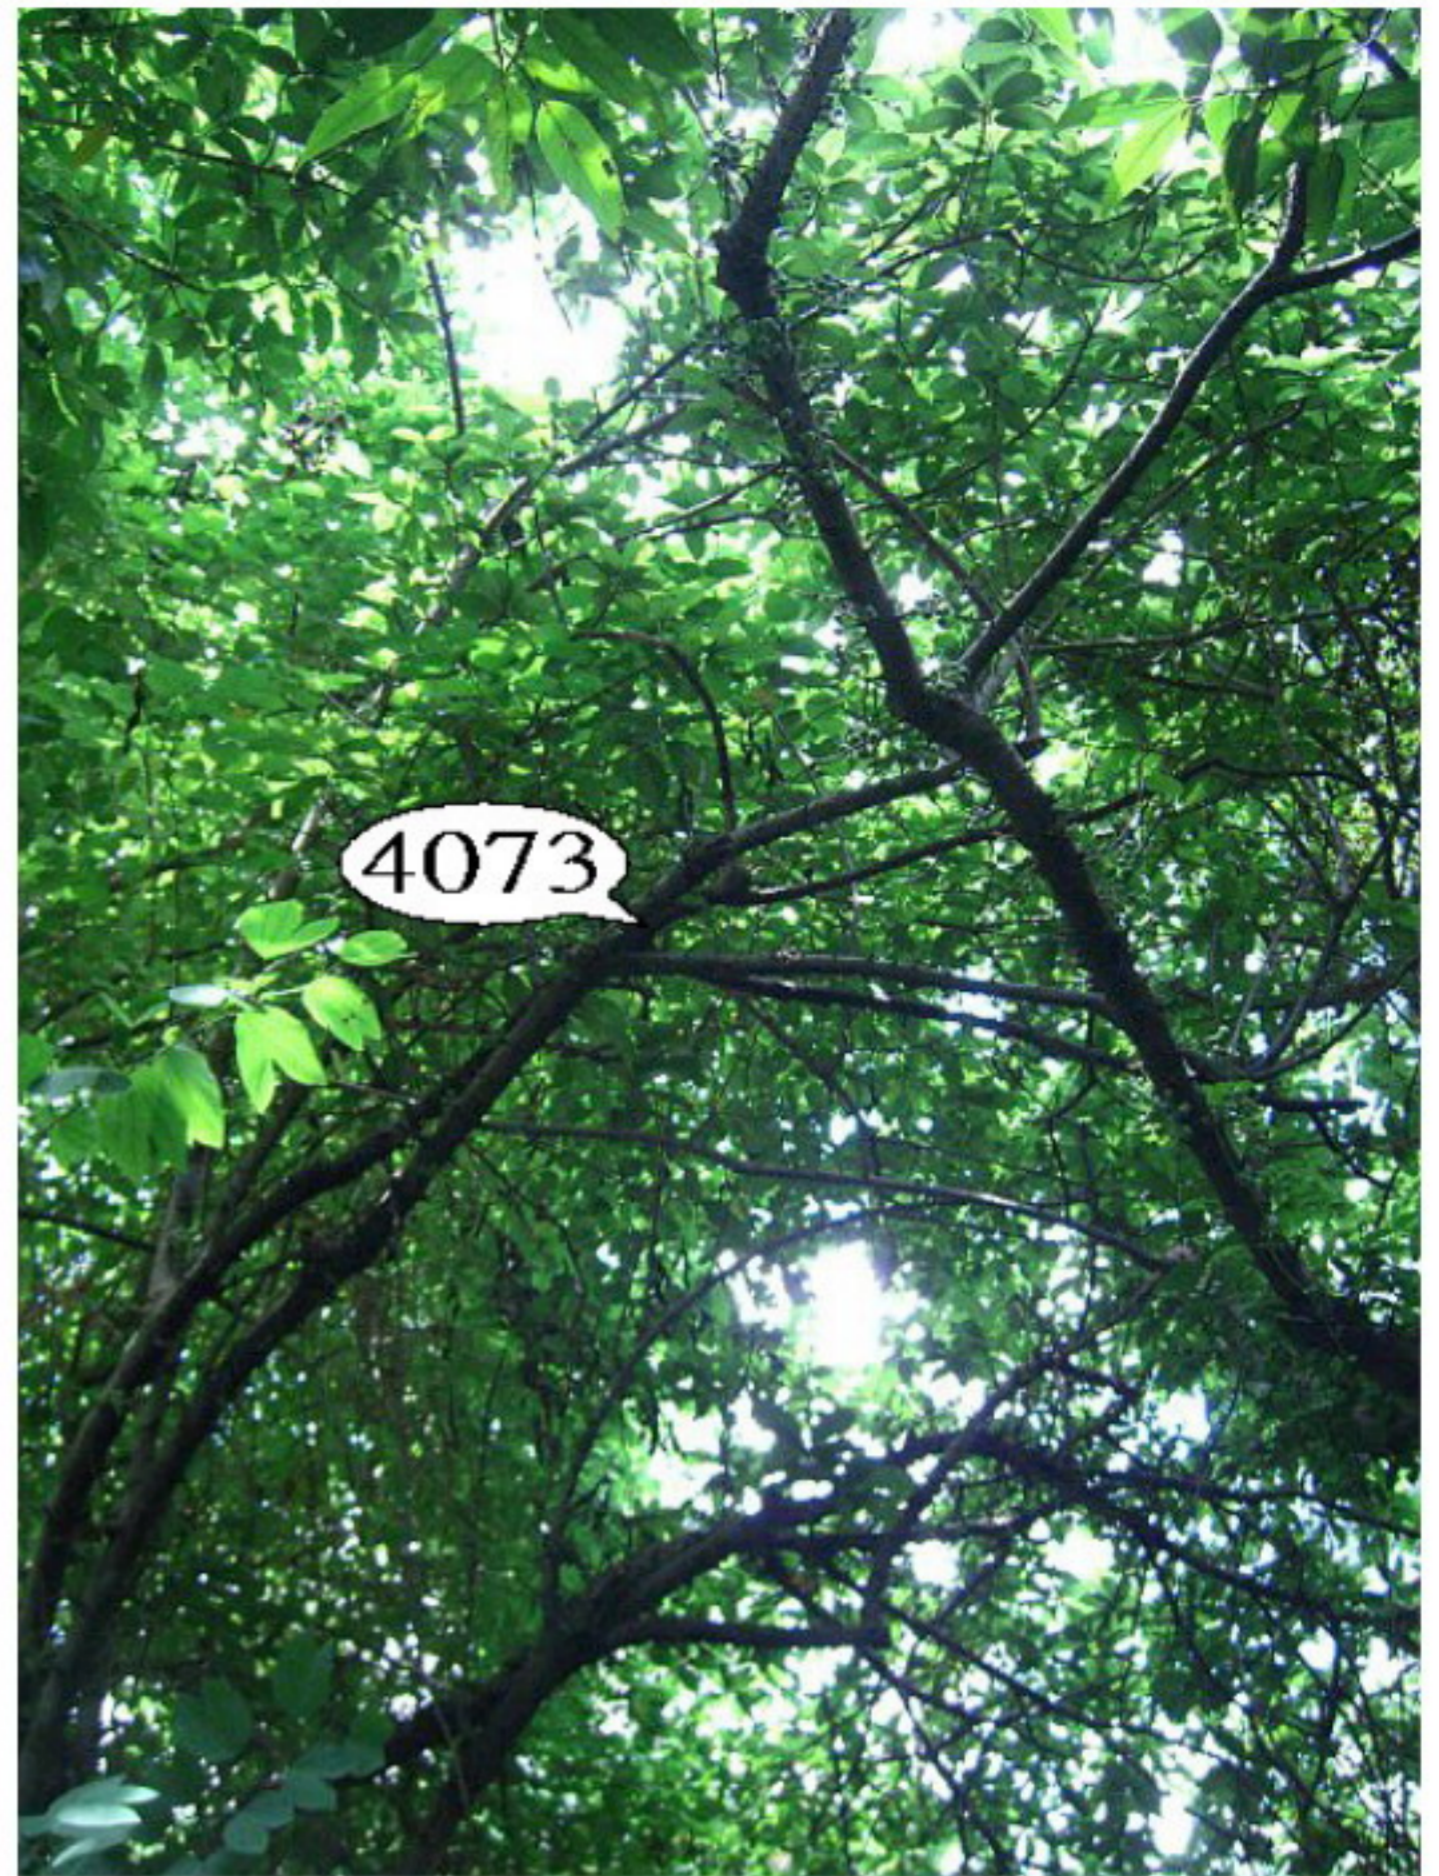
Tree 4073

Poor form which lead to low amenity value. Besides, the tree is unbalance. It may need heavy pruning after transplanted that will affect its transplanted survival rate. Moreover, the operation of the transplanted for poor form tree is also difficult.

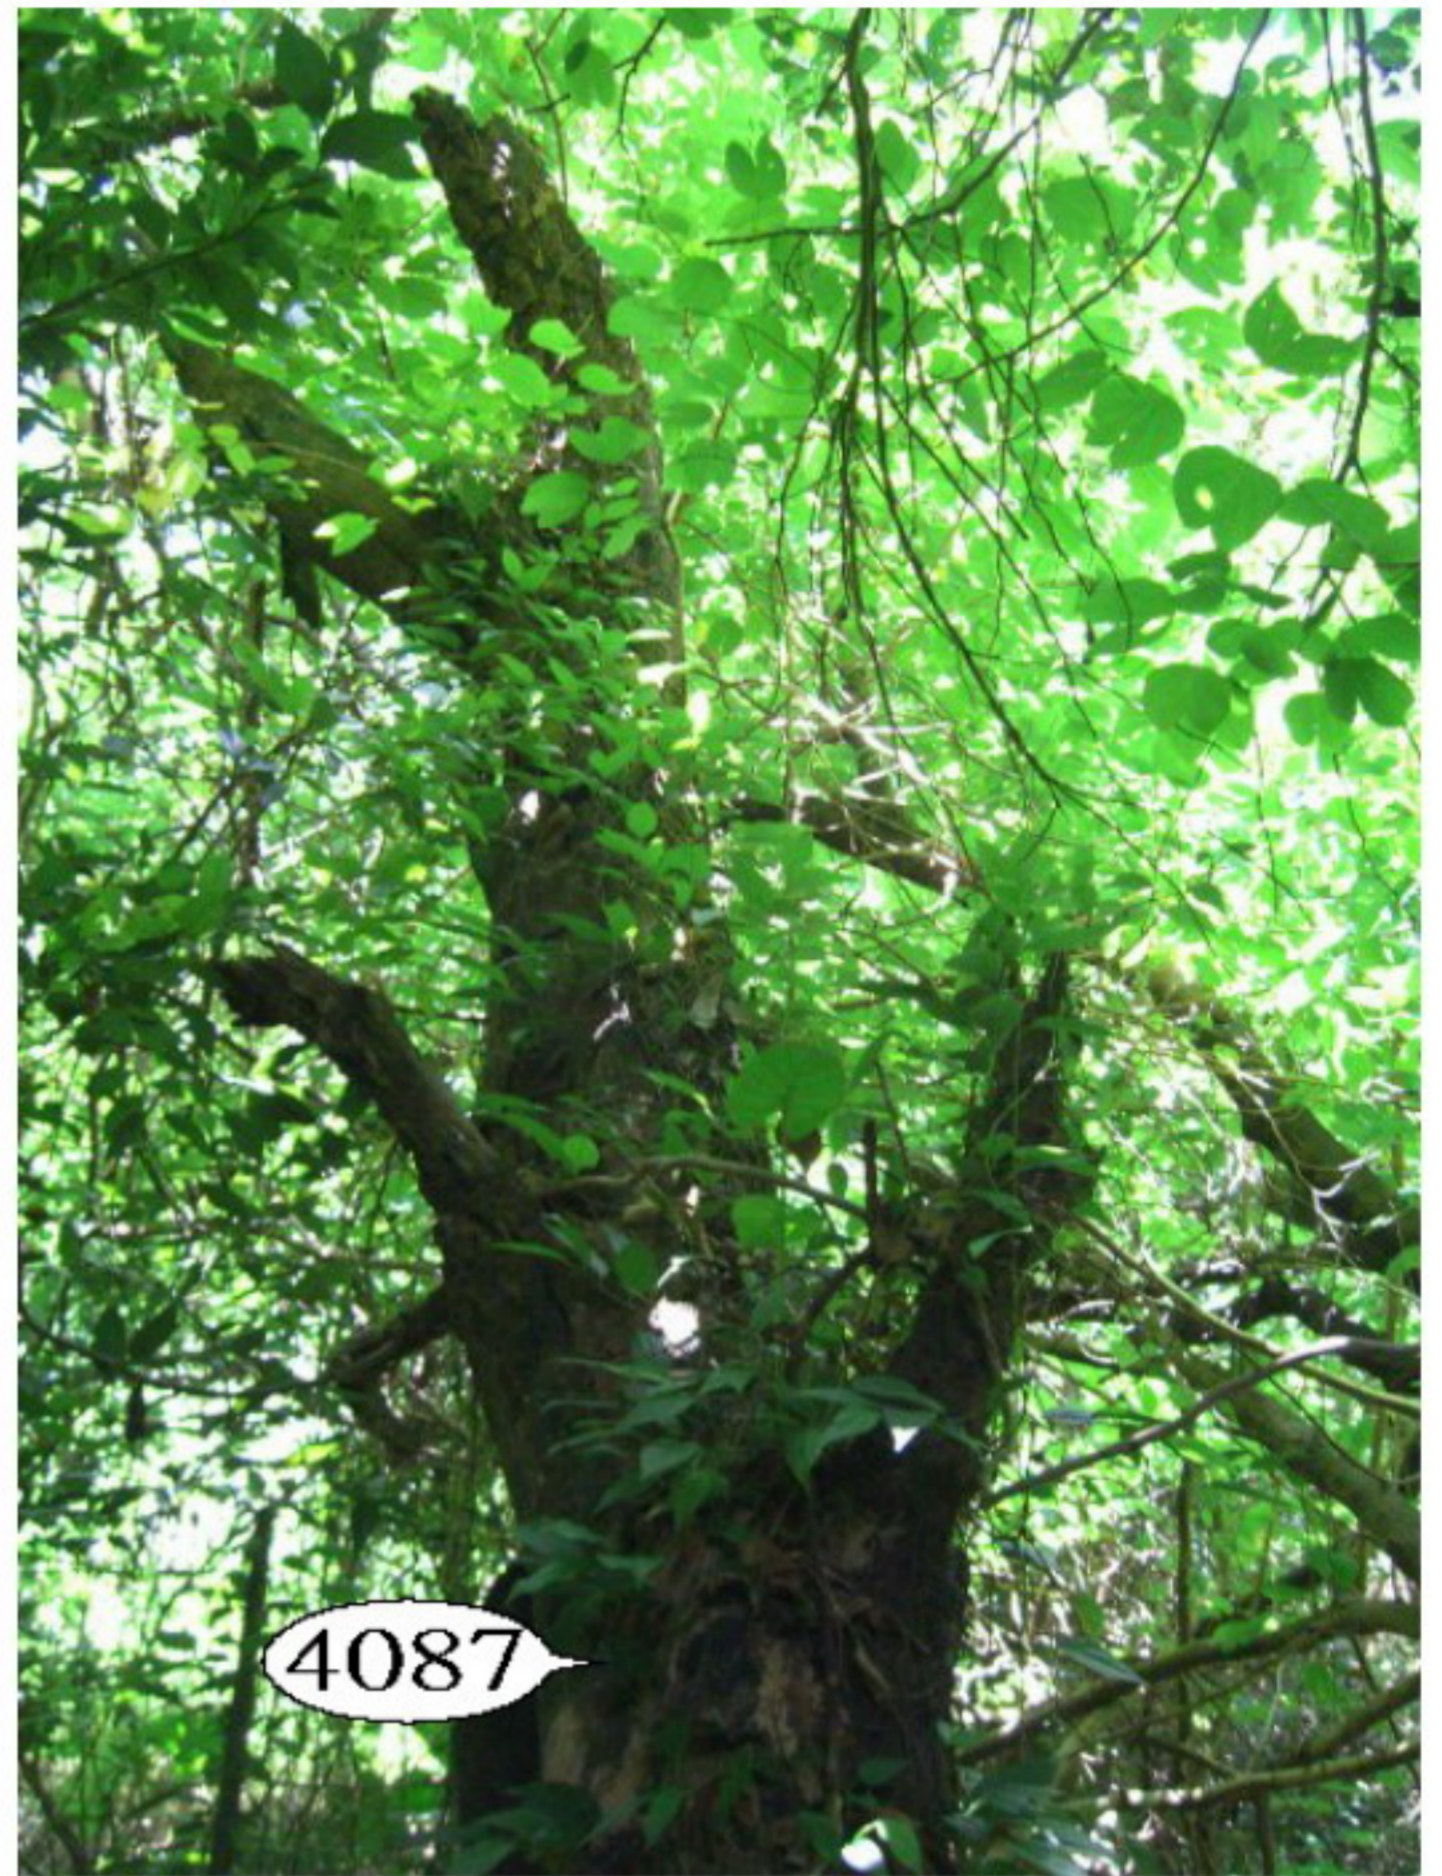
Tree 4087  
Dead Tree.

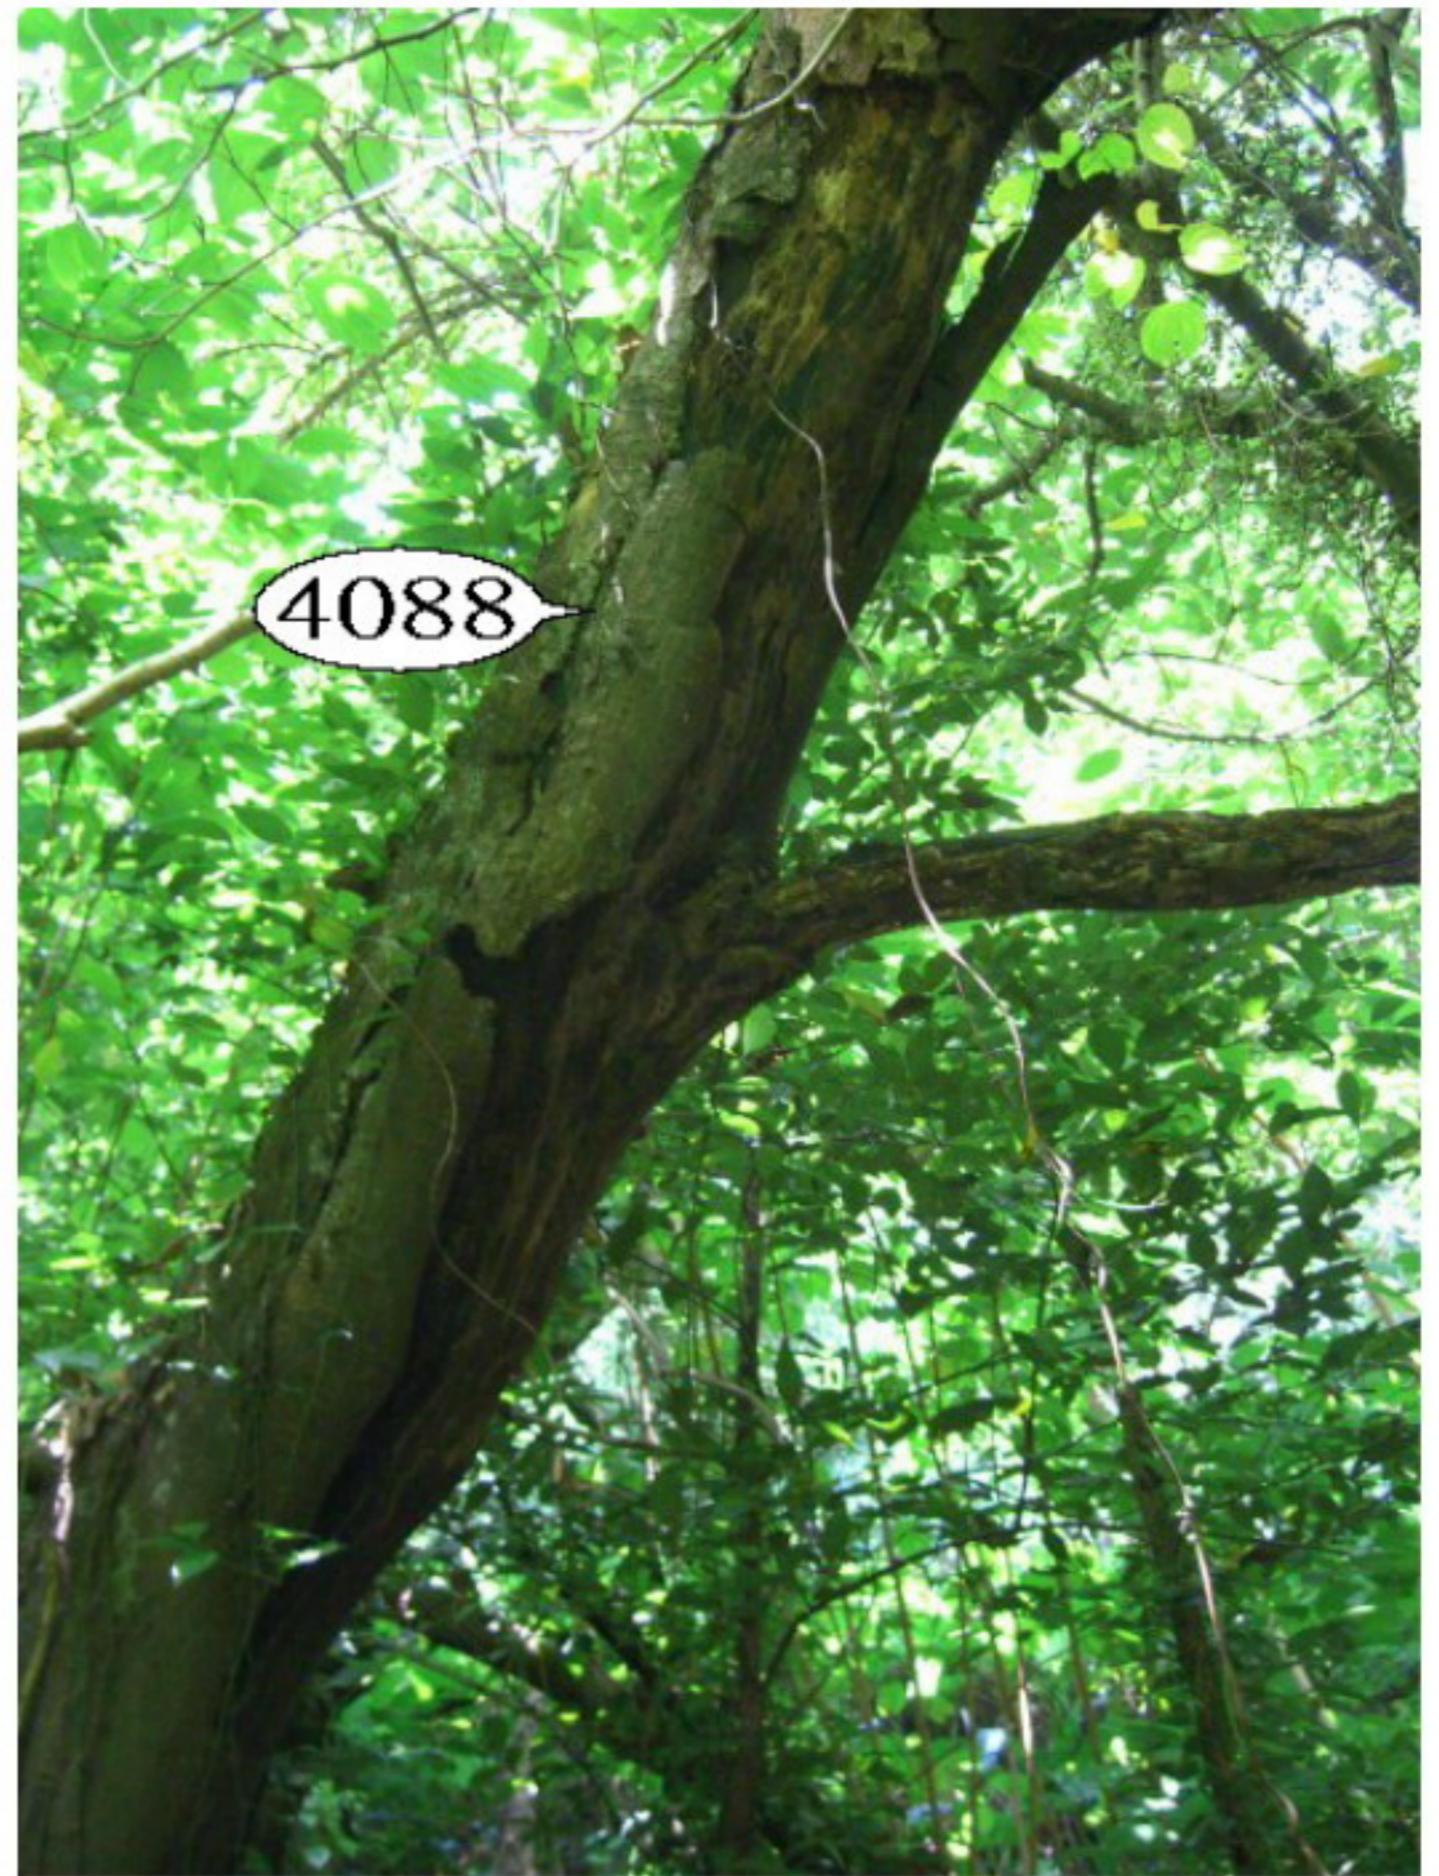
Tree 4088  
Poor health lead to low transplantation survival rate.
