# Provision of Cremators at Wo Hop Shek Crematorium

Tree Survey Report

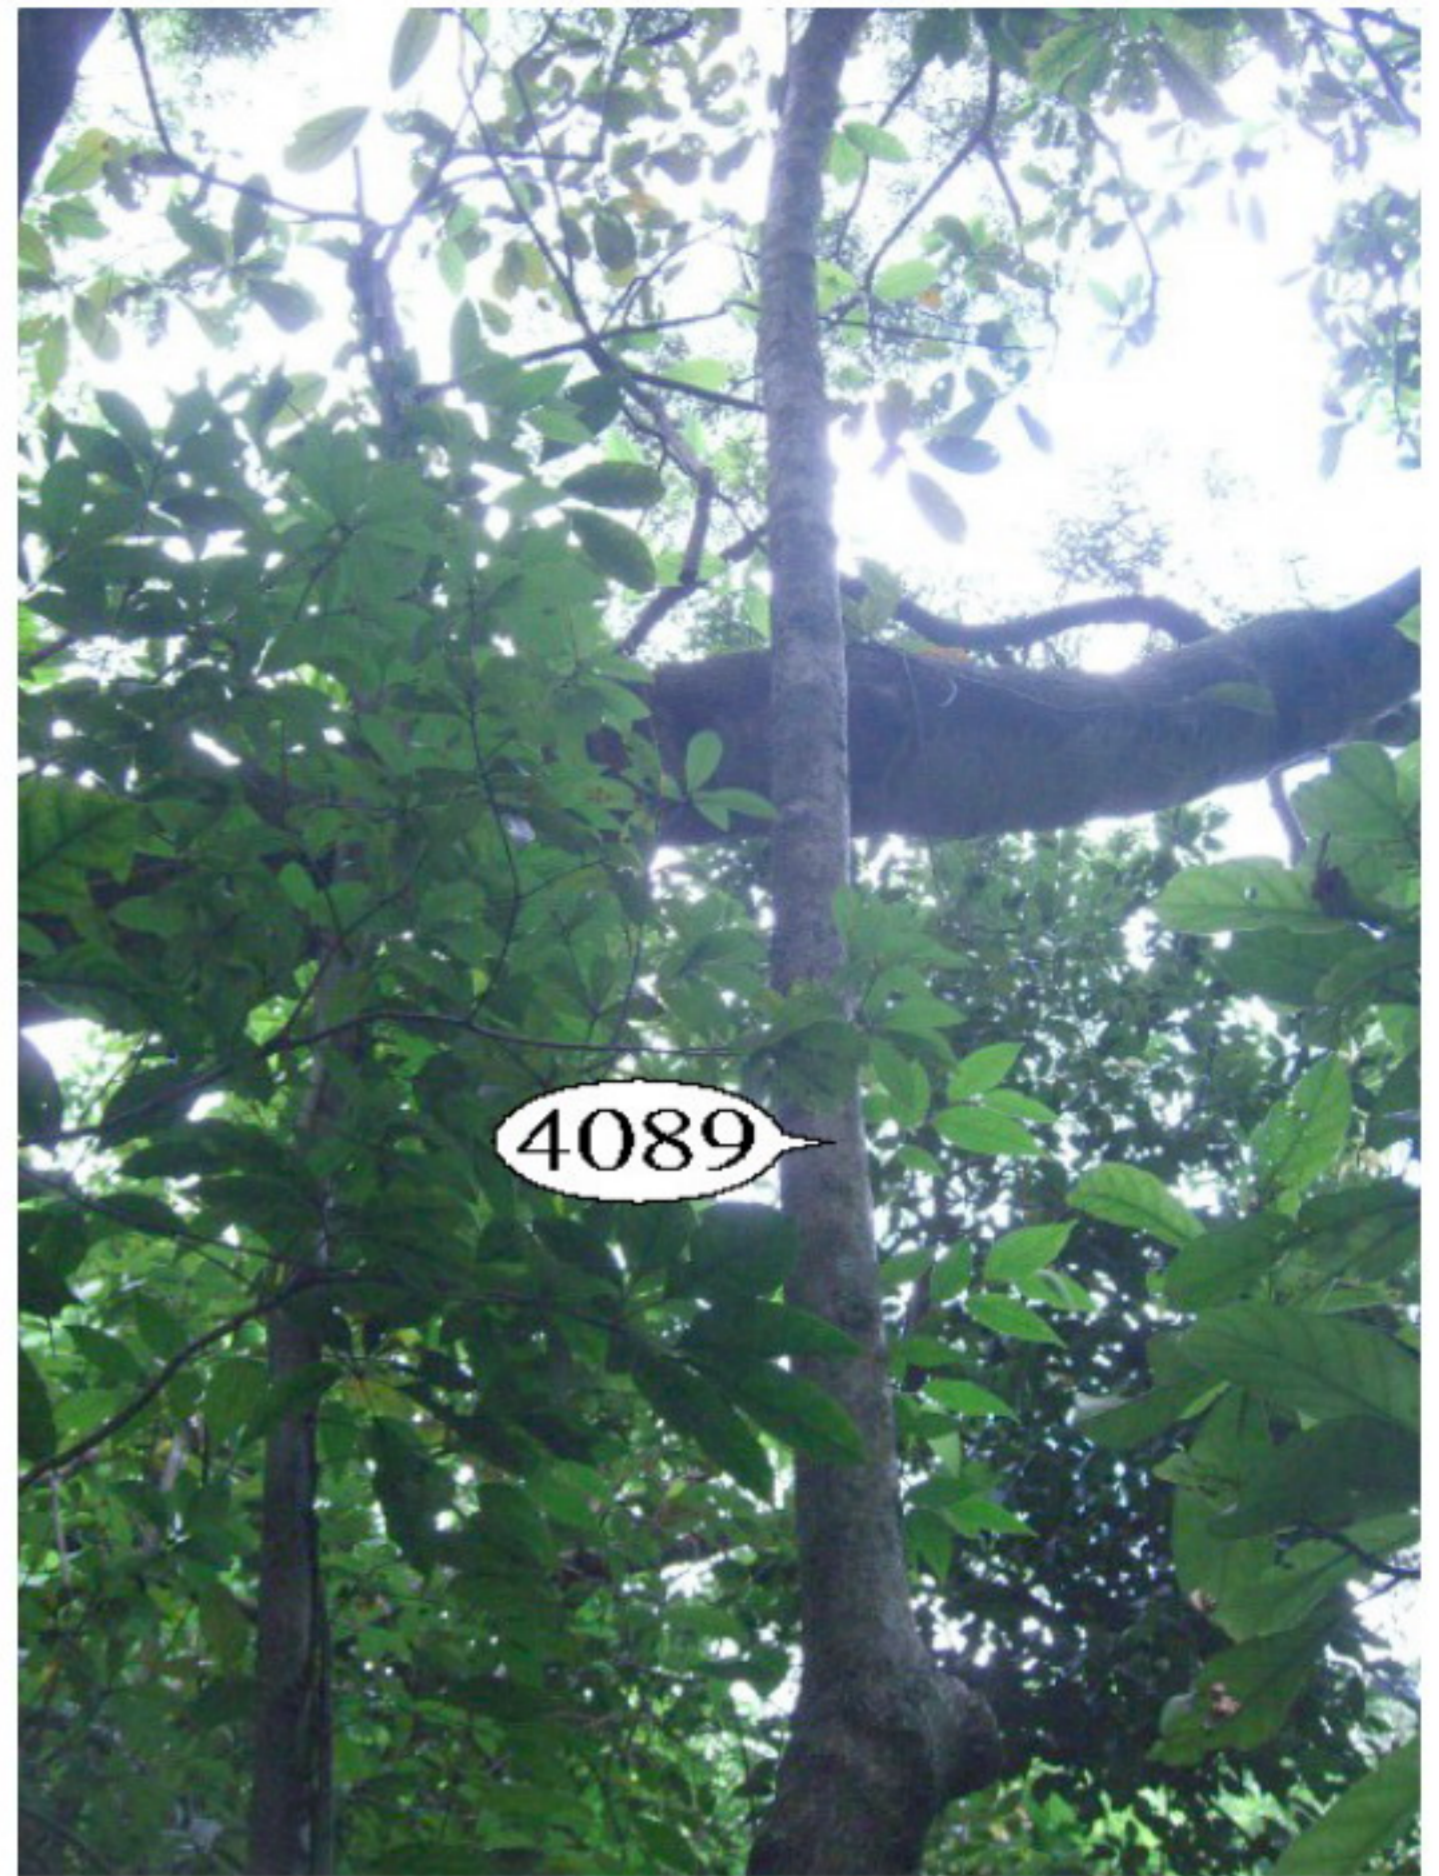
Tree 4089

This species is generally low in transplantation survival rate. Besides, poor form lead to low transplantation survival rate

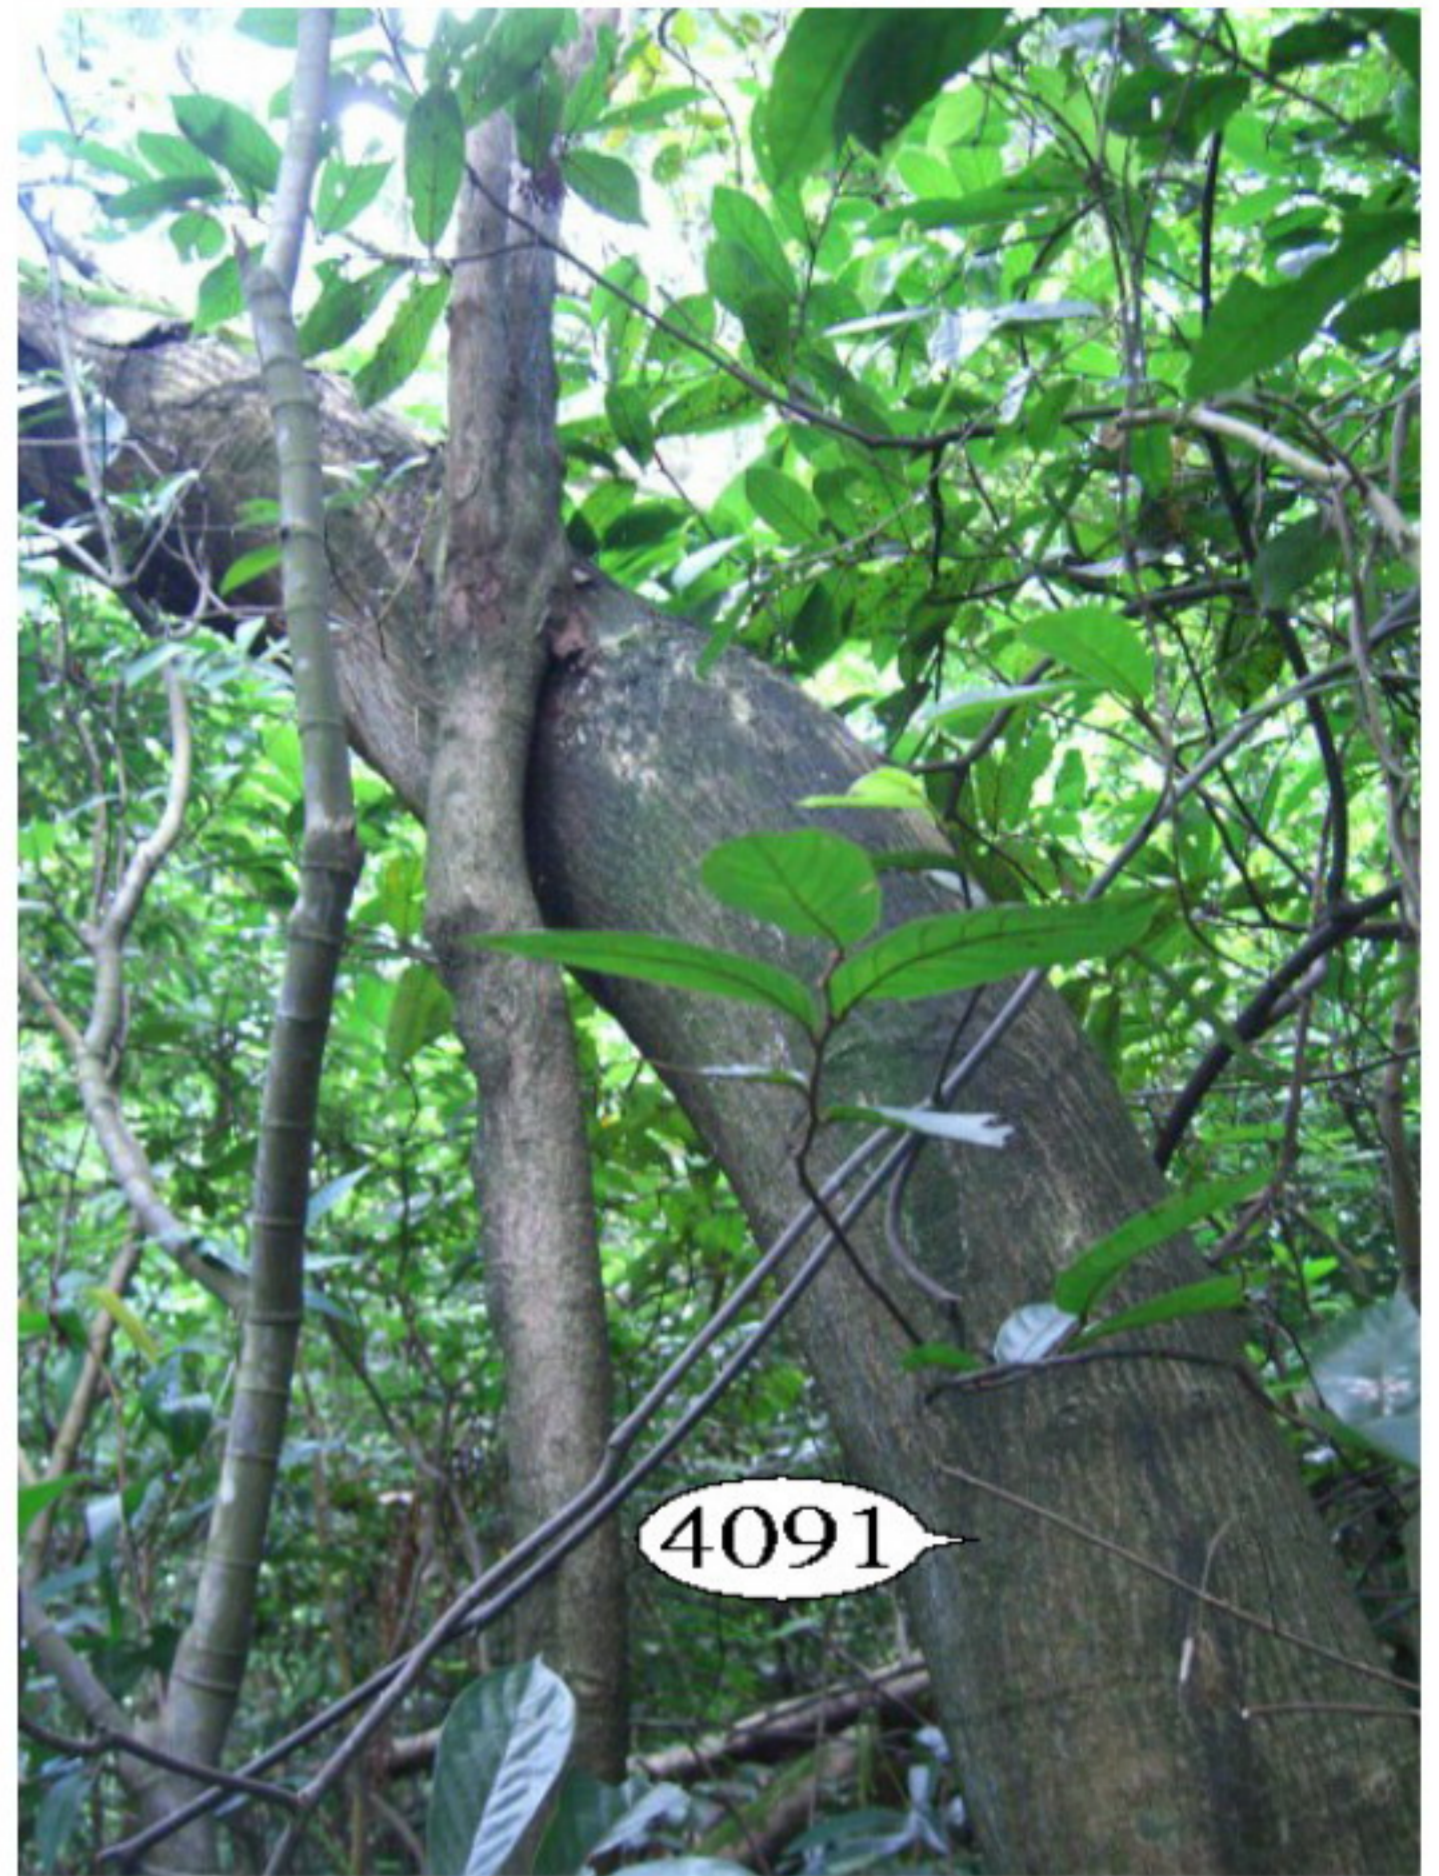
Tree 4091

Poor form which lead to low amenity value. Besides, the tree is unbalance. It may need heavy pruning after transplantation that will affect its transplantation survival rate. Moreover, the operation of the transplantion for poor form tree is also difficult.

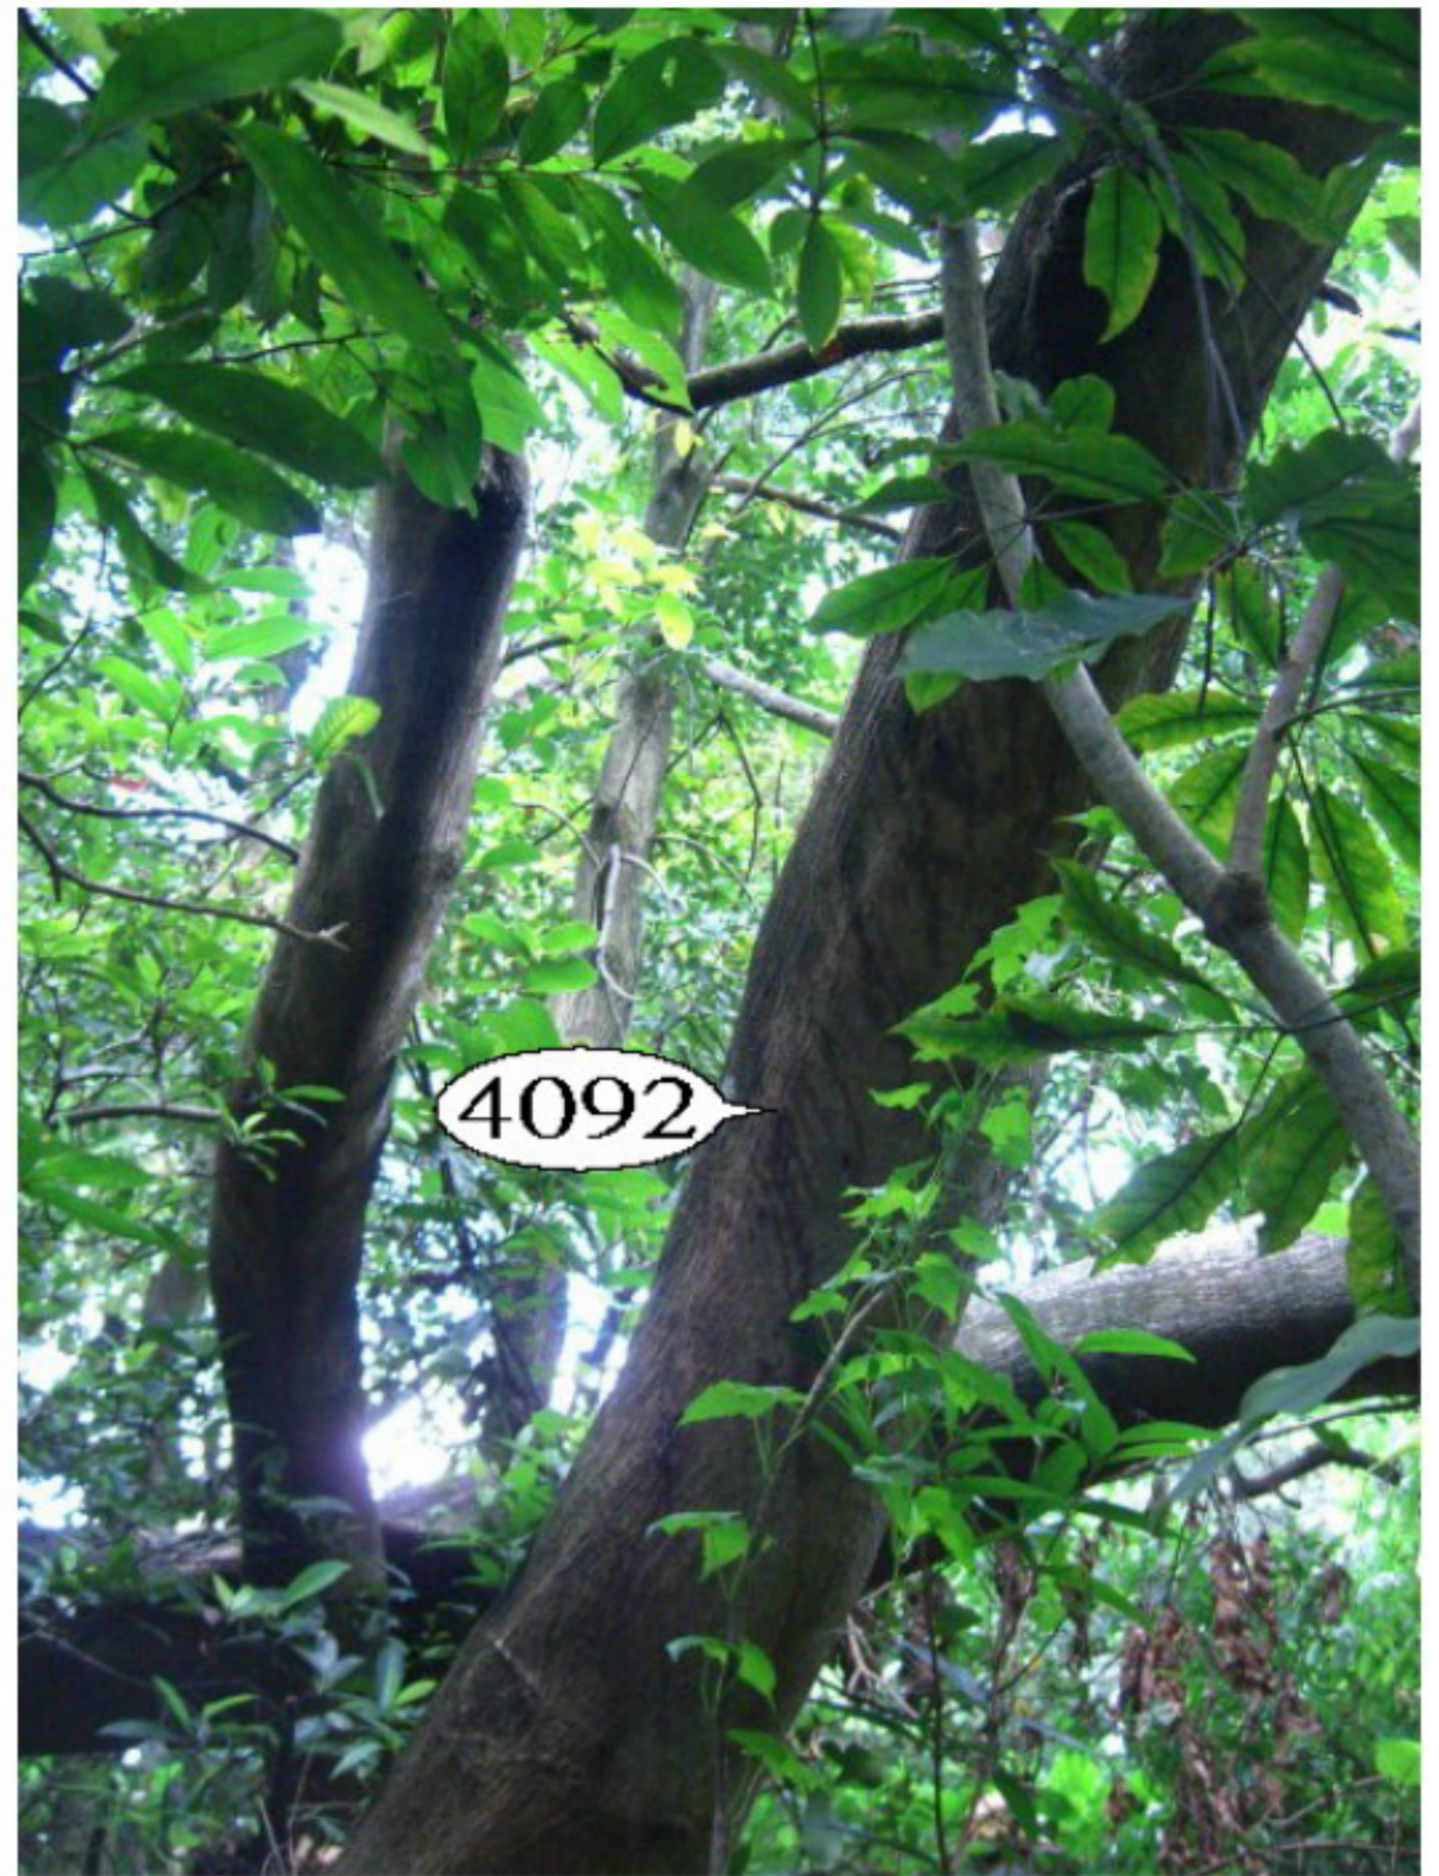
Tree 4092

Poor form which lead to low amenity value. Besides, the tree is unbalance. It may need heavy pruning after transplantation that will affect its transplantation survival rate. Moreover, the operation of the transplantation for poor form tree is also difficult.

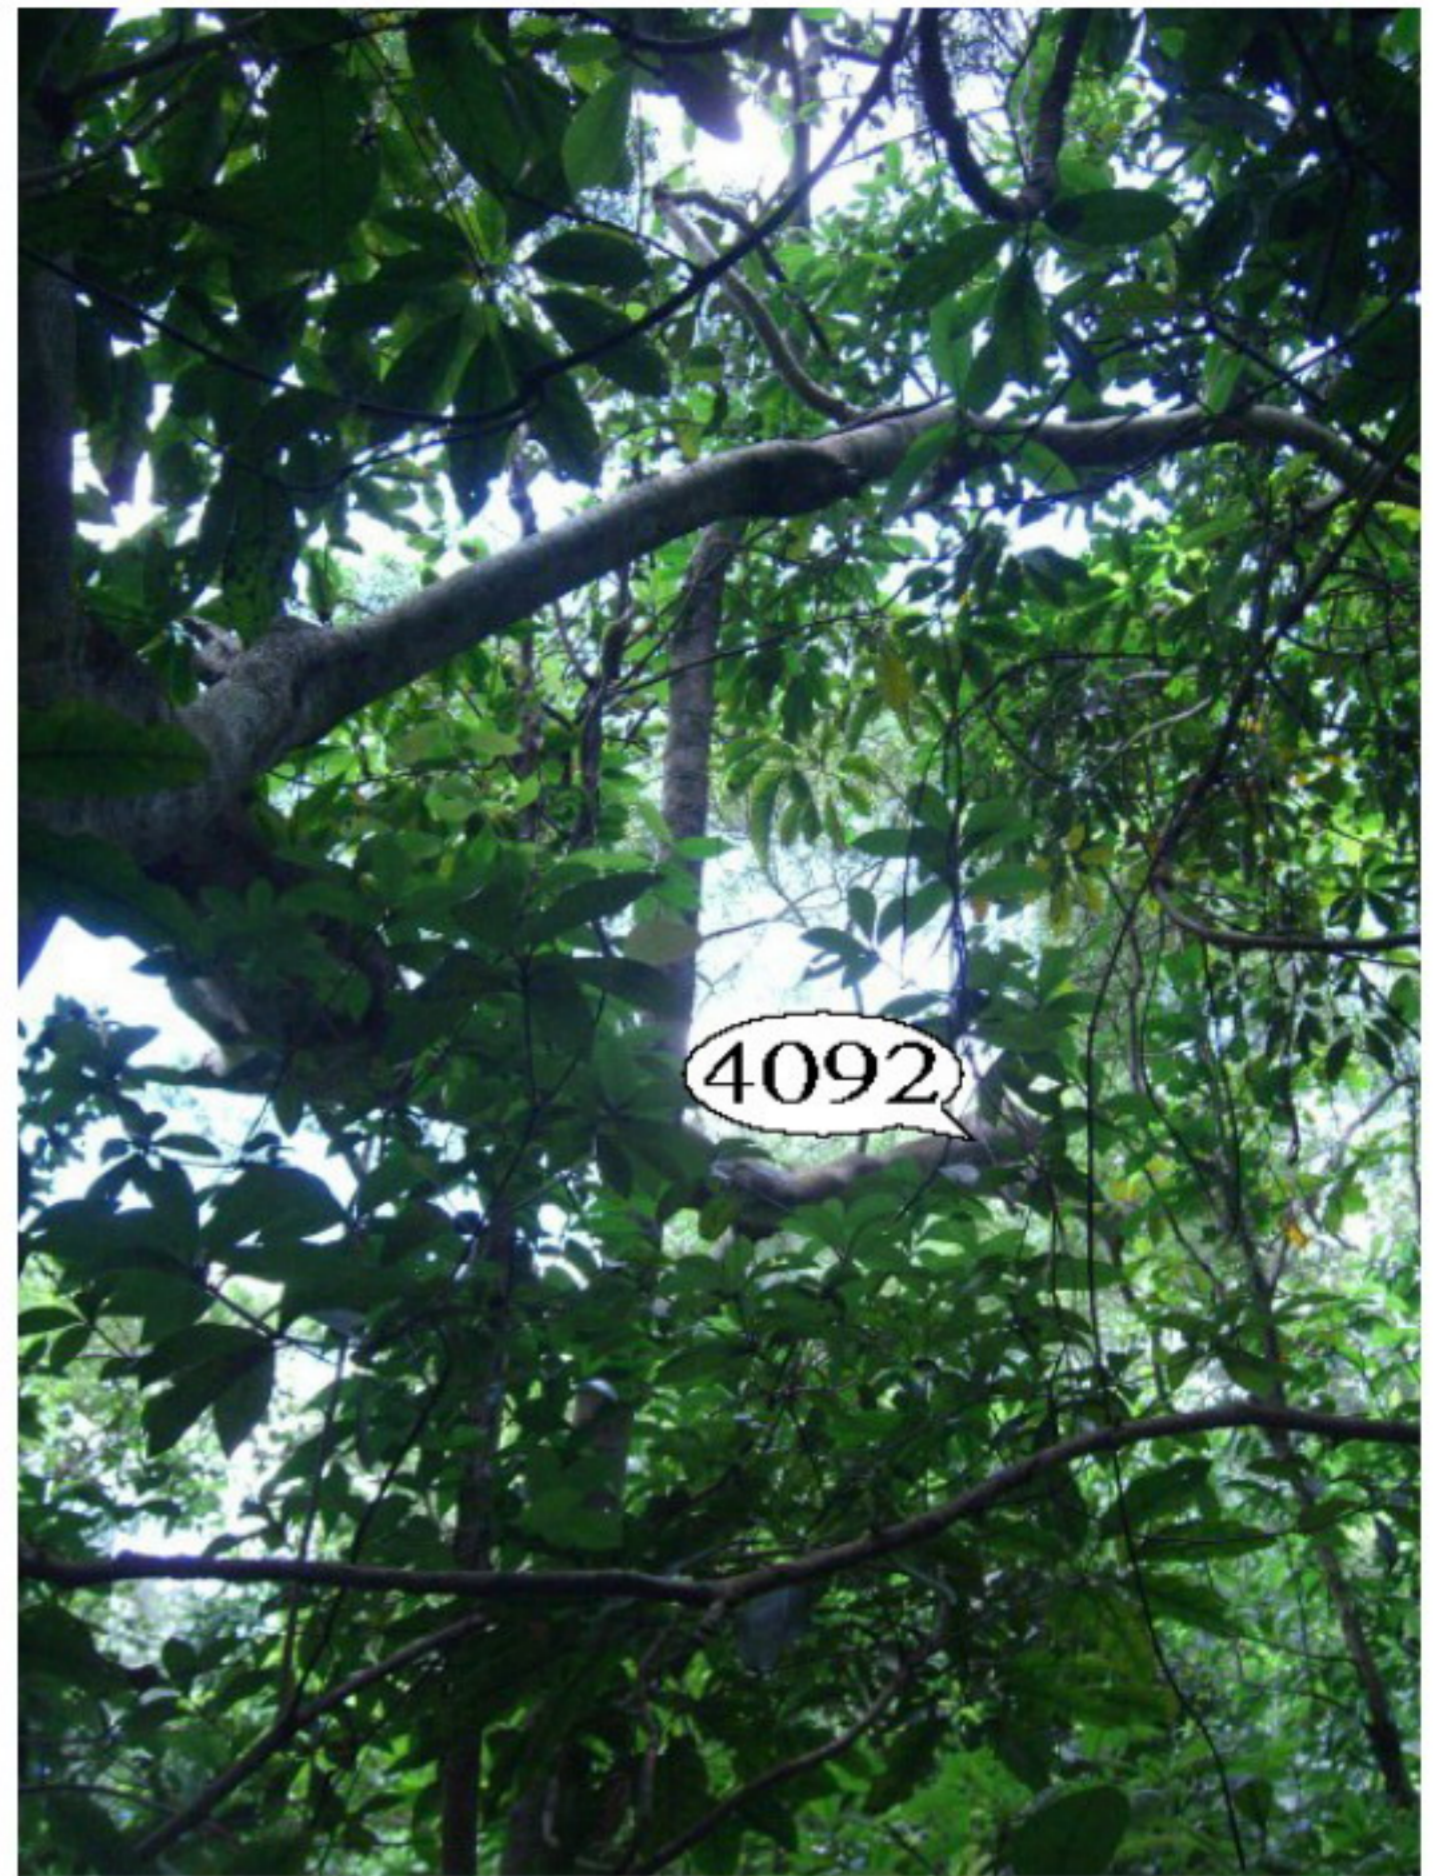
Tree 4092

Poor form which lead to low amenity value. Besides, the tree is unbalance. It may need heavy pruning after transplantation that will affect its transplantation survival rate. Moreover, the operation of the transplantation for poor form tree is also difficult.

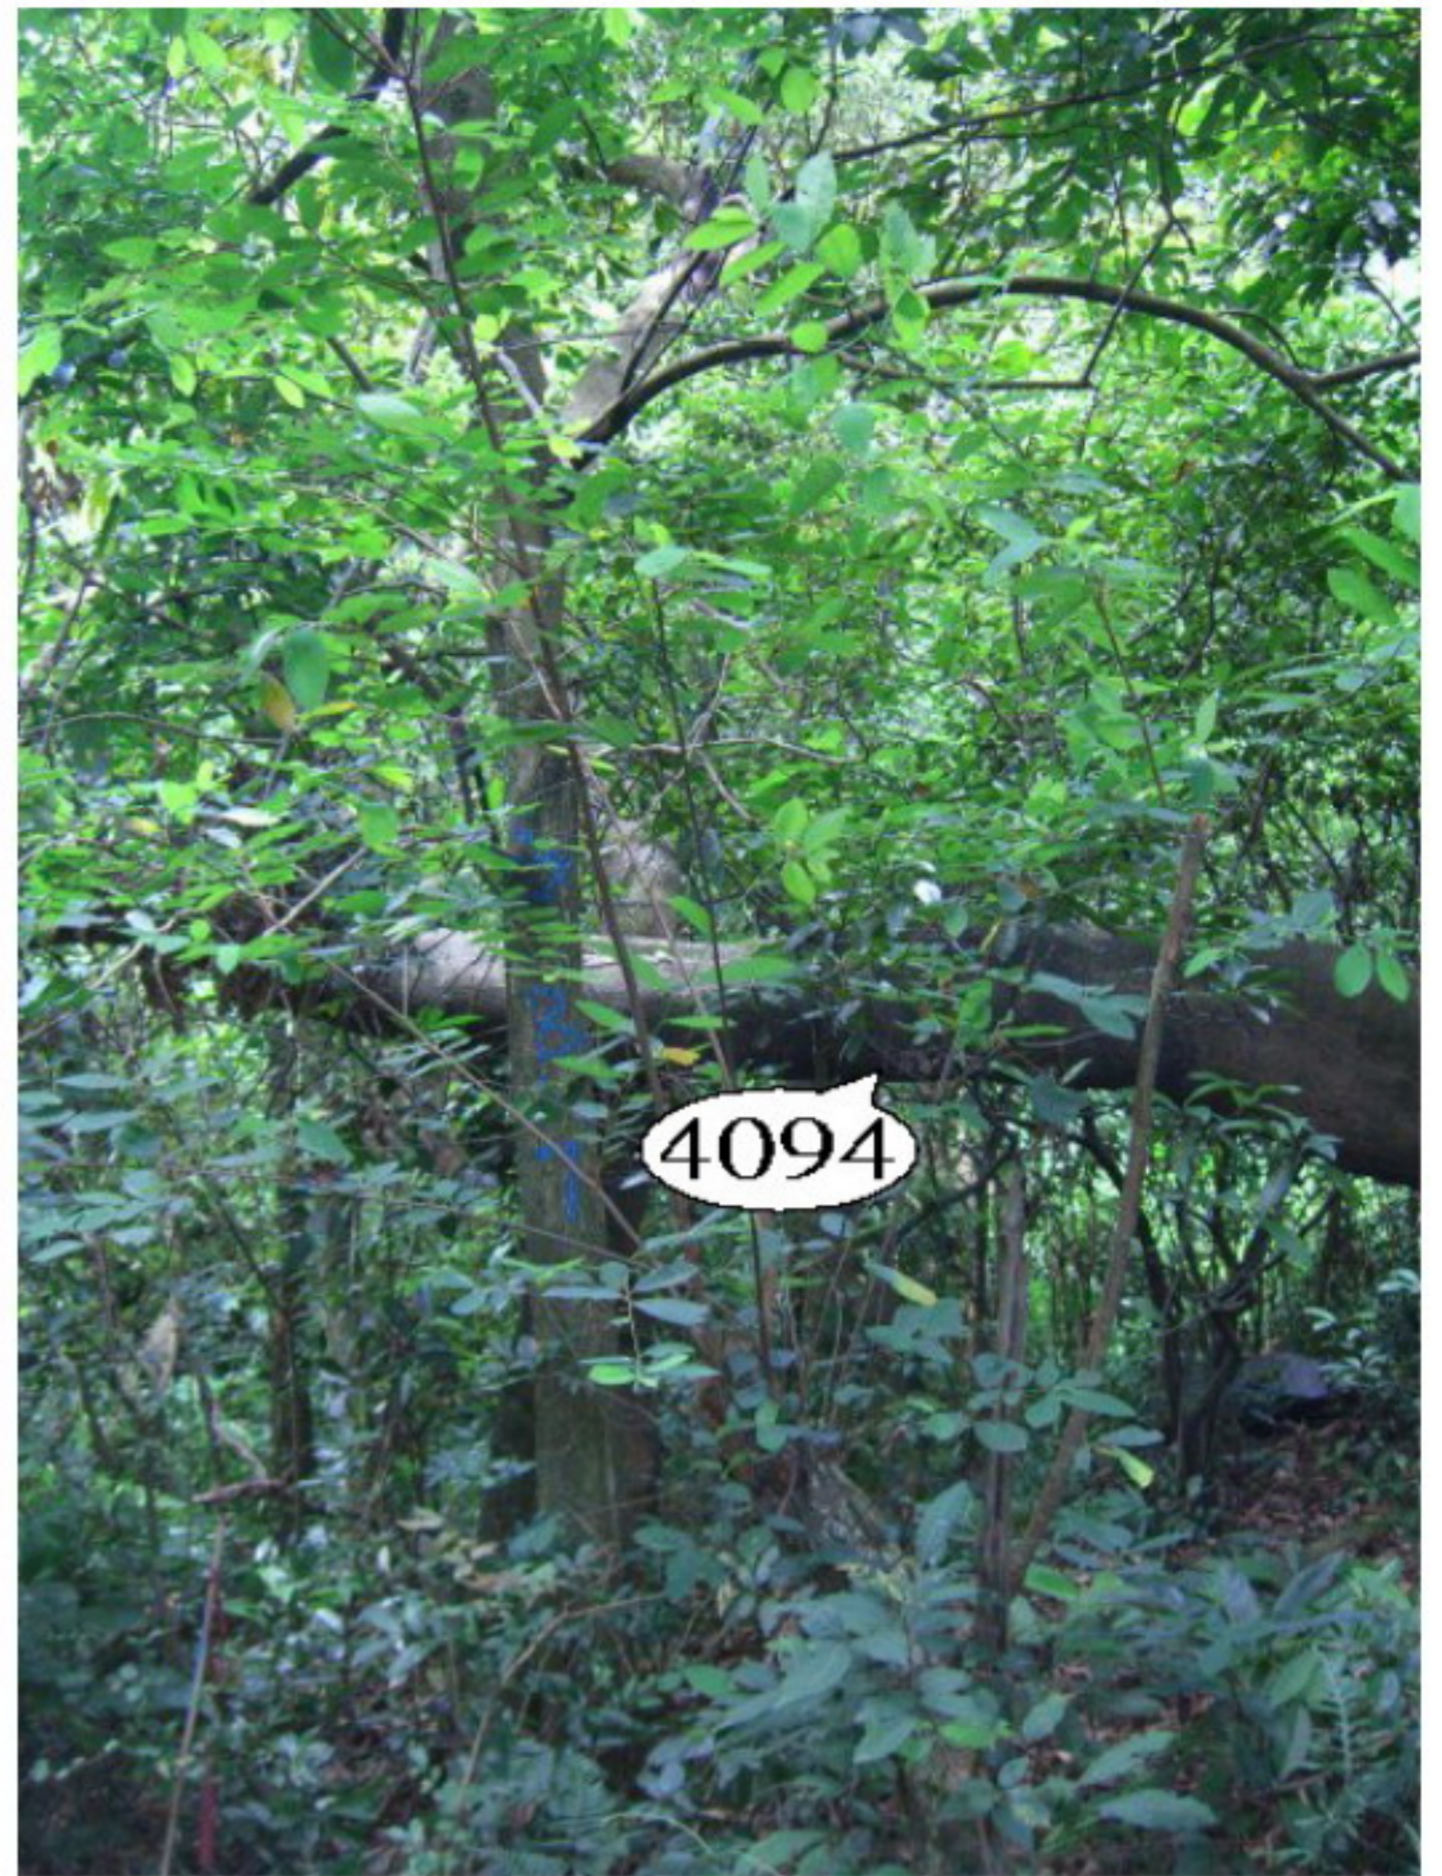
Tree 4094  
Poor health lead to low transplantation survival rate.

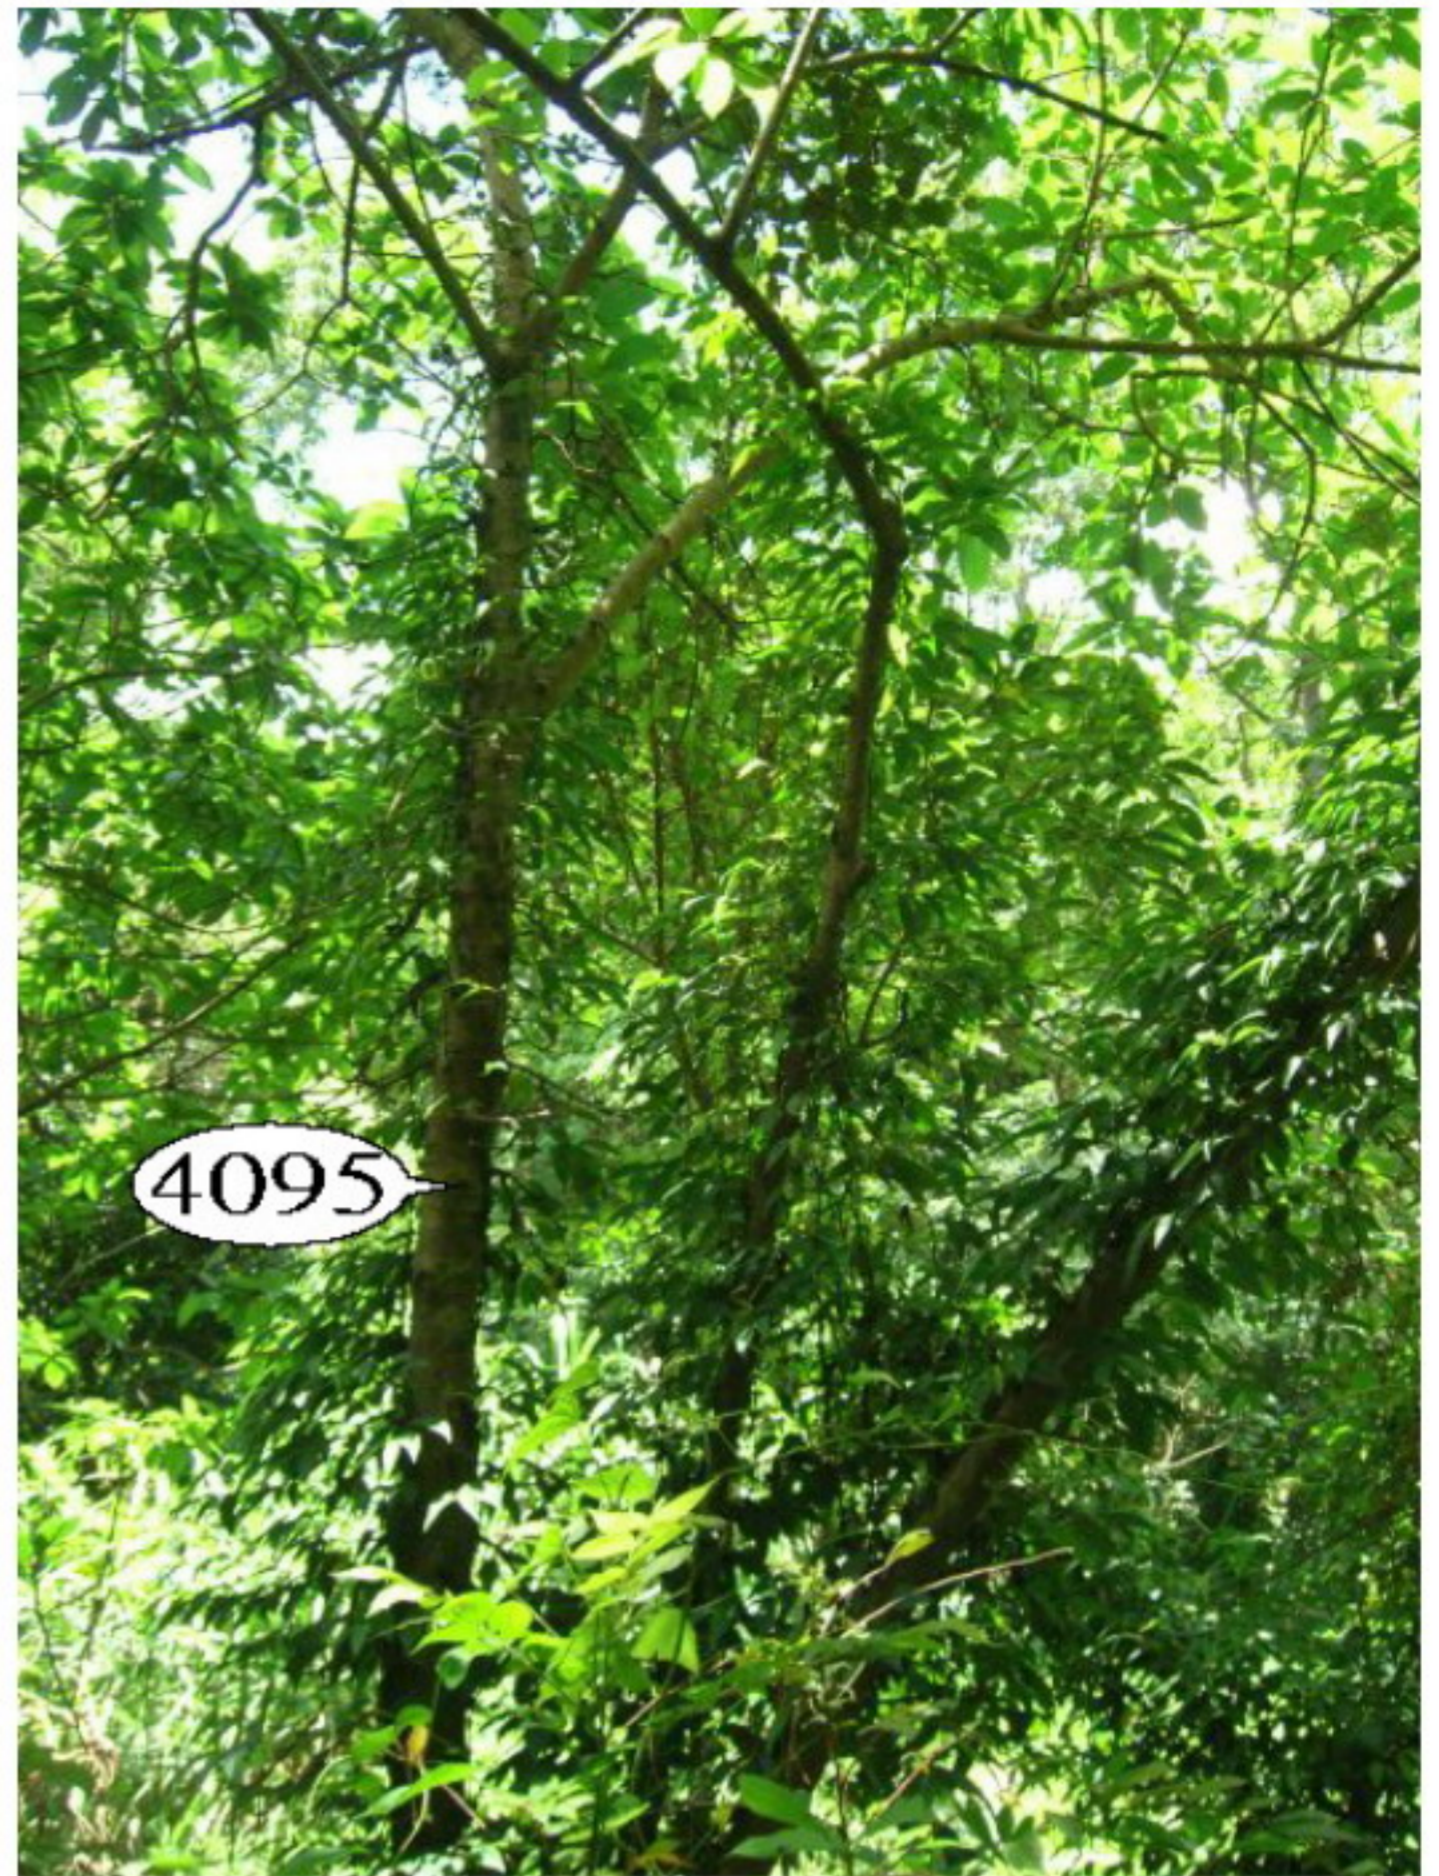
Tree 4095

Poor form which lead to low amenity value. Besides, the tree is unbalance. It may need heavy pruning after transplantaion that will affect its transplantaion survival rate. Moreover, the operation of the transplantaion for poor form tree is also difficult.
