# Provision of Cremators at Wo Hop Shek Crematorium

Tree Survey Report

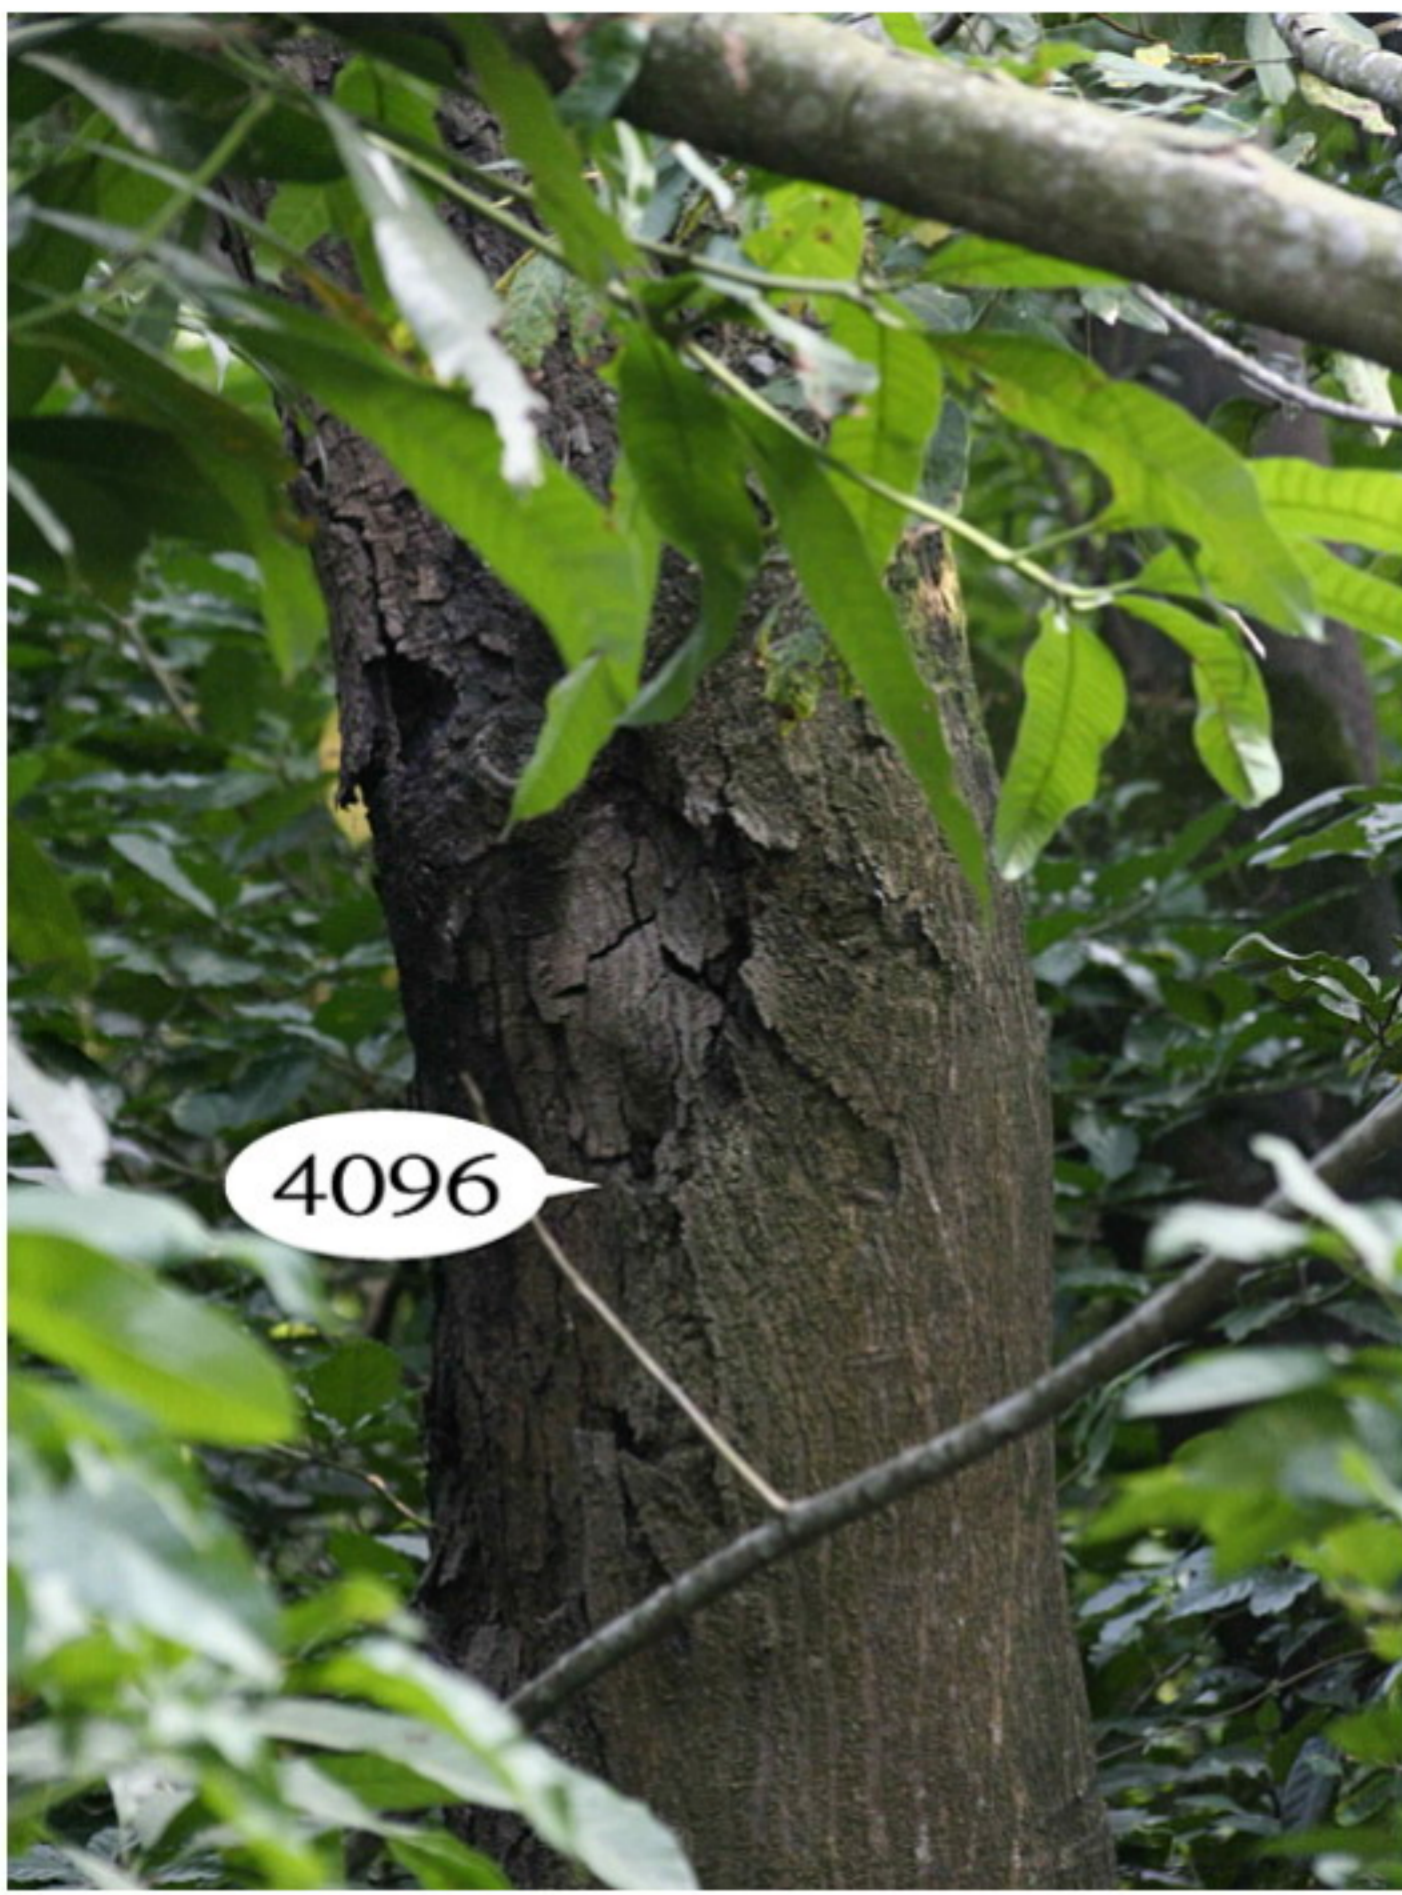
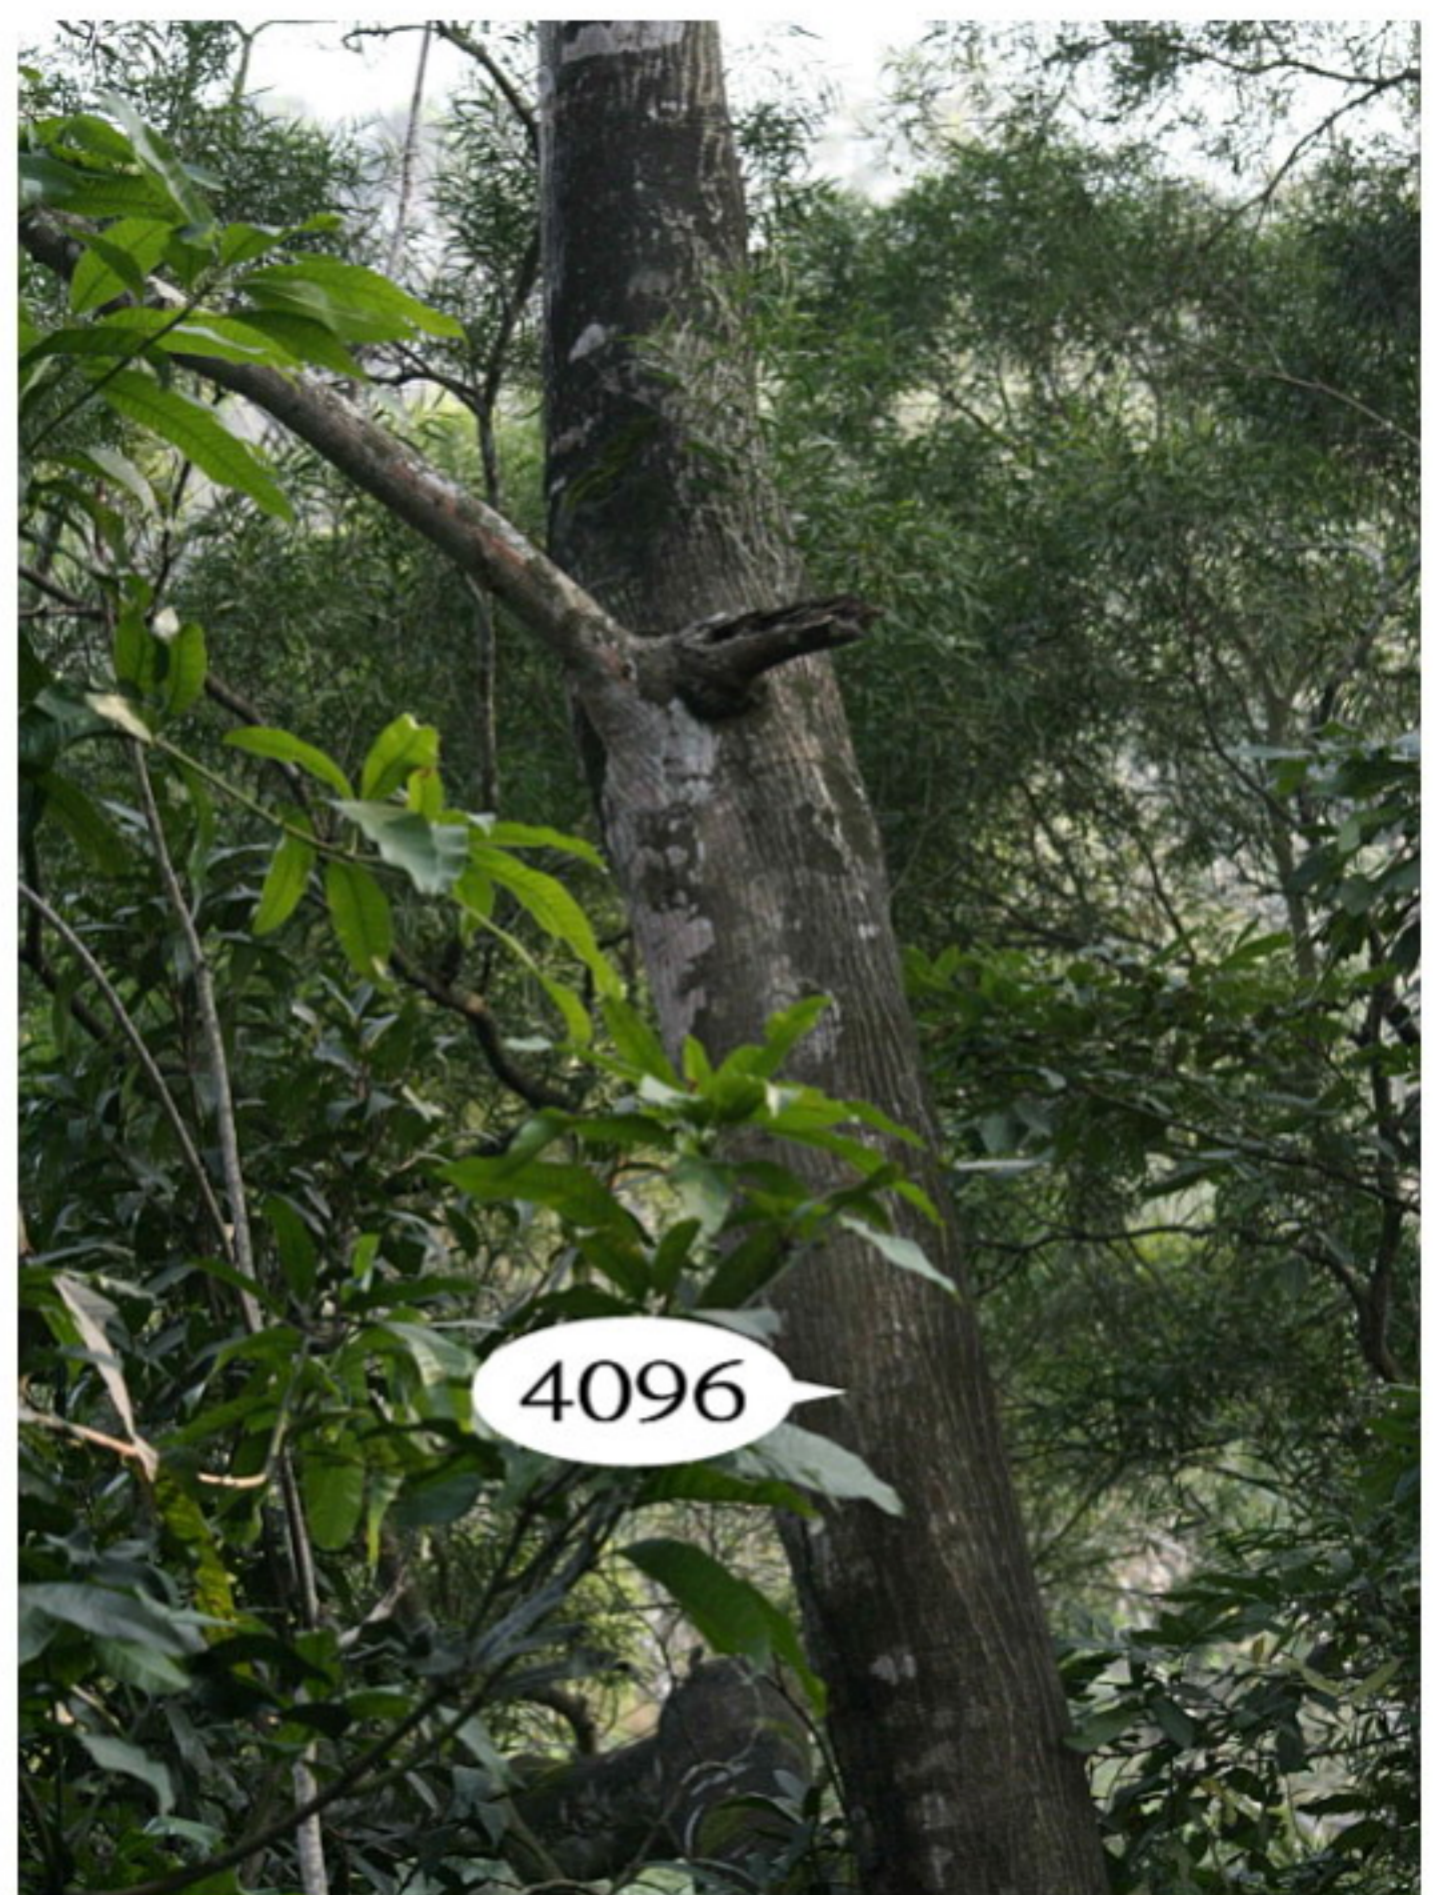
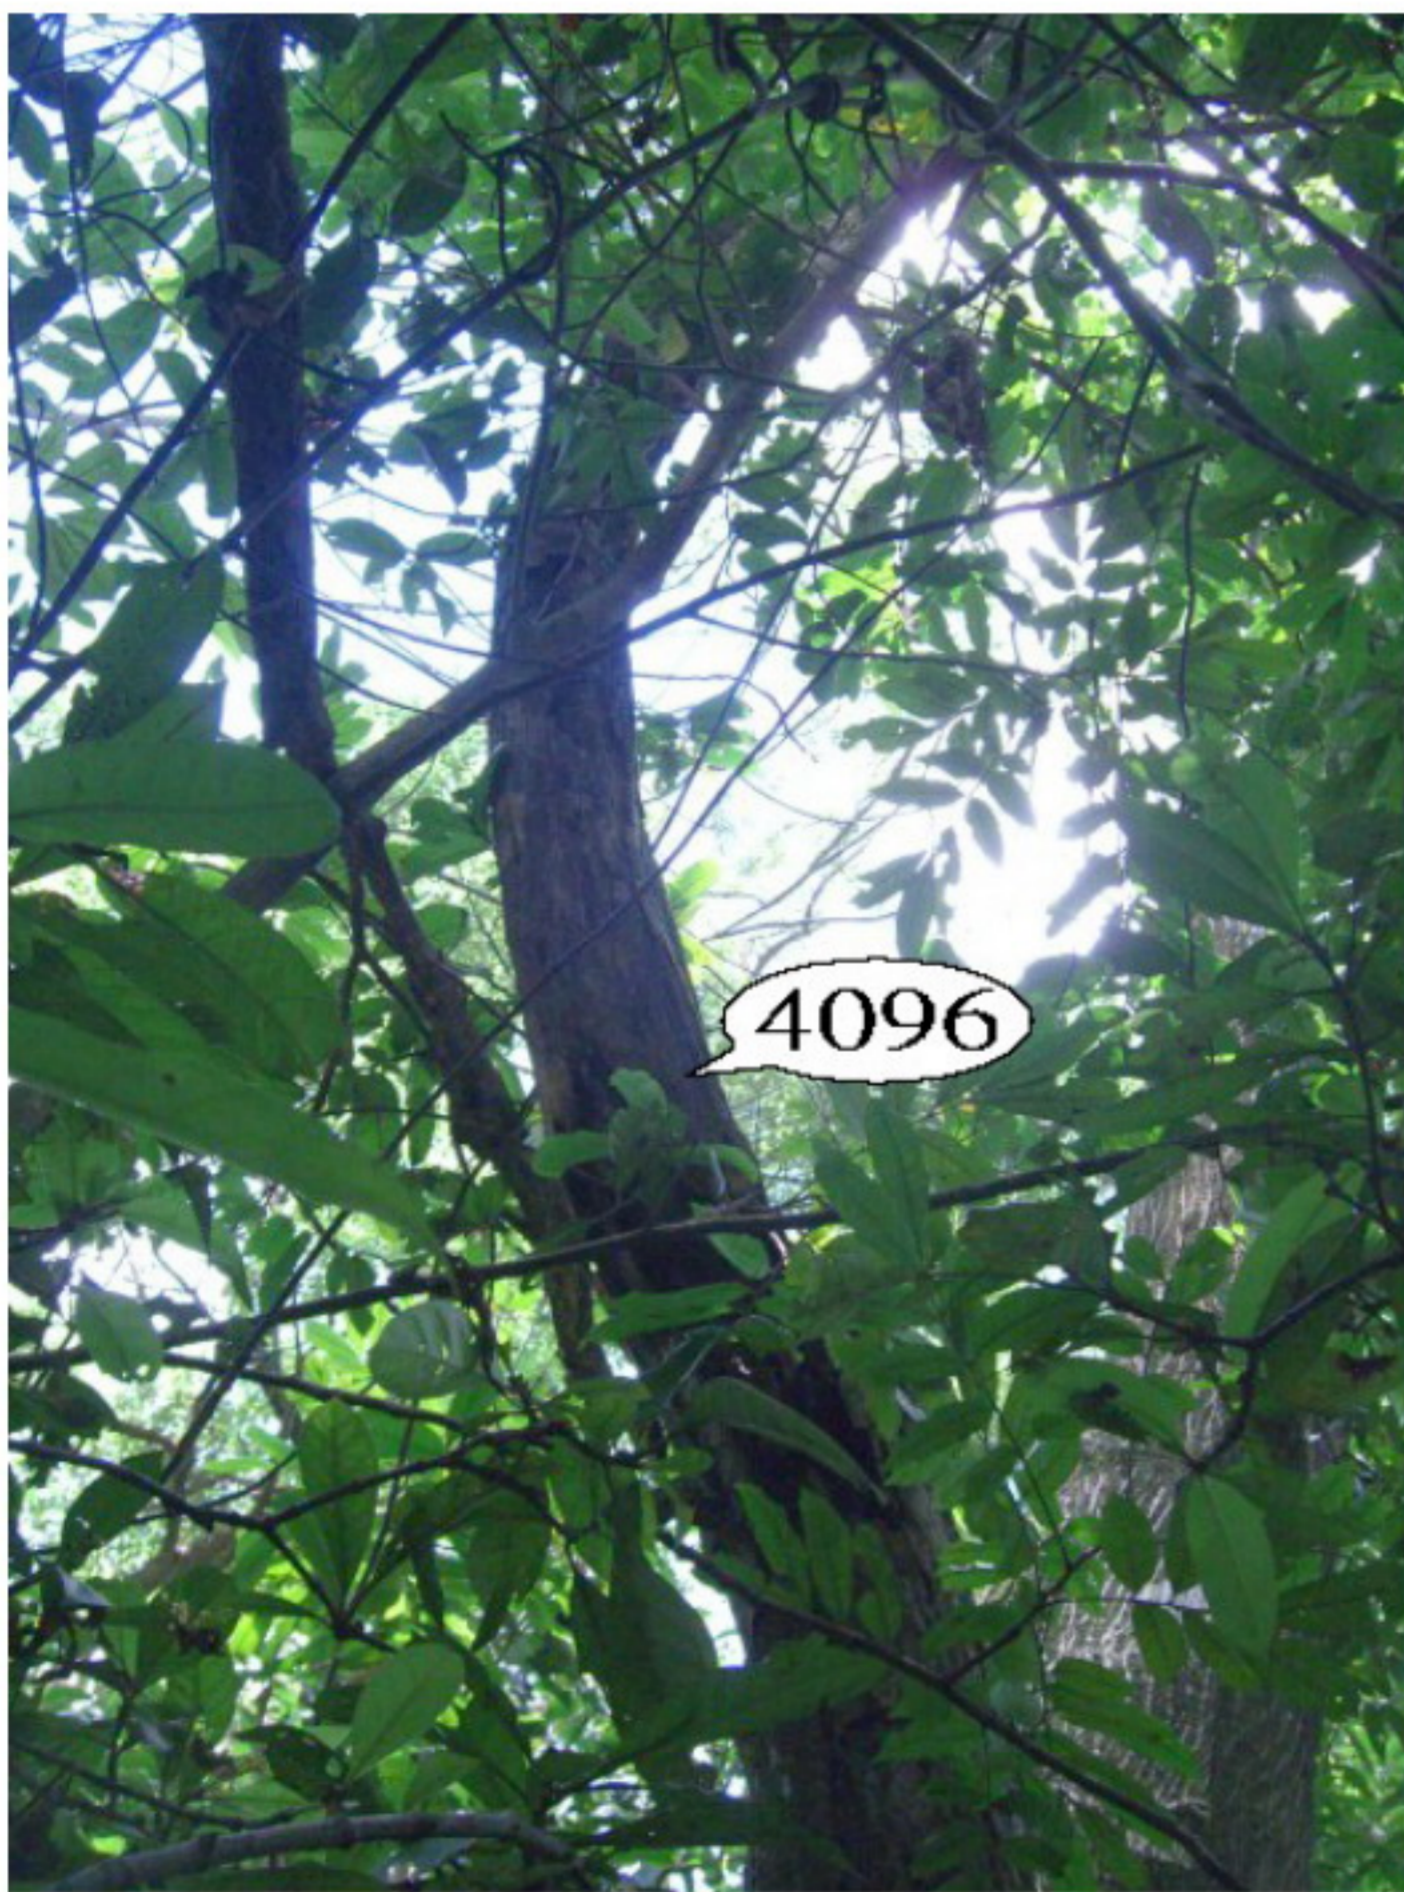
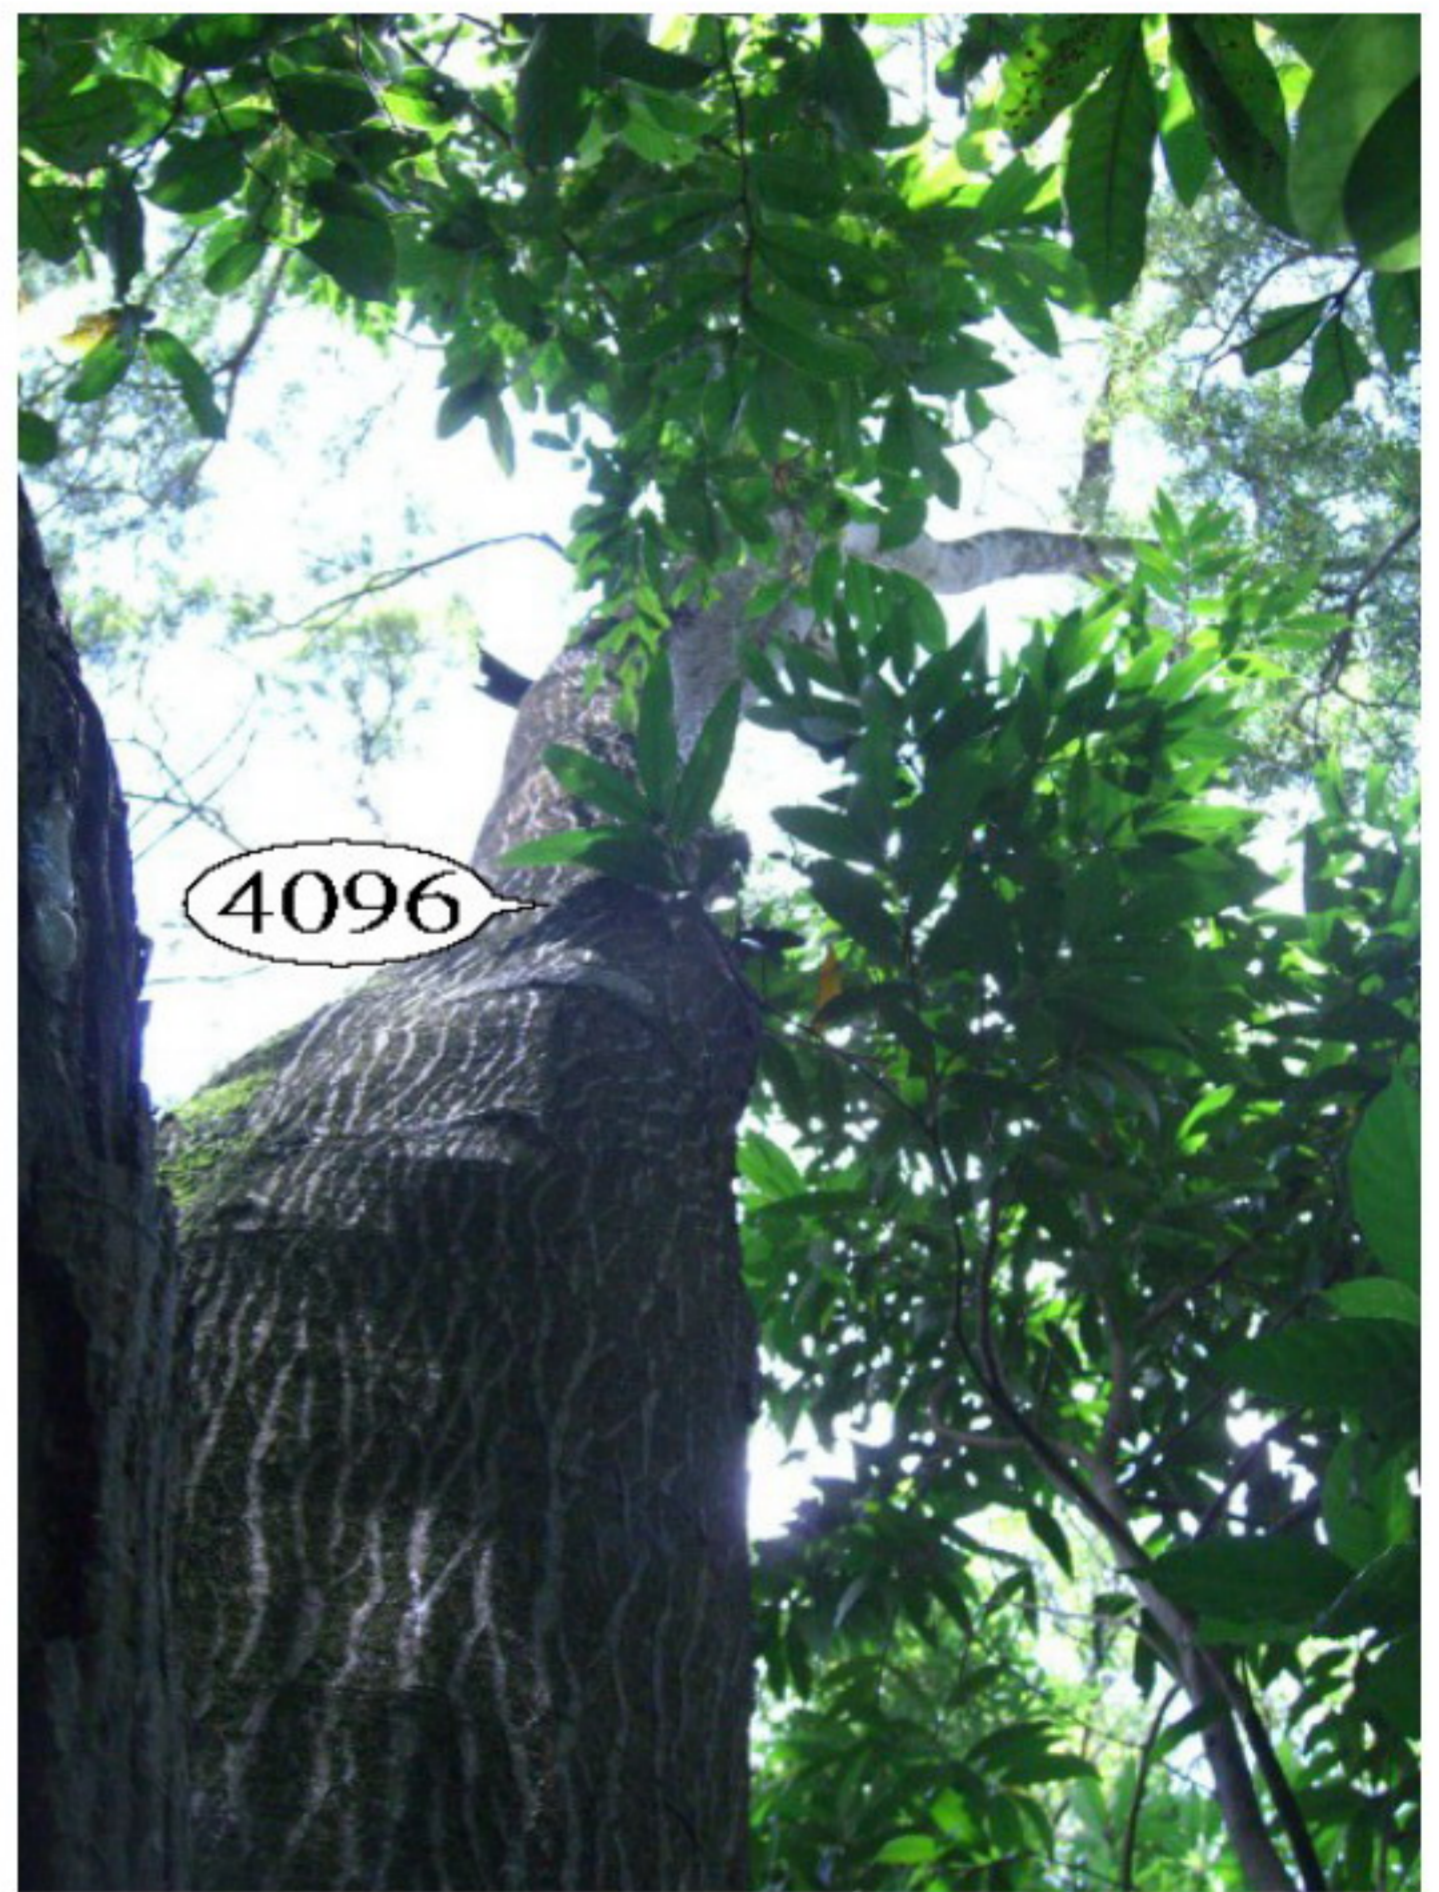
Tree 4096  
Poor health lead to low transplantation survival rate. Branches decay was found.

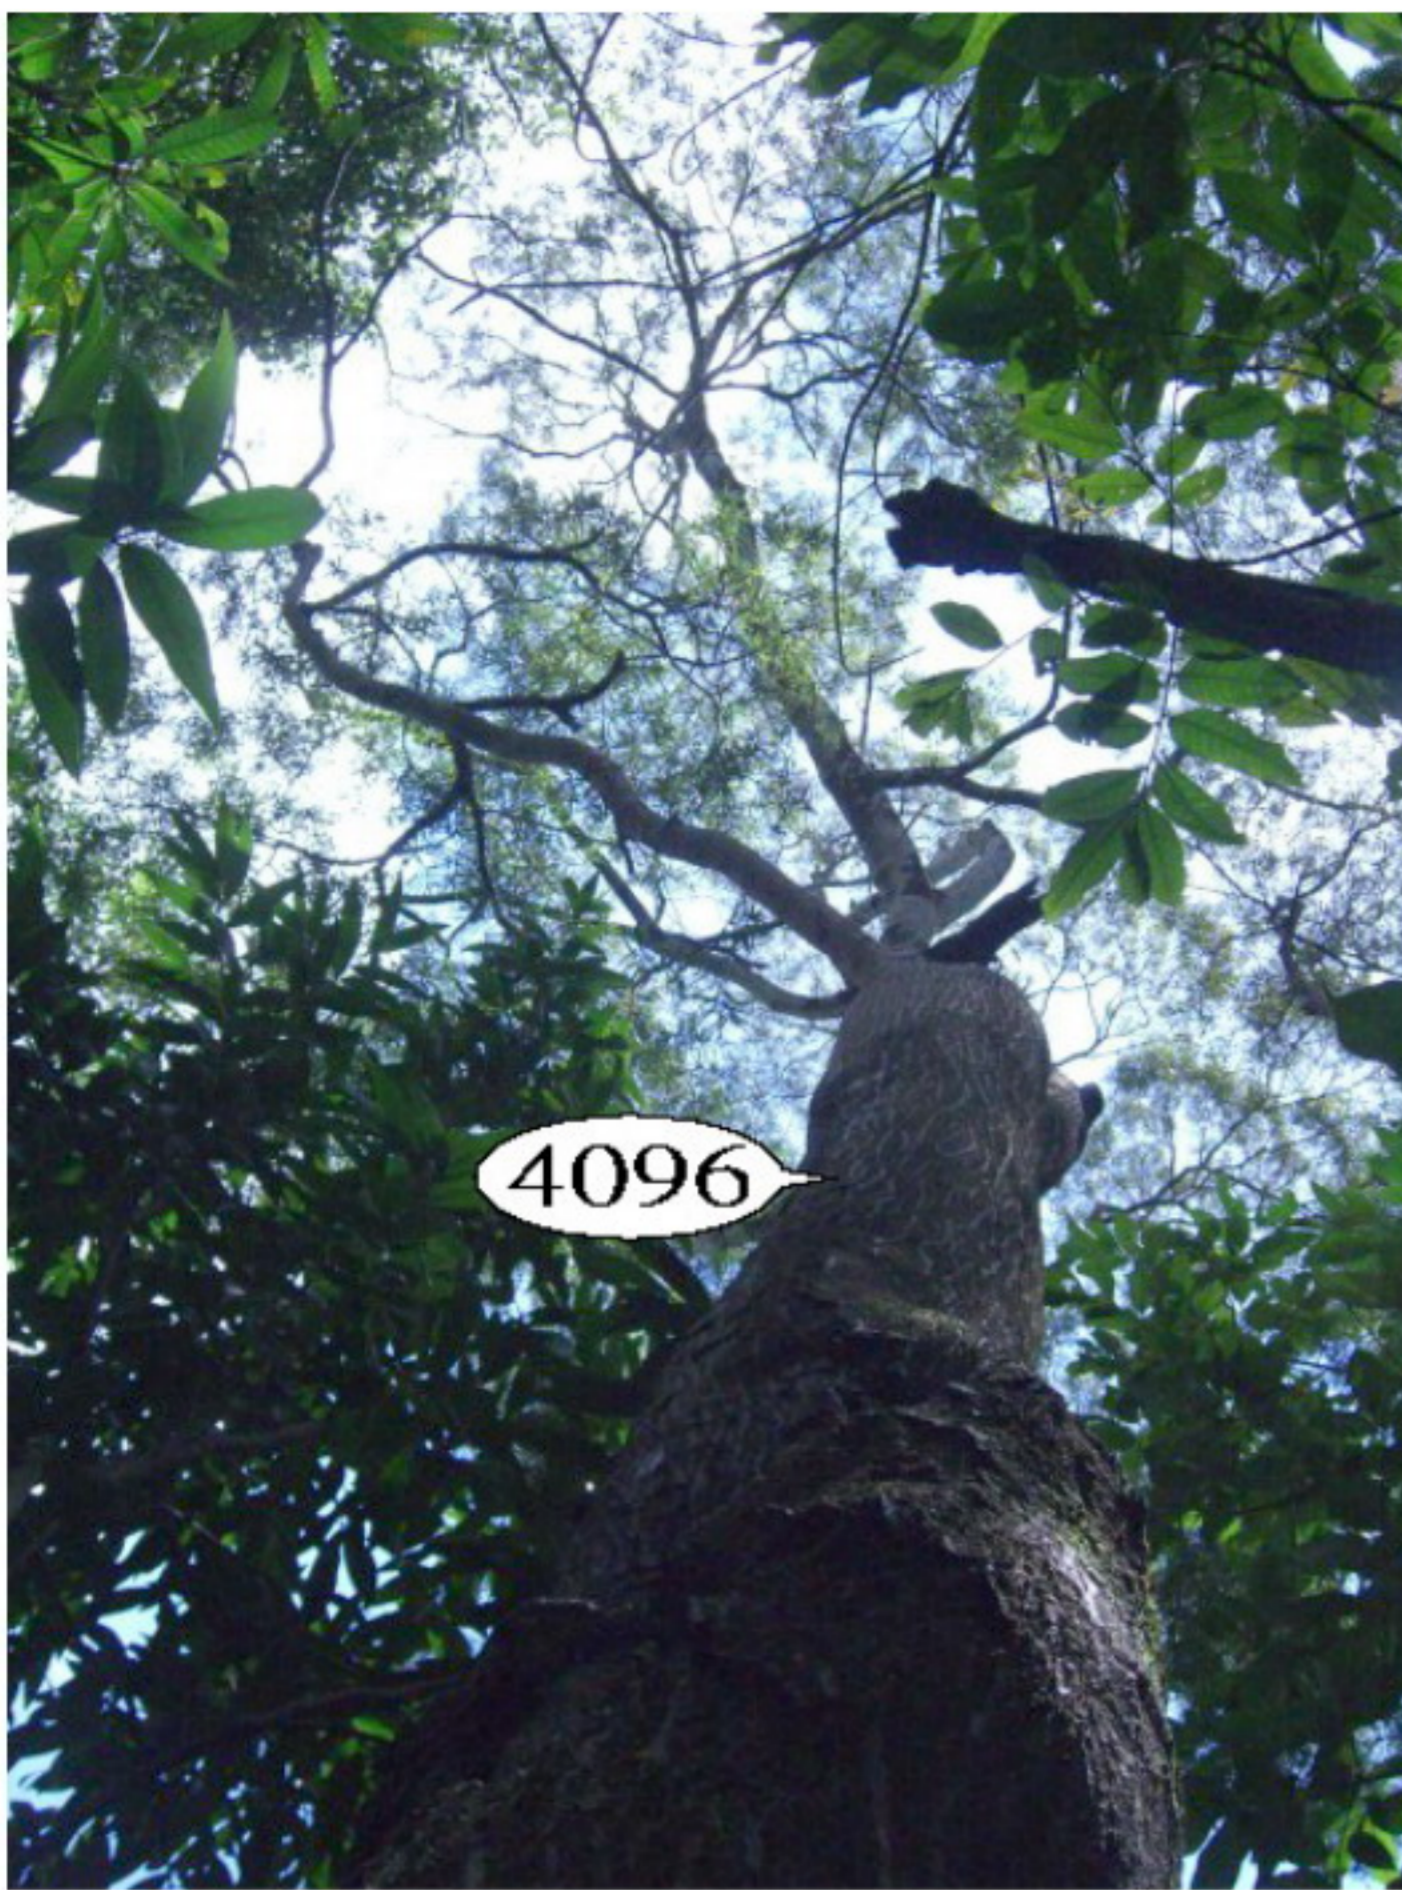
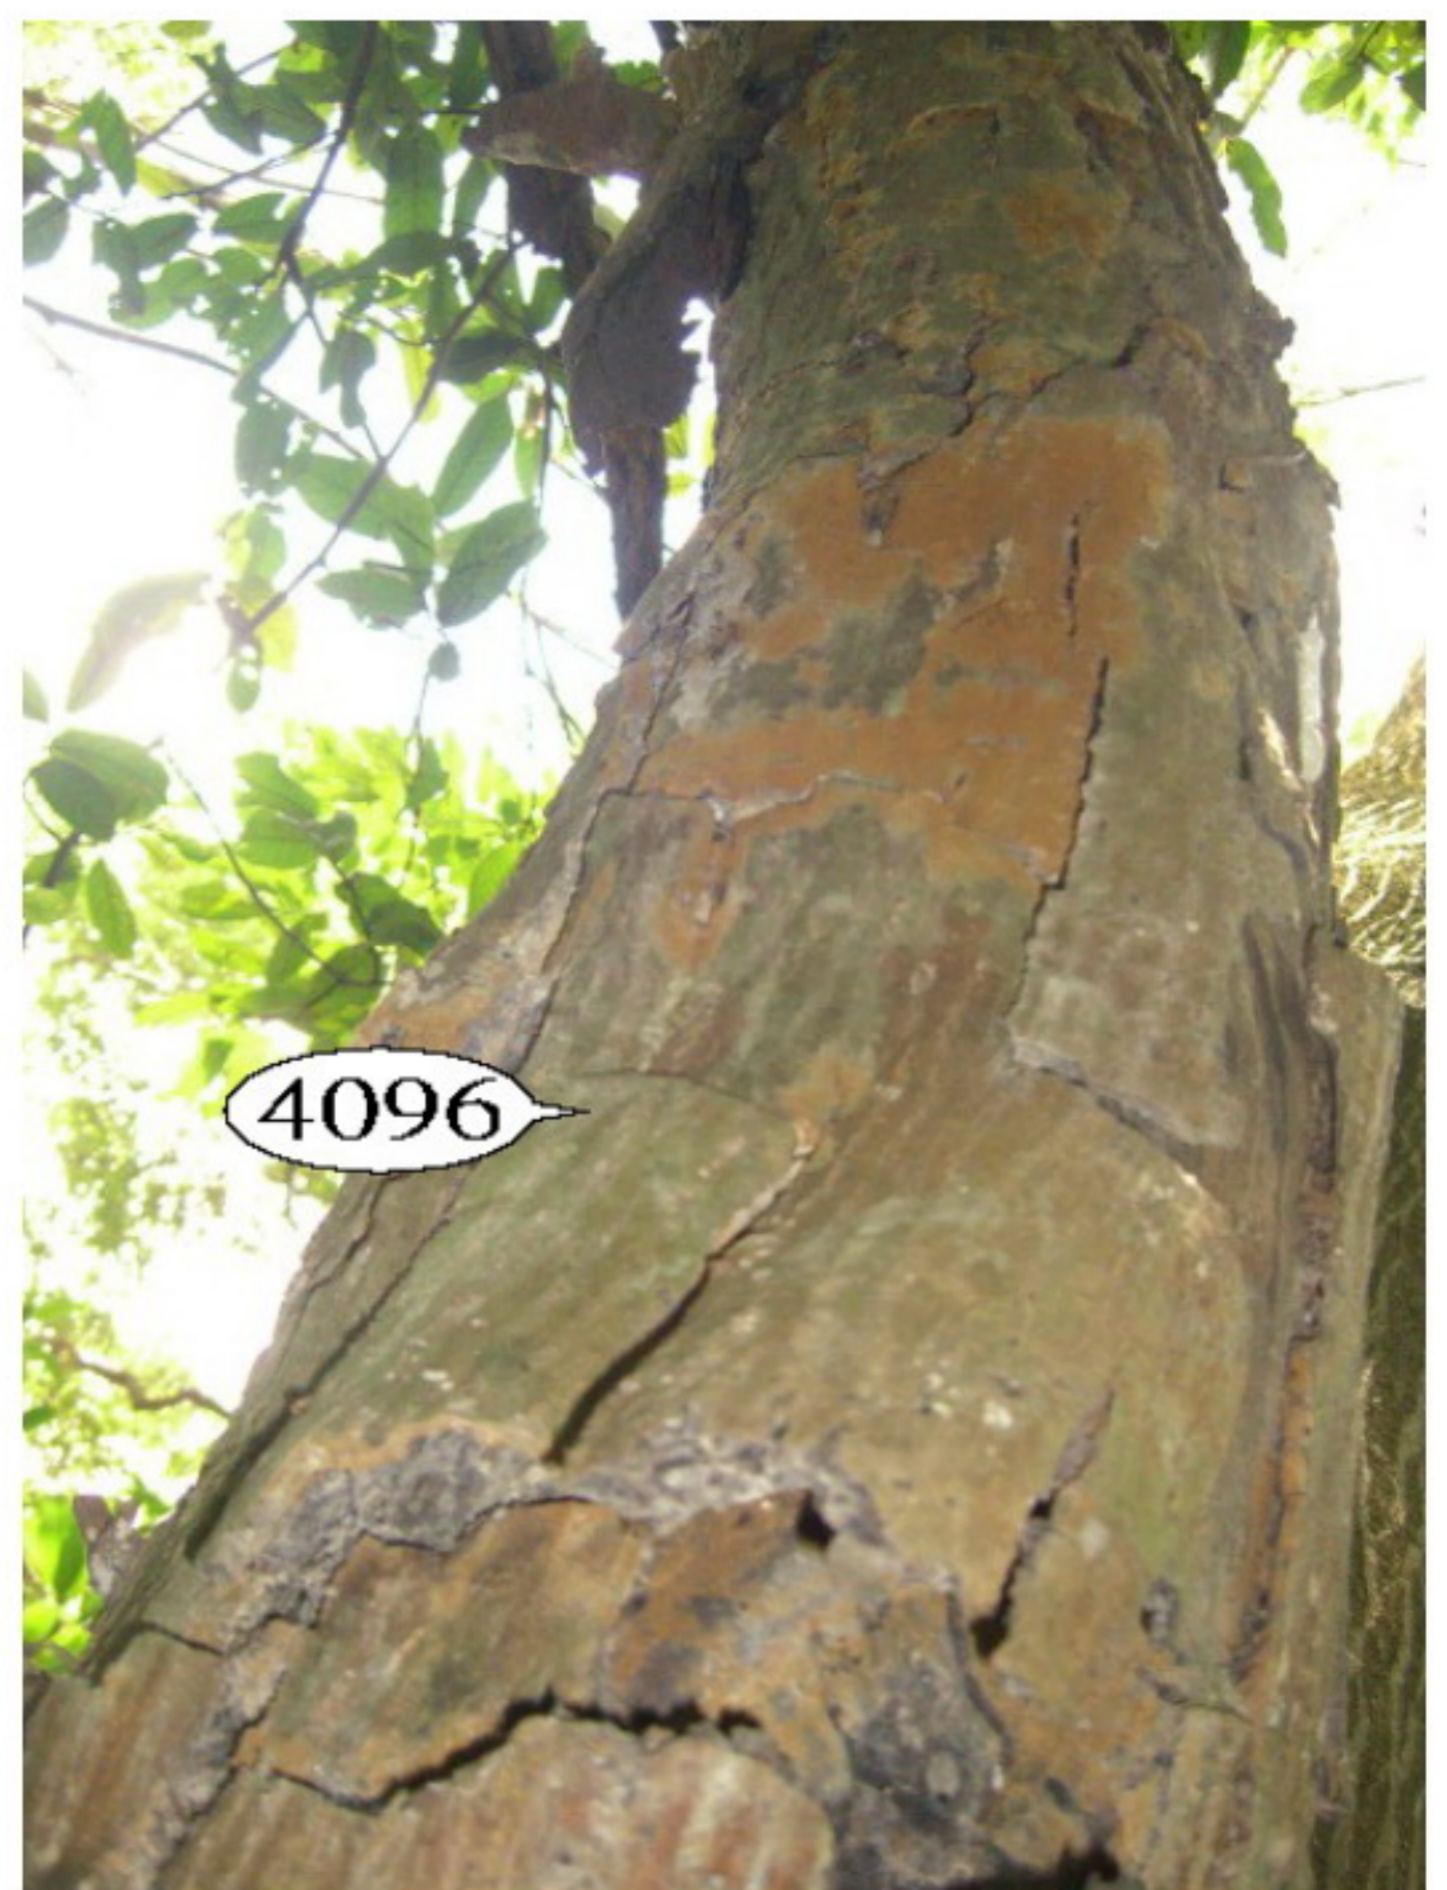
Tree 4096

Poor health lead to low transplantation survival rate. Branches decay was found.

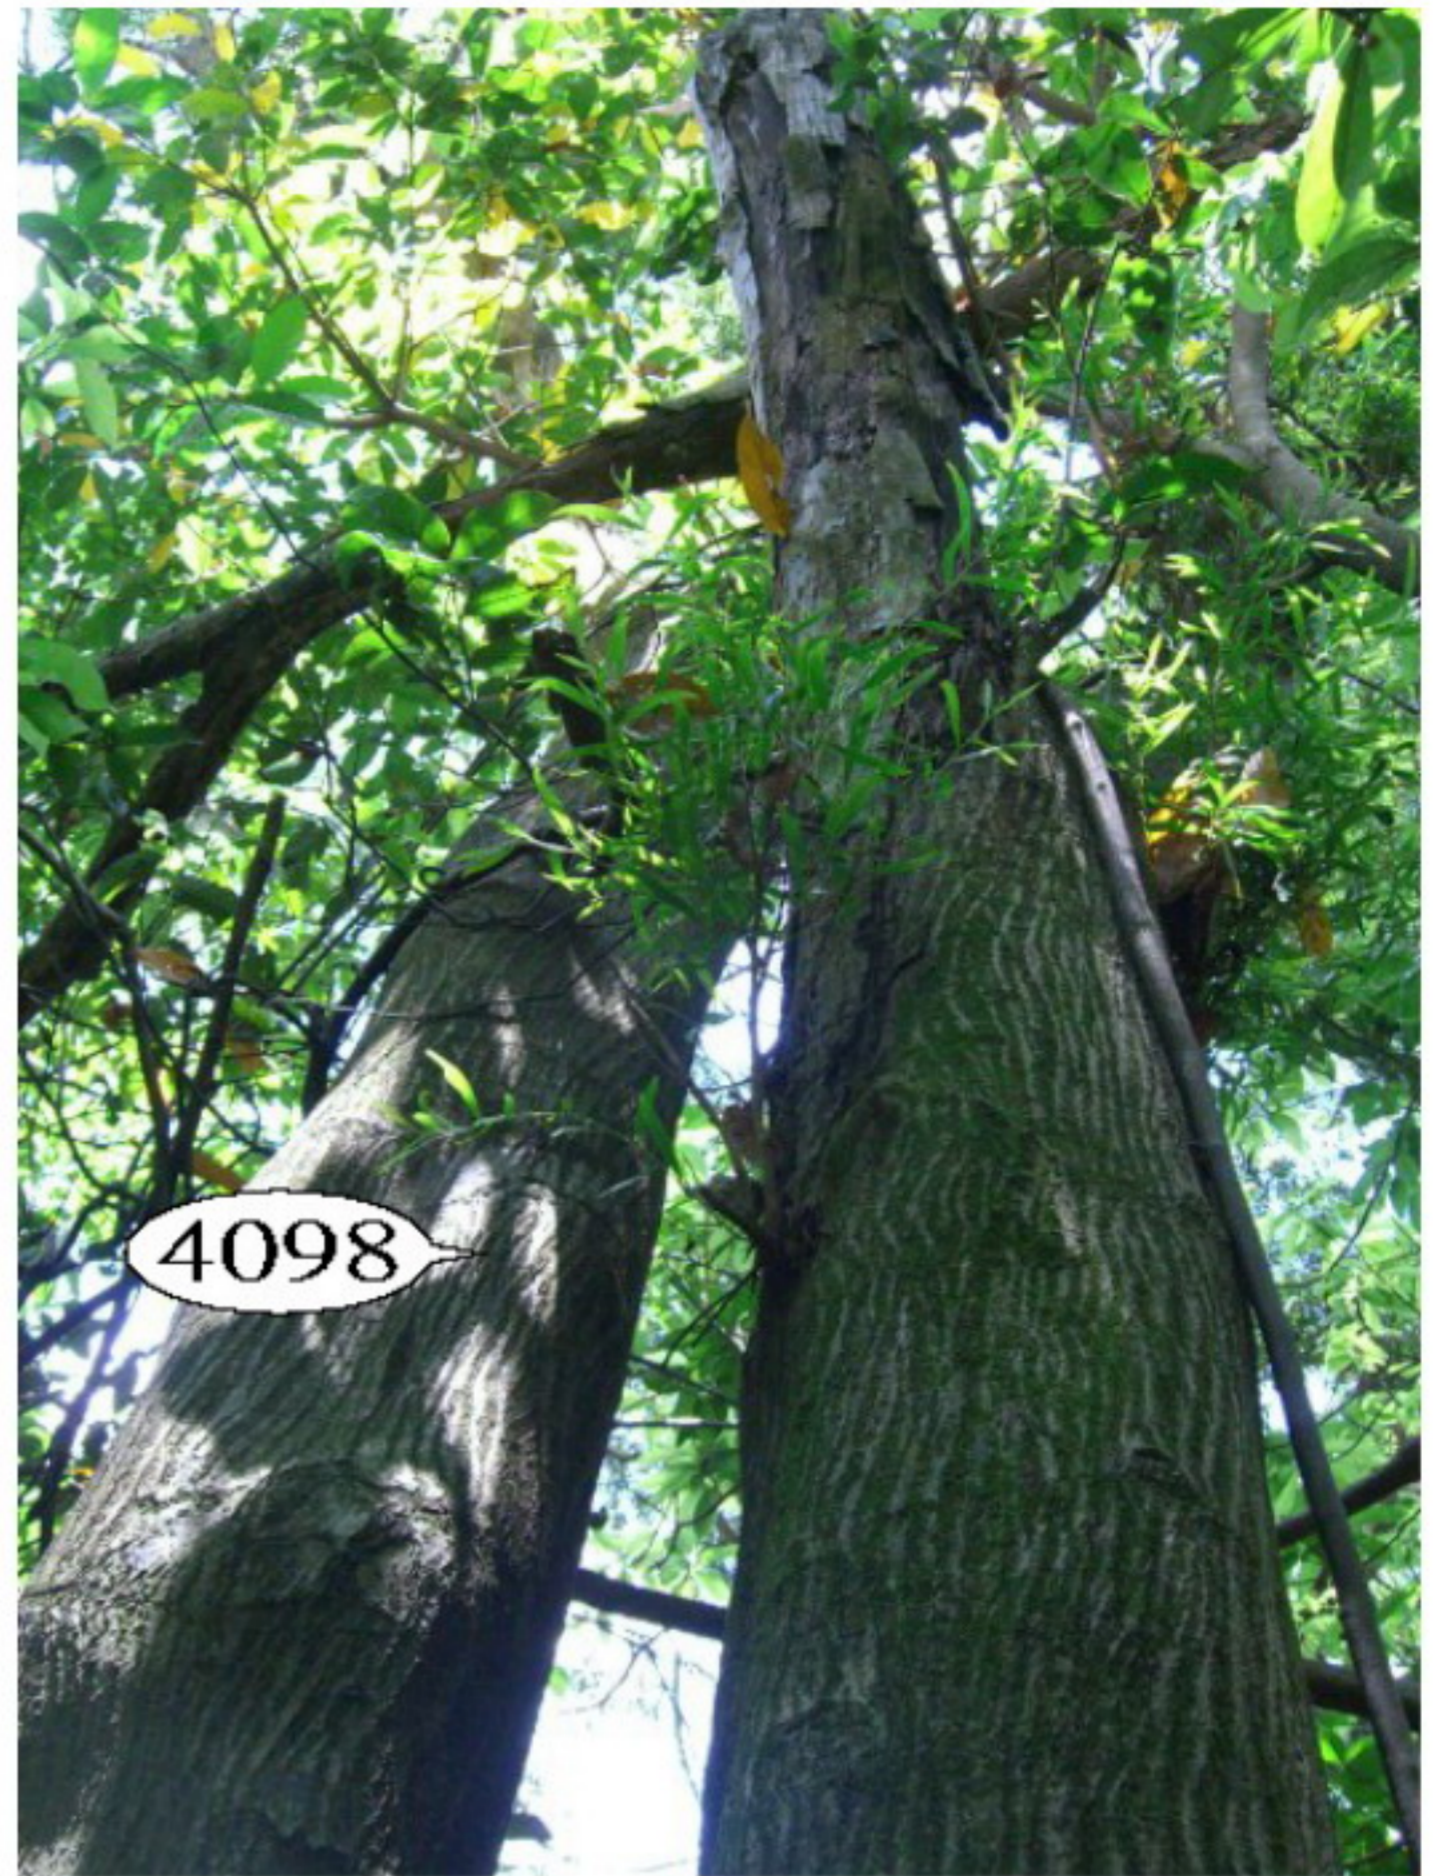
Tree 4098  
Poor health lead to low transplantation survival rate.

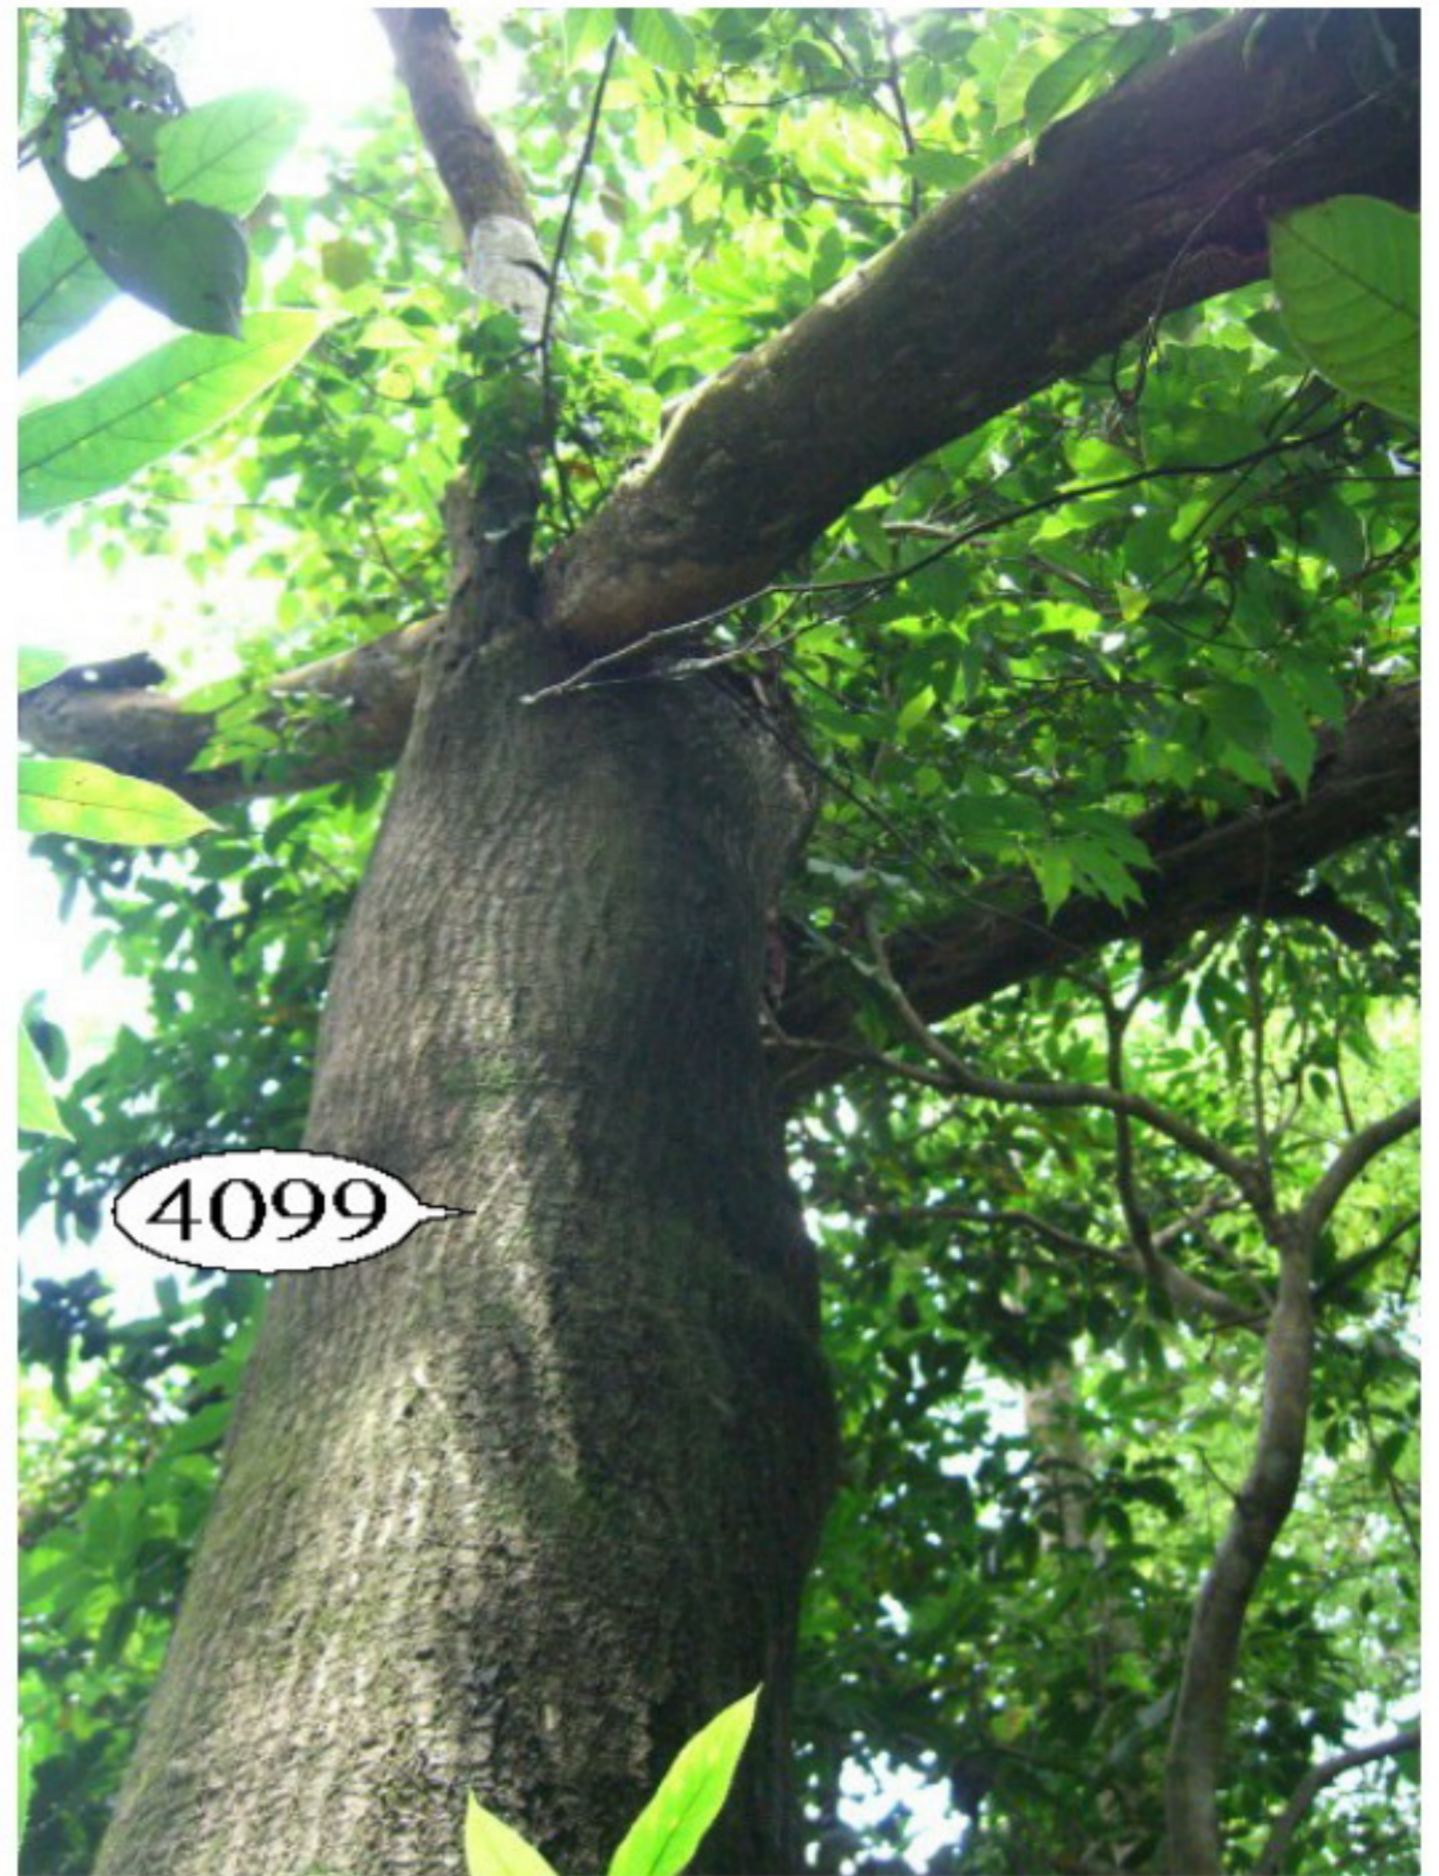
Tree 4099  
Poor health lead to low transplantation survival rate.
